**Exterior Housing Conditions Study**  
County of El Dorado

**Submitted to:**  
Daniel Nielson, MPA, Director  
Health and Human Services Agency  
County of El Dorado

**February 8, 2012**

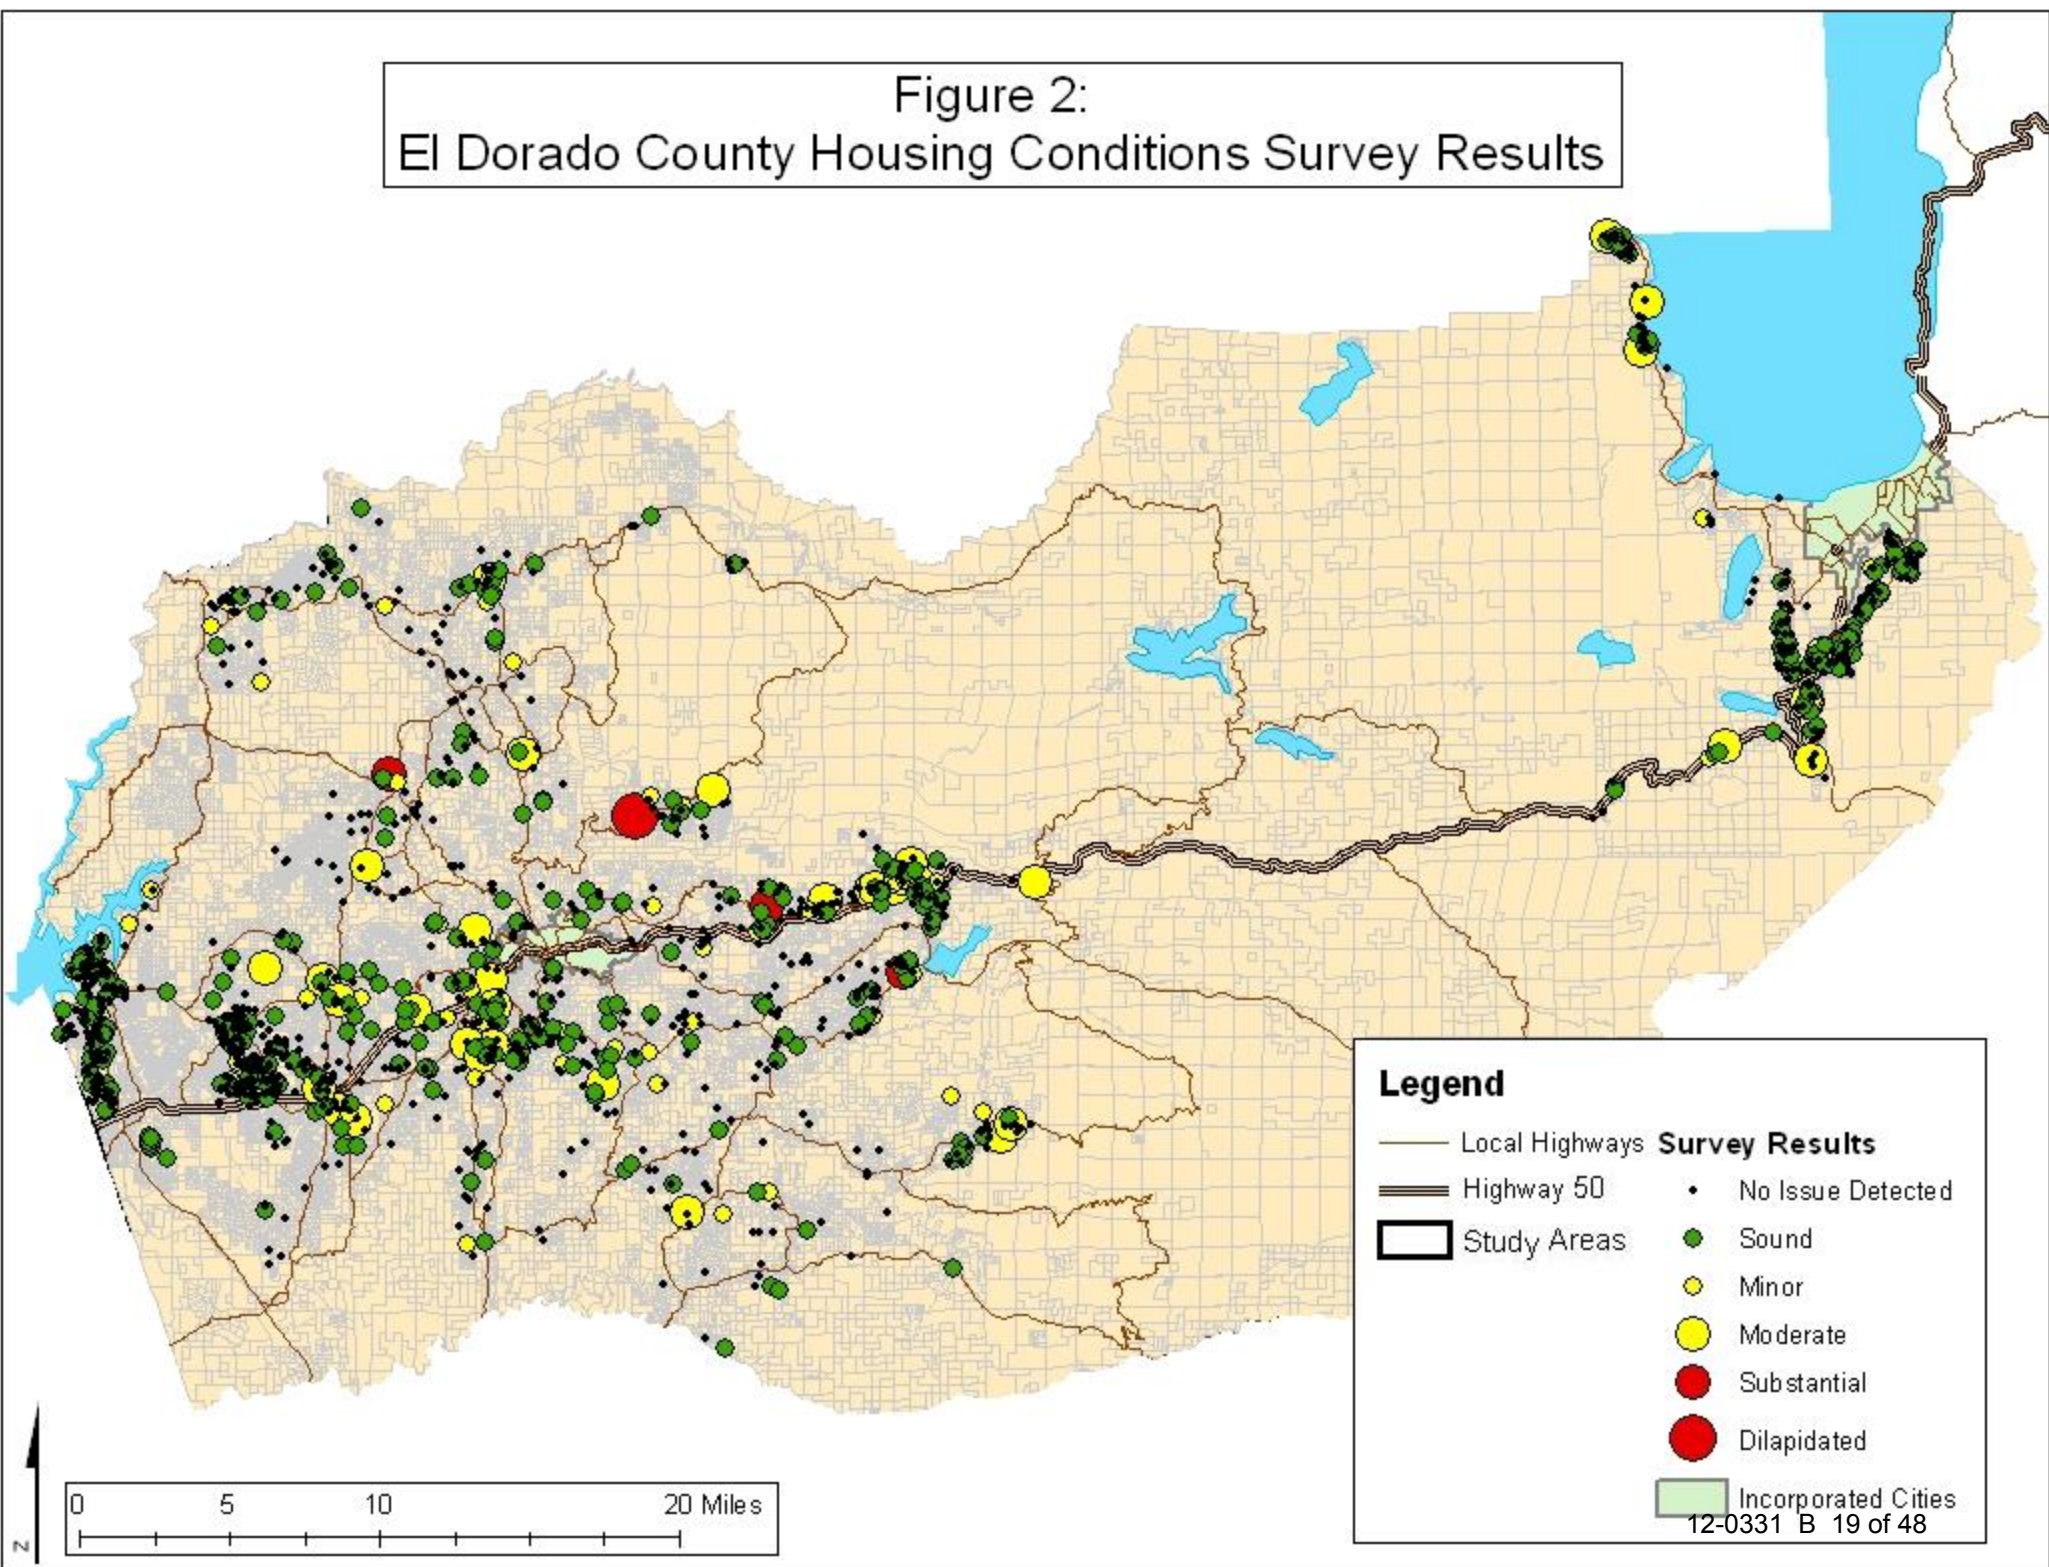
Figure 2:  
El Dorado County Housing Conditions Survey Results

As shown in Figure 2 on page 15, which maps the location of all residential parcels surveyed, dwelling units located along the U.S. Highway 50 corridor within approximately ten miles of the City of Placerville were particularly likely to be in need of minor or moderate repairs. Homes located within ten miles of Sacramento County were more likely to be in sound condition, with few

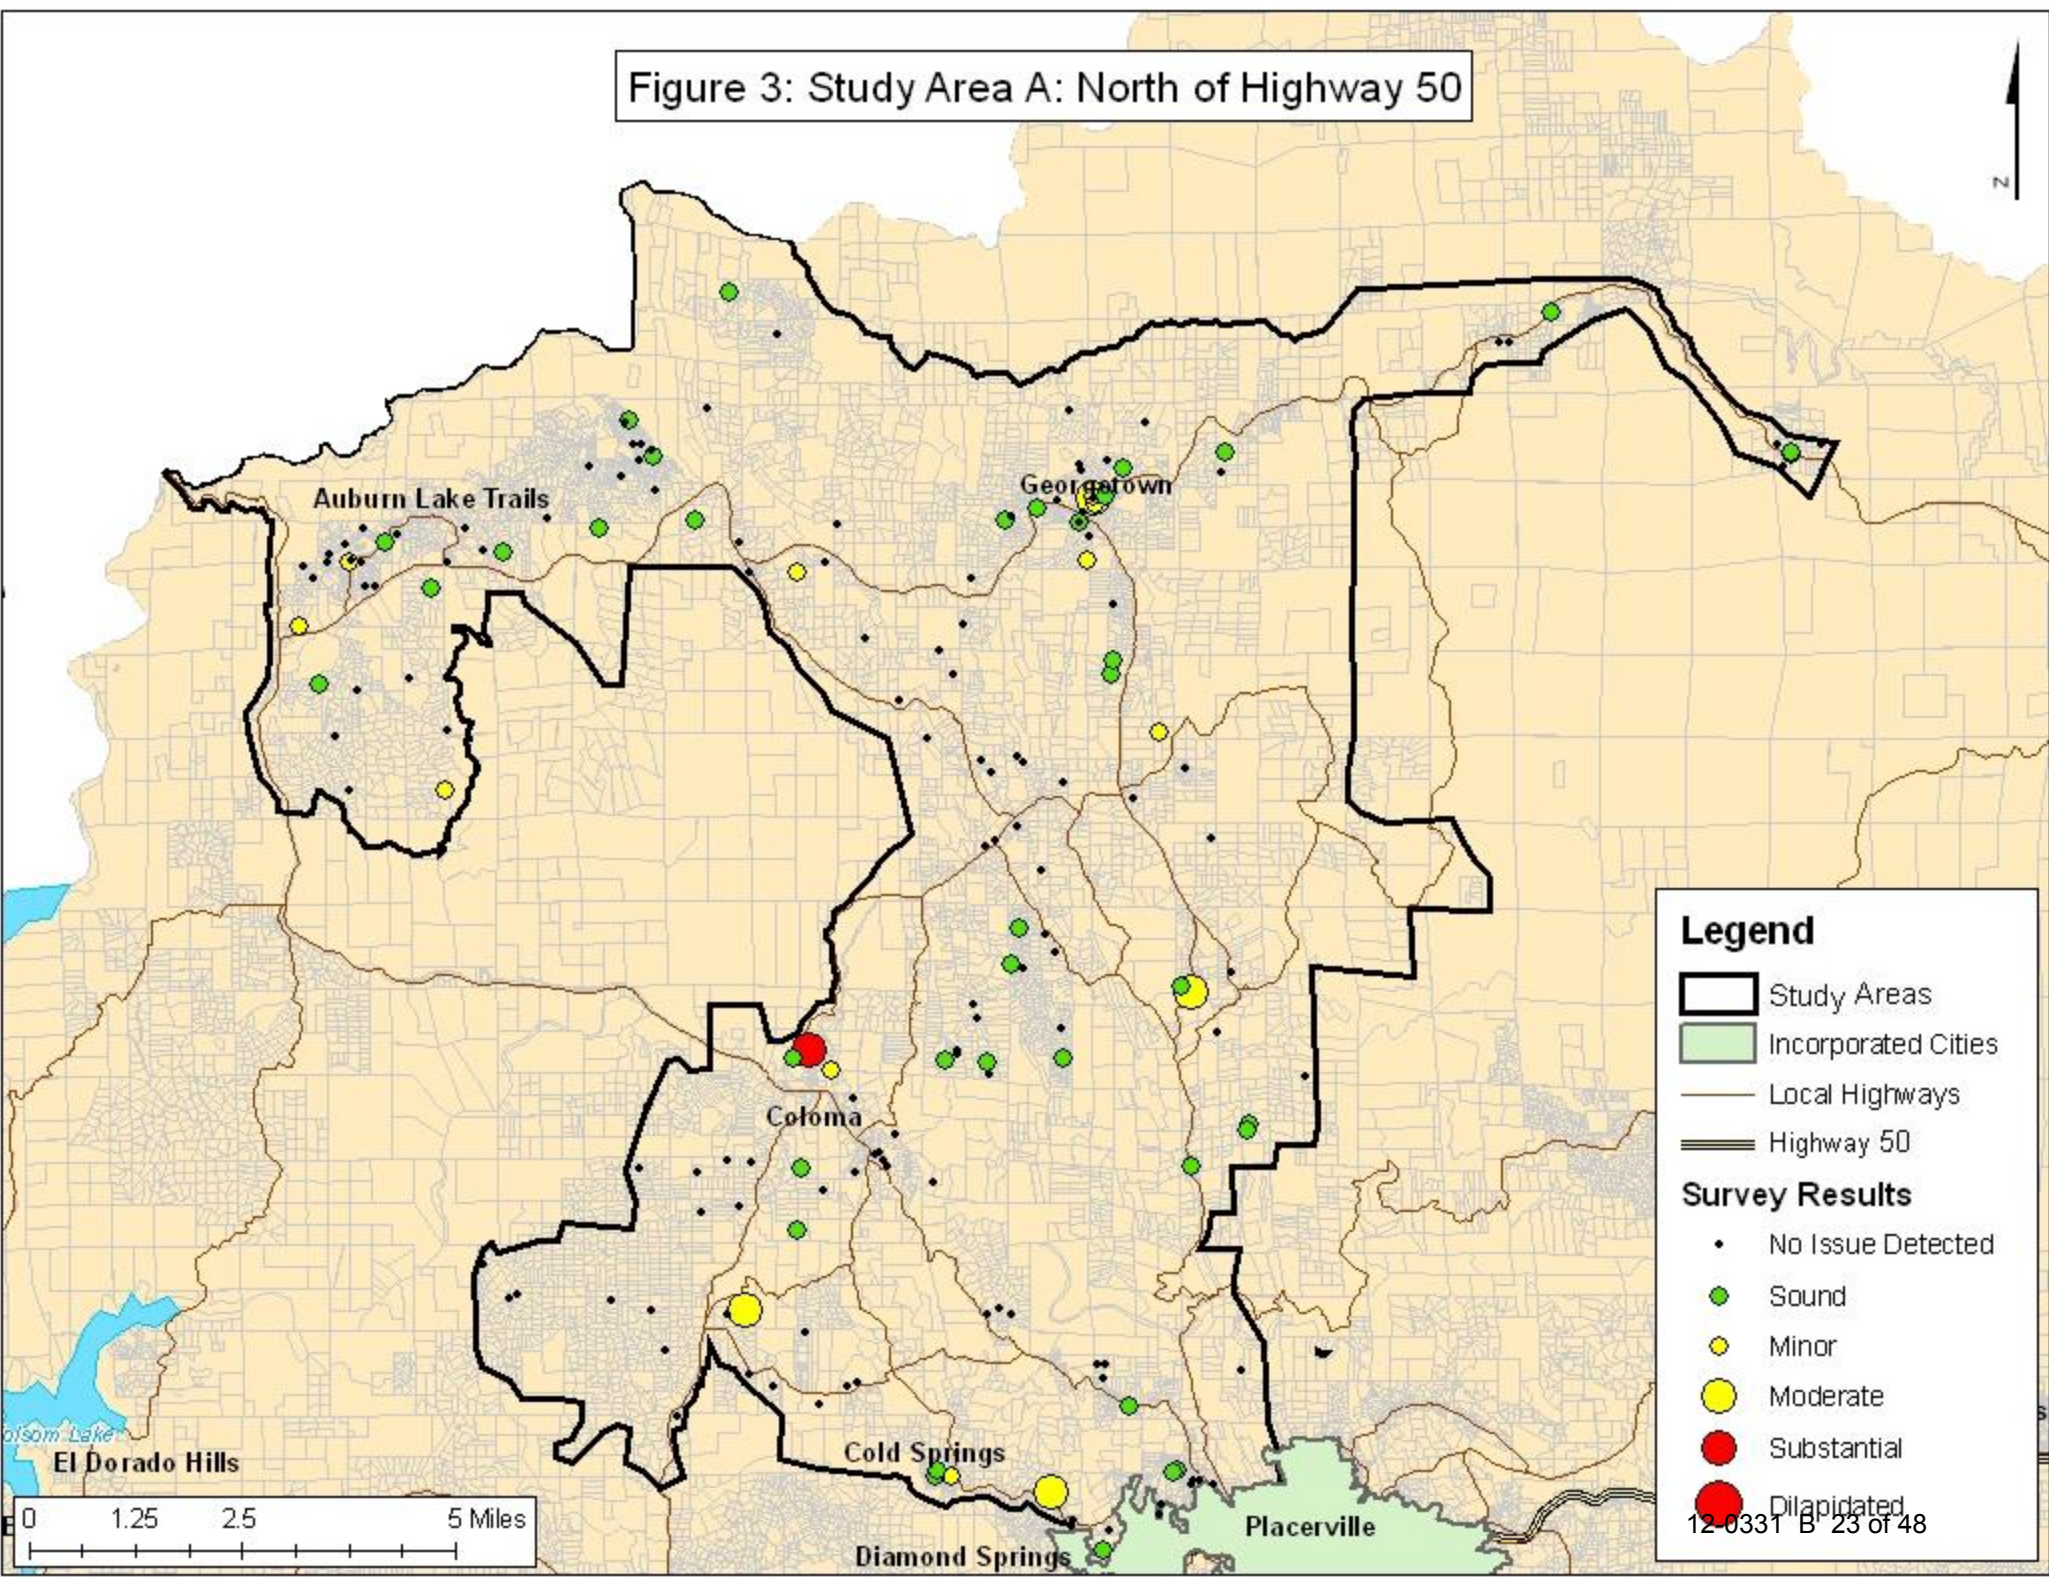
Figure 3: Study Area A: North of Highway 50

As shown in Figure 3 on page 19, which maps the location of all residential parcels surveyed, dwelling units located near Georgetown and Cold Springs were particularly likely to be in need of minor or moderate repairs. Additionally, though classified as “sound” by the scoring system, several homes were identified in need of maintenance within the Auburn Lake Trails community and in the residential communities located along the north ridge above the American River.

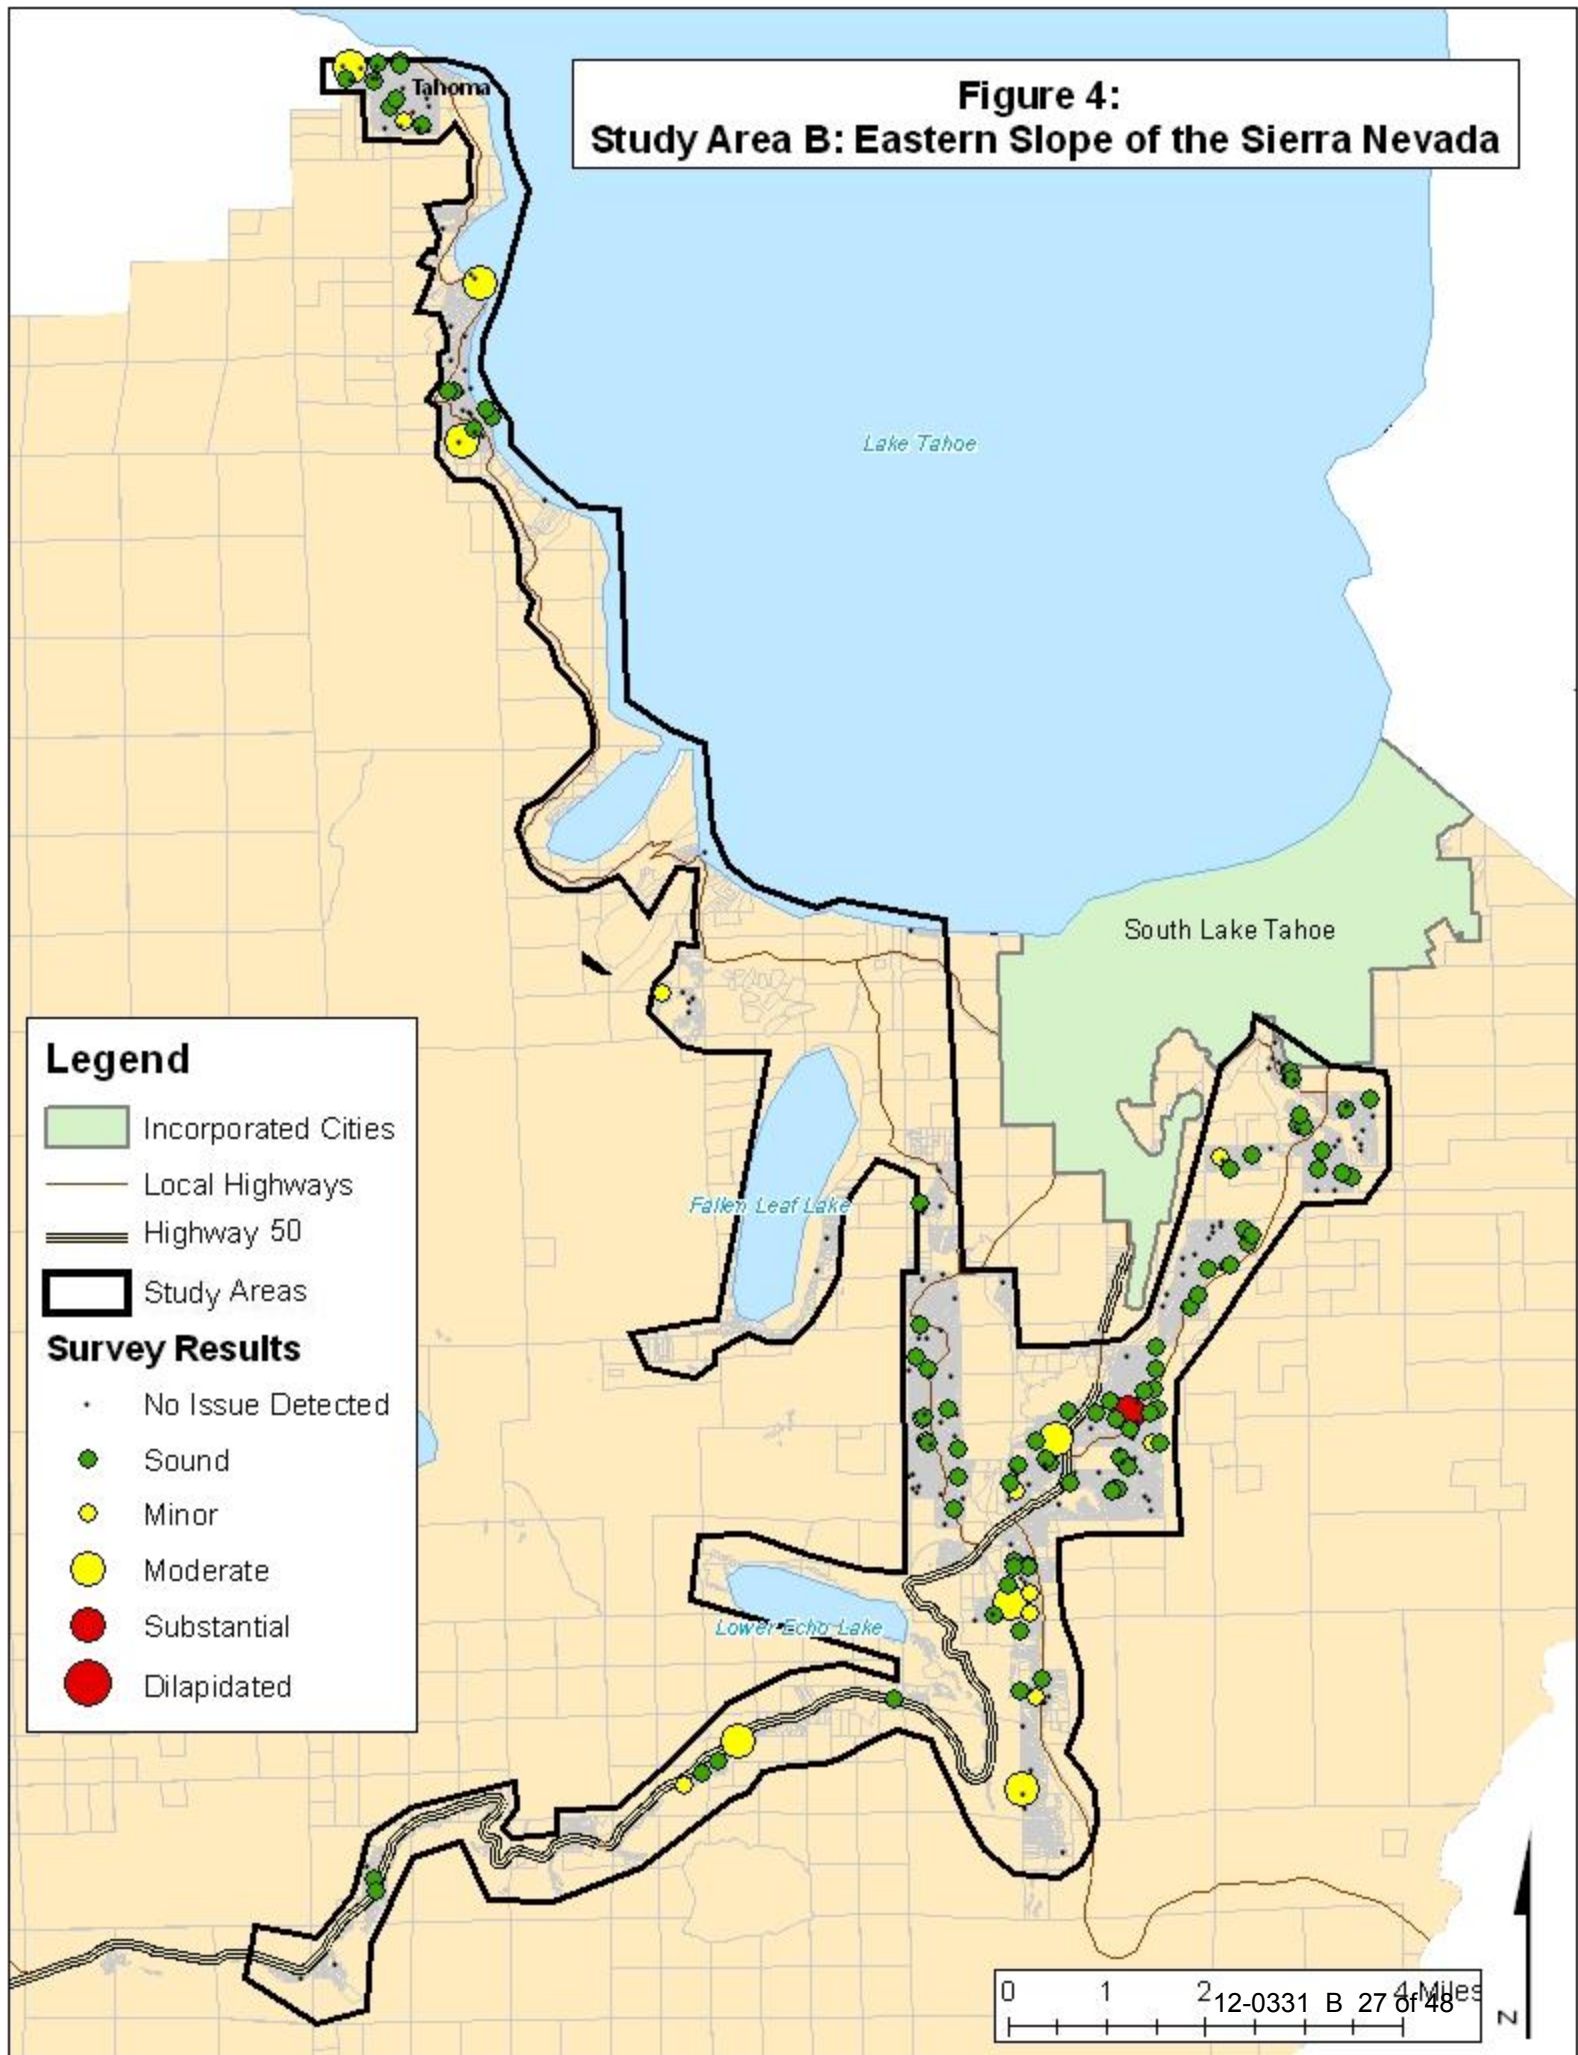
**Figure 4:**  
**Study Area B: Eastern Slope of the Sierra Nevada**

As shown in Figure 4 on page 23, which maps the location of all residential parcels surveyed in Study Area B, dwelling units located along Pioneer Trail Road, Upper Truckee Boulevard, and Luther Pass Road were particularly likely to be in need of minor to substantial repairs. Several homes located near these thoroughfares were classified as “sound” by the scoring system, but were nonetheless in need of maintenance. There was also a significant number of homes in need of repair located in the communities of Tahoma and Meeks Bay, along the western shore of Lake Tahoe.

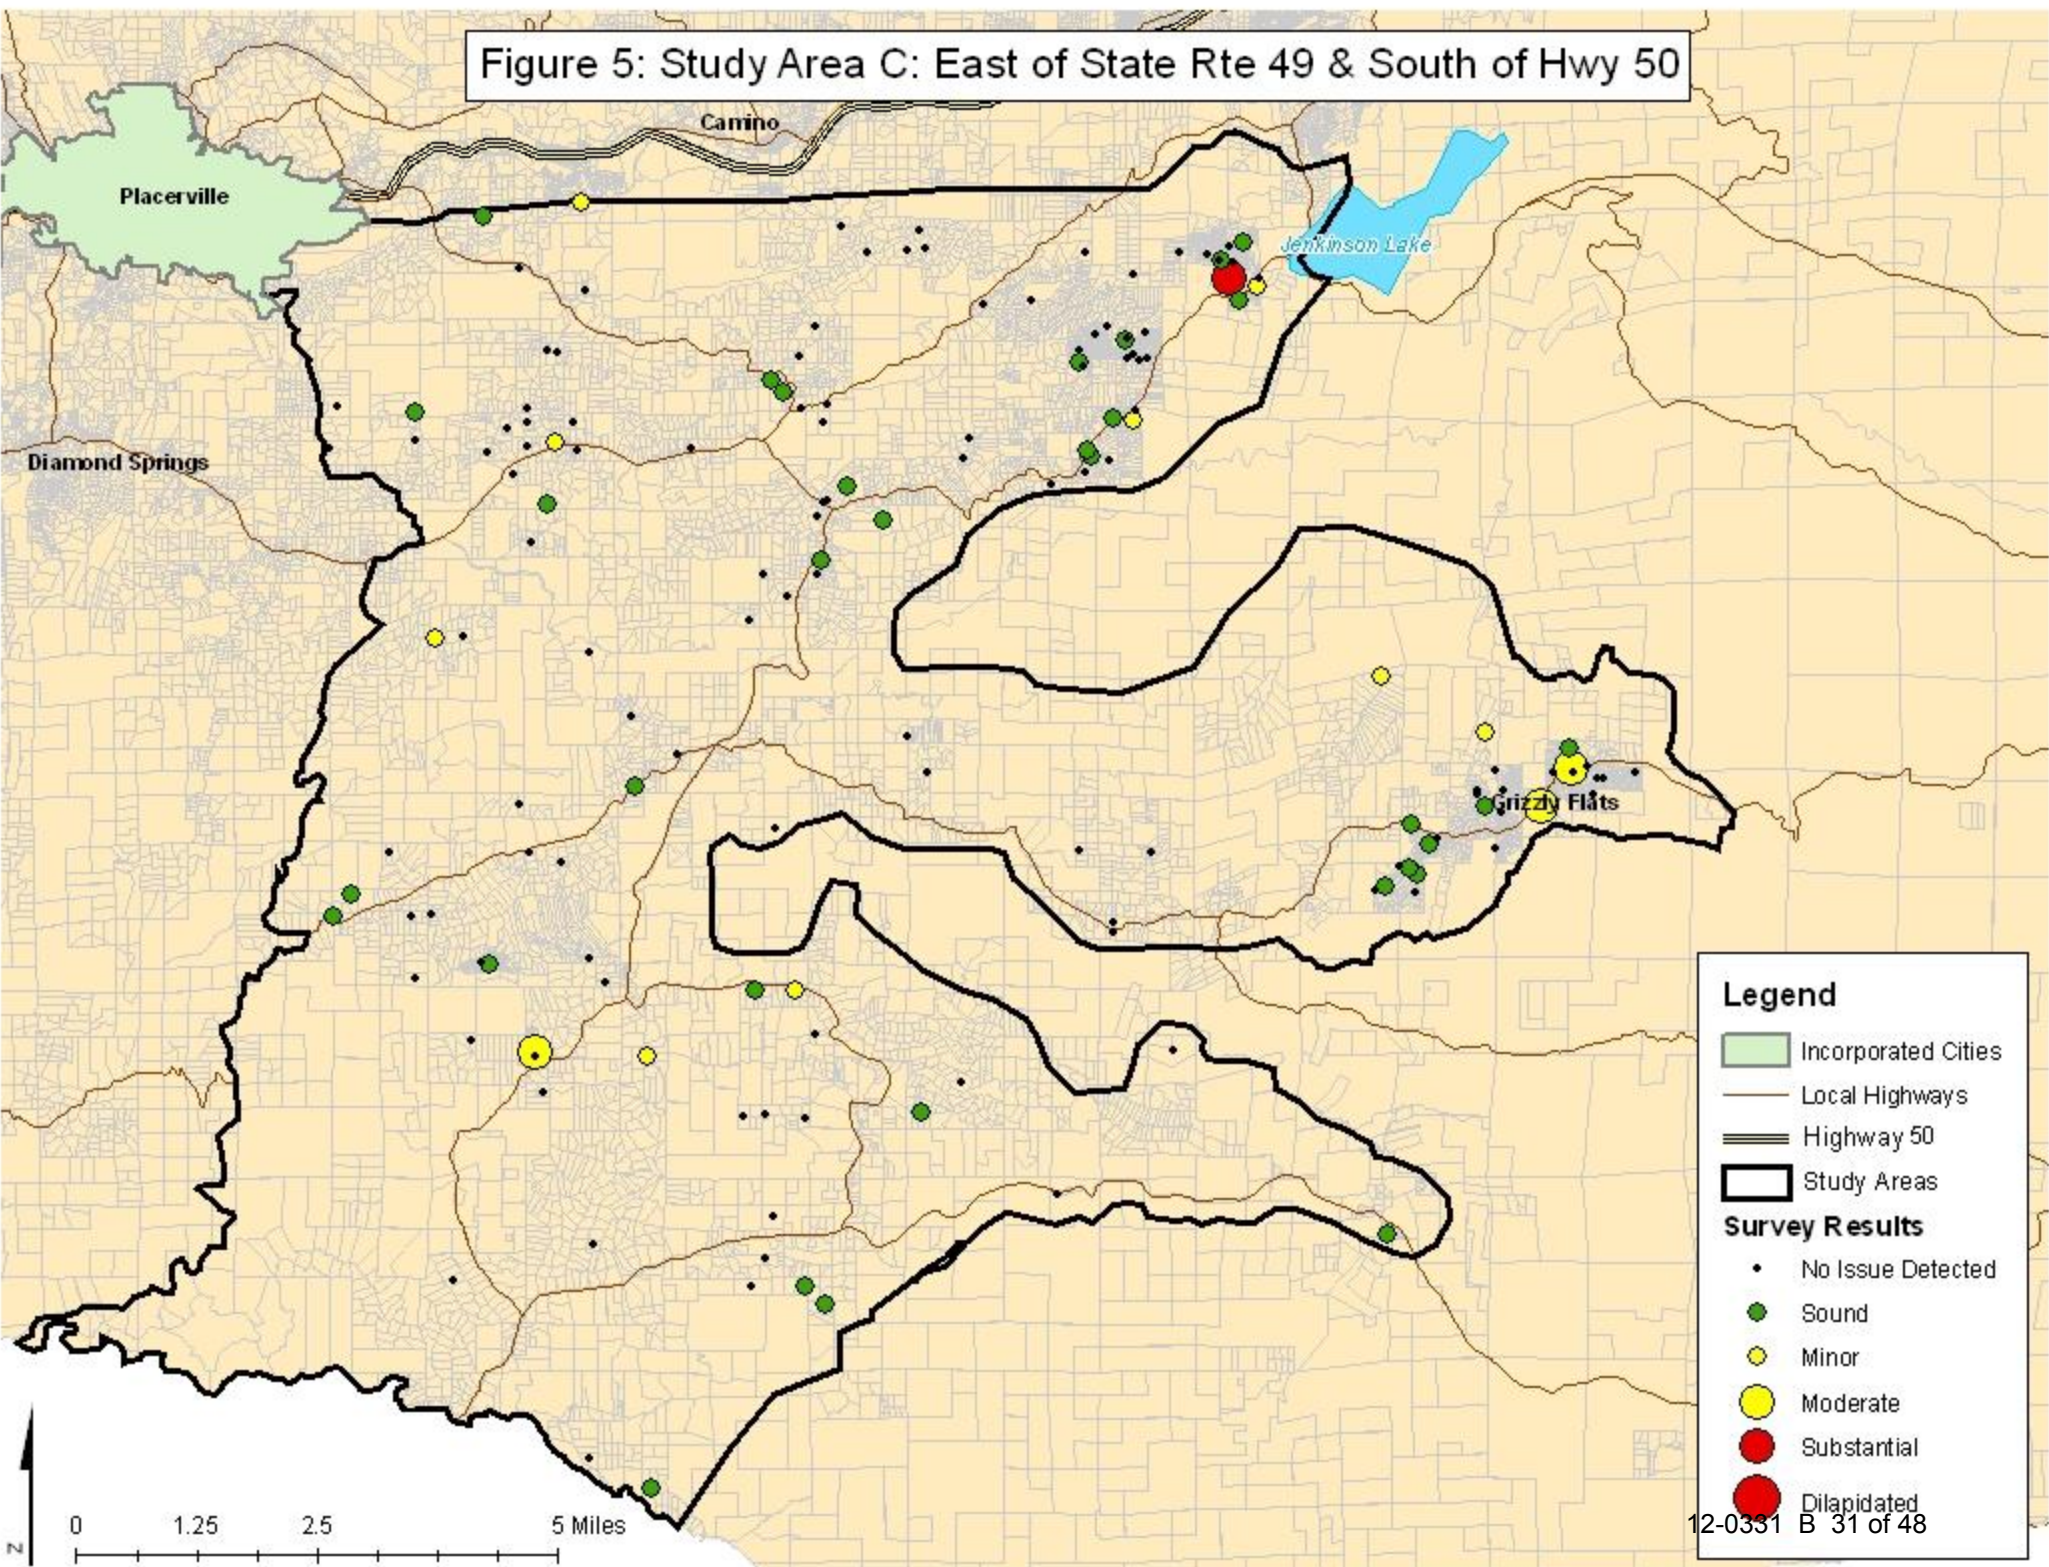
Figure 5: Study Area C: East of State Rte 49 & South of Hwy 50

As shown in Figure 5 on page 27, which maps the location of all residential parcels surveyed,

dwelling units located in the communities of Grizzly Flat, Sly Park, and Sierra Springs were particularly likely to be in need of minor to substantial repairs.

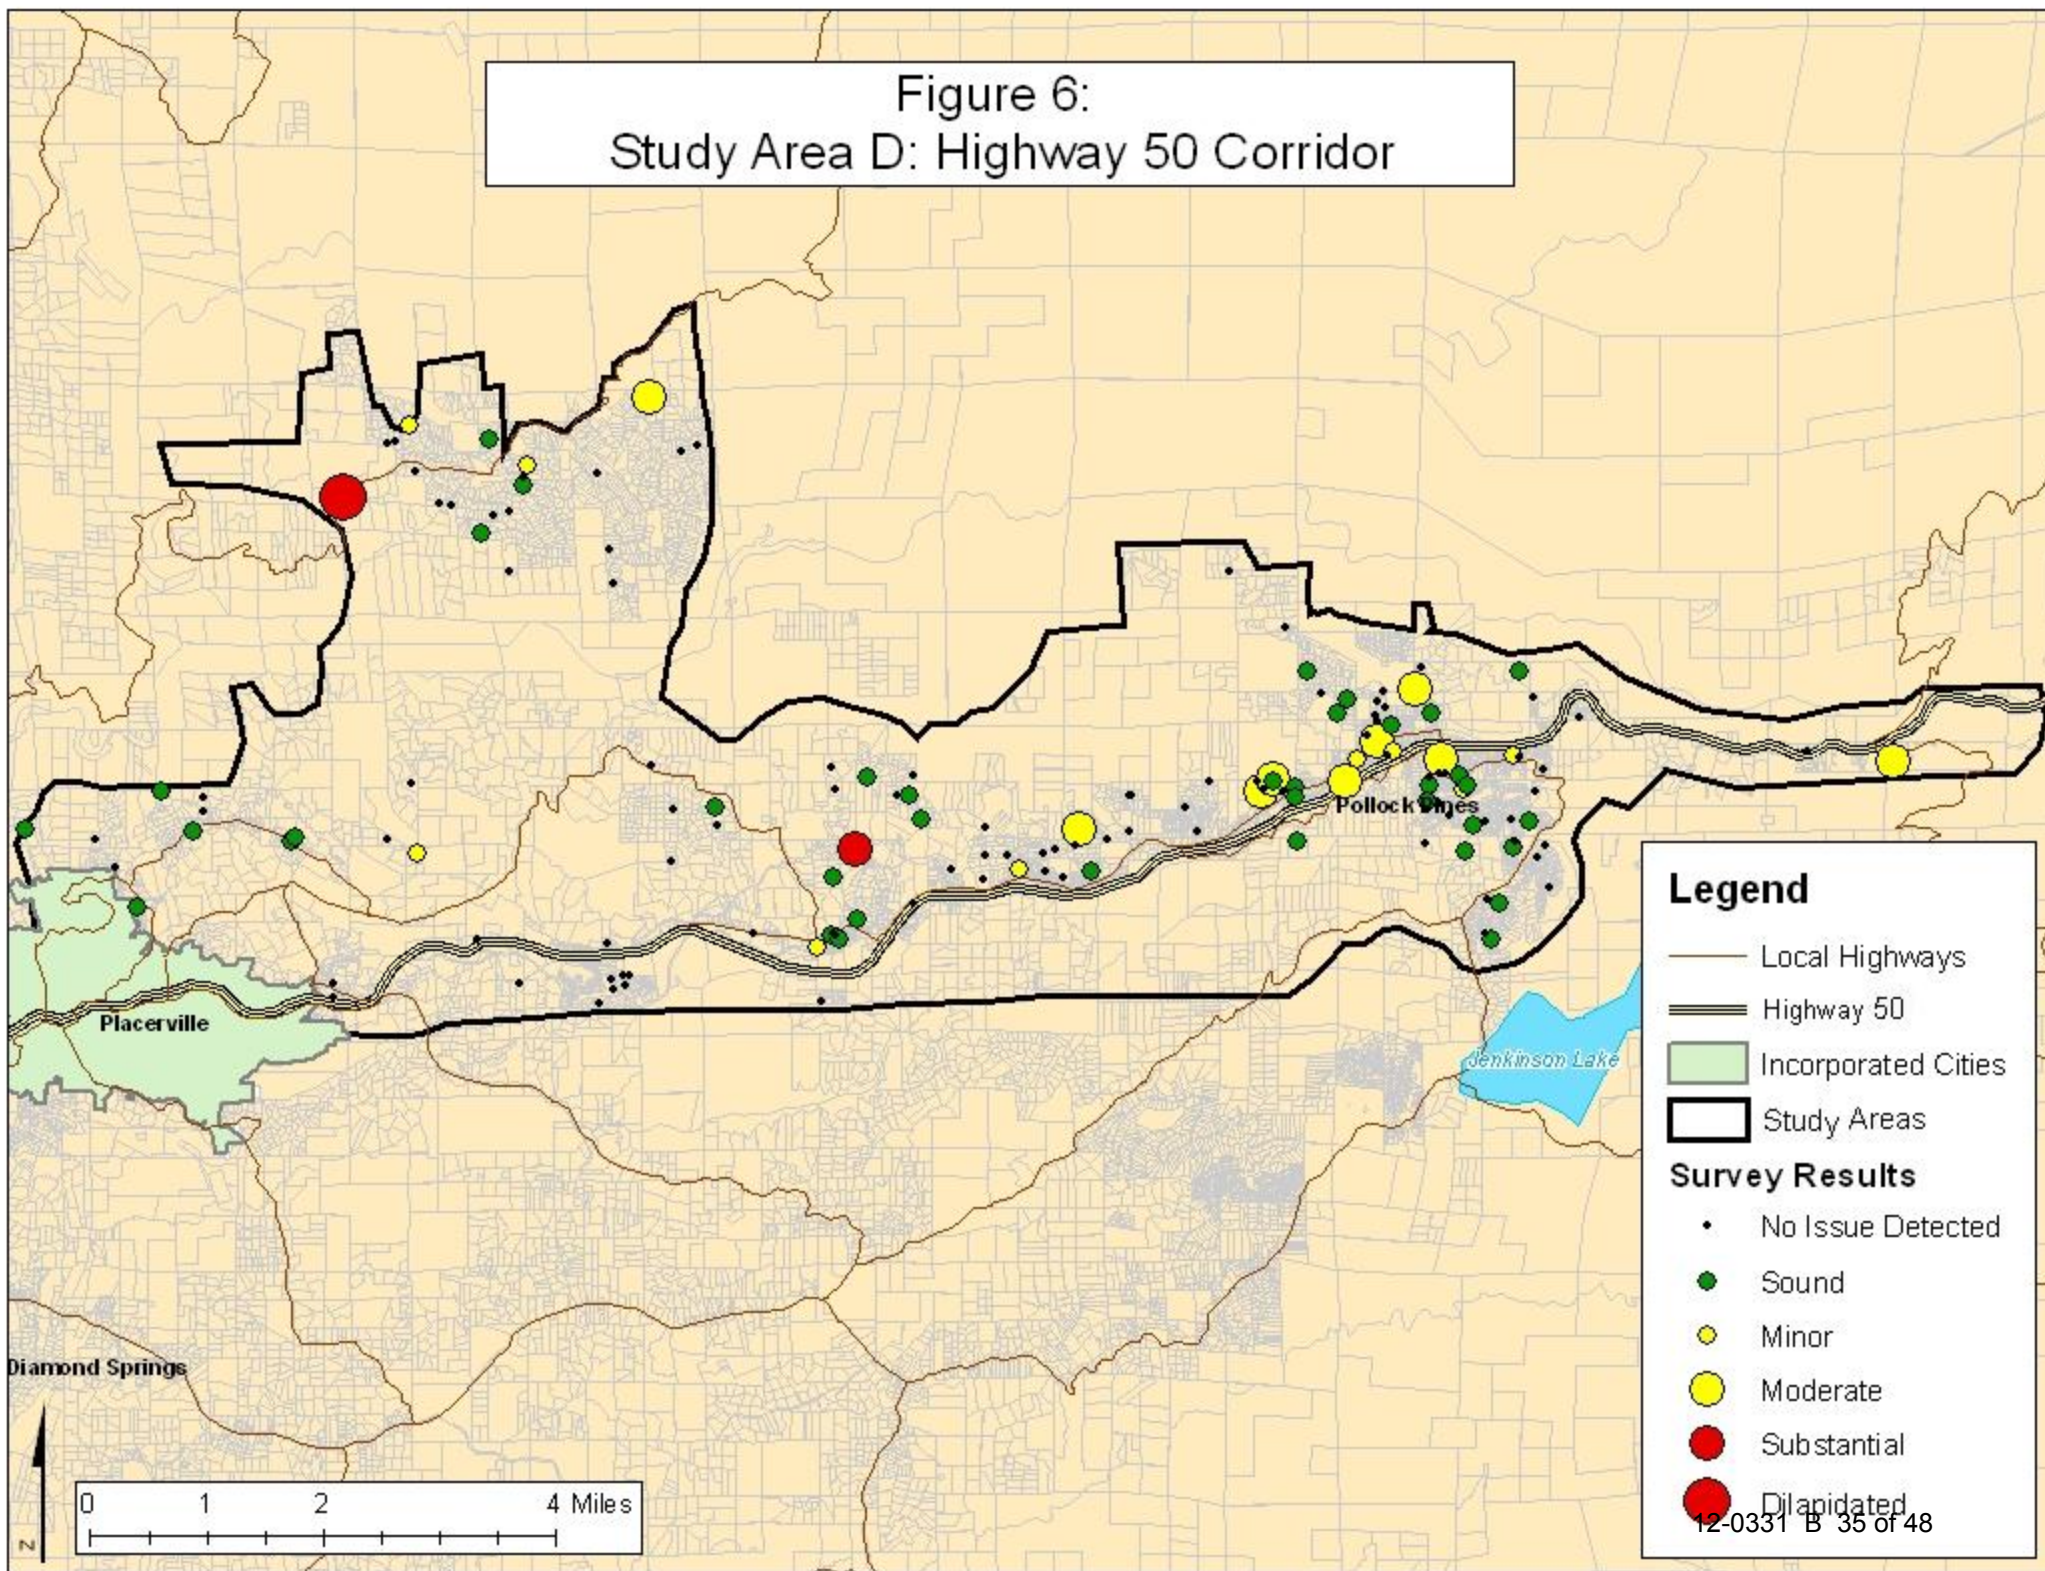
Figure 6:  
Study Area D: Highway 50 Corridor

As shown in Figure 6 on page 31, which maps the location of all residential parcels surveyed

within this Study Area, a significant proportion of the houses surveyed between Camino Heights and Pollock Pines were in need of at least some repair and maintenance work; many Pollock Pines residences were in need of moderate repairs. Additionally, a notable percentage of homes located along Mosquito Road between Placerville and the Slab Creek Reservoir were classified as “sound” by the scoring system, but were nonetheless in need of maintenance.

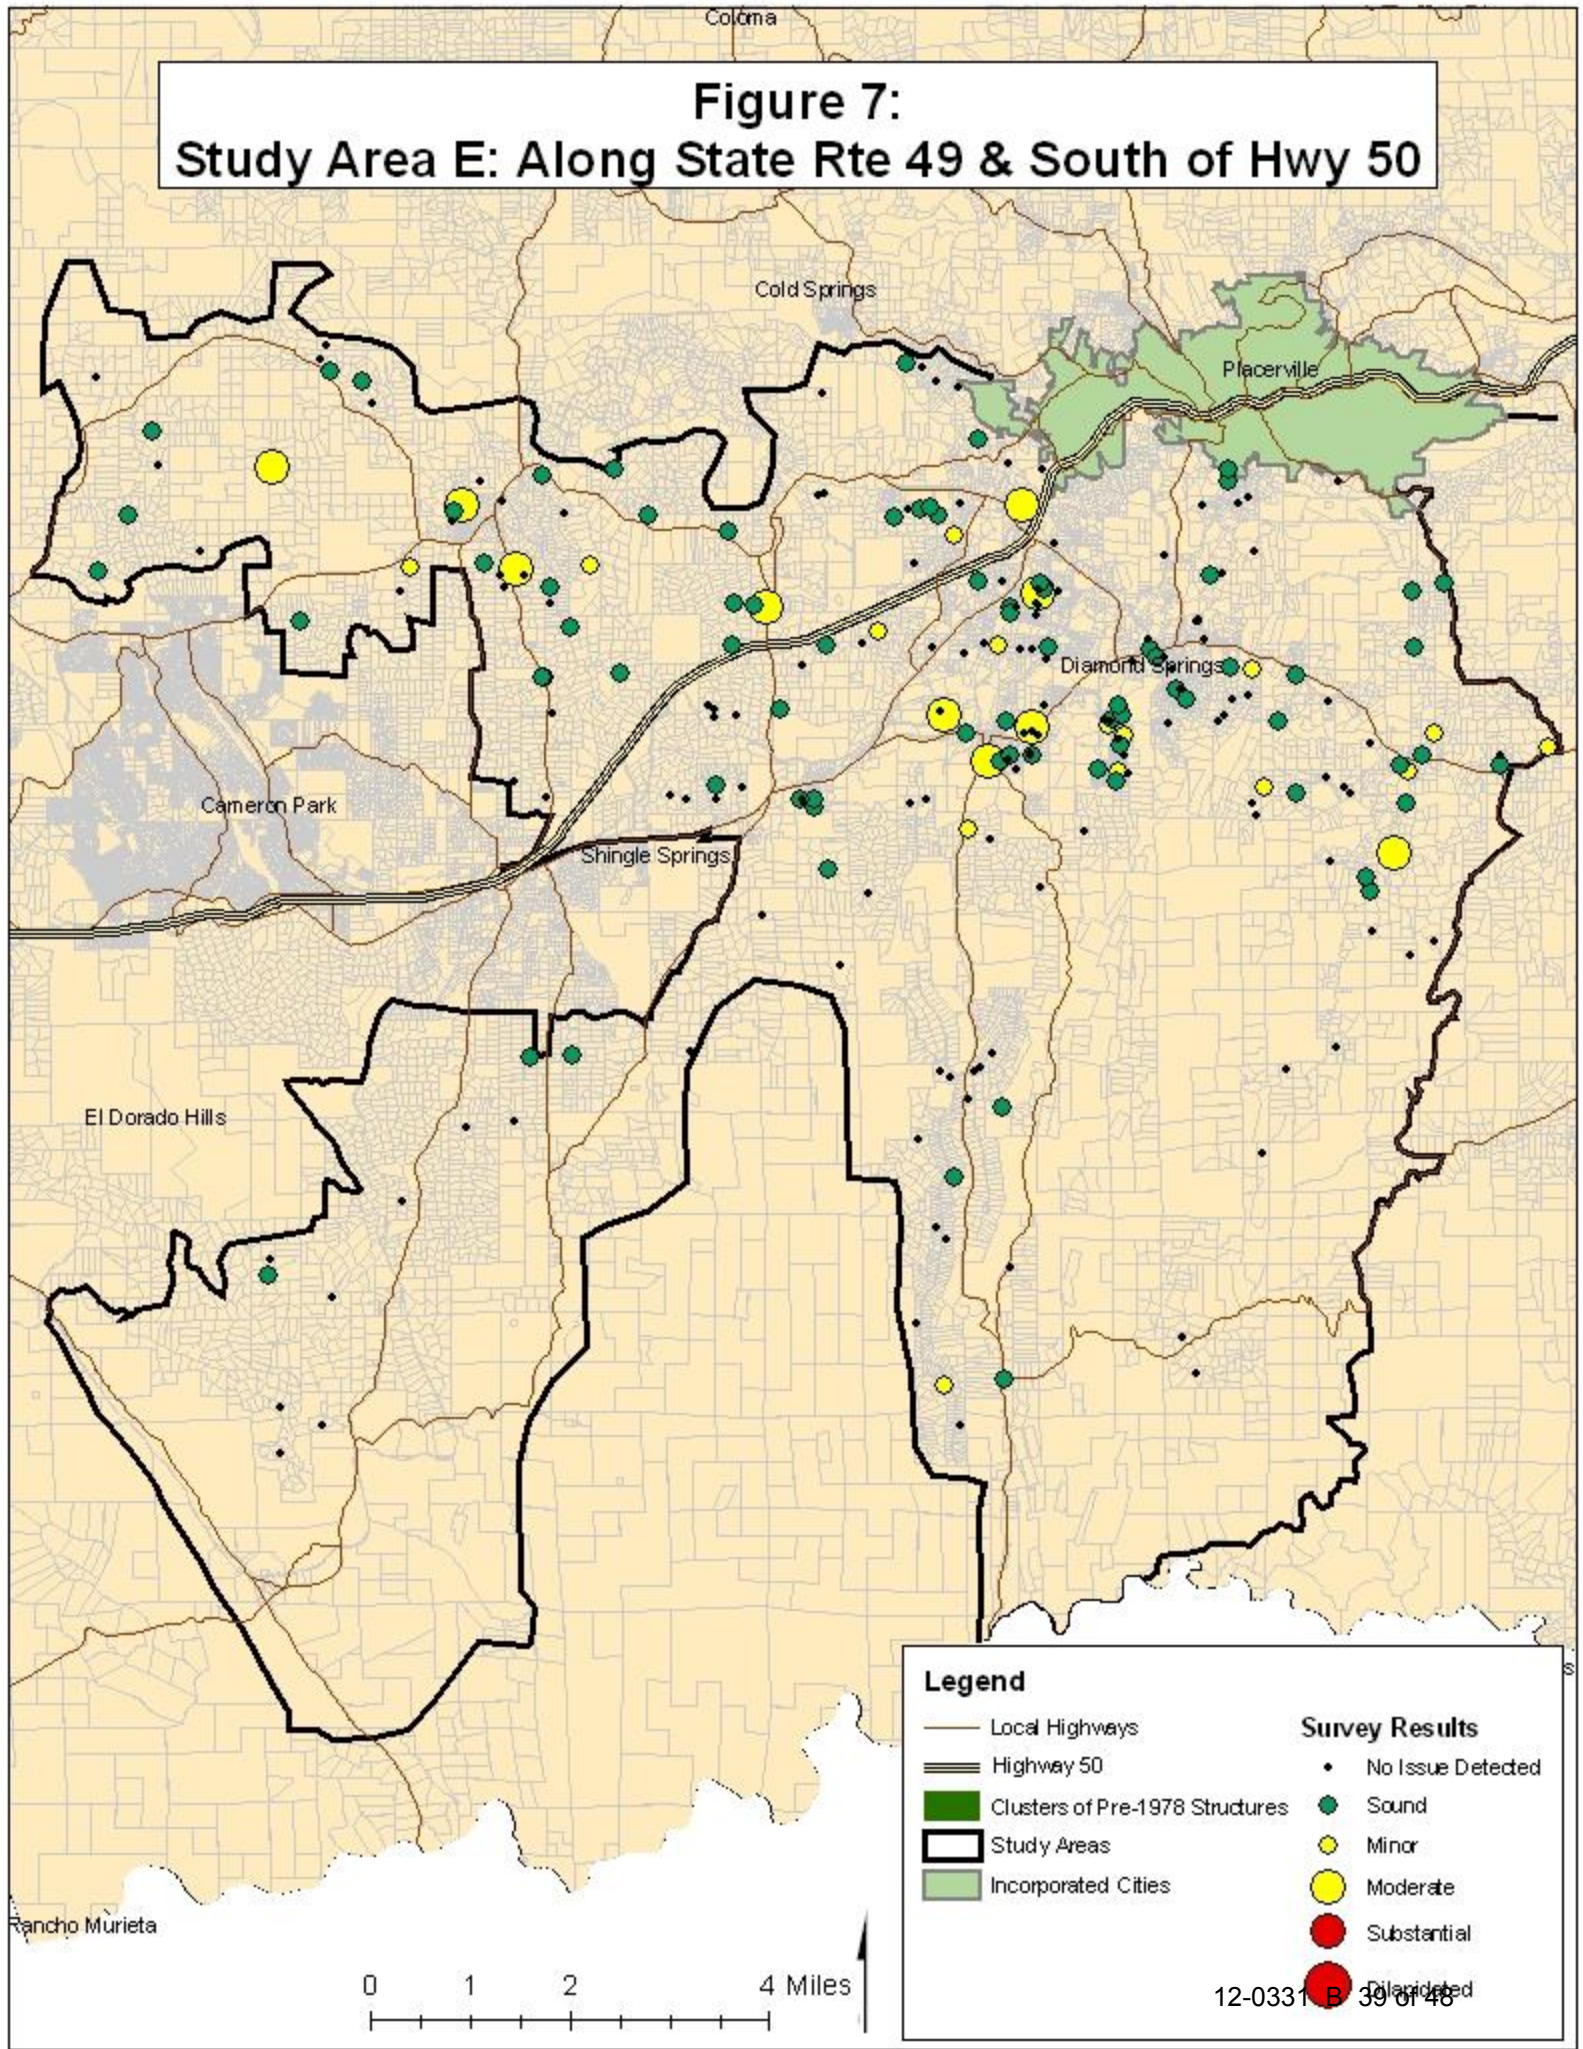
**Figure 7:**  
**Study Area E: Along State Rte 49 & South of Hwy 50**

As shown in Figure 7 on page 35, a significant proportion of the houses surveyed near Diamond Springs were in need of repair and maintenance work, particularly when compared with houses located along South Shingle Road or along State Route 49. Additionally, several homes located north of Highway 50 were judged to be in need of minor to moderate repairs.
