**Exterior Housing Conditions Study**  
County of El Dorado

**Submitted to:**  
Daniel Nielson, MPA, Director  
Health and Human Services Agency  
County of El Dorado

**February 8, 2012**

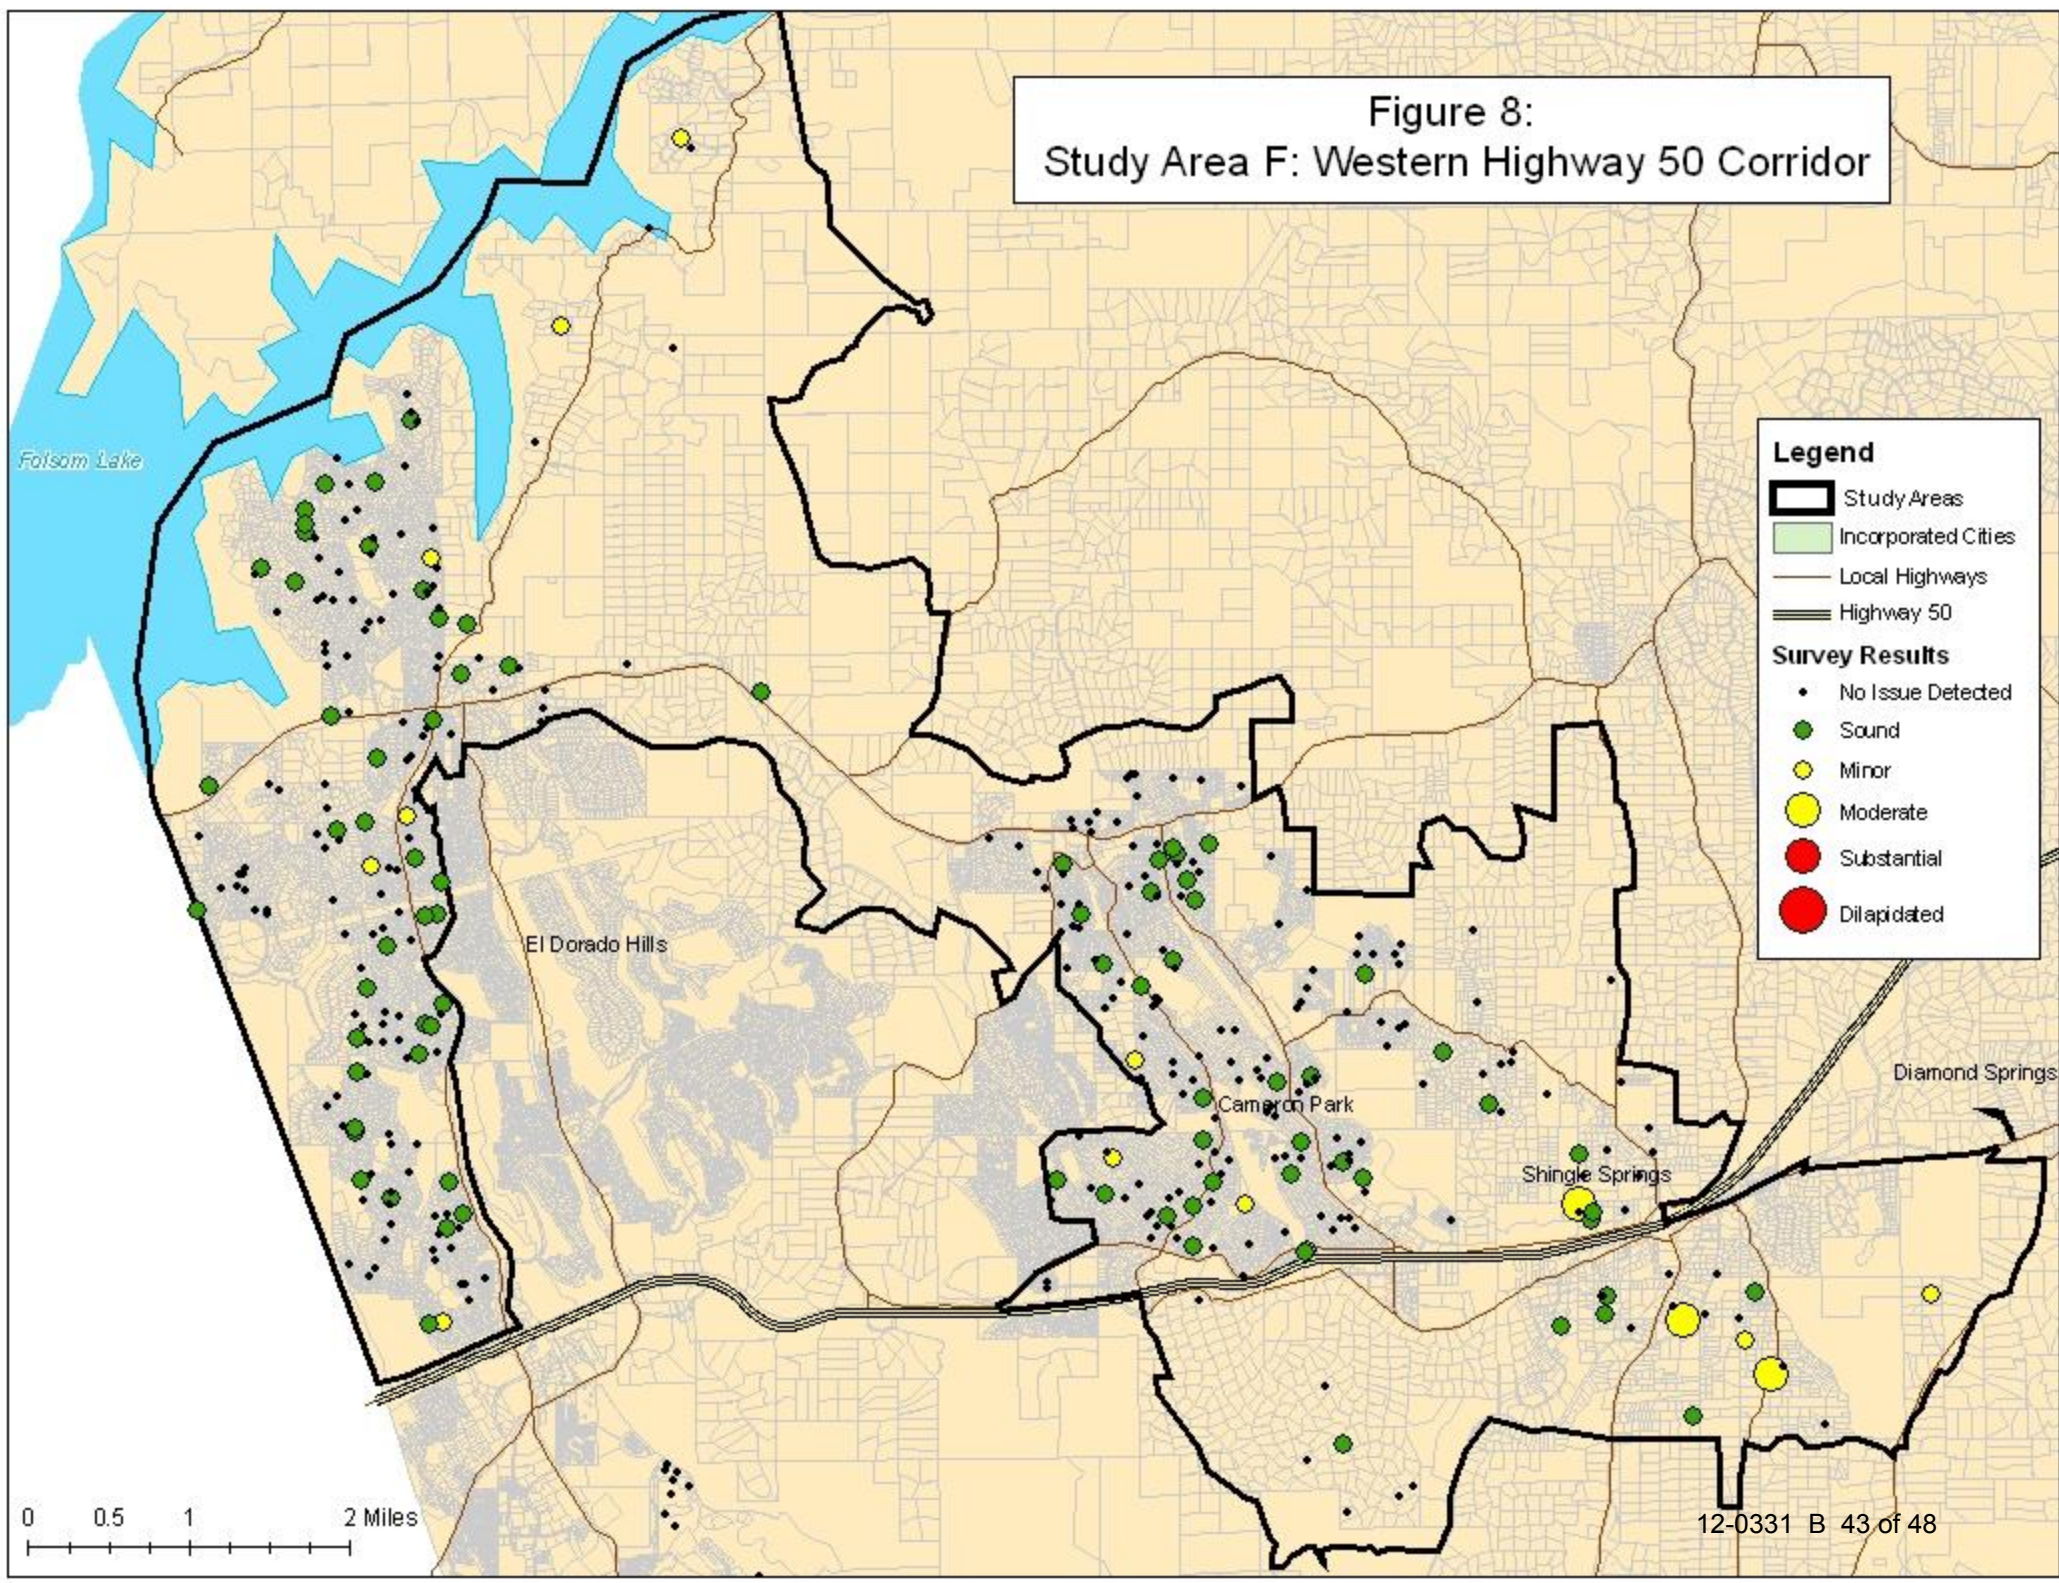
Figure 8:  
Study Area F: Western Highway 50 Corridor

As shown in Figure 8 on page 39, there is a relatively even spatial distribution throughout El Dorado Hills and Cameron Park of parcels with homes that were classified as “sound” but still in need of minor maintenance work. Dwellings in need of more substantial repairs are predominantly located in Shingle Springs, on the eastern side of Area F.
