DEPARTMENT OF TRANSPORTATION
Structure Maintenance & Investigations

Bridge Number : 25C0004
Facility Carried: MT MURPHY RD
Location : 0.1 MI E OF SR 49
City :
Inspection Date : 01/05/2011

Bridge Inspection Report

STRUCTURE NAME: SOUTH FORK AMERICAN RIVER

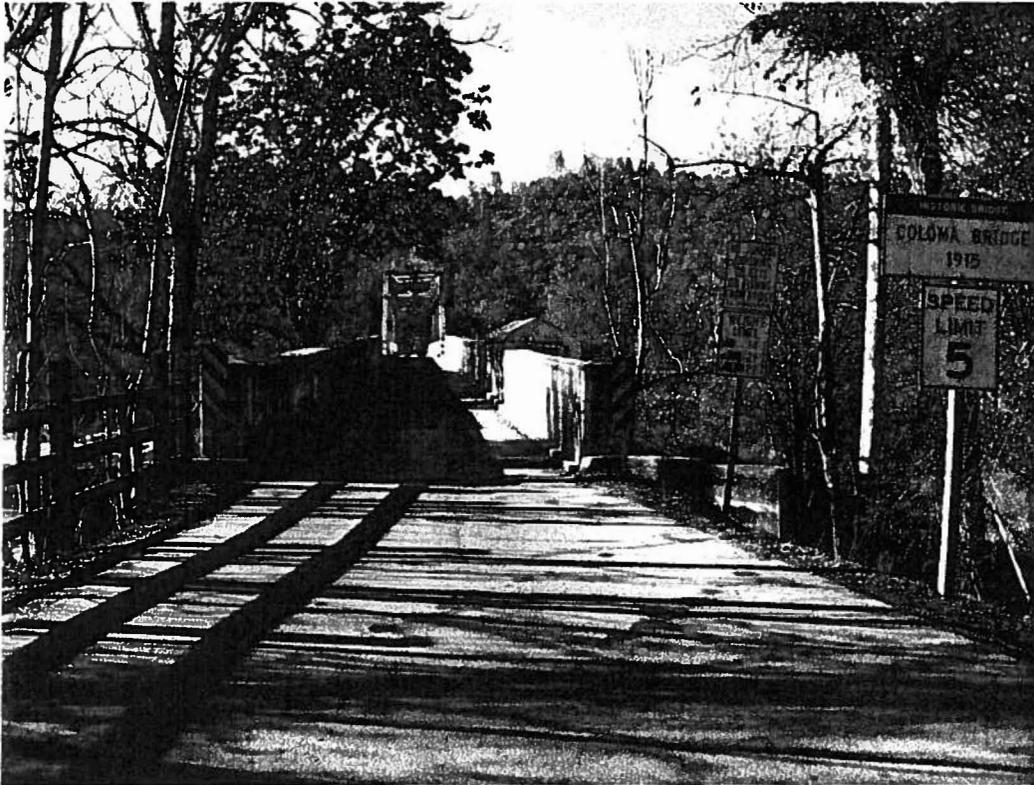
Photo No. 1

Roadway View (looking east).

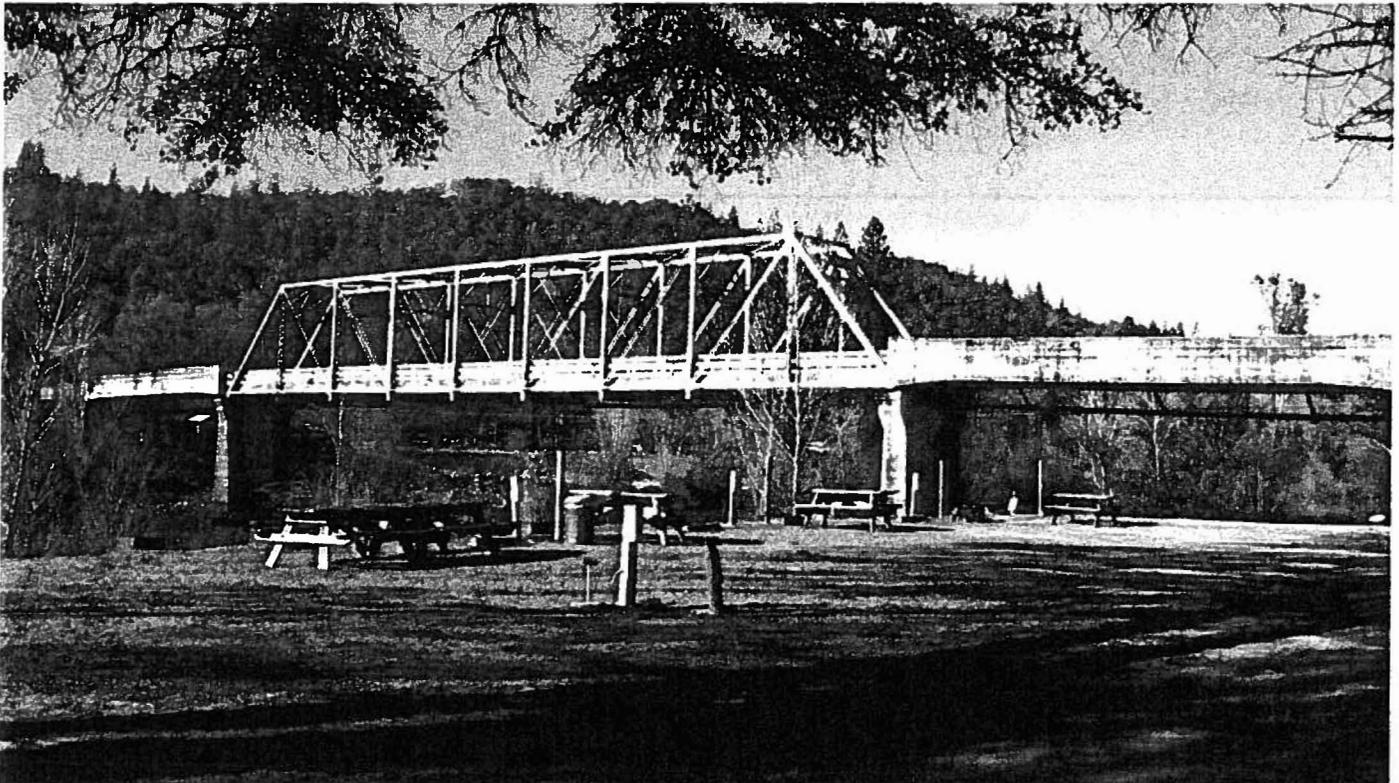
Photo No. 2

Elevation View (right side).

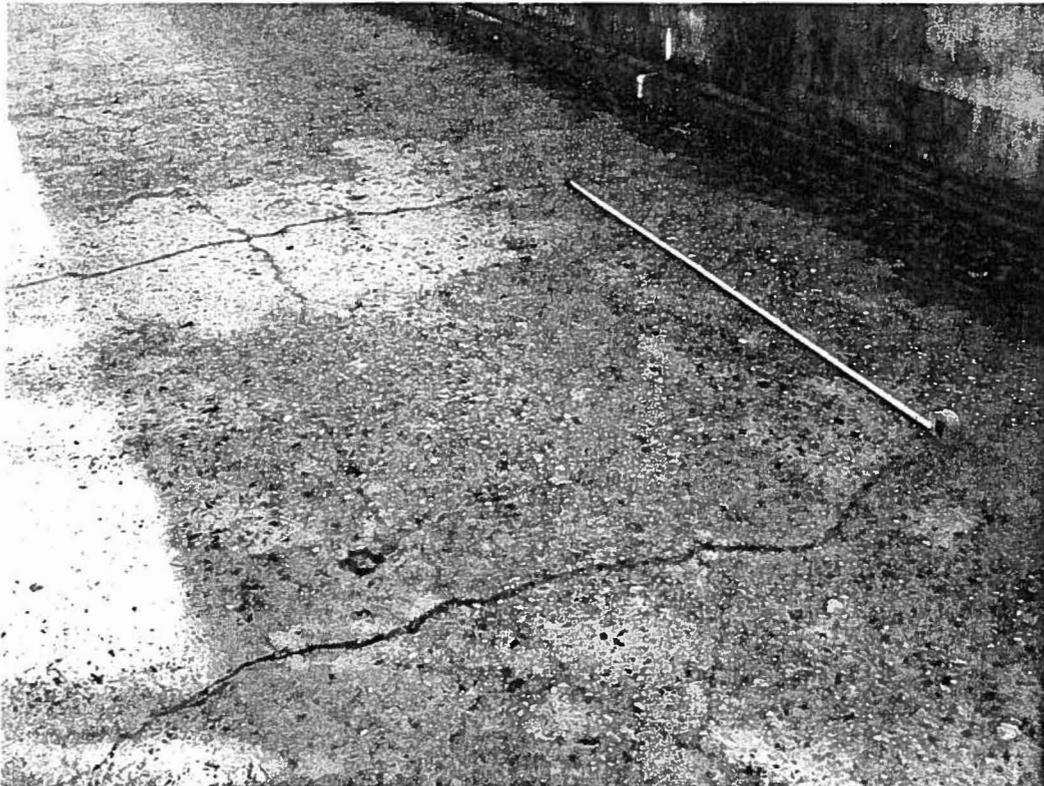
Photo No. 4

The surface of the approach slabs are scaled and abraded with shallow spalls and edge spalls at the joints, probably caused by the spoked wheels with a metal band surface of the horse and carriage attraction at the local park. There are also 0.020" to 0.080" wide transverse cracks throughout the deck (see photo #3 and #4). These cracks are mirrored on the soffit with efflorescence (see photo #5). This condition has been reported since November 25, 1991.

Typical transverse deck cracks in Span 2.

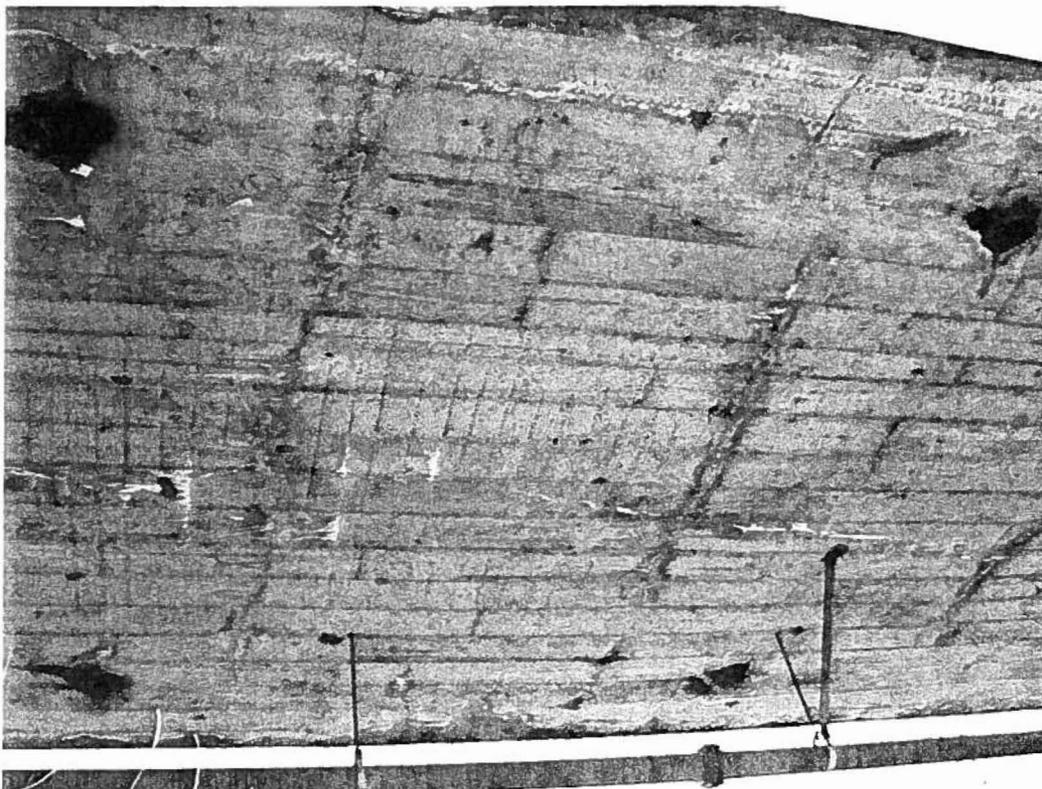
Photo No. 5

Typical transverse soffit cracks with efflorescence and rust stains in Span 2.

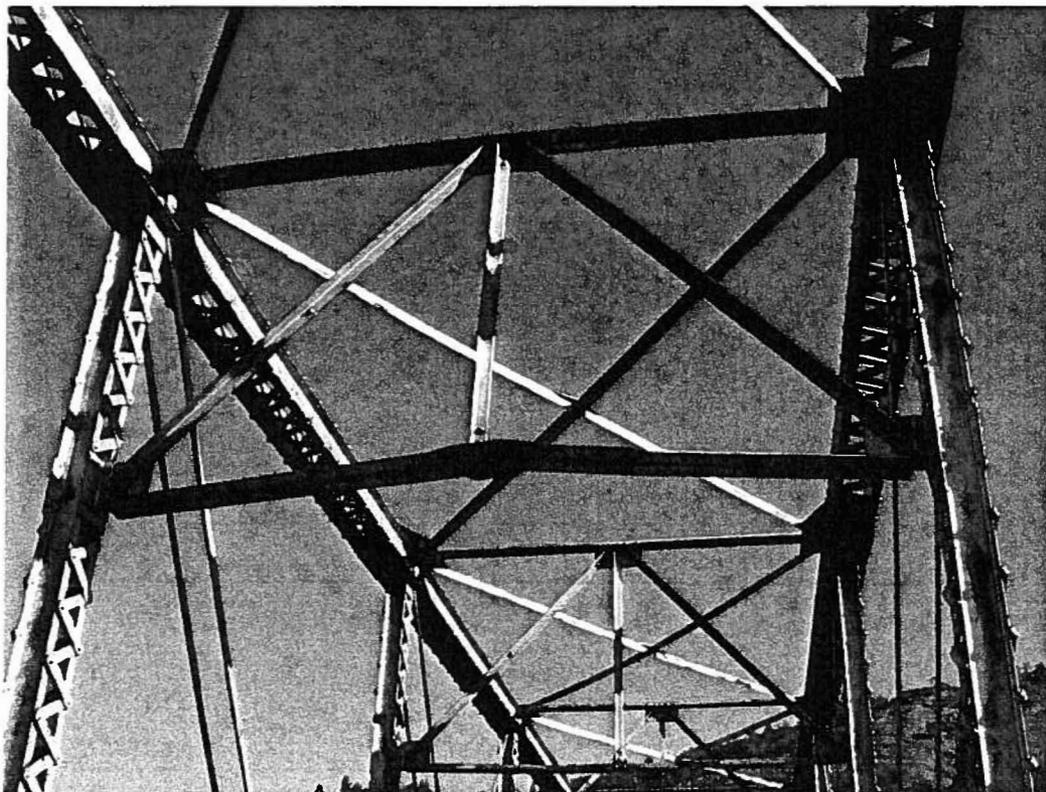
Photo No. 6

The lower double angle of each lateral overhead bracing frame has some level of vehicle impact damage (see photo #6). The damage generally consists of out-of-plane local deformations up to 2". This damage was first noted in the November 25, 1991, inspection.

Damaged sway bracing from vehicle impact.

Repair the damaged lateral frame elements.

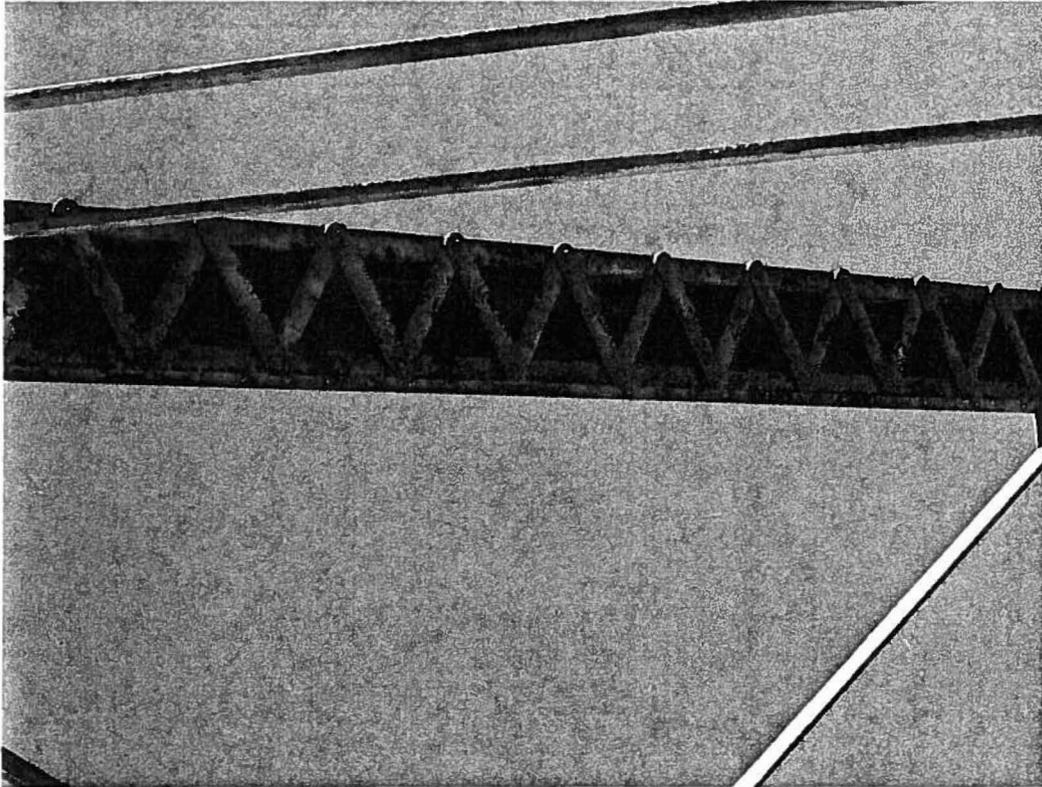
Photo No. 7

Chipped paint with rust, blush rust and scattered areas of blanket rust were noted on the bottom chord, stringers and floor beams (see photo #7 and #10). There is random freckled rust on the remaining steel members.

Paint condition of top chord in Span 3.

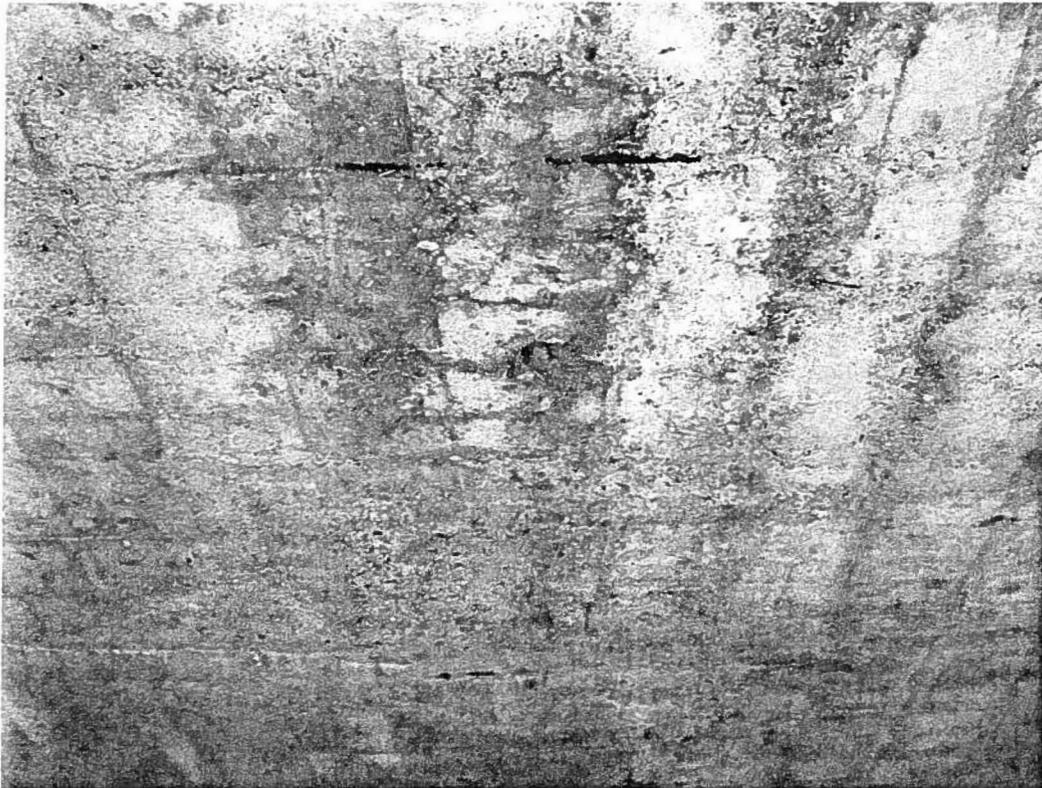
Photo No. 8

There is about 2' of exposed rebar in the soffit of Span 6 (see photo #8). The bar appears to have inadequate concrete cover and does not warrant repairs at this time.

Exposed transverse rebar in the soffit of Span 6.

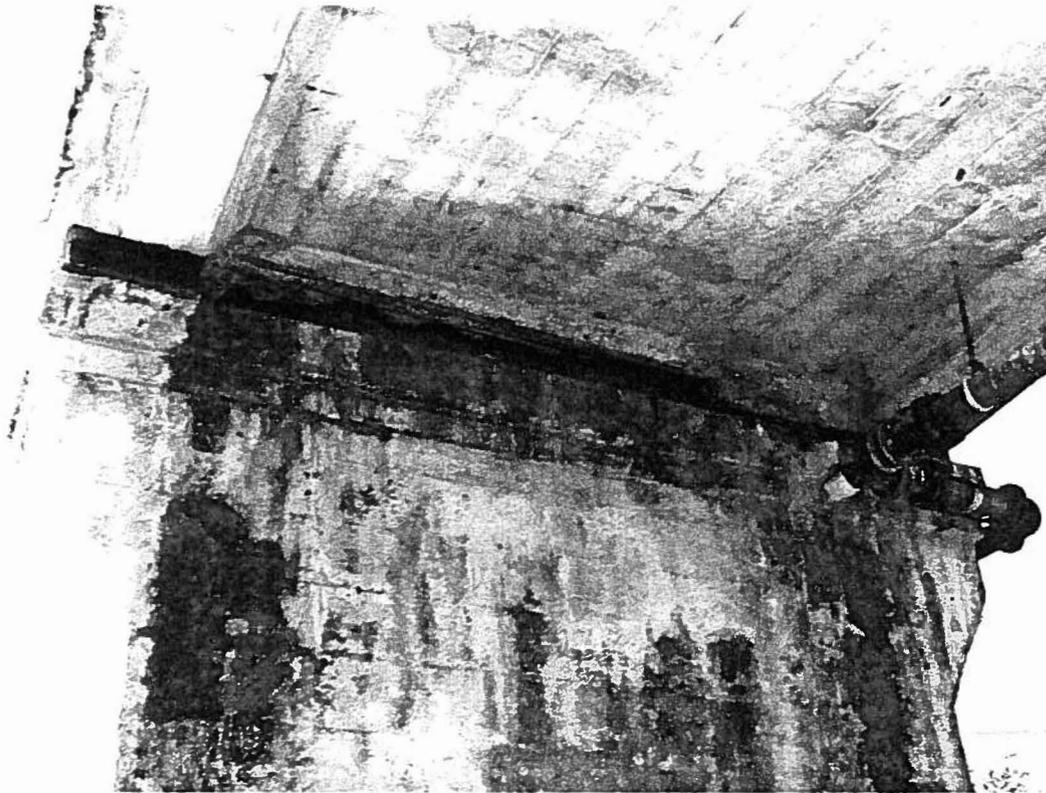
Photo No. 9

There is spalling of the end diaphragm at Pier 4. The concrete is missing on the bottom 6" along three-quarters of the length of the diaphragm. The bottom longitudinal reinforcing steel is exposed, but does not appear to be rusting (see photo #9). No cracks could be seen in the adjacent area or soffit. A 1995 work order to repair this spall remains incomplete.

Pier 4 end diaphragm spall with exposed rebar.

Remove unsound concrete on the end diaphragm at Pier 4 and recast.

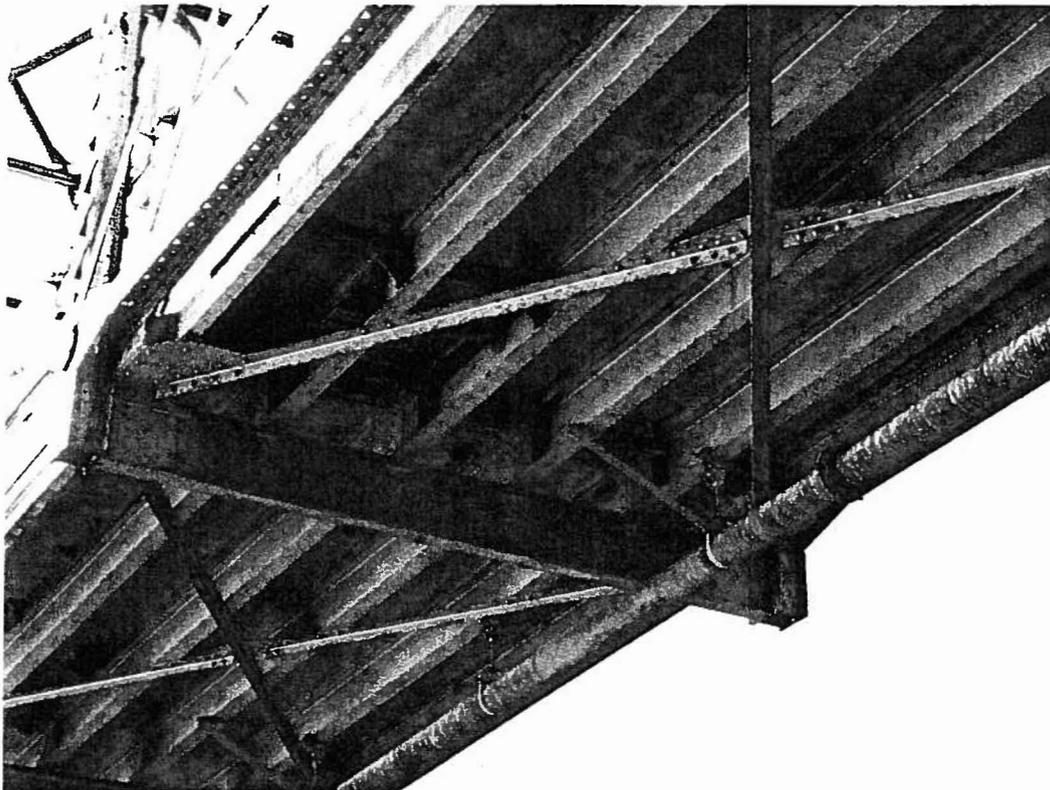
Photo No. 10

Typical paint condition of floorbeams and stringers.
