**Mt.Murphy Road Bridge  
Structural Analysis and Rehabilitation  
Feasibility**

# Mt. Murphy Road Bridge at South Fork of the American River Structural Analysis and Rehabilitation Feasibility

PROJECT NUMBER: County CIP # 77129, Federal ID, BRLO-5925 (090), Bridge No. 25C0004

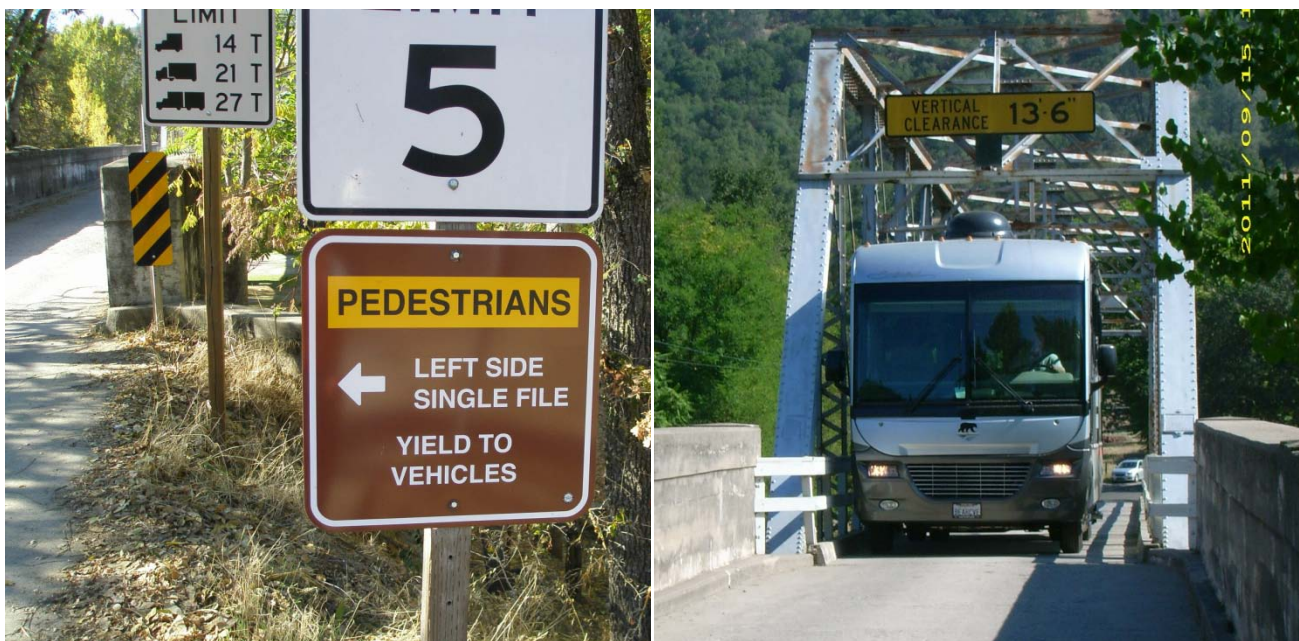
On September 25, 1980, the County posted the bridge for reduced live load of 14 tons for two axles, 21 tons for 3 axles and 27 tons for four axles. The posted loads are based on load rating calculations of the existing structure performed by Caltrans and found in the bridge inspection report dated October, 1979. The conclusion was that the truss is not sufficient for code recommended live load trucks. The truss was then load rated for legal loads, which resulted in the posted loads controlled by the floorbeams, see Figure 1.

Figure 1 - Structurally Deficient and Functionally obsolete: shared vehicular and pedestrian use and posted truck loads

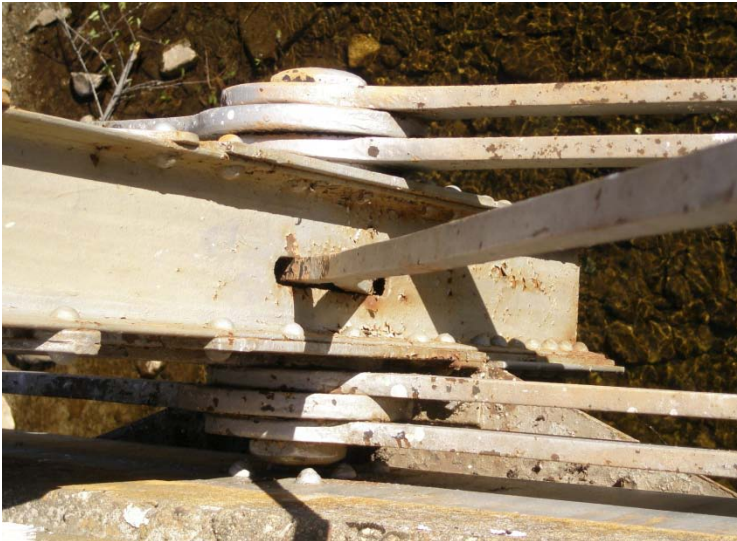
A Caltrans fracture critical inspection found that the eye-bar diagonal members have visible cracks in the turnbuckle loops at the bottom of many members. The report notes that they are approximately 1" long and parallel to the direction of loading and appear to be related to the forging process. These members are considered fracture critical and are recommended for in-depth investigation propagation of the cracks, see Figure 2.

**Figure 2 - Fracture critical diagonal eye-bar truss**

Diagonal truss members are overstressed and require replacement due to fatigue cracks in the turnbuckles at the ends of the eye-bar members. In addition, the eye-bar diagonal members would also be replaced because they are essentially tension-only eye-bars, which cannot resist compression induced by earthquake loading.

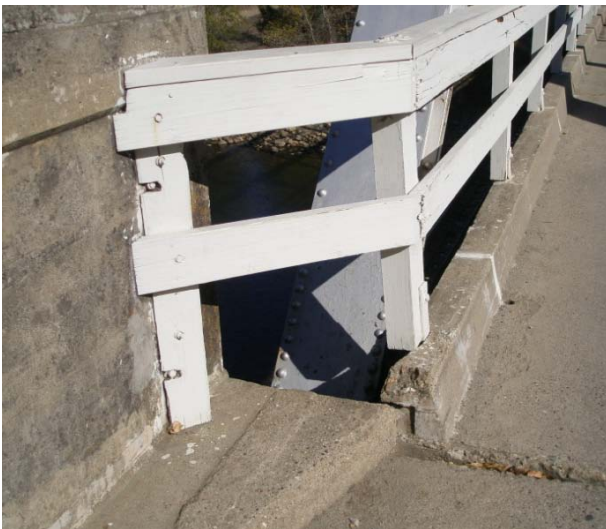
**Figure 3 - Expansion joint at end of truss spans showing sub-standard approach, barriers and transition**

Expansion joints at the abutments and piers are in poor condition and should be replaced along with the floorbeams, stringers and deck.

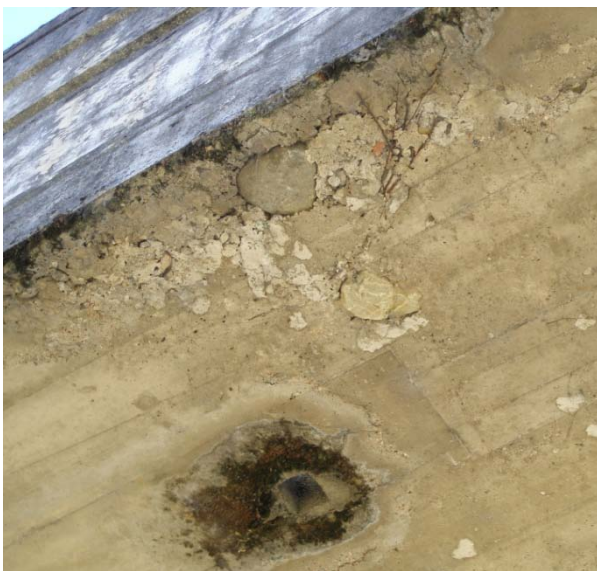
The southern and northern approach spans are in "fair" condition and a condition factor of 0.85 will be used to reduce member capacity. Visual inspection of the bridge soffit identified longitudinal and transverse cracks visible in the soffit. In addition, there is exposed rebar due to low concrete cover. There is very large stone aggregate and the presence of other material (hay, pine needles and even a hack saw blade) that reflect poorly on the quality of concrete used for the approach spans, abutments and piers.

**Figure 4 - Exposed large aggregates on underside of approach spans**

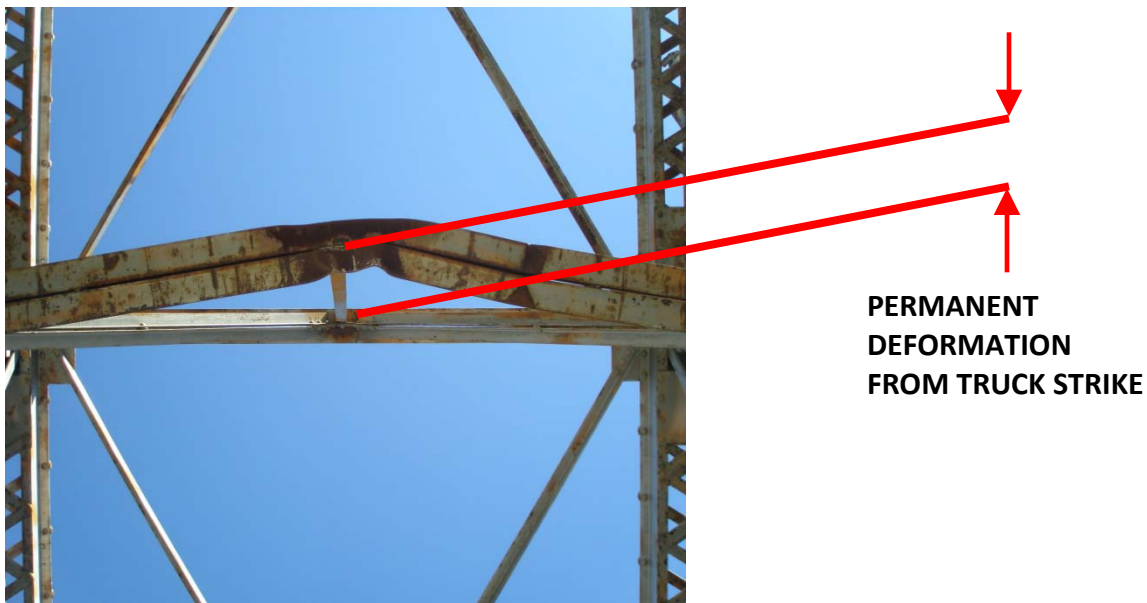
The main truss has top and bottom lateral bracing member and overhead lateral bracing trusses that run transversely at each panel point. Several of these have been damaged by truck strikes. This lateral truss is not specifically evaluated as part of this vulnerability assessment, but will require member replacement at the truck strike locations and rehabilitation of many existing members, see Figure 5. Top and bottom lateral bracing members and the overhead lateral bracing frames are single rolled angles.

Figure 5 - Truck strike in upper lateral bracing frame (on bridge, looking straight up)

Upper lateral bracing has a truck strikes at every panel point along the truss and requires complete replacement.

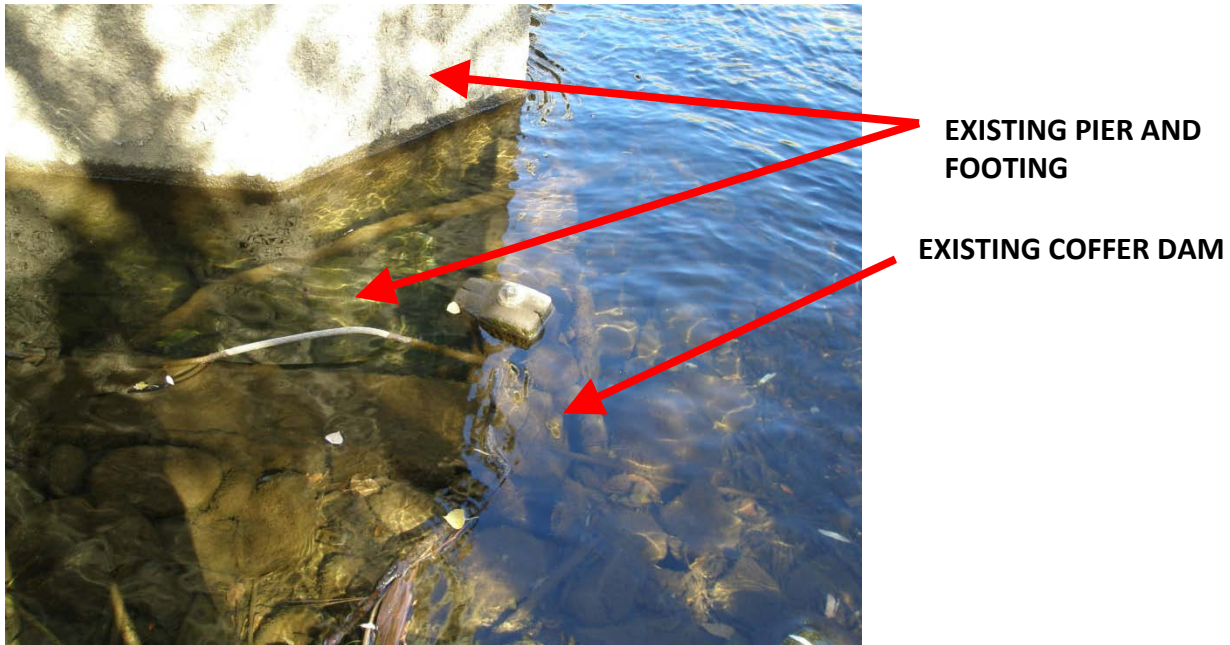
noted that the pier at the east end of the truss was scoured down to the top of the footing. The pier footing along the northern face is exposed by up to 1.6'. The exposure decreases to approximately 6" along the west and east faces of the pier. The pier concrete is moderately abraded throughout, see Figure 6. The proposed ultimate countermeasure in the report is to replace the bridge but daily monitoring during flood events was also required.

Figure 6 - Existing Pier at South end of Truss Span, North truss span pier similar

No analysis was performed for the foundation as a part of the phase. Visual inspection and reference to bridge inspection reports indicate that the foundations are vulnerable to scour at the piers supporting the truss span over the river. A 1982 bridge inspection report noted that the pier at the east end of the truss was scoured down to the top of footing. The pier footing along the northern face exposed approximately 1.6'. The exposure decreases to approximately 6" along the west and east faces of the pier. Pier concrete is moderately abraded throughout.

The existing abutments and piers will be protected in place during retrofit construction. Existing pier footings located within the river flood limits have a small footprint and are considered scour critical. A pier underpinning retrofit consisting of additional footing concrete and piling will be constructed to mitigate scour and seismic vulnerabilities. Scour protection will also be recommended for protection of the retrofitted pier footings. The pier columns will require seismic retrofit to address inadequate transverse confinement reinforcing bars, which results in poor ductility capacity to resist seismic movements. The pier column connection to the superstructure and footing is vulnerable to tension loads from seismic overturning due to inadequate development of longitudinal column bars. Likewise the reinforcing bars also lack flexural capacity needed to sustain the lateral earthquake loads. It would be extremely costly and difficult to perform these retrofits and maintain the historic shape and proportions of the existing piers since the footings would have to be enlarged and the columns enlarged with steel casings or added concrete and bar reinforcing.

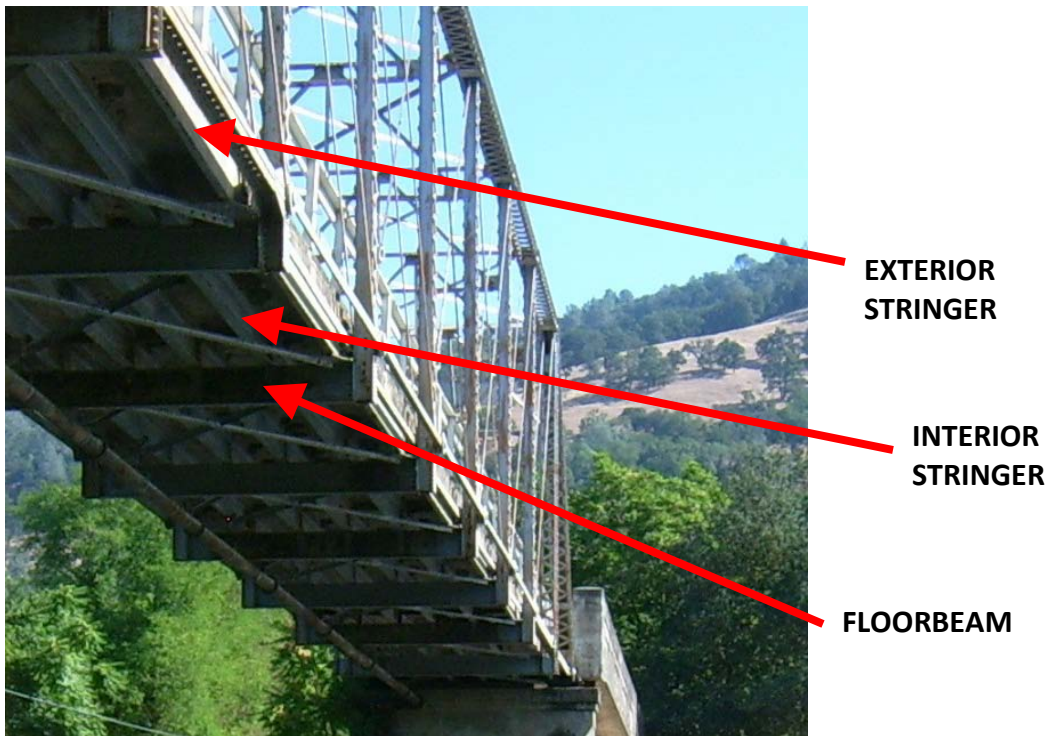
**Figure 7 - Steel Truss Span**

Floorbeams are rolled W15x5-1/2 sections located at each panel point, see Figure 7. They are connected to the truss vertical members and support the deck stringers. Factored Strength-I demand produces a DCR of 1.86 for Case A.

The interior stringers and floorbeams are overstressed and require replacement with heavier sections.
