**RE: Work Order: Senior Center Facility Assessment, Recommendations and Estimate;
El Dorado County, 937 Spring Street, Placerville, CA 95667**

Spring Street Senior Center Facility Description

Exhibit A
Recommendations and Cost Estimate
El Dorado County Senior Center
937 Spring Street, Placerville CA

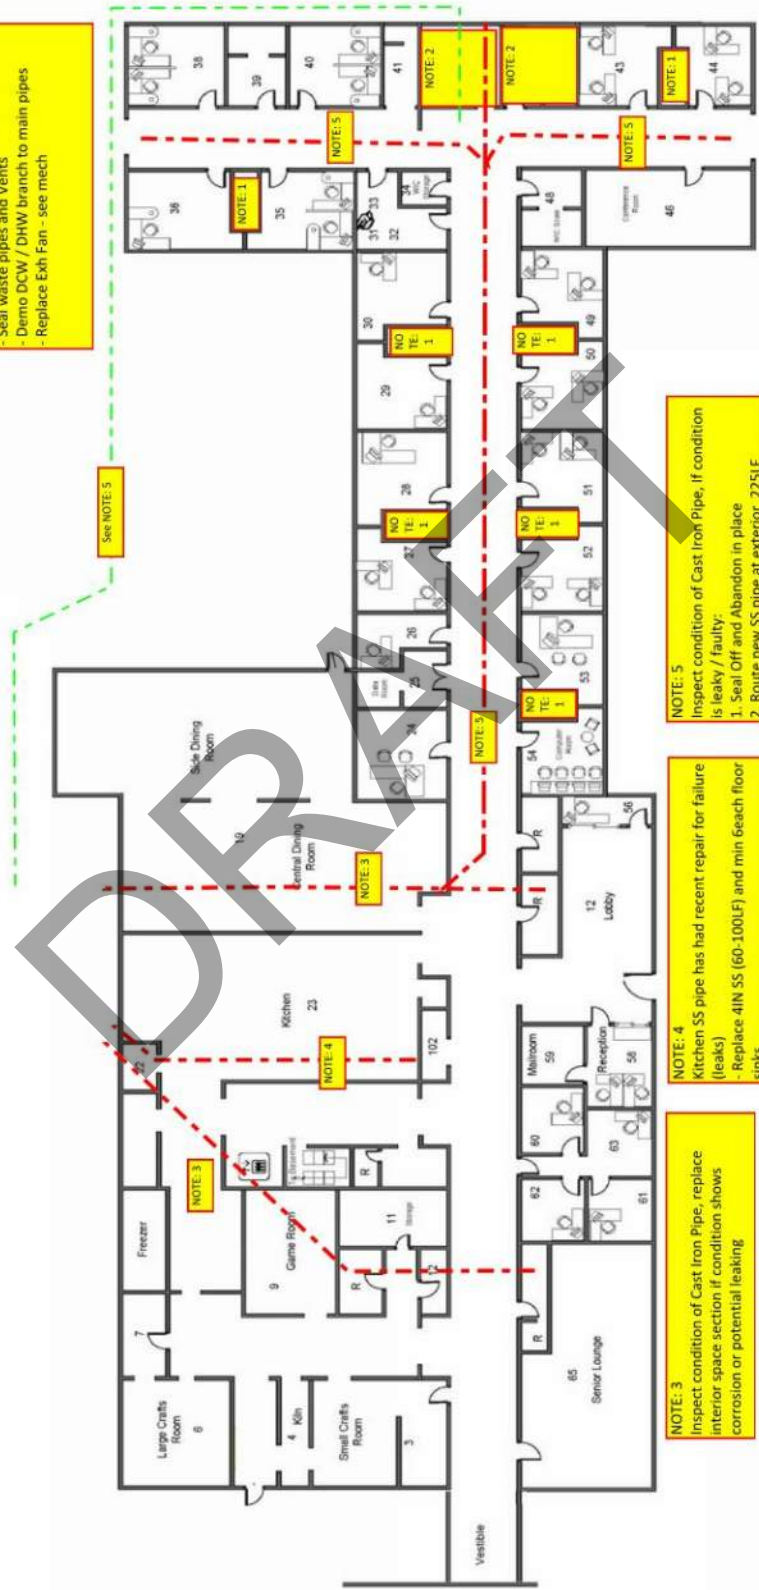
Plumbing Plan - 1st Floor
 937 Spring St. Placerville, CA 95667

NOTE: 3
 Inspect condition of Cast Iron Pipe, replace interior space section if condition shows corrosion or potential leaking

NOTE: 4
 Kitchen SS pipe has had recent repair for failure (leaks)
 - Replace 4IN SS (60-100LF) and min Beach floor sinks

NOTE: 5
 Inspect condition of Cast Iron Pipe, If condition is leaky / faulty:
 1. Seal Off and Abandon in place
 2. Route new SS pipe at exterior 225LF
