Caples Ecological Restoration Project

Amador and Placerville Ranger Districts
Eldorado National Forest

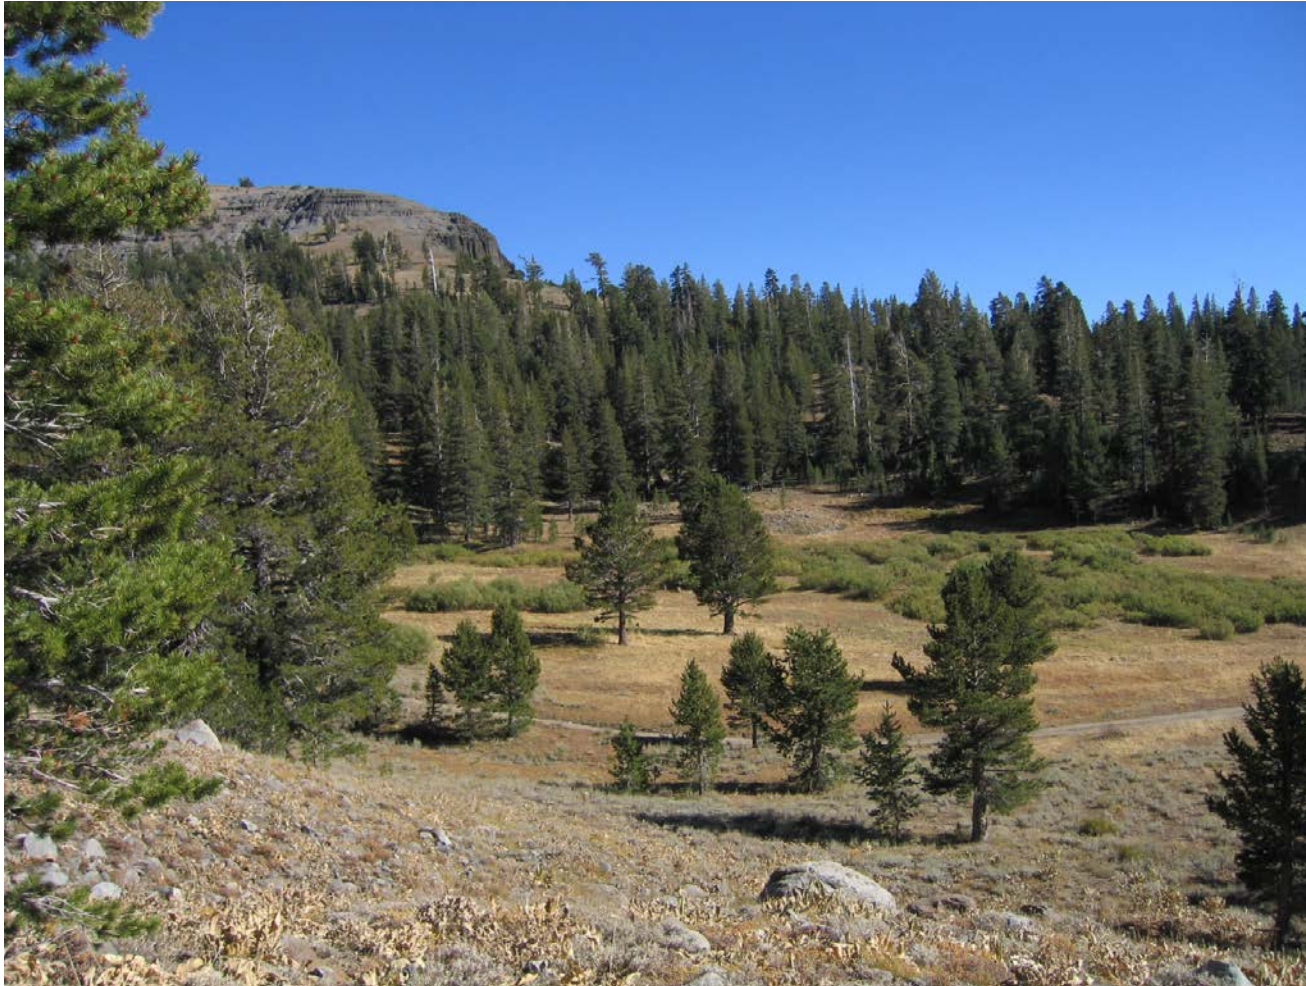
1. Schneider Camp Meadow: Information from Proper Functioning Condition (PFC) Assessments (USFS 2004, Still Water Sciences 2010) indicates that two roads are eroding sediment directly into Schneider Camp Meadow. USFS route 10N13, visible in the foreground of this photo, follows the eastern boundary of the meadow and crosses the stream channel at the upstream boundary of the meadow. A non-system route, which intersects 10N13 and leads to a livestock barn and unimproved camping area, forms a portion of the northern meadow boundary. Impaired meadow function and hydrologic disruption occur from these road related sources of increased sediment and runoff.

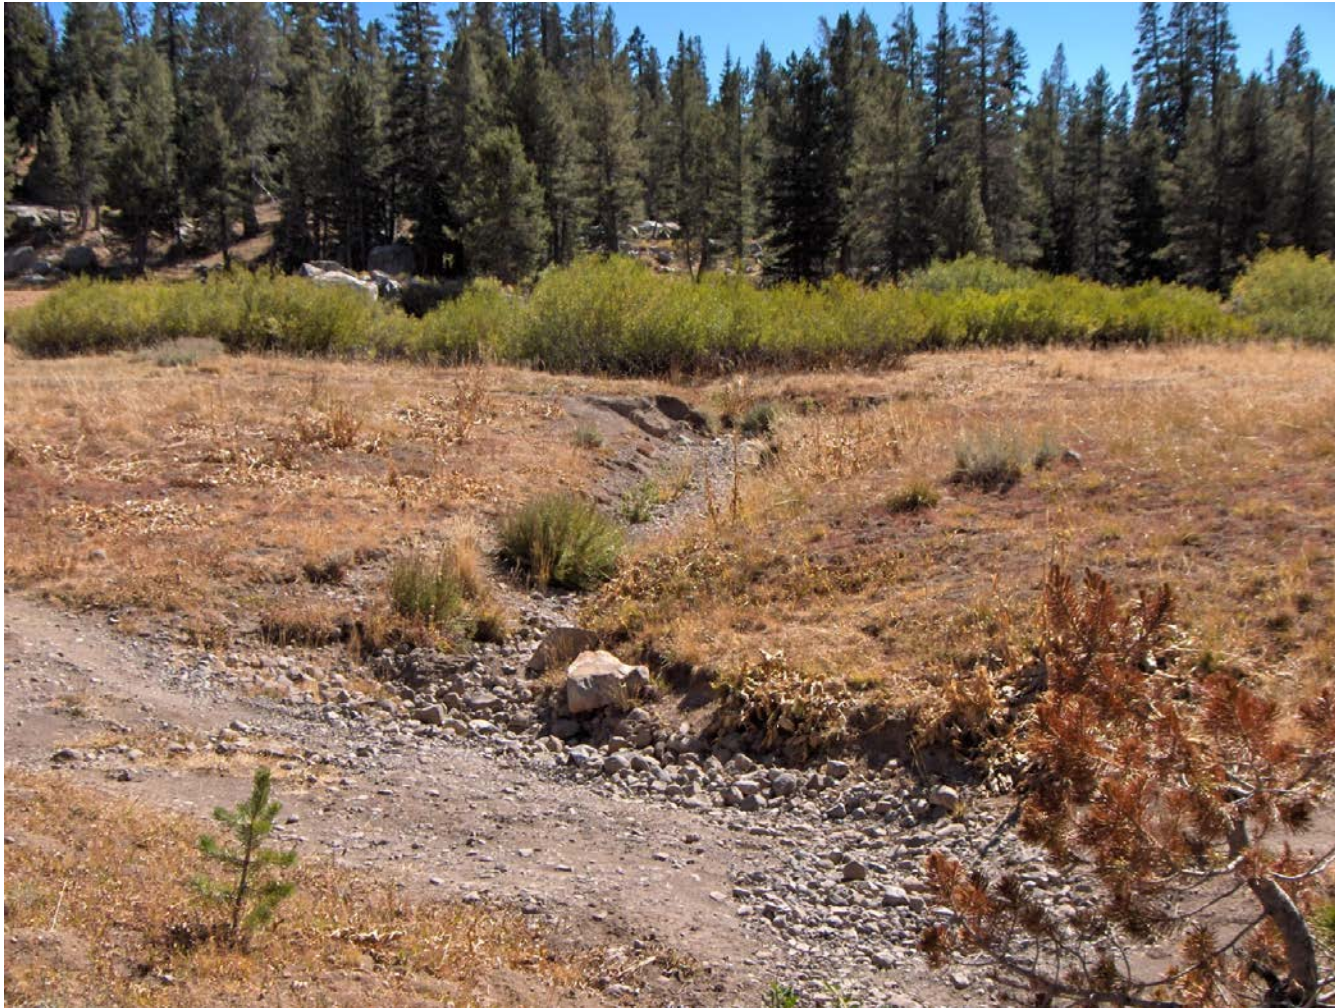
2. Schneider Camp Meadow: Schneider Camp Meadow is at risk of losing additional hydrologic function if actions are not taken to reduce road and trail related effects, such as the erosion visible in this photo. Easily erodible volcanic deposits with steep slopes and somewhat sparse vegetation add to sediment transport into the meadow via an eroding gully on the northwest side of the meadow and the stream that flows into the eastern side of the meadow.

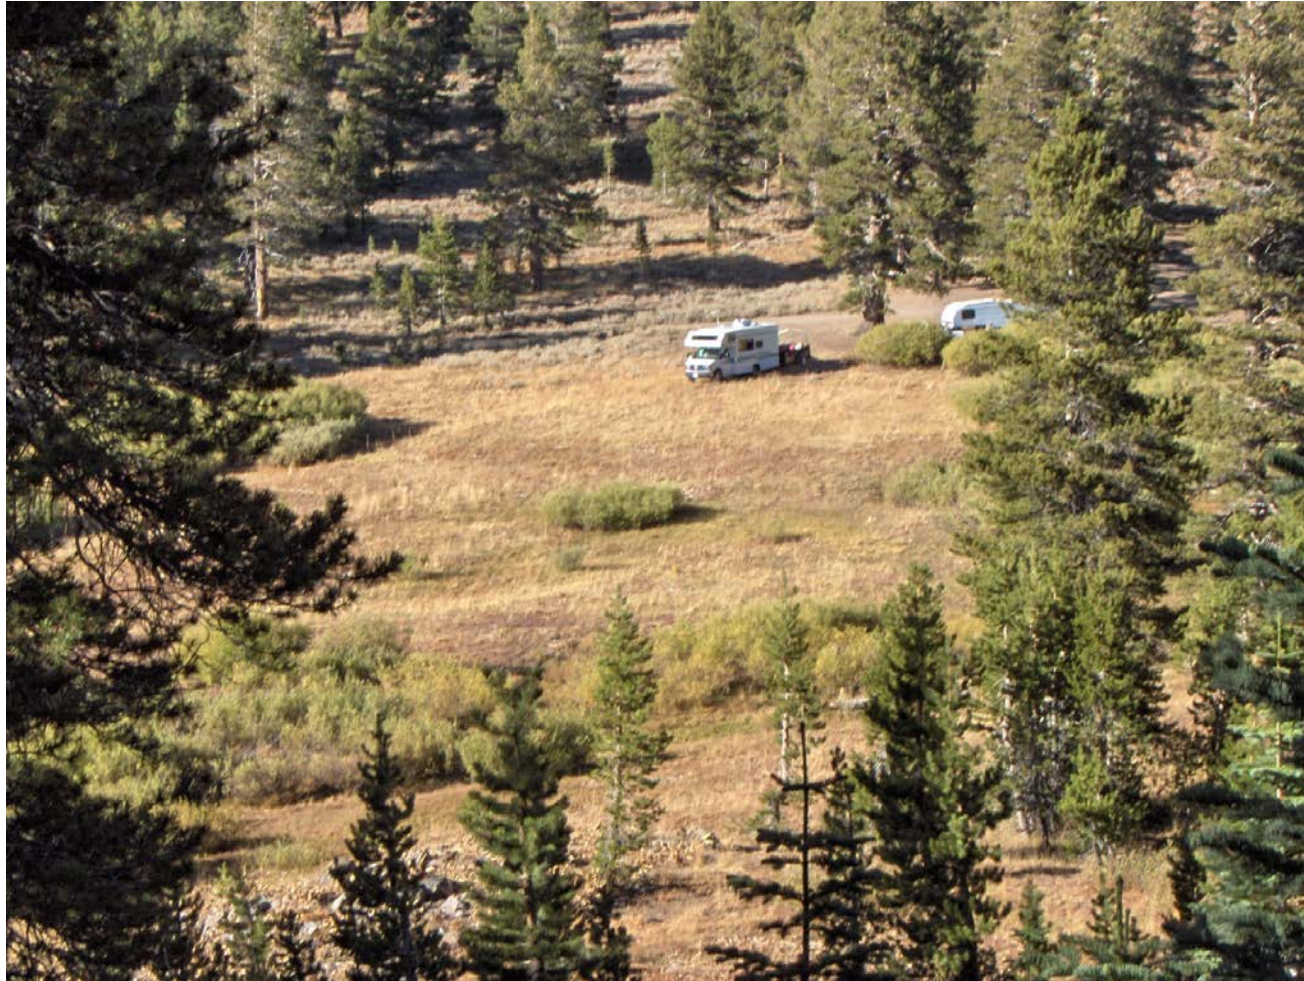
3. Schneider Camp Meadow: Vehicles drive on Schneider Camp Meadow, as seen in this photo, and directly in the stream channel. Schneider Camp Meadow is classified in the moderately wet to dry wetness categories (SWS 2010). *Epilobium howellii* (a sensitive plant species) occurrence near Schneider Cow Camp has been impacted by non-designated vehicle traffic and may have been extirpated from the site. Riparian wetland and rangeland vegetation have been degraded by driving in the meadow and soil productivity may be impaired. In addition to information contained in PFC assessments, vegetation conditions at Schneider Camp Meadow have been documented via a long-term range condition and monitoring plot (the meadow is part of the Cody Allotment) that is measured every five years.

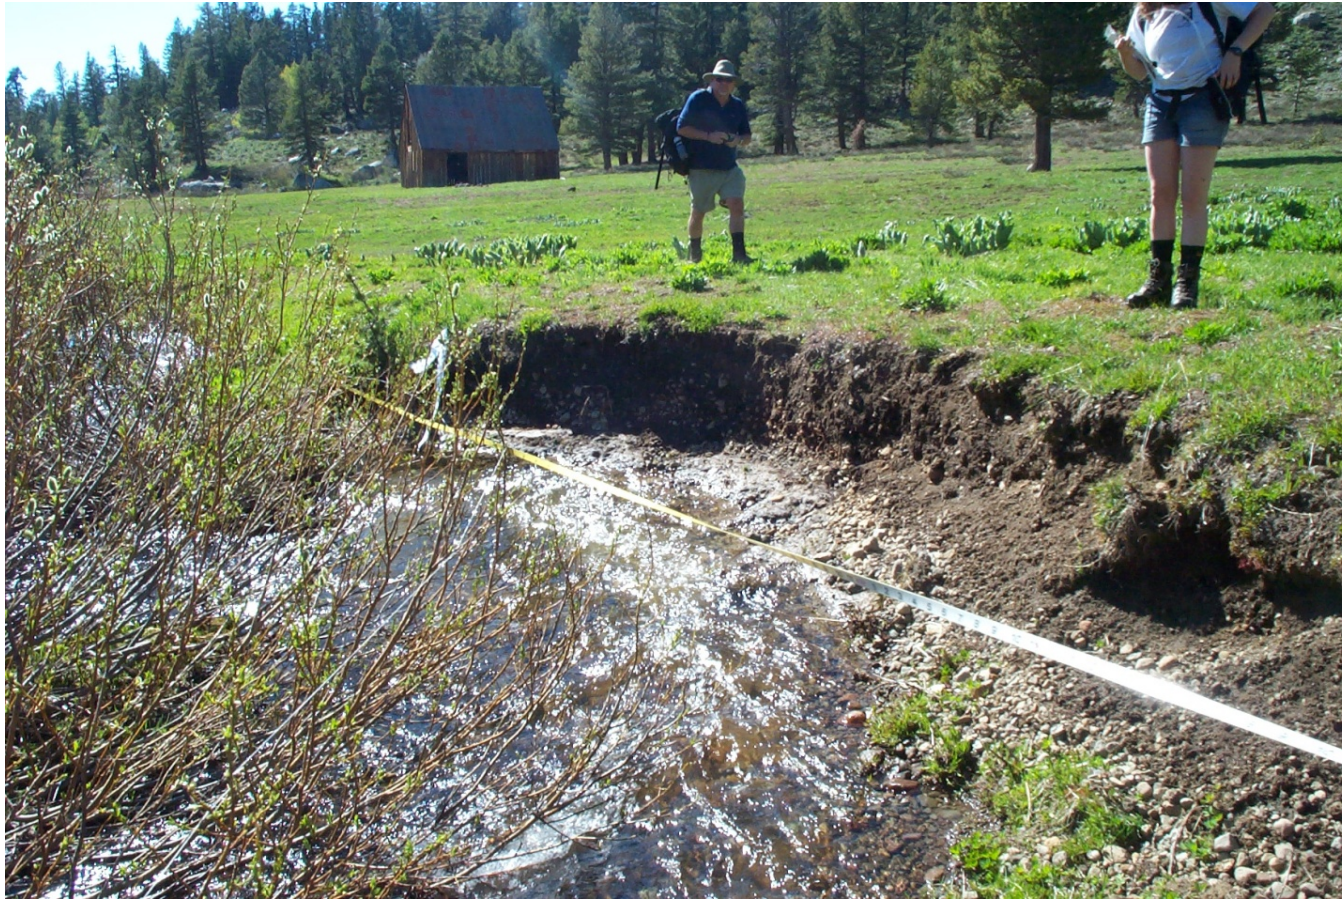
4. Schneider Camp Meadow: Visible in the foreground of this photo, the intermittent stream that flows through Schneider Camp Meadow is now held together largely by willow. Active erosion features observed include: active headcuts (including a 3.5 foot relief headcut on the main channel, downstream of which the banks are actively failing), rill and gully erosion, streambed incision, undercut banks, stream bank alteration, and active sediment deposition. Rainbow trout were present in 2004. In addition to vehicle impacts, cattle trampling has altered surface flow paths in some portions of the meadow.

Visible in the background of this photo is Schneider Barn, which is on the northern side of the meadow. Vehicle tracks near the barn lead to several dispersed campsites. While a predominance of hydrophytic species and diversity of plant species exist in most parts of the meadow (five community types, including willow thickets, were identified by SWS in the meadow in 2010), areas supporting *Artemisia tridentata* with very high percent cover of bare ground reflect large impacts from human use along the barn and access road.

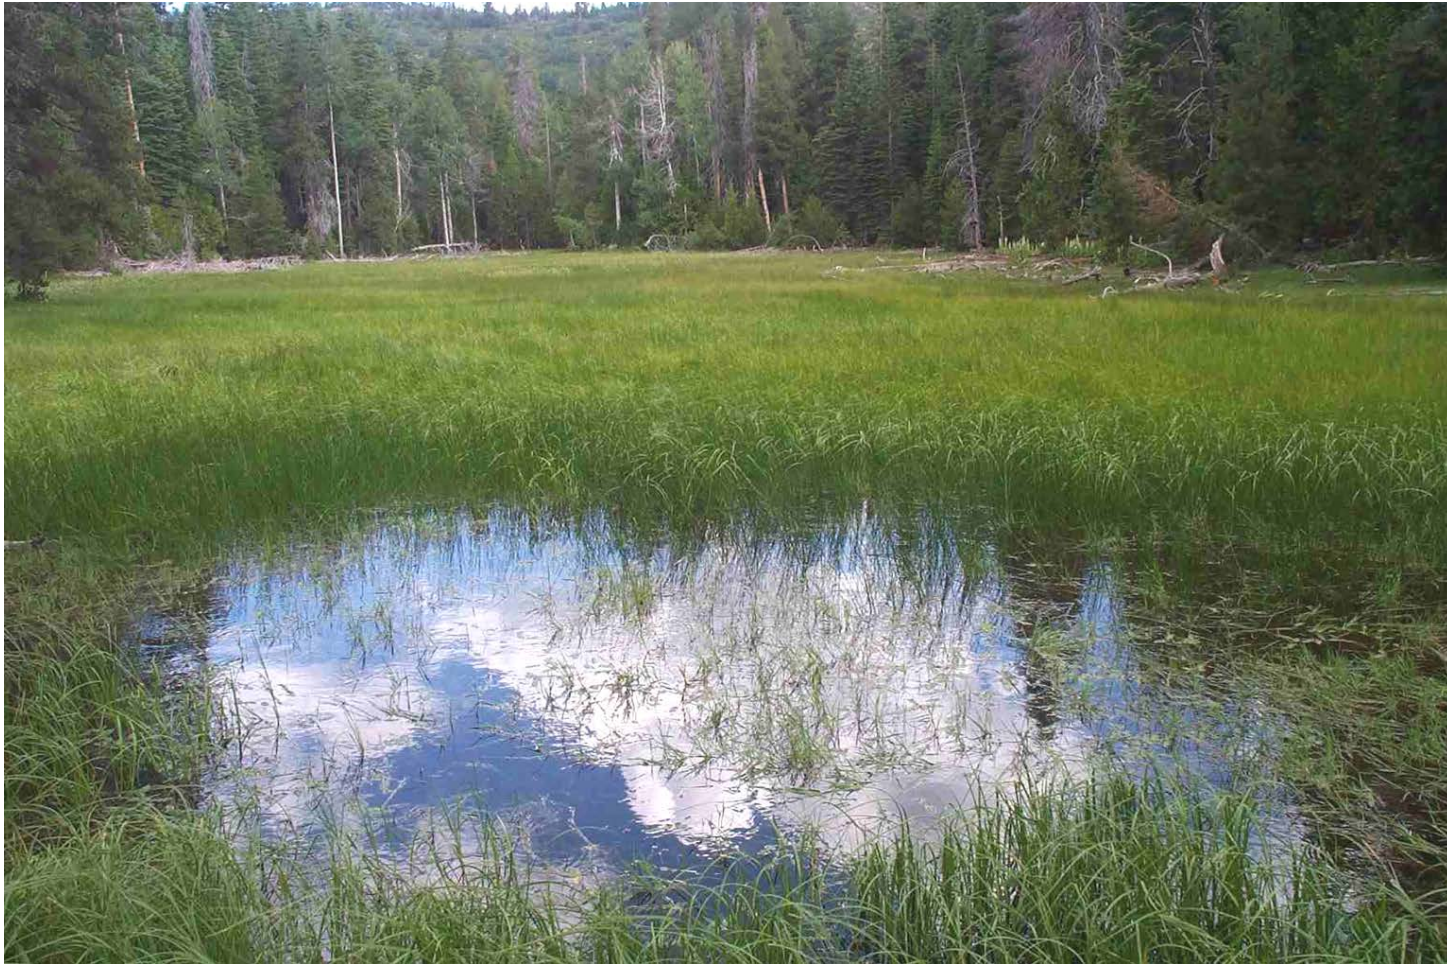
5. Government Meadows: Vegetation conditions within meadow and riparian areas have been documented via long-term range condition and trend monitoring plots within the watershed (two in Jake Schneider Meadow, two in Government Meadow, and one in Schneider Camp Meadow); Proper Functioning Condition Assessments done for range NEPA (Schneider Camp Meadow and Government Meadow) and by Still Water Sciences (Schneider Camp Meadow); and Rapid Assessments done for range NEPA (Convict Meadow).

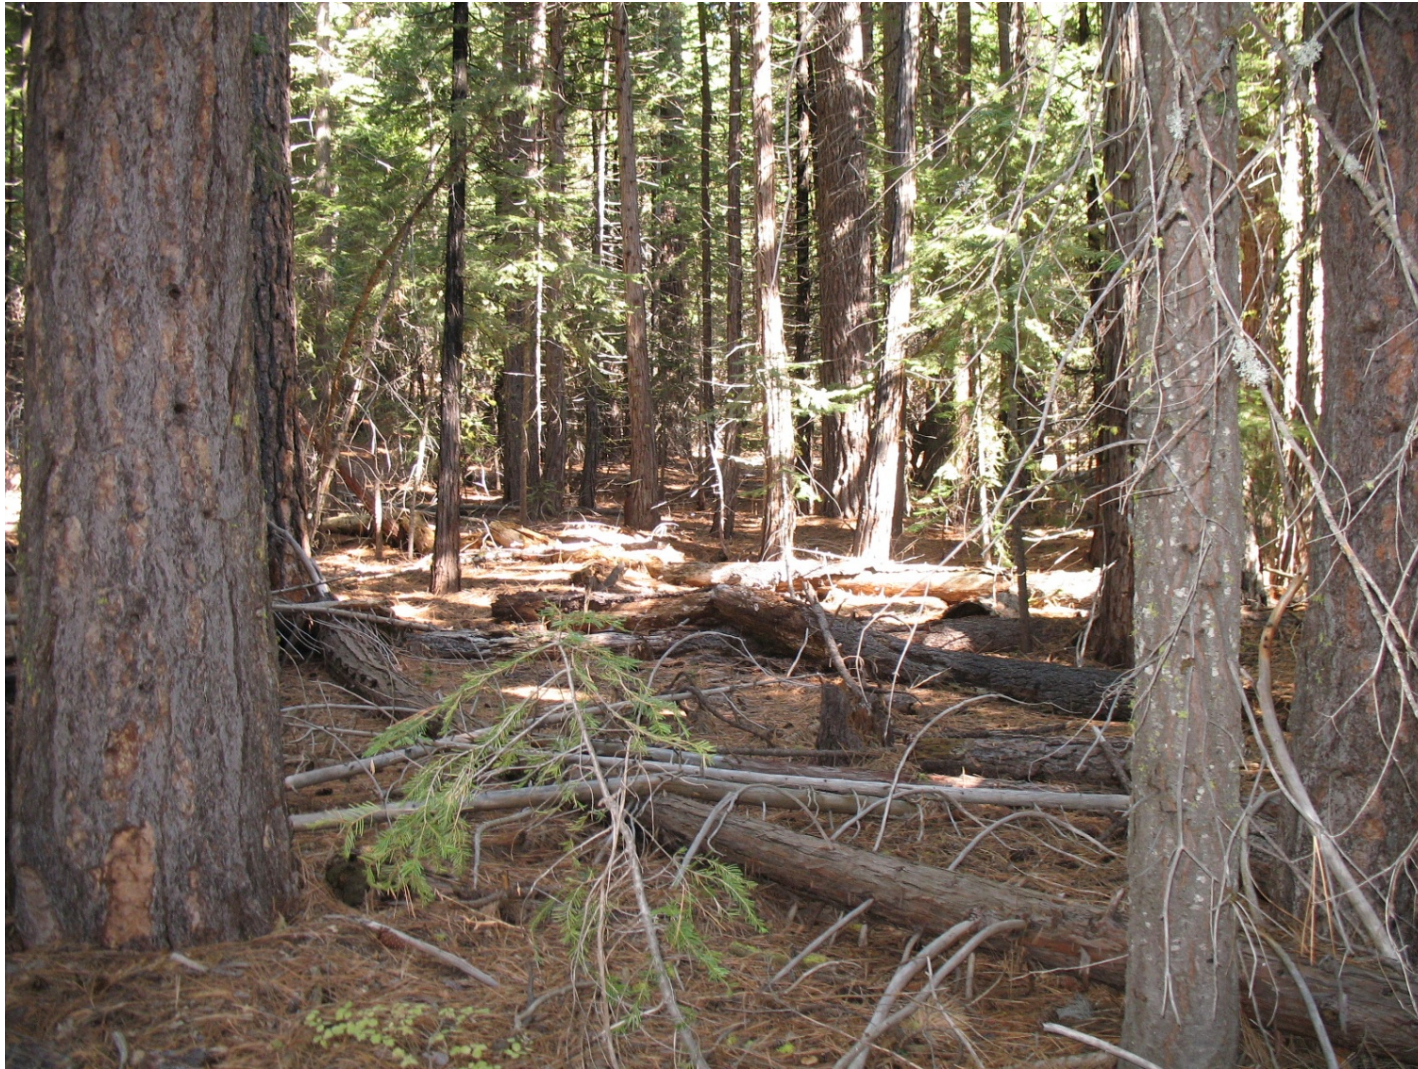
6. Fuels Conditions Example: In the Caples Creek watershed, heavy fuel loading is a concern where pre-settlement fire return intervals were between 5 and 35 years, with generally low to mixed severity, and have now lengthened to 35 to 100 years. Lengthened fire return intervals have allowed for accumulations of dead woody materials and a dense understory of brush and/or saplings; and have influenced stand structure, density, and distribution. The site in this photo is located along the Caples Creek Trail, near where the trail runs along the Silver Fork American River.

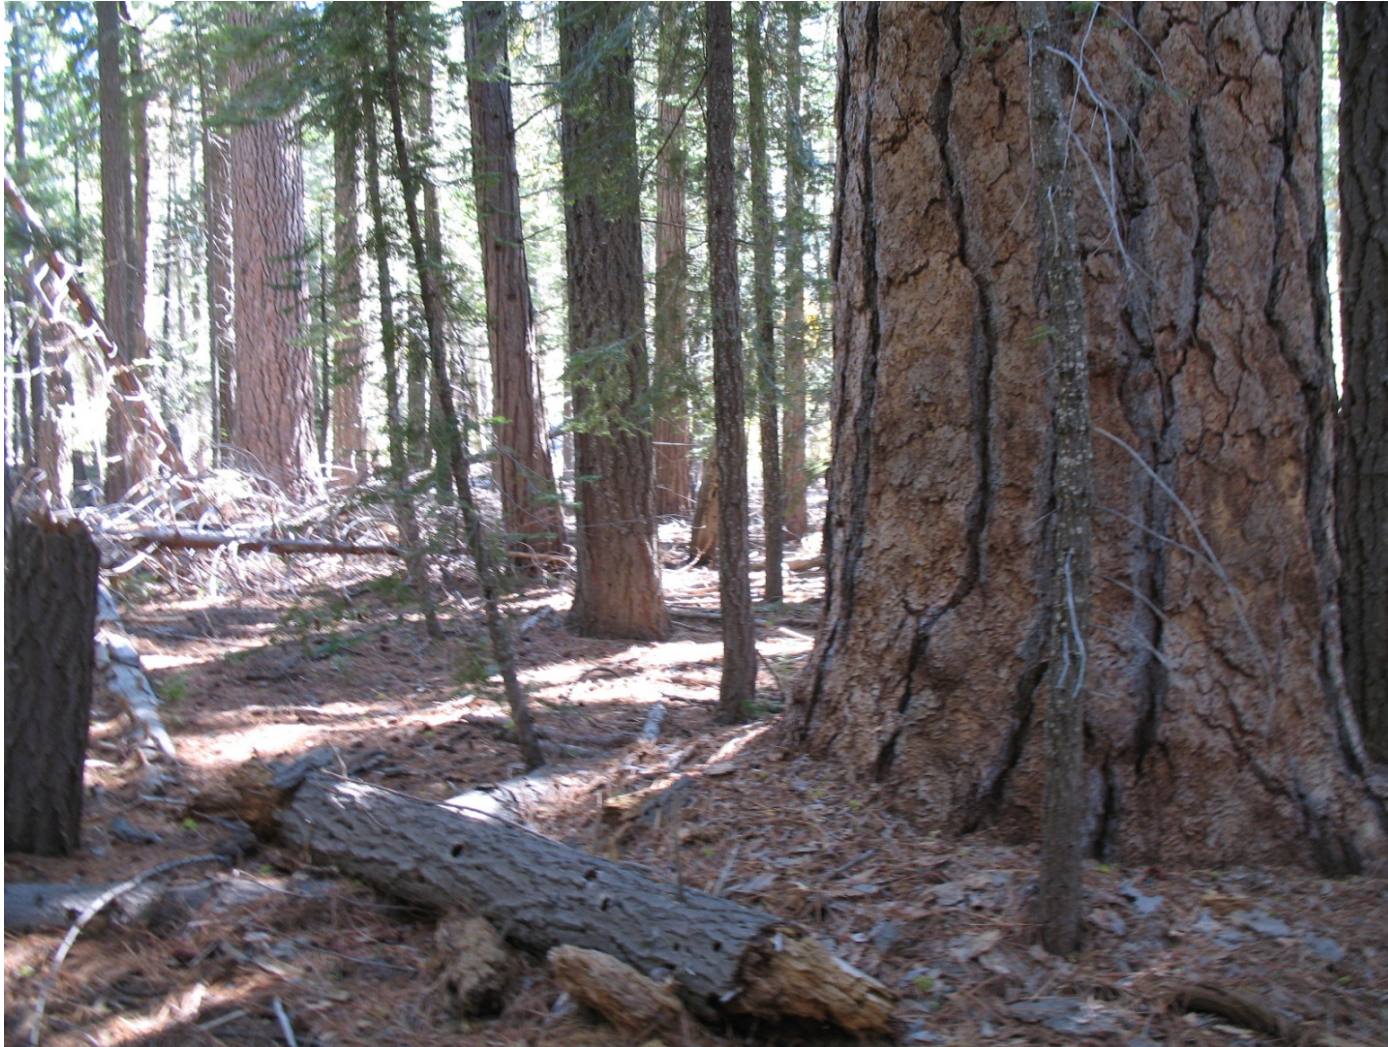
7. Fuels Conditions Example: The Eldorado National Forest fire history geospatial layer indicates that approximately 47 fires occurred within the Caples Creek watershed since 1908. Those fires were not allowed to burn, however, and all were contained at less than eleven acres. Sites such as this are located along the Caples Creek Trail, near where the trail runs along the Silver Fork American River.

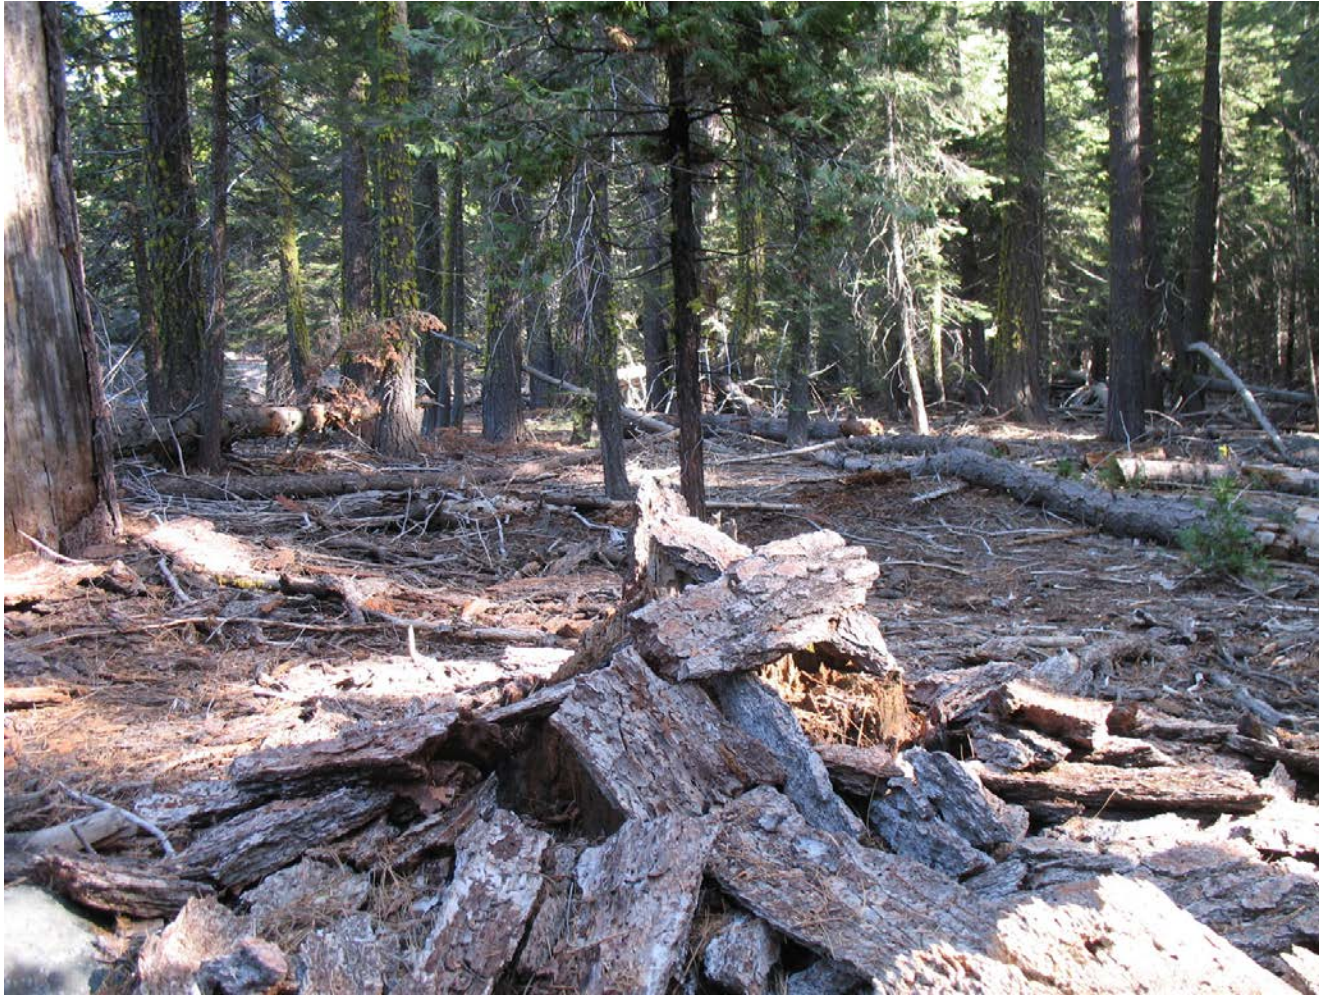
9. Fuels Conditions Example: Longer fire return intervals allow for more fuel and vegetation to accumulate between fires, resulting in a higher severity fire than what may have occurred in pre-European settlement. Consequently, fires today kill more vegetation and are more difficult to control (FMP, 2009). The site in this photo is located along the Caples Creek Trail.
