# Facilities Capital Improve Plan

Fiscal Year 13/14

# El Dorado County

CAO Facilities

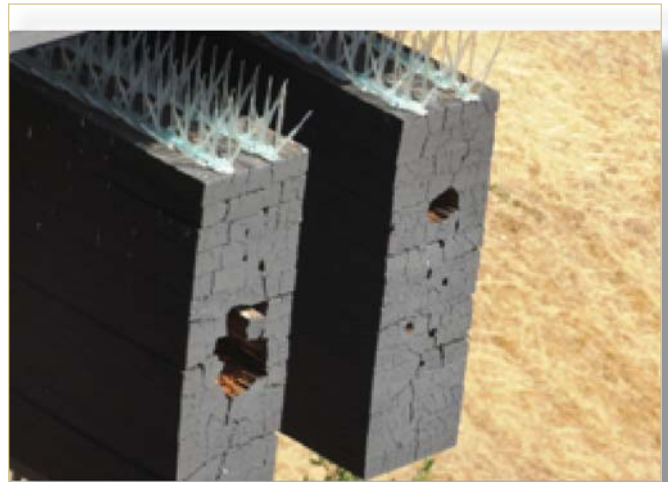
**BEAMS**

Woodpecker damage to end of beams. Wood damage to ends of beam with splitting and cracking.

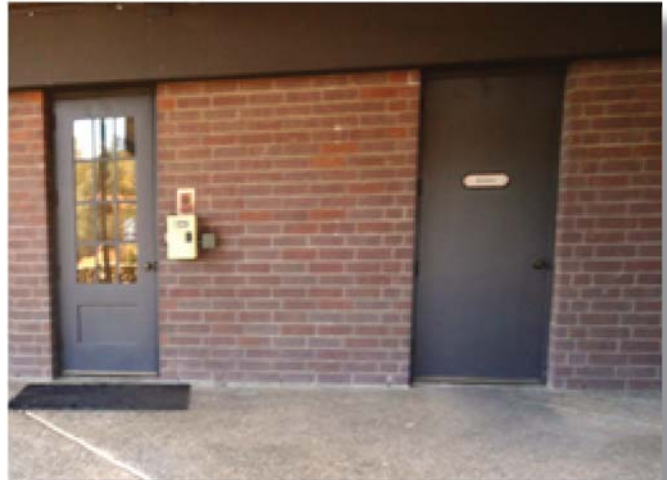
**EXTERIOR**

Non ADA locksets.

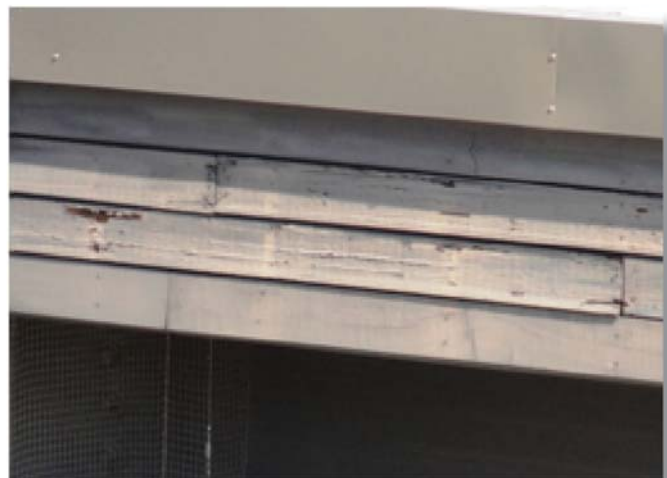
**FASCIA**

Sun damaged fascia. Wood cupping, dry rot damage and nails popping.

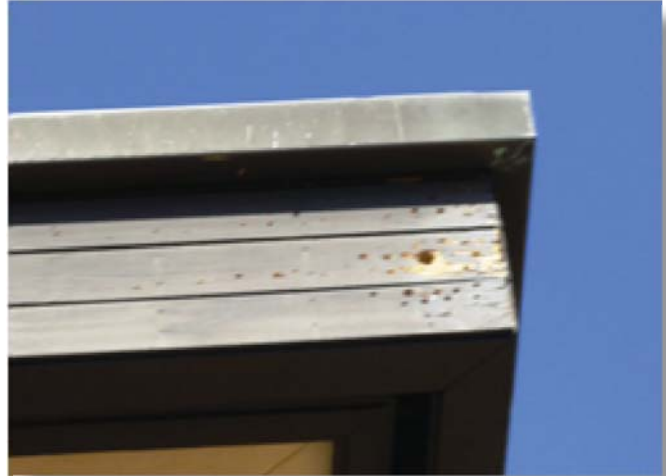
**FASCIA**

Woodpecker damage to fascia.

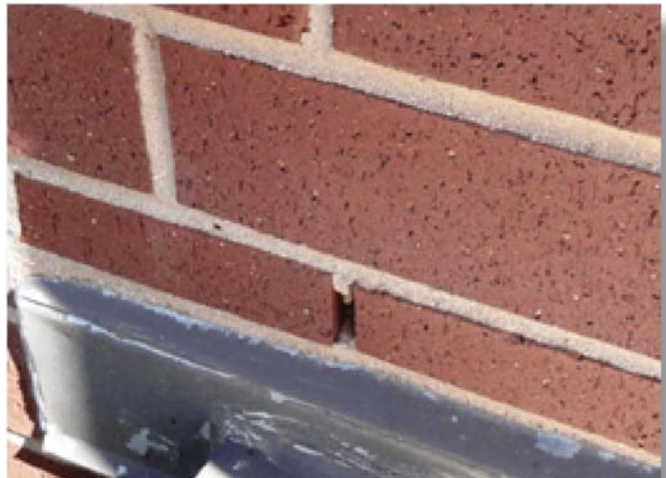
**GROUT**

Grout missing at brick veneer joint.

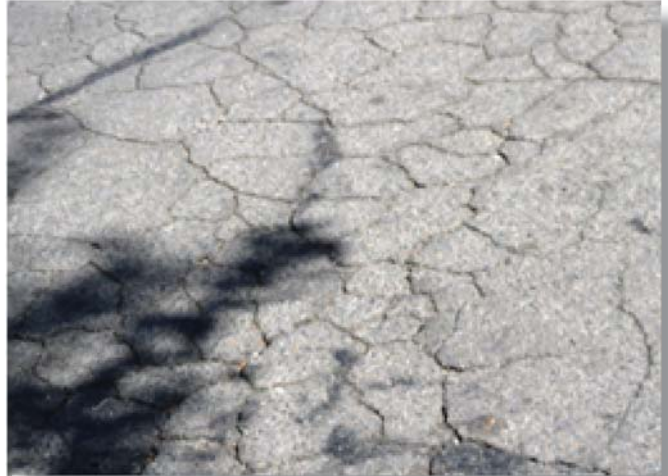
**PARKING**

Cracking in asphalt paving.

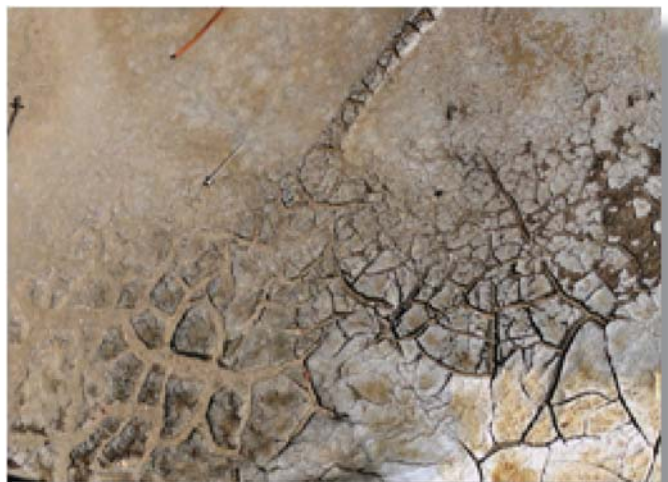
**ROOF**

Alligator cracking in roofing membrane.

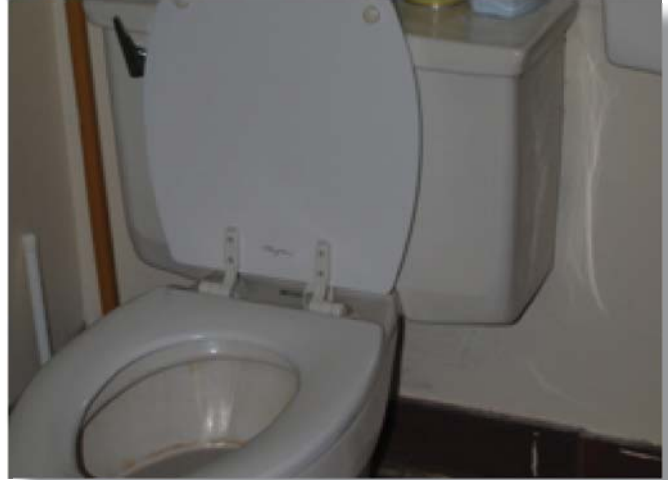
**WATERCLOSET**

Outdated fixture at search and rescue.

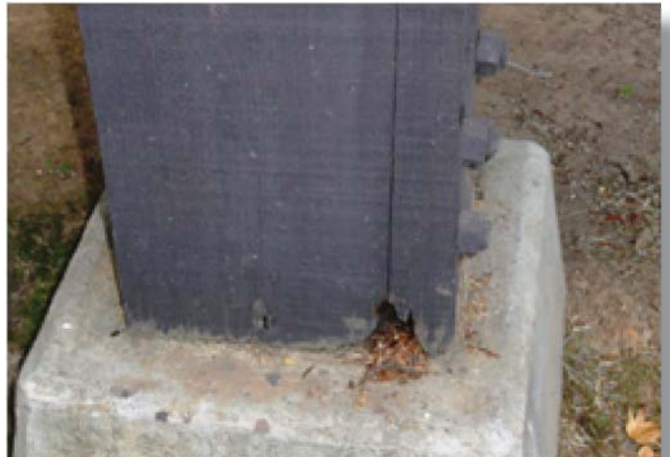
### **COLUMN**

Dry-rot damage at base of exterior column.

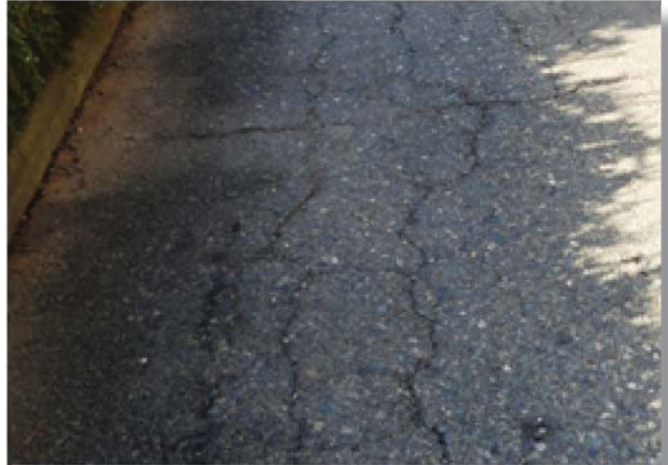
### PAVEMENT – EAST DRIVEWAY

Asphalt paving in poor condition due to cracking. Complete failure will follow if remedial action not taken.

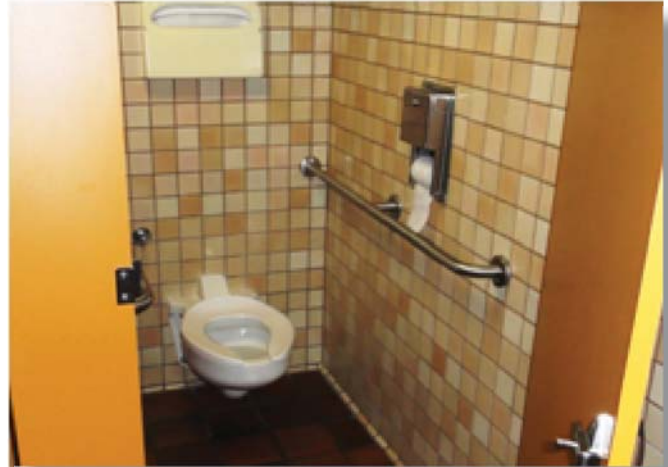
### RESTROOM 2

Grab bars have been added to sides of toilet, but compartment is not ADA accessible.

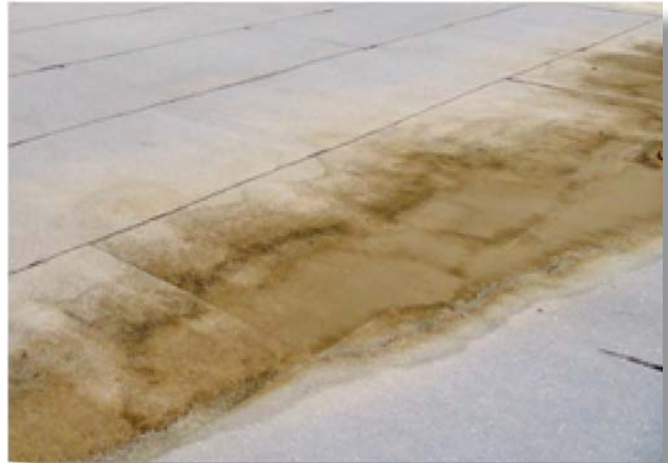
### ROOF

The roof has drainage problems. Staining due to standing water which contributes to shortened life cycle for roofing material.

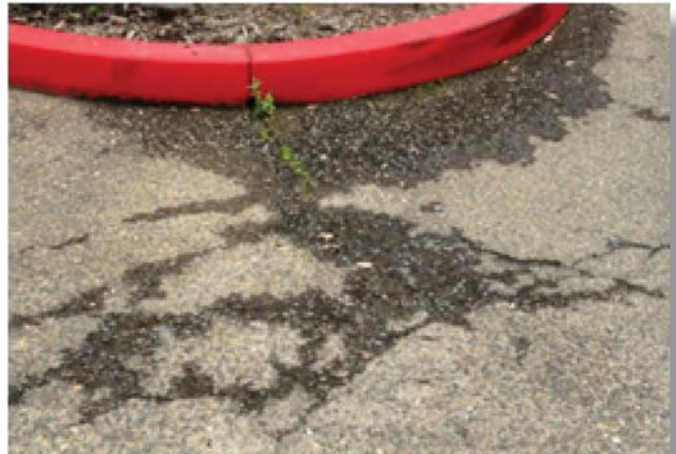
### ASPHALT

Cracking in asphalt pavement, vegetation growing in crack.

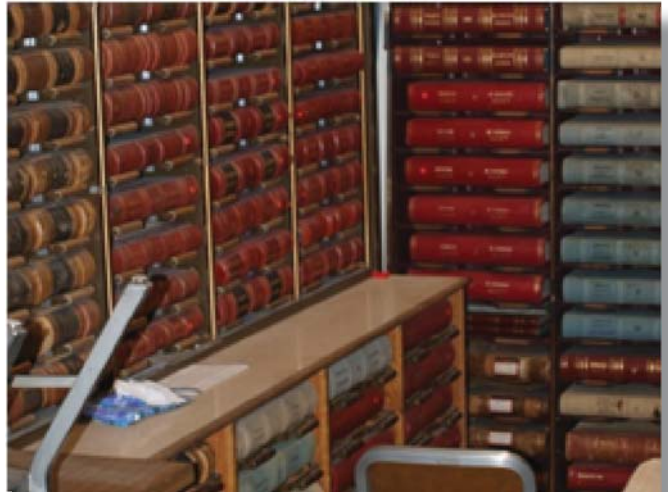
### RECORDS

Historical records kept in basement. Wet type fire alarm system would destroy these books if activated.

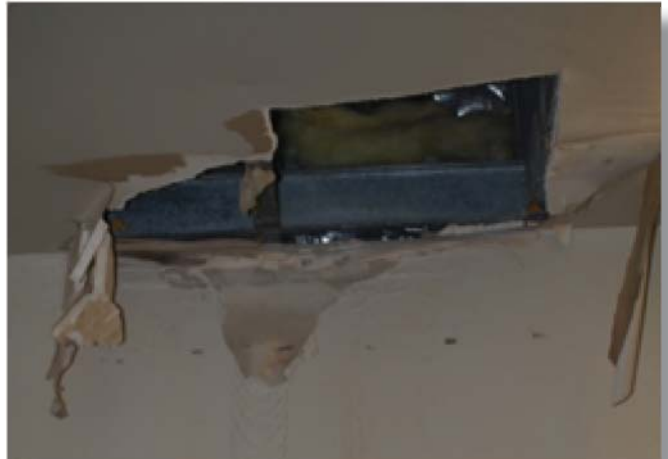
**ROOF LEAK**

Ceiling damage in traffic court break room roof leak.

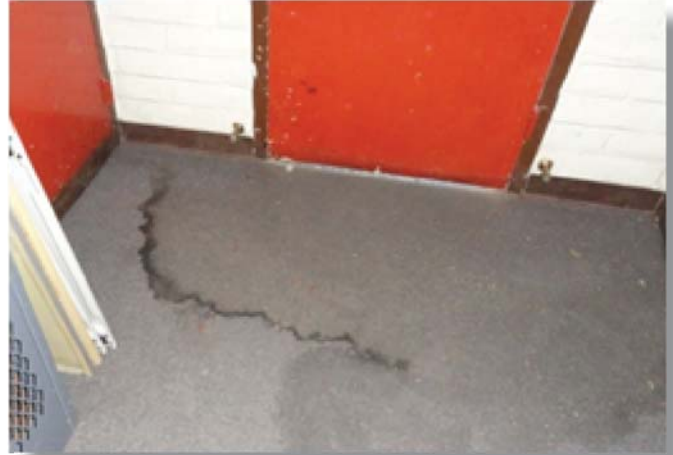
**CARPET**

Water stained carpet.

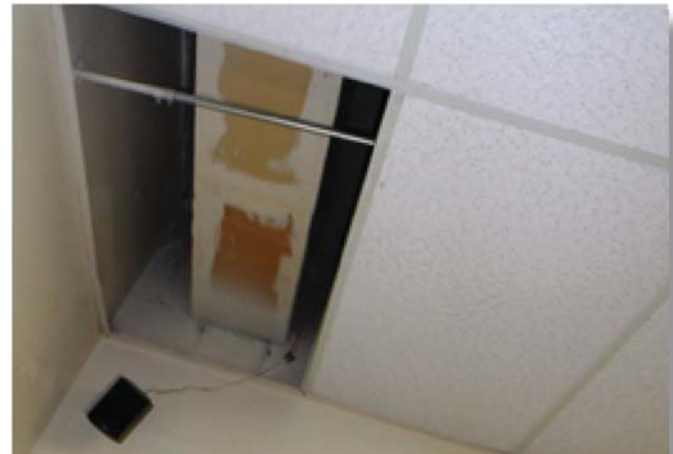
**CEILING**

2 X 4 ceiling panel missing.

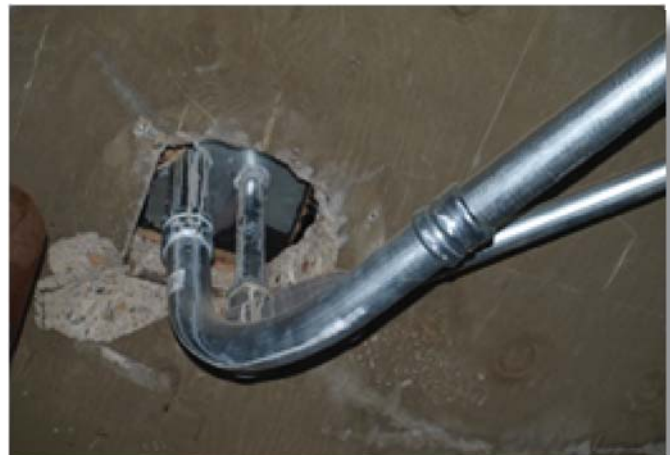
**CONDUIT**

Conduit penetrations through ceiling not properly sealed.

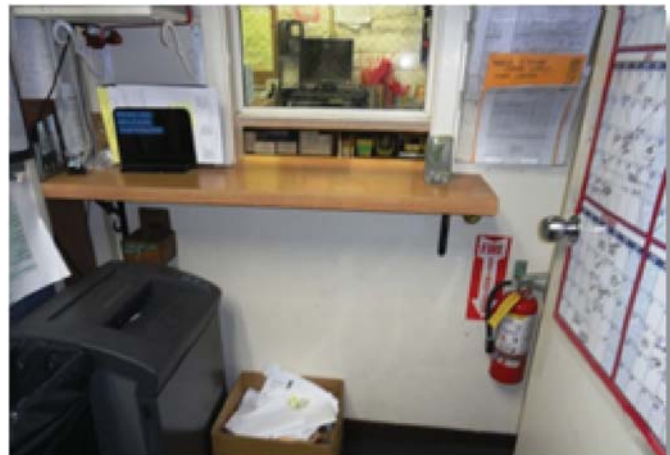
### EVIDENCE WINDOW

No ADA access at evidence window and door does not have ADA lockset.

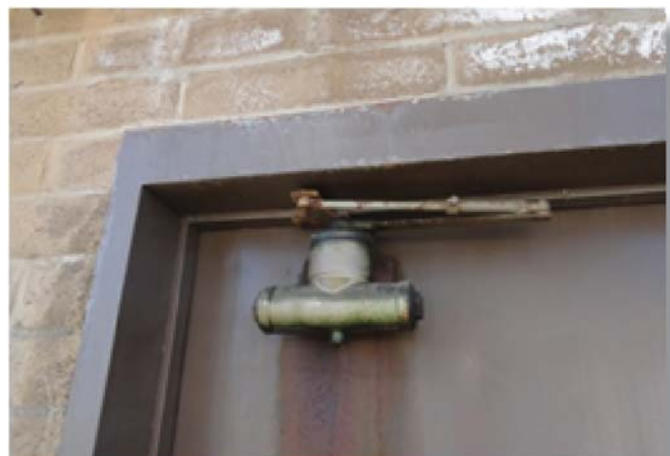
### EXTERIOR DOOR

Exterior door and closer rusted. Doors and hardware at exterior typically should be replaced.

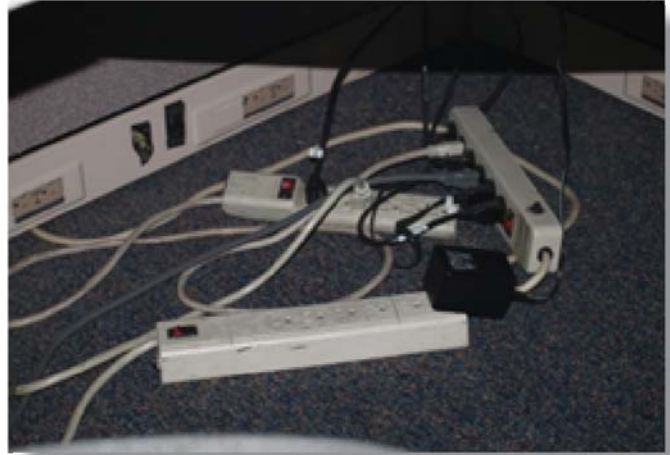
### WORKSTATION

Typical workstation. There are not enough power outlets. Extension cords present, possible fire and tripping hazard.

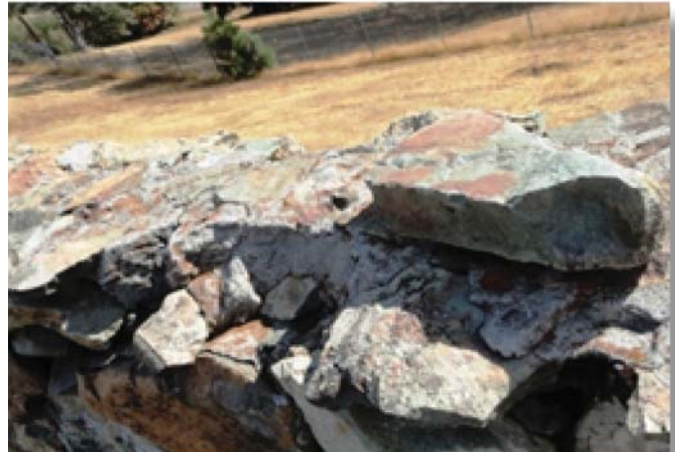
### **STONE WALL**

Stones are loose and missing in the rear retaining.

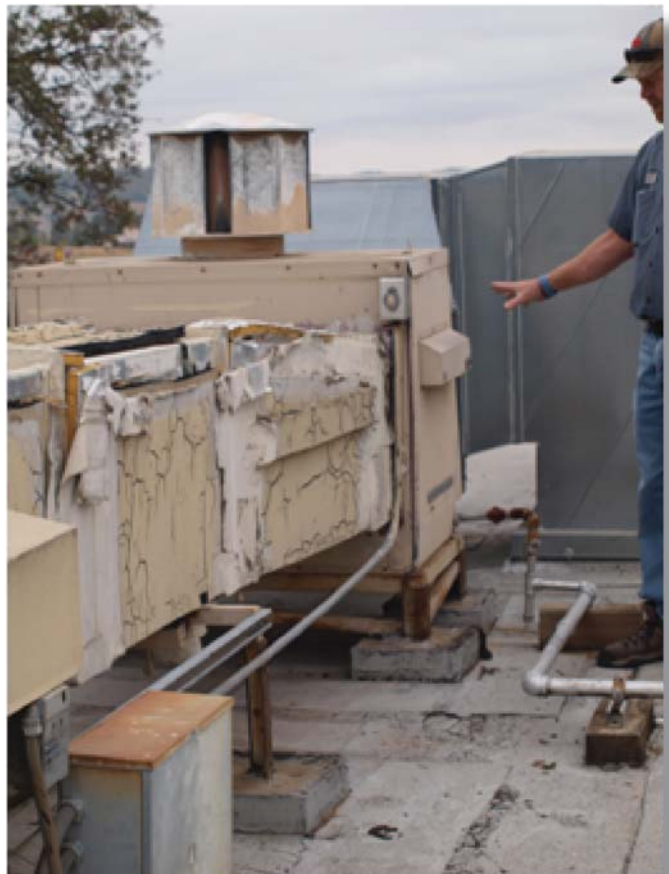
### DUCTWORK

Roof top ductwork is in poor condition.

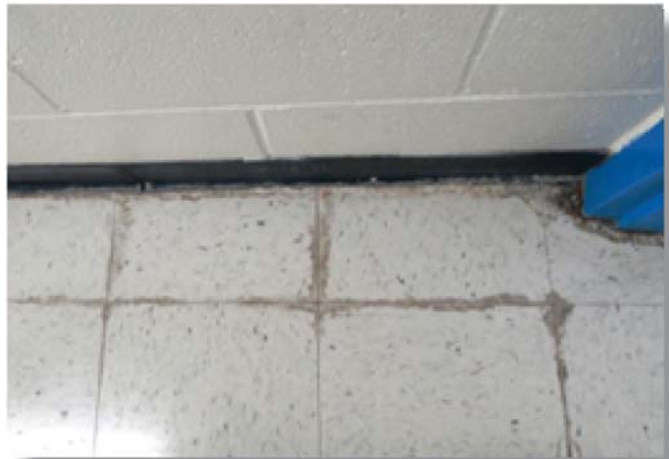
**FLOORING**

Vinyl Composition Tile flooring is worn out.

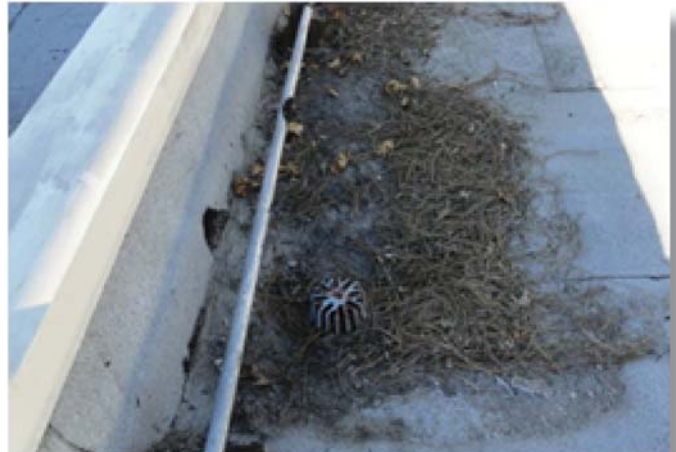
### ROOF

Evidence of standing water due to debris blocking roof drain.

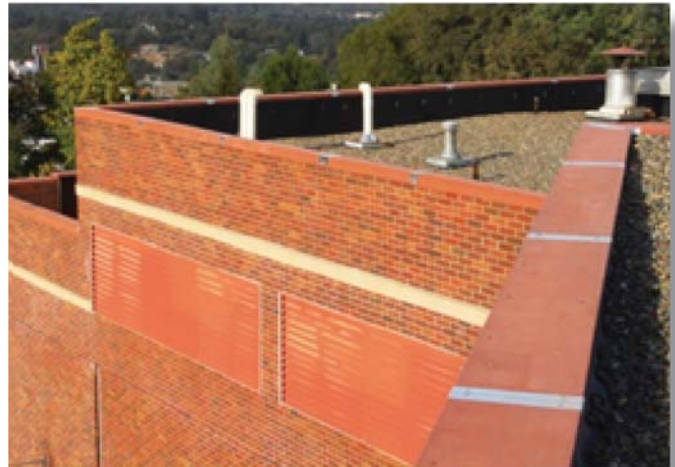
**FLASHING - DUCT TAPE**

Duct tape used to seal joints at parapet flashing.

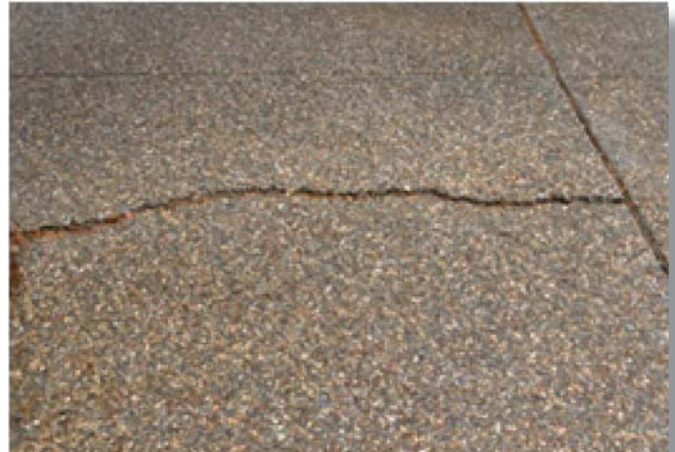
**CONCRETE**

Crack in concrete walkway.

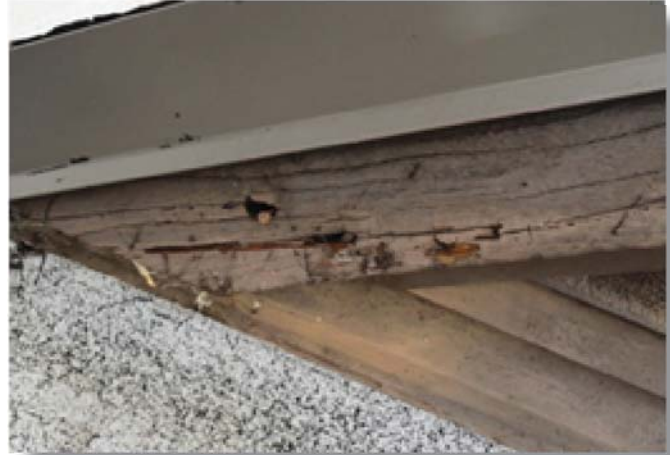
**FASCIA**

The sun damaged fascia has dry-rot damage and rusted nails popping out.

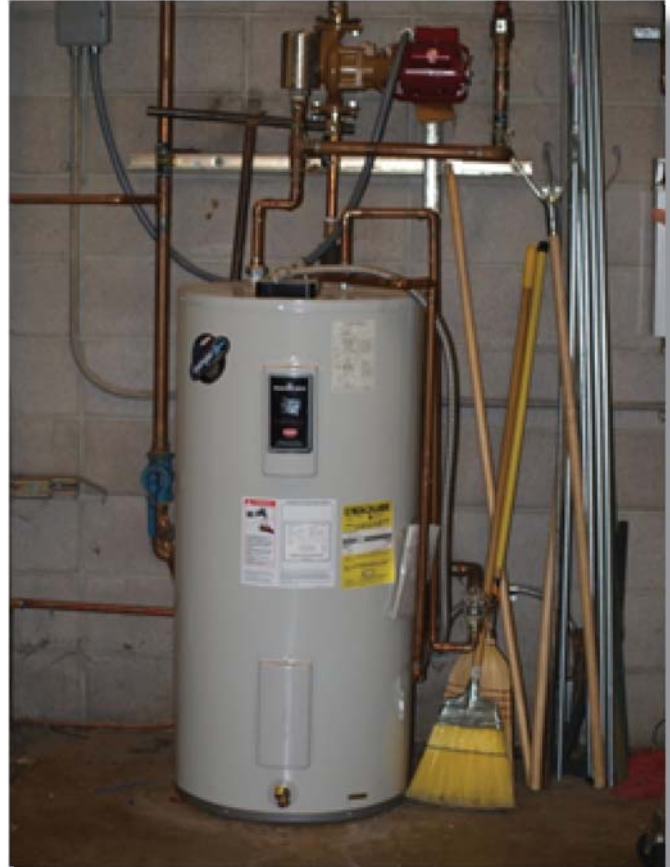
**HOT WATER**

Hot water heater does not have earthquake strap installed.

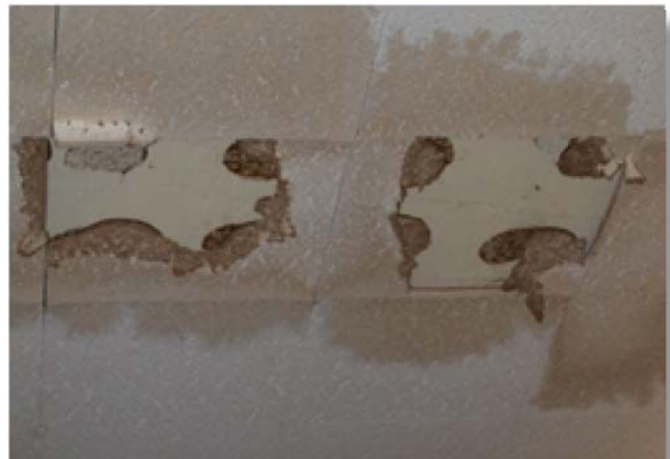
**LEAK**

Ceiling damage from water leak. Leak believed to come from HVAC equipment or piping.

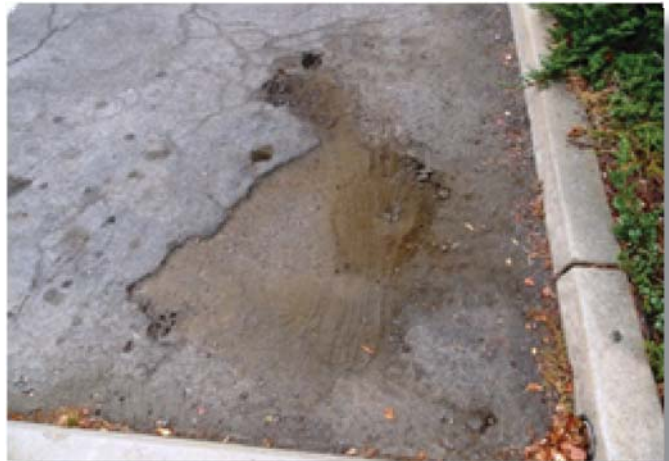
**PAVEMENT**

Asphalt pavement is failing.

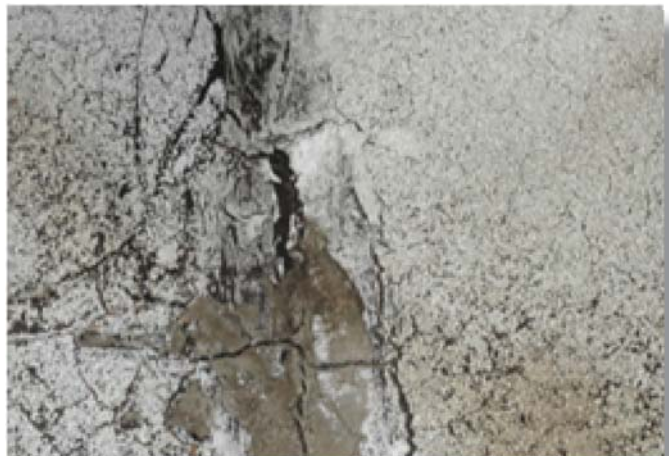
**ROOF**

Roof membrane has cracking and deterioration.

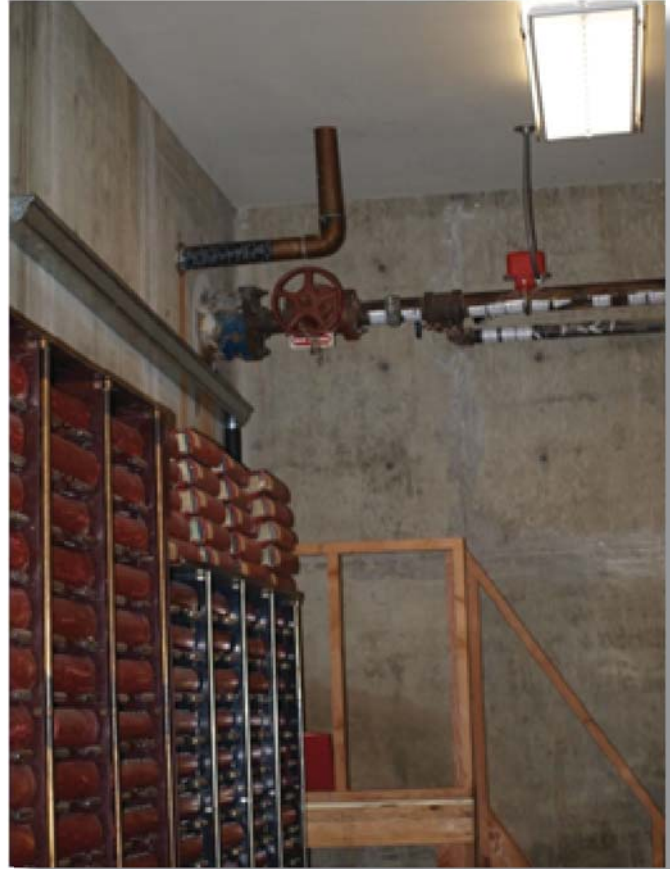
**RECORDS**

Historical records kept in basement. Wet type fire alarm system would destroy these books if activated. Also note the metal gutter and drain above the books.

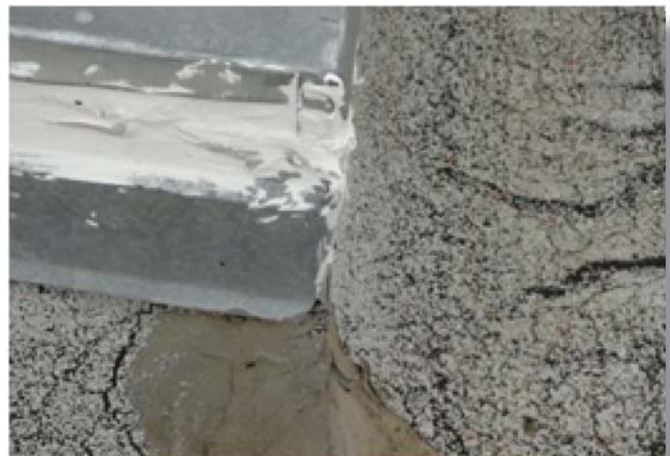
**ROOF**

Roof and flashing repair work was needed to prevent leaking.

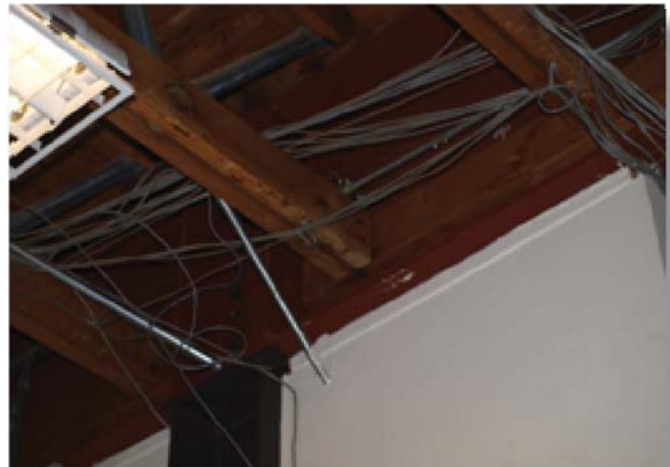
**CABLING**

Telephone cabling run haphazardly above framing.

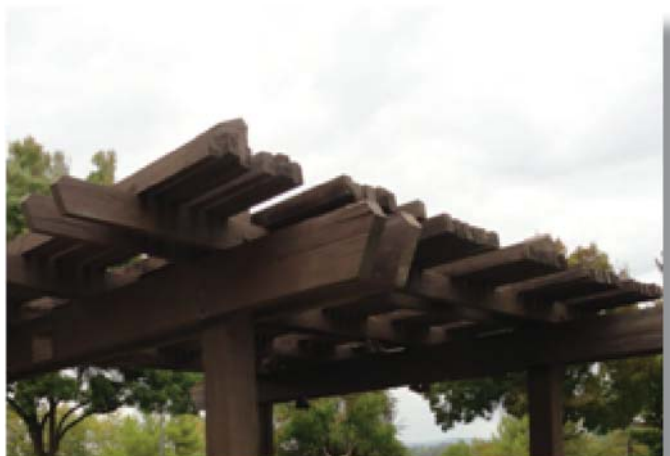
**PERGOLA**

The exterior pergola has sun damaged framing members with splitting and dry-rot.

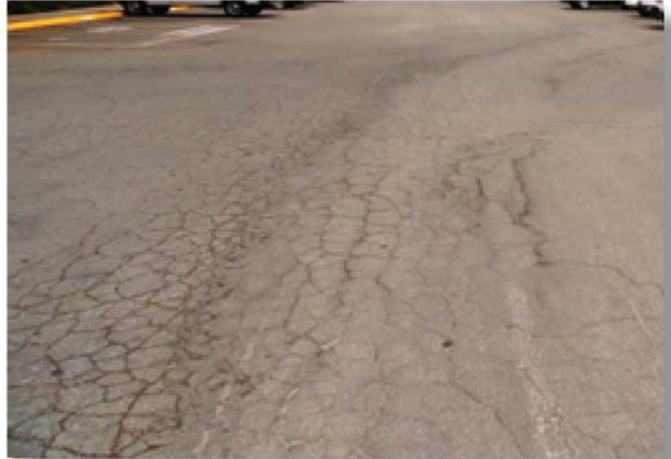
### **PAVEMENT**

Asphalt pavement is severely cracked and on verge of failure.

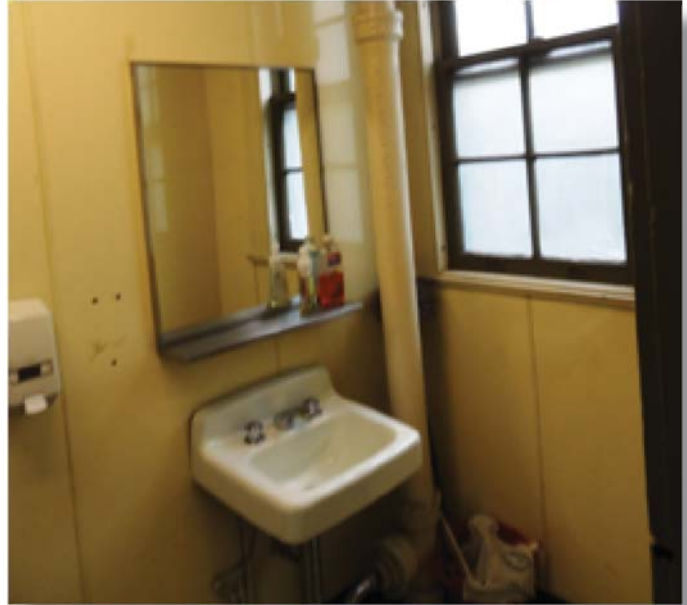
**RESTROOM**

Restroom is in poor condition. Original fixtures at end of lifecycle. Holes in wall where accessory was removed. Exposed piping is unappealing.

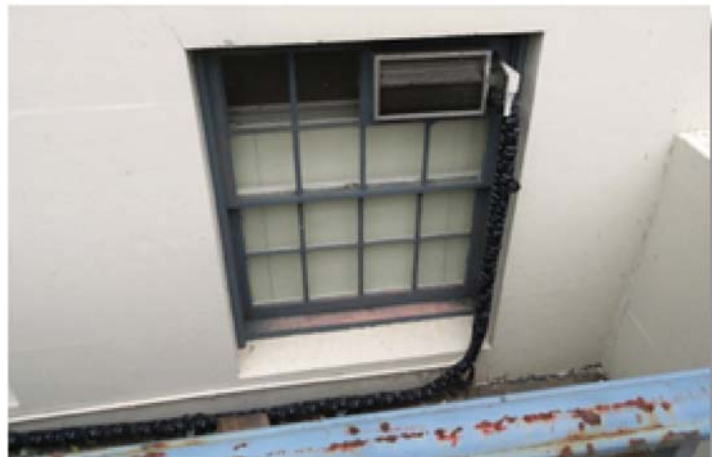
### WINDOW

Single glazed windows do not provide energy efficiency. There is paint peeling. Small window unit to cool room.

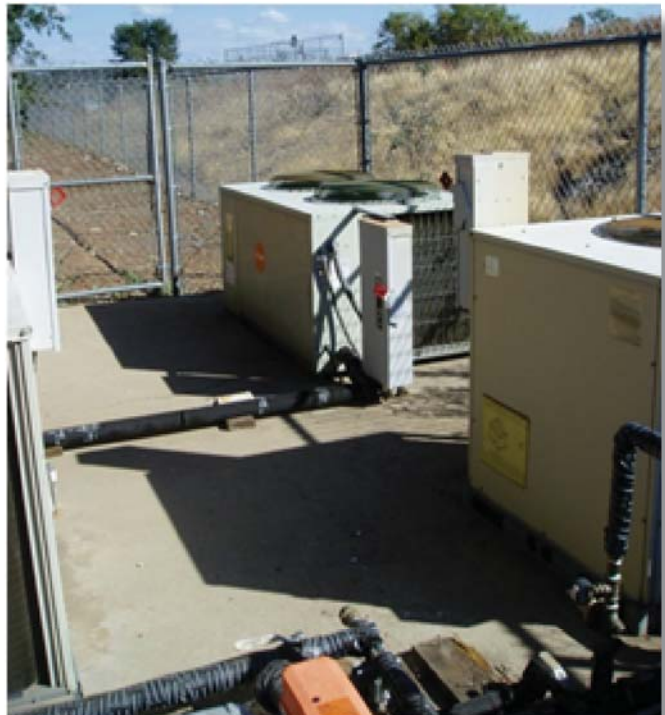
**CONDENSING**

Old condensing units are ready for replacement.

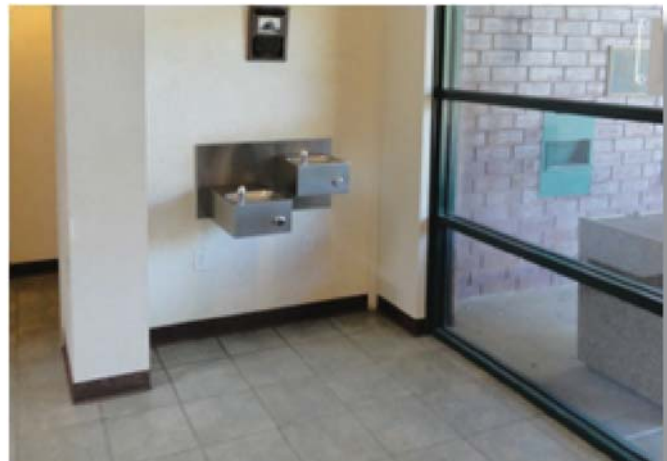
**DRINKING FOUNTAIN**

Building has ADA compliant drinking fountain along with restrooms. Lobby finishes are in good condition.

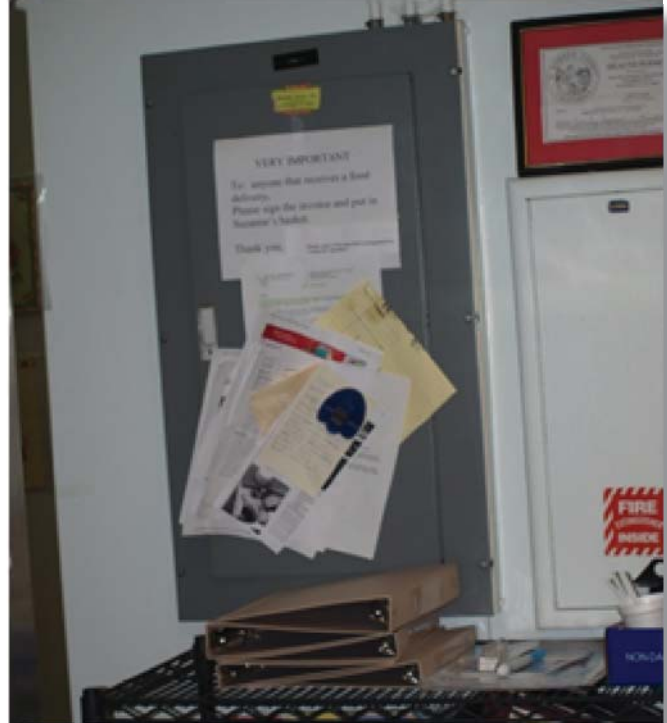
### PANEL

Electrical panel is blocked by shelving and used for bulletin board.

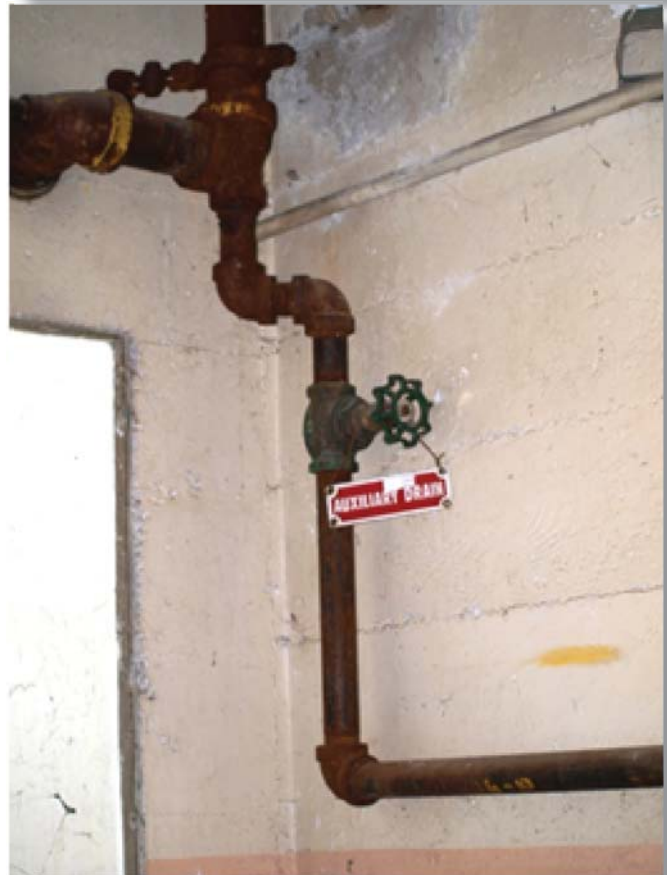
### PIPING

Fire sprinkler drain piping has corrosion.

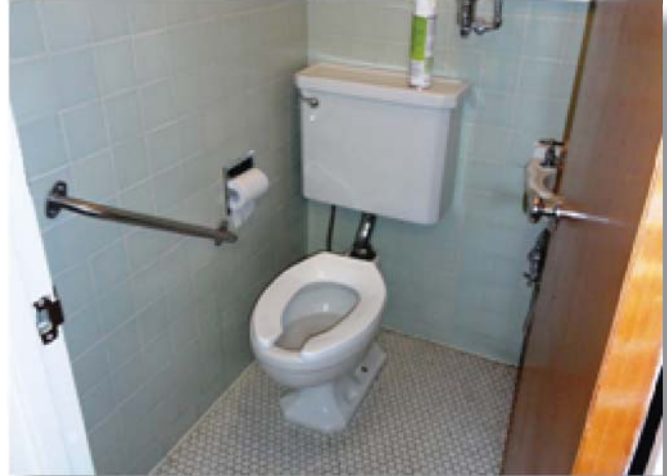
**RESTROOM**

Restroom has grab bar installed, but is not ADA compliant.

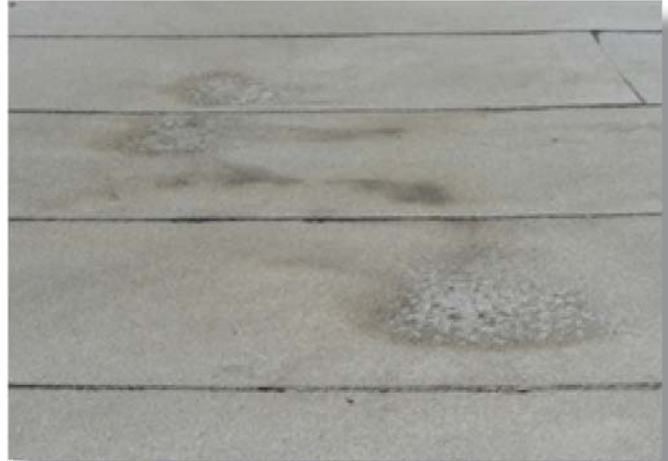
**ROOF**

Seek N Seal applied to roof to stop water leak.

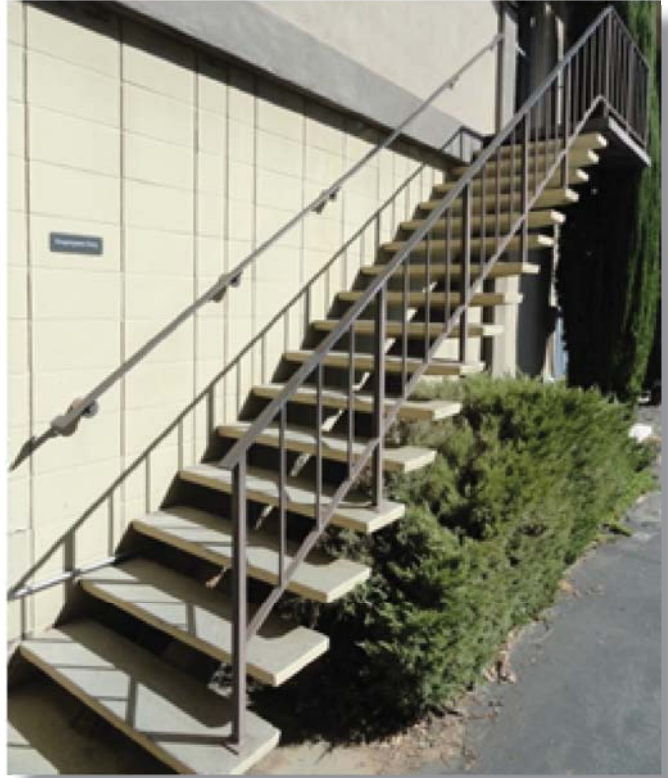
### STAIRS

Exterior stairs do not have contrasting stripe.  
Vertical spacing on guardrail requires updates &  
railings don't extend 12 inches past steps.

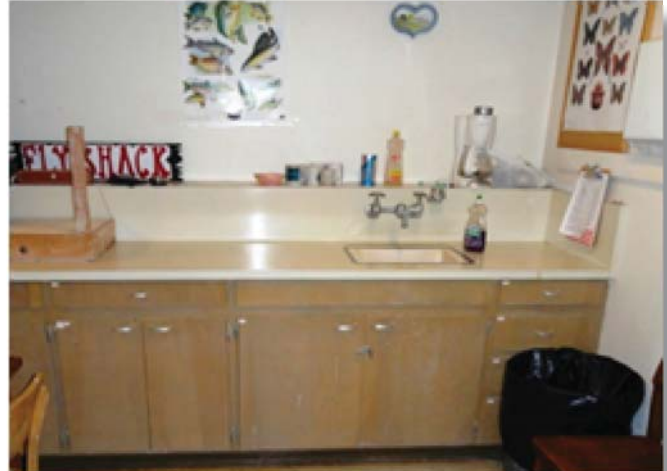
**CASEWORK - ARTS**

Cabinets in condition, however may require ADA updates.

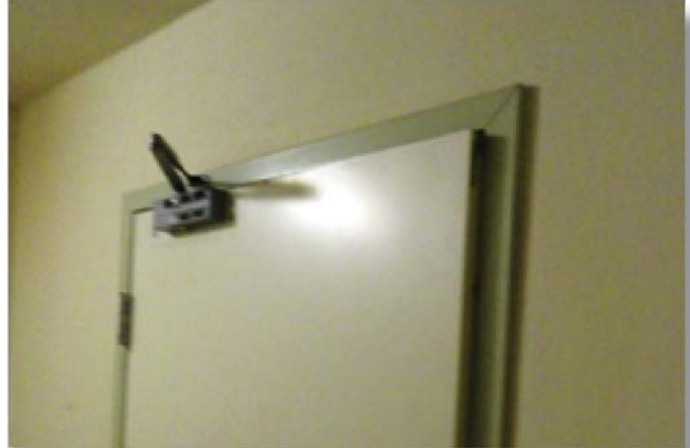
**INTERIOR DOOR - CLOSER**

Much of the interior hardware is obsolete. The cover is missing from the closer on this door.

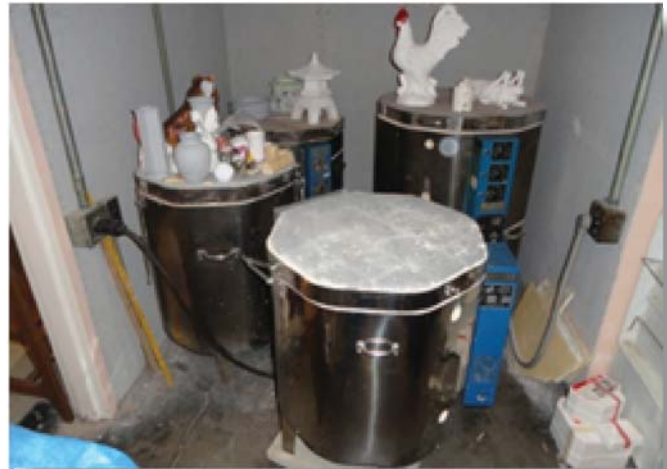
**KILN ROOM**

Three kilns are jammed into this tiny room. The room does not have an exhaust hood or fan.

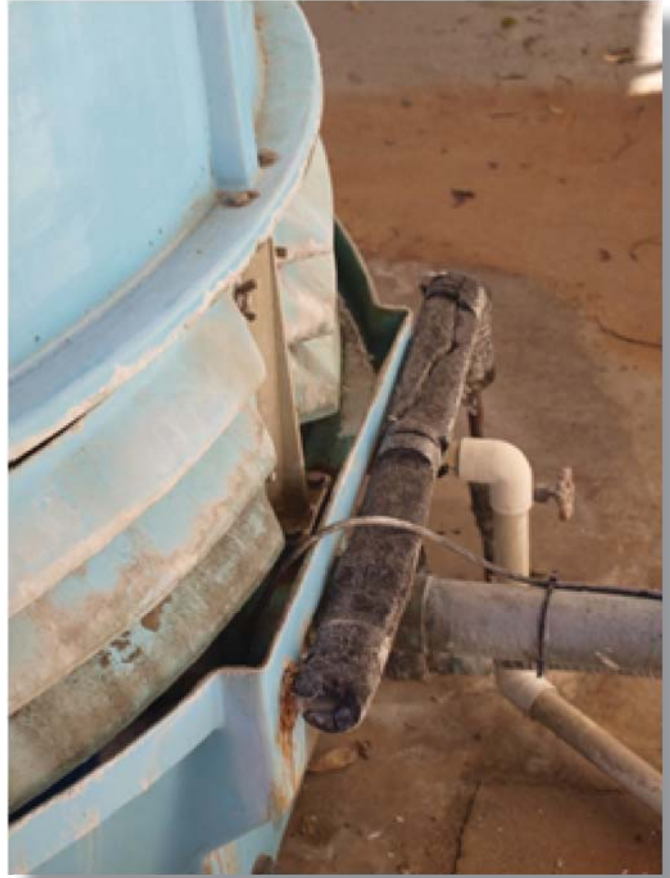
**COOLING**

Cooling tower water is not treated and results in corrosion issues.

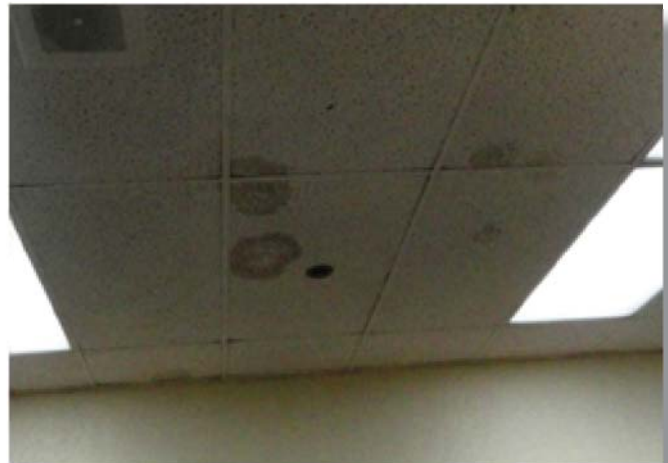
**CEILING**

Stained ceiling tiles.

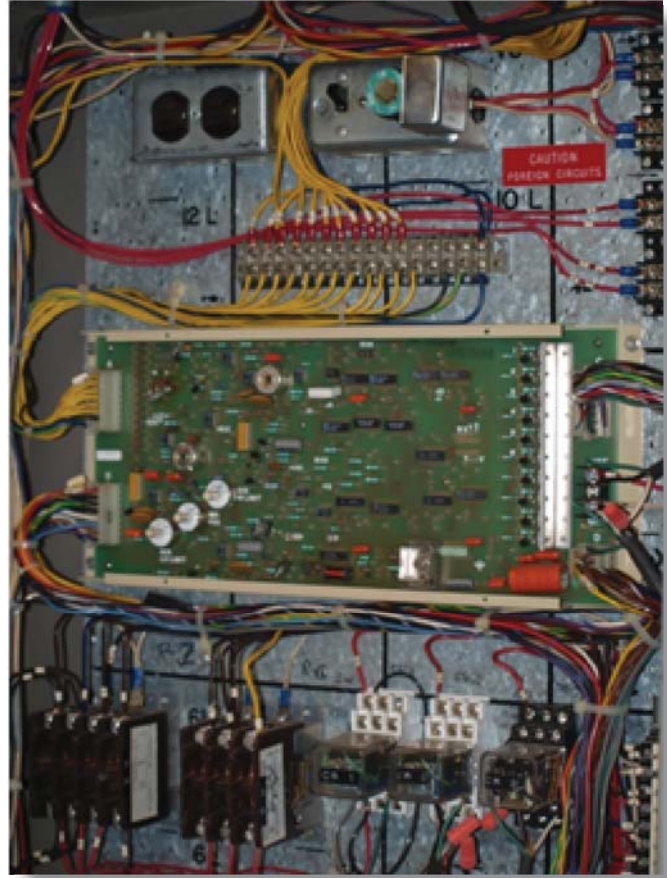
**CONTROLS**

Original HVAC controls are obsolete.

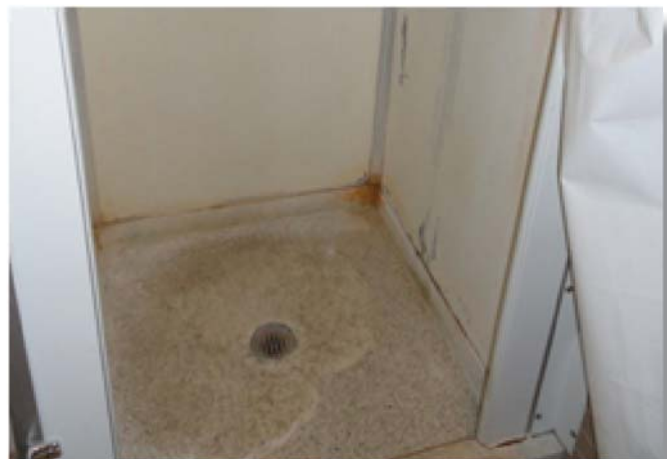
**SHOWER**

Shower does not meet current ADA standards and in very poor condition.

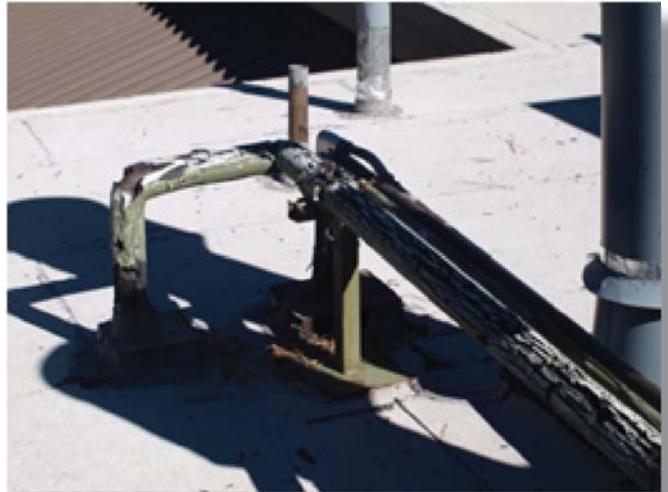
**HVAC PIPING**

Insulation of roof piping is almost completely deteriorated.

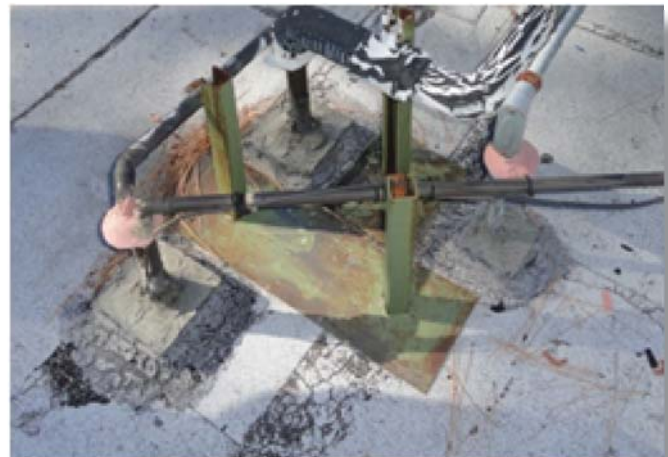
**ROOF**

Alligator cracking and numerous patches at electrical and mechanical penetrations.

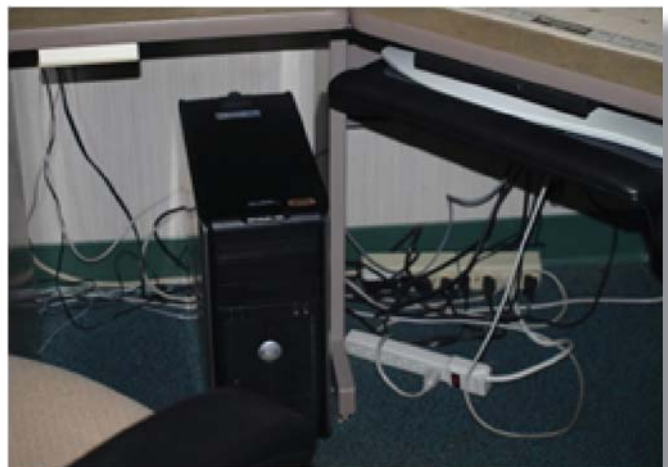
**WORKSTATION**

Typical workstation. There are not enough power outlets. Extension cords present possible fire and tripping hazard.

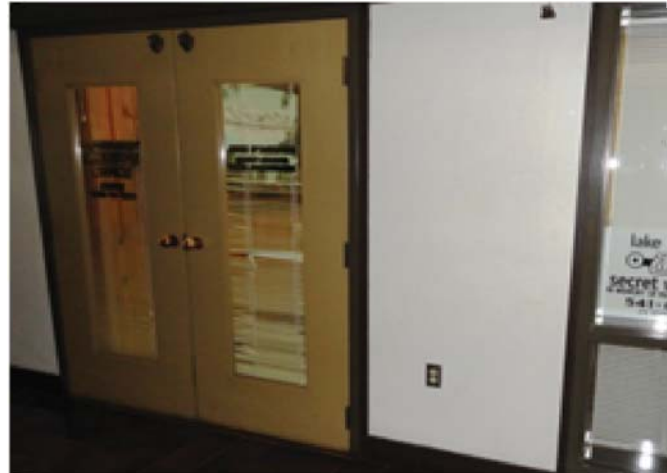
**SHERIFF**

Main entrance to sheriff's office does not have ADA accessible hardware..

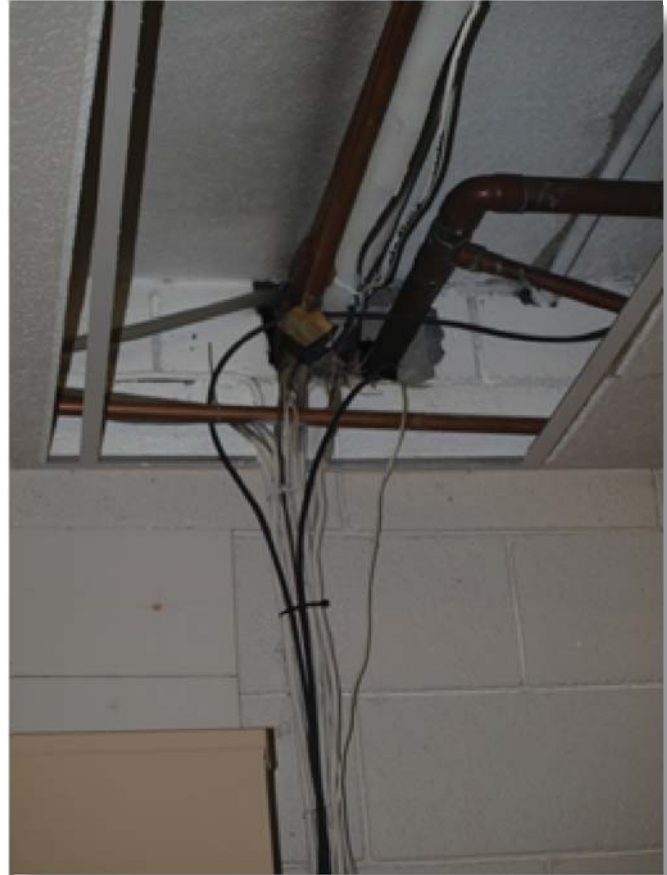
**PENETRATIONS**

Pipe penetrations are not properly sealed at wall.

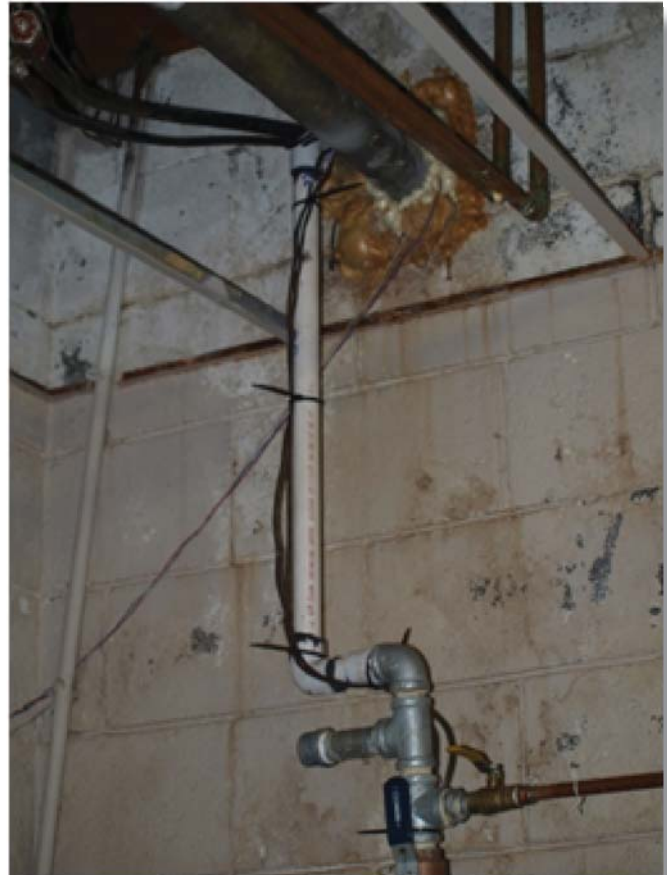
**PIPE**

Pipe repair with mixture of PVC, copper and galvanized steel.

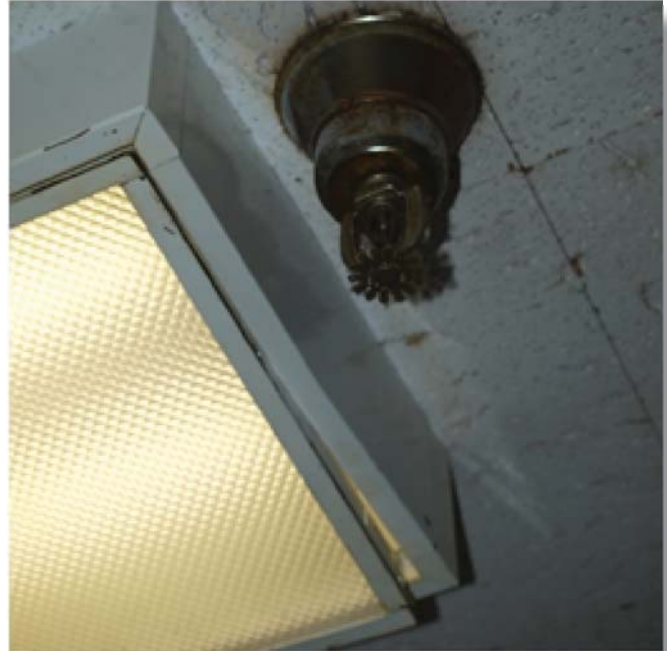
**FIRE SPRINKLER**

Old dirty and corroded fire sprinkler head. The light fixture has a broken hinge.
