# Facilities Capital Improve Plan

Fiscal Year 13/14

# El Dorado County

CAO Facilities

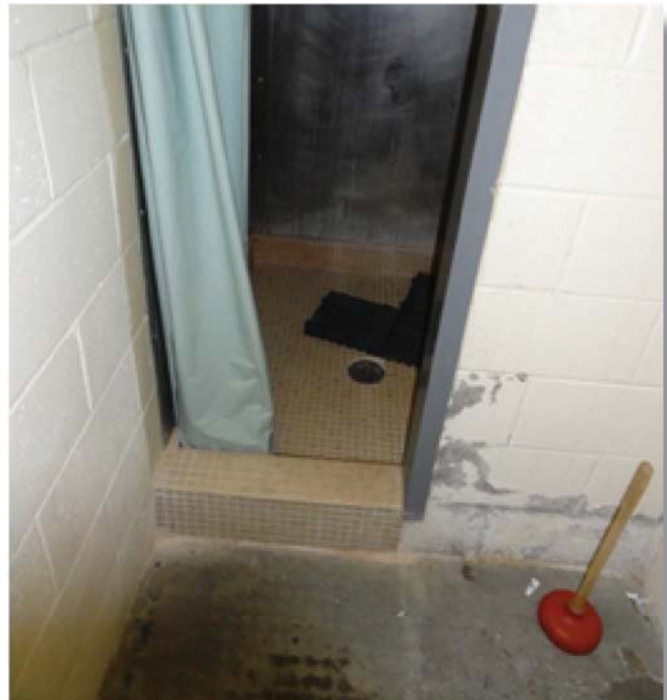
**SHOWER**

Shower may need ADA upgrades. Shower and finishes in poor condition.

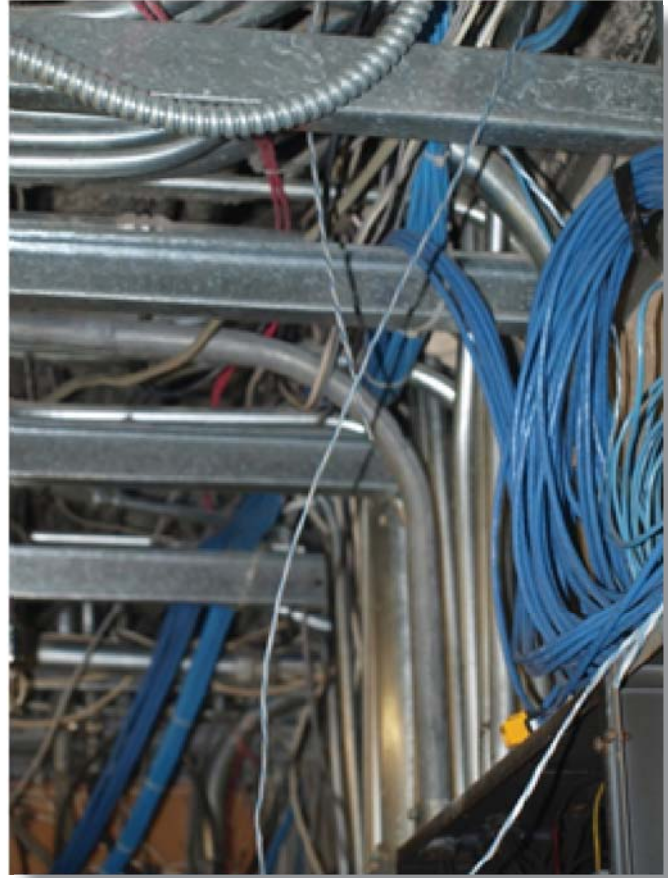
**CABLING**

Cabling below control station is haphazard. Note exposed wire nut connection.

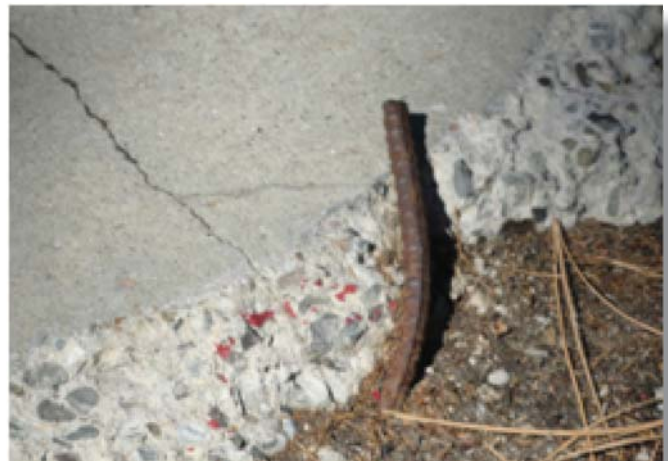
**CONCRETE EXPOSED REBAR**

Concrete in sidewalk is broken and left exposed rebar.

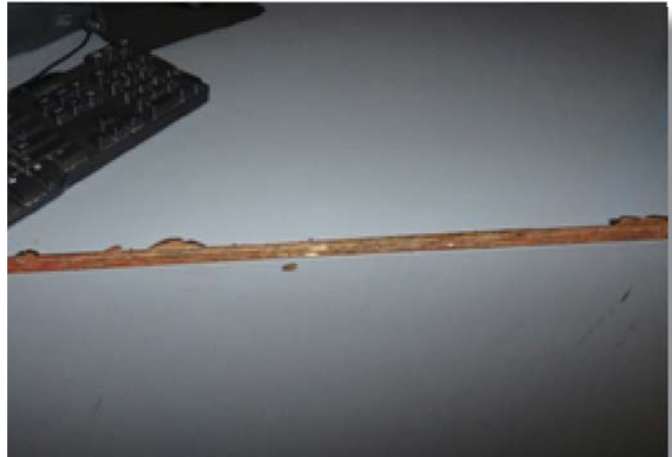
### **CONTROL ROOM COUNTER**

Control room counter is in poor condition. The wood substrate is exposed and plastic laminate is chipped.

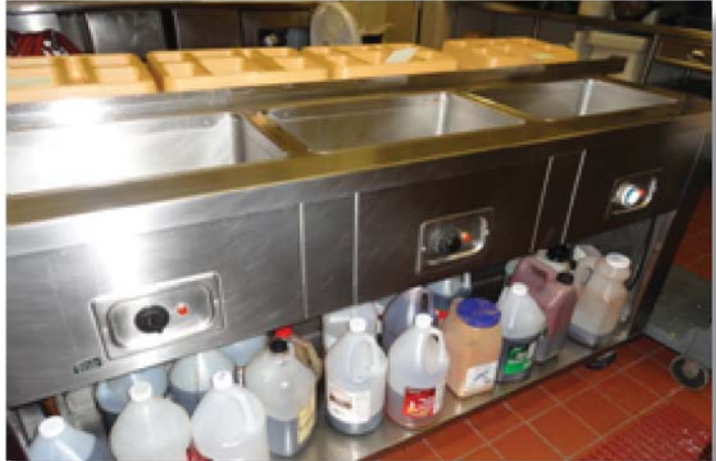
### **HOT CART**

Steam table does not work. Maintenance hasn't been able to locate parts to repair.

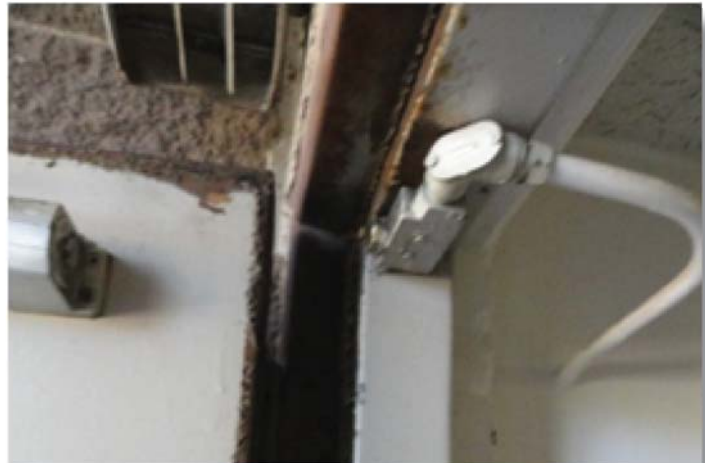
### **KITCHEN DOOR EXTERIOR**

Exterior door and frame are rusted. Frame is not secure to the wall framing making closing problematic.

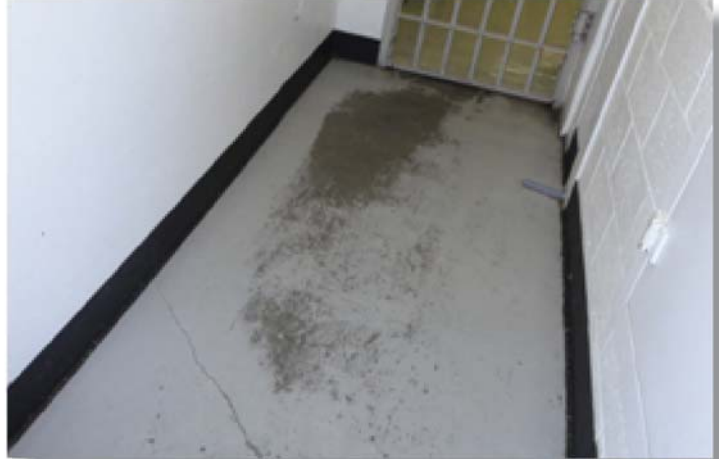
**PAINTED CONCRETE FLOOR**

Paint of floor is worn through. There is minor cracking in the concrete.

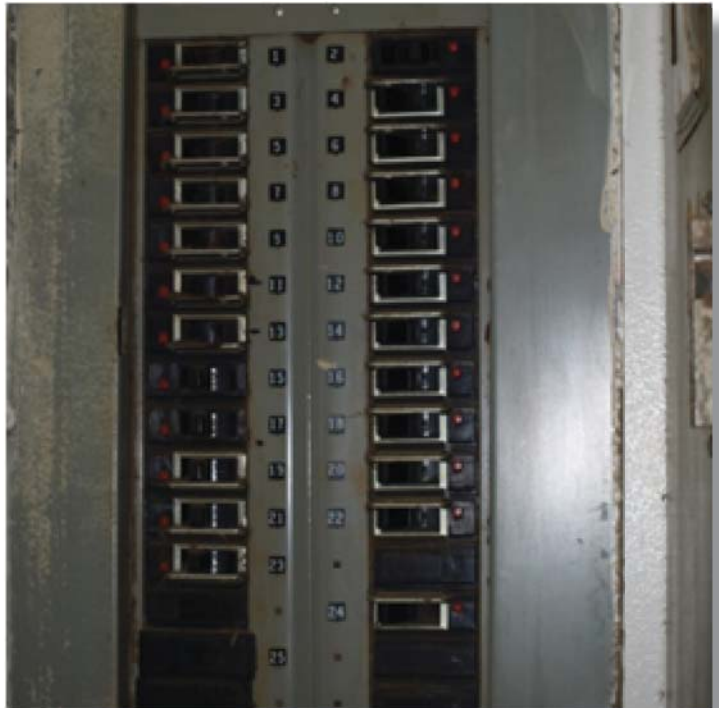
**PANEL**

Antiquated electric panel in older portion of jail services.

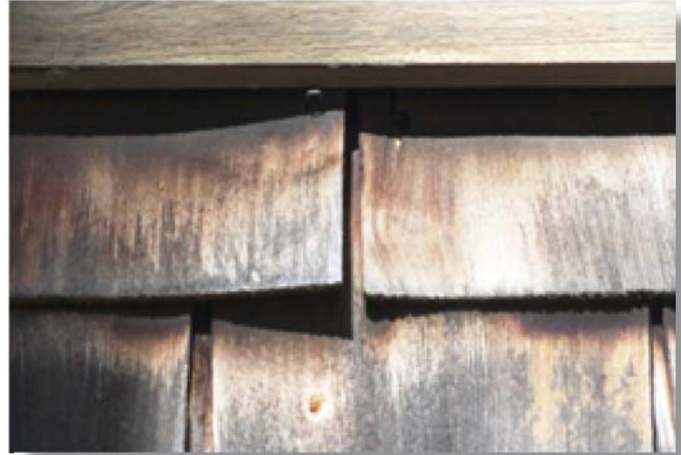
### **MANSARD**

Wood shingles on mansard are brittle, cupped and have splits.

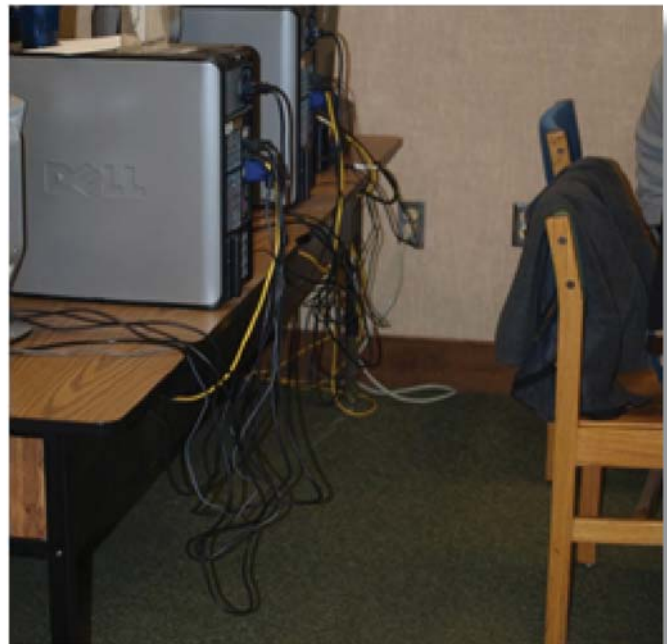
**WORKSTATION**

Typical computer station. Extension cords and loose wiring present possible fire and tripping hazard.
