From: [Donald Knight](#)
To: [Karen L. Garner](#)
Subject: 10880 US Hwy 50
Date: Wednesday, May 13, 2026 1:29:05 PM

On May 7, 2026, Senior Civil Engineer Rachel McFatter, Supervising Building Inspector Richard Taylor, and Code Enforcement Officer Nicolaus Heuer conducted an on-site structural assessment of the building located at 10880 US Highway 50. Following this assessment, Engineer McFatter prepared a detailed report outlining the condition and structural integrity of the building.

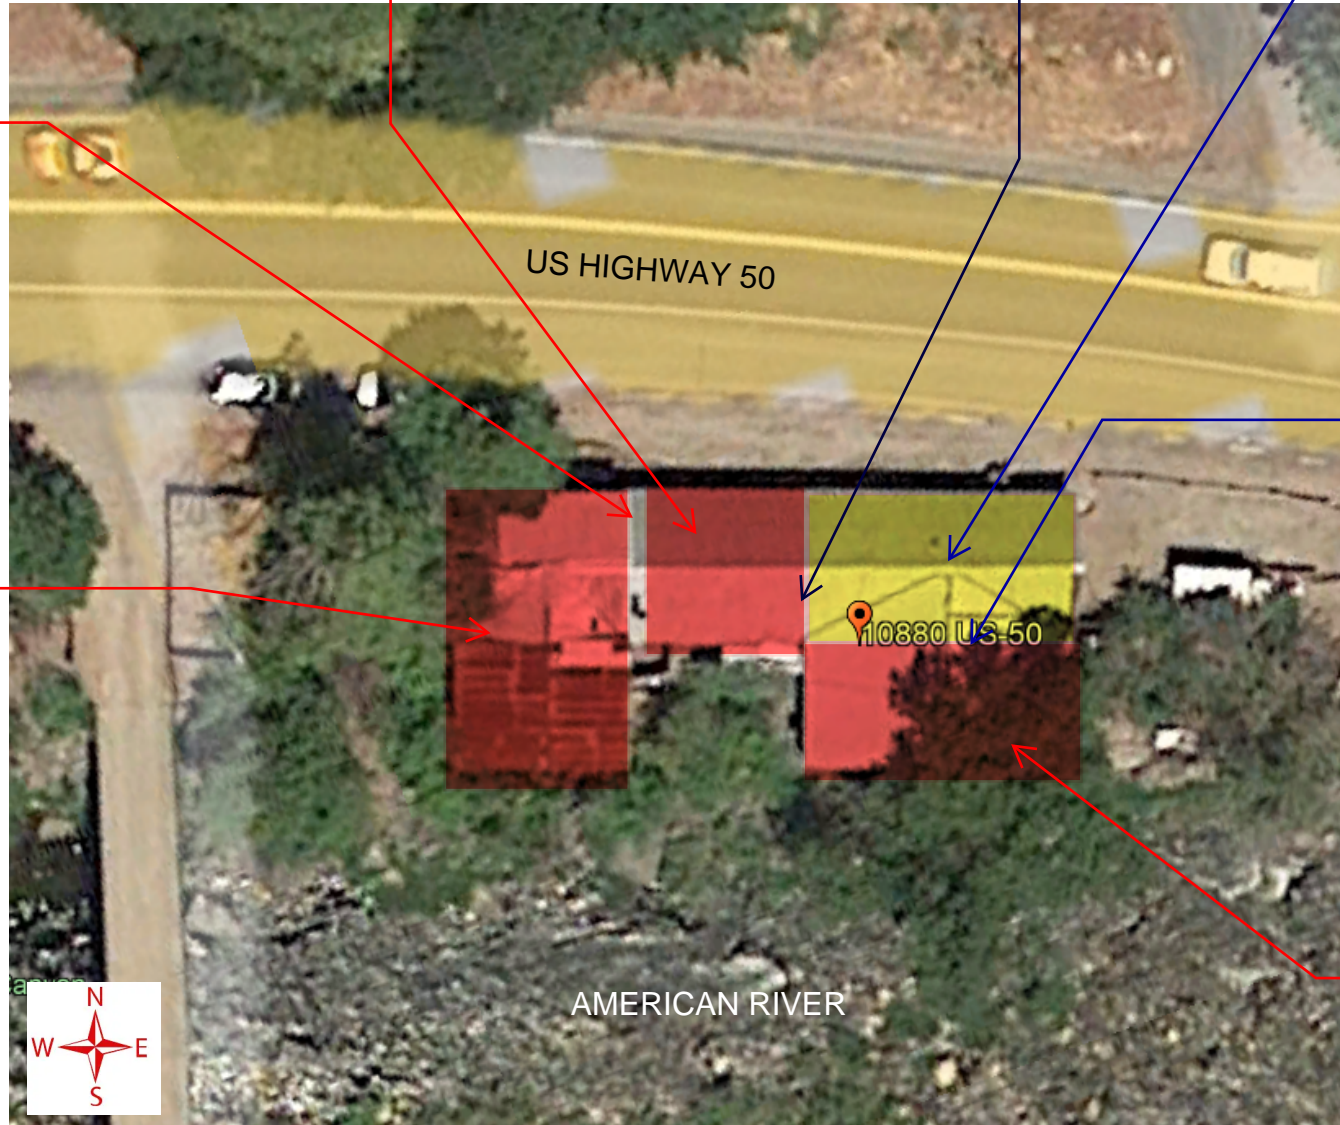
- **Mid-section (south side)** – A failing south bearing wall, incomplete lateral load-resisting system, and an inadequate foundation system. These deficiencies indicate global structural instability and would require major reconstruction to meet even minimum structural safety standards.

- **Visible separation between building sections** – A measurable gap between the west and east building segments, indicating substantial differential settlement or structural movement.

- **West end** – Lateral displacement of approximately 3–4 feet toward the river, significant racking of the wall and framing system, and an inadequate foundation. This portion exhibits severe structural failure that cannot be economically or reasonably corrected.

- **Southeast end** – Inadequate foundation and bearing conditions; deteriorated floor joists showing cracking, splitting, and weathering; and insufficient lateral bracing. This area is structurally unstable.

- **Northeast end** – While no obvious exterior distress was visible, the engineer could not verify the condition of the internal framing. The area is not safe or occupiable in its current state, and any localized stability does not mitigate the global structural hazards affecting the building.

Mid section red shaded area: **STRUCTURALLY COMPROMISED / UNSTABLE**
visible evidence of distress or damage:
south bearing wall failing; incomplete lateral system; inadequate foundation system on south side. significant efforts required to restore.

transition would likely be defined by location of south bearing wall having adequate stability, but could not verify

Northeast end yellow shaded area: **MAY BE STABLE**, but not occupiable as is, no visible evidence of distress or damage from exterior, but could not confirm framing

transition would be roughly defined by location of retaining wall:
south of retaining wall (with raised floor framing) is unstable;
north of retaining wall possibly stable, could not verify

Southeast end red shaded area: **STRUCTURALLY COMPROMISED / UNSTABLE**
visible evidence of distress or damage:
inadequate foundation;
inadequate bearing;
floor joists show signs of cracking, splitting, weathering;
inadequate lateral bracing. significant efforts required to restore.

visible separation / gap between west and east sections of building

West end red shaded area: **STRUCTURALLY COMPROMISED / UNSTABLE**
visible evidence of distress or damage:
lateral displacement of 3-4 feet to the south, (toward river); racking of wall/framing; inadequate foundation. significant efforts required to restore.

For these reasons, it is my professional recommendation that this structure be declared unsafe and that the County proceed with demolition through the abatement process to eliminate the danger.
