BOS Agenda Item #3, (13-0217) Mt Murphy Bridge Project

Bridge Number : 25C0004
Facility Carried: MT MURPHY RD
Location : 0.1 MI E OF SR 49
City :
Inspection Date : 01/05/2011

Bridge Inspection Report

STRUCTURE NAME: SOUTH FORK AMERICAN RIVER

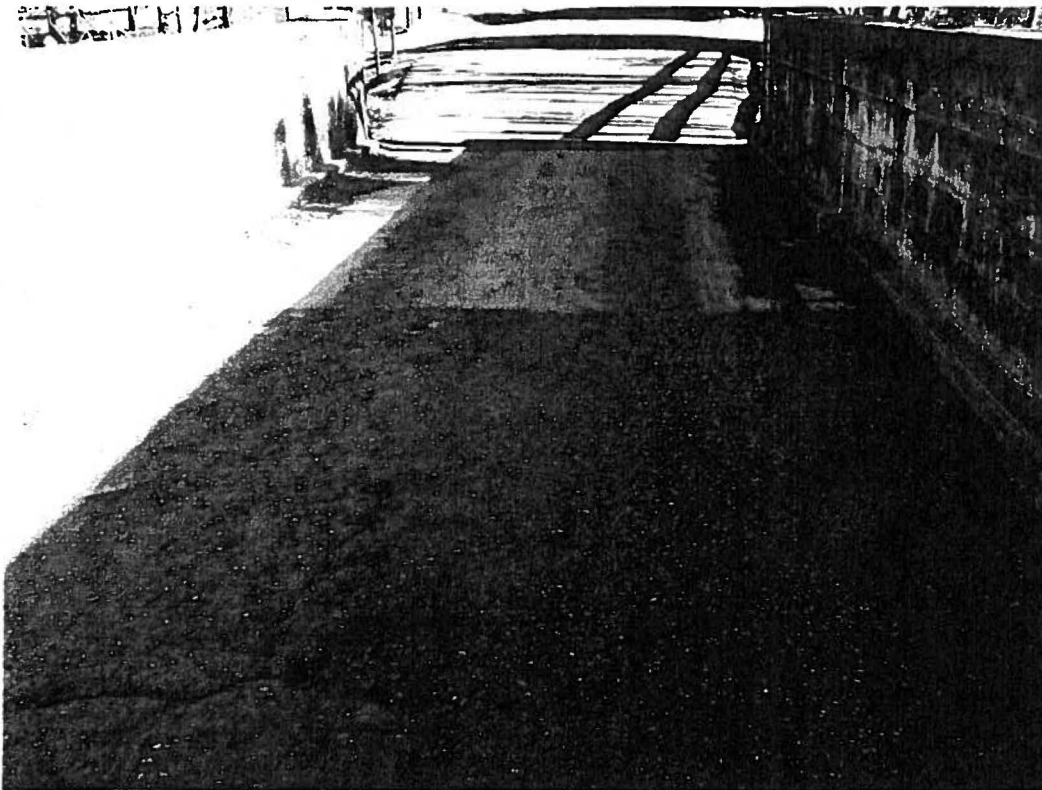
Photo No. 3

The surface of the approach slabs are scaled and abraded with shallow spalls and edge spalls at the joints, probably caused by the spoked wheels with a metal band surface of the horse and carriage attraction at the local park. There are also 0.020" to 0.080" wide transverse cracks throughout the deck (see photo #3 and #4). These cracks are mirrored on the soffit with efflorescence (see photo #5). This condition has been reported since November 25, 1991.

Abrasion, scaling, and spalls on the deck surface in Span 7.

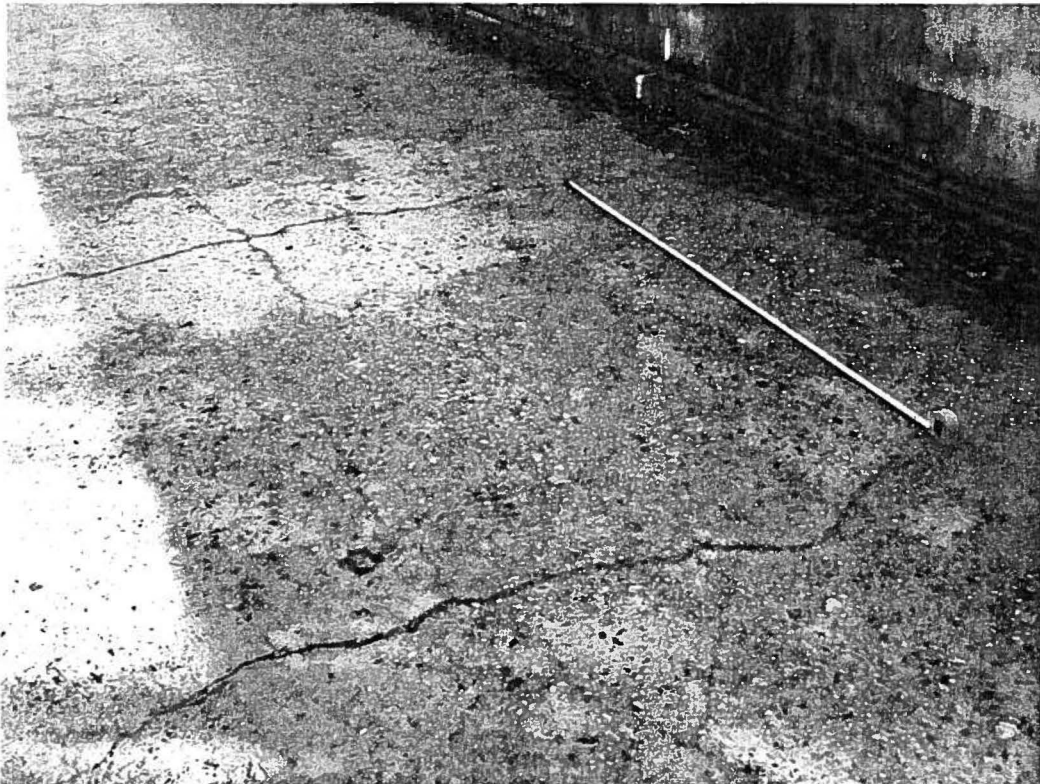
Photo No. 4

Typical transverse deck cracks in Span 2.

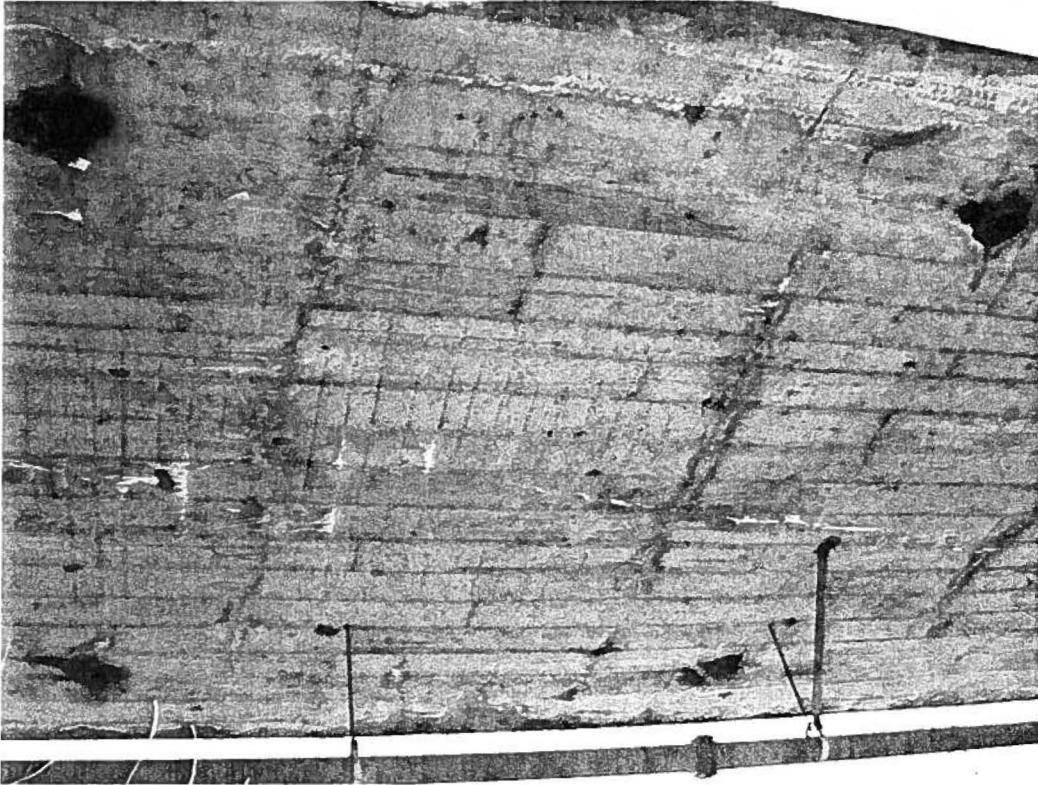
Photo No. 5

Typical transverse soffit cracks with efflorescence and rust stains in Span 2.

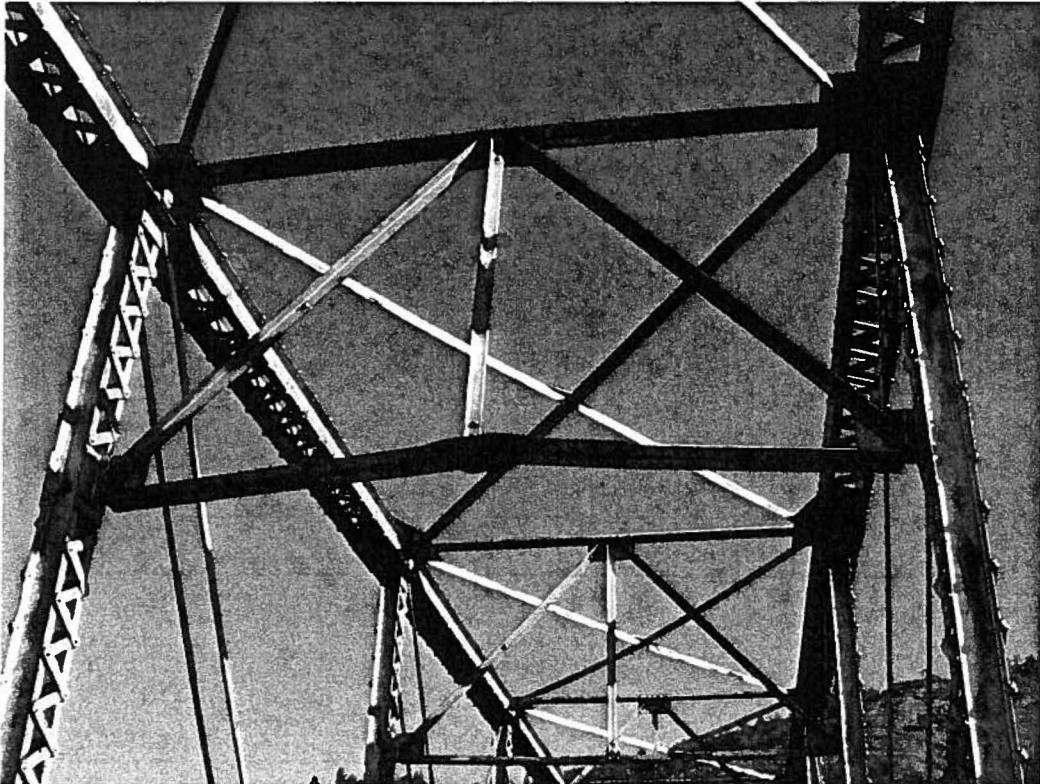
Photo No. 6

The lower double angle of each lateral overhead bracing frame has some level of vehicle impact damage (see photo #6). The damage generally consists of out-of-plane local deformations up to 2". This damage was first noted in the November 25, 1991, inspection.

Damaged sway bracing from vehicle impact.

Repair the damaged lateral frame elements.

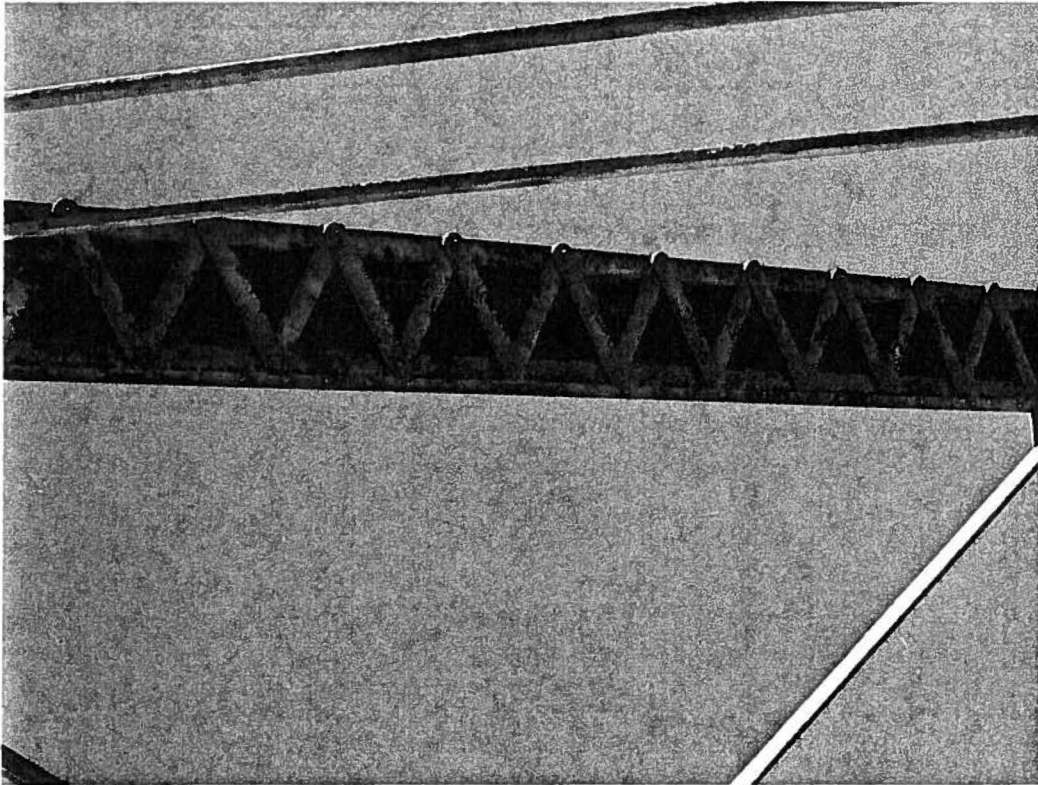
Photo No. 7

Chipped paint with rust, blush rust and scattered areas of blanket rust were noted on the bottom chord, stringers and floor beams (see photo #7 and #10). There is random freckled rust on the remaining steel members.

Paint condition of top chord in Span 3.

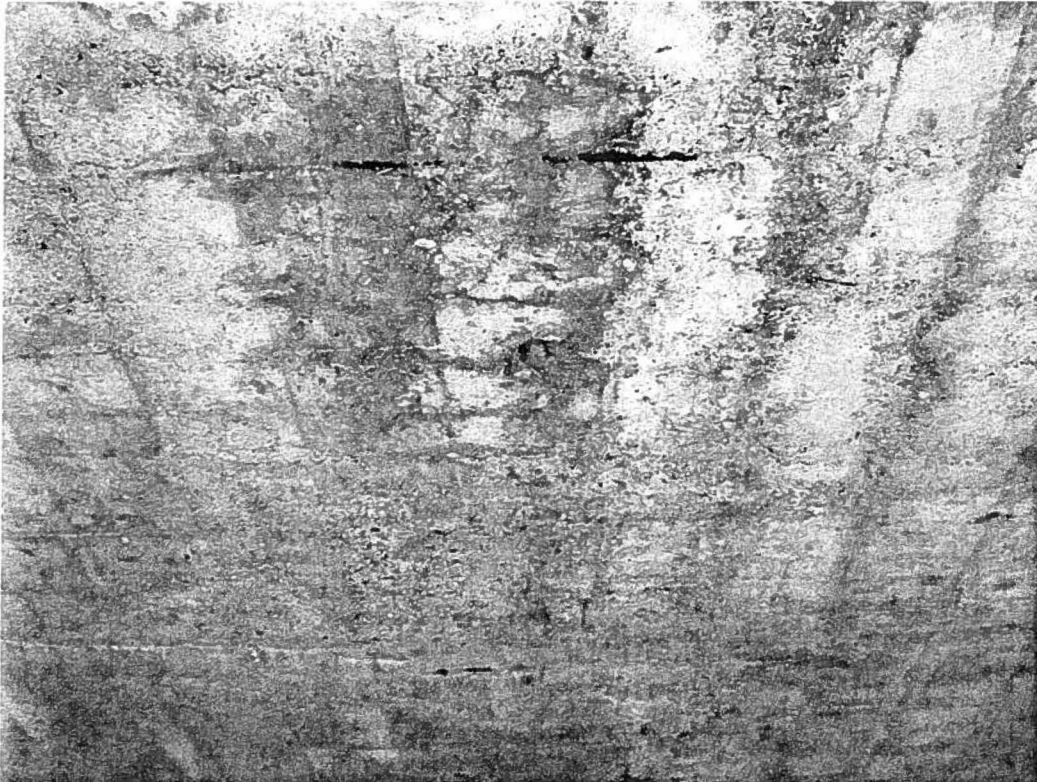
Photo No. 8

There is about 2' of exposed rebar in the soffit of Span 6 (see photo #8). The bar appears to have inadequate concrete cover and does not warrant repairs at this time.

Exposed transverse rebar in the soffit of Span 6.

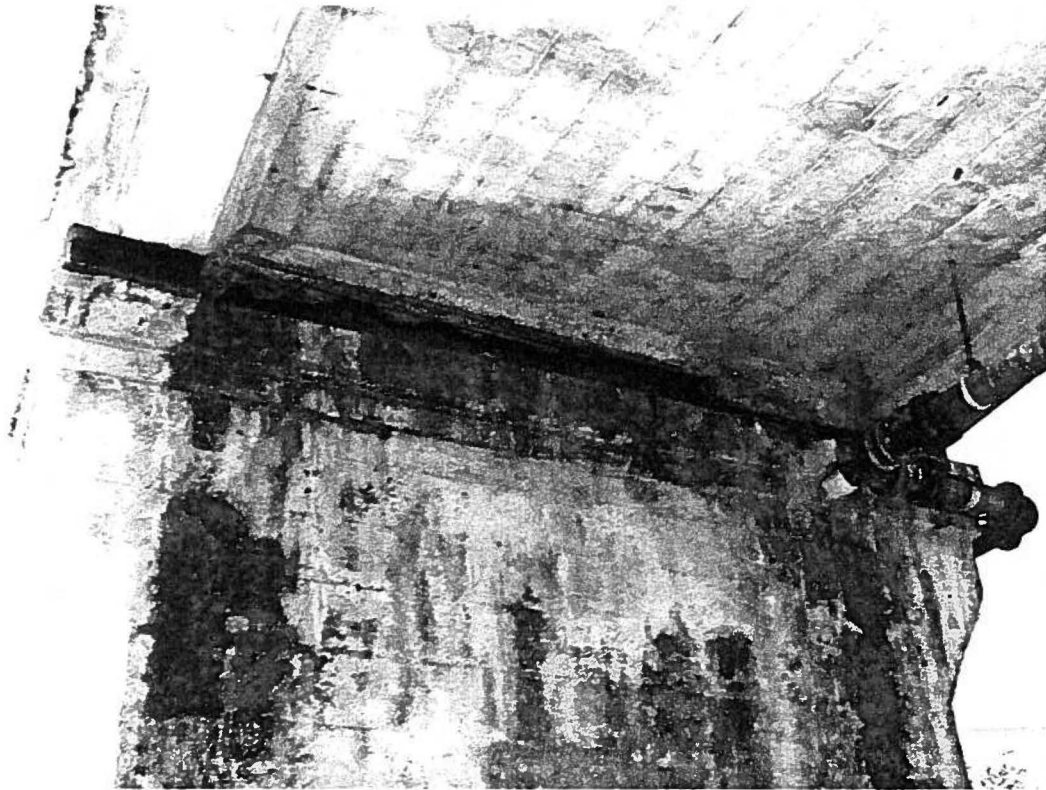
Photo No. 9

There is spalling of the end diaphragm at Pier 4. The concrete is missing on the bottom 6" along three-quarters of the length of the diaphragm. The bottom longitudinal reinforcing steel is exposed, but does not appear to be rusting (see photo #9). No cracks could be seen in the adjacent area or soffit. A 1995 work order to repair this spall remains incomplete.

Pier 4 end diaphragm spall with exposed rebar.

Remove unsound concrete on the end
diaphragm at Pier 4 and recast.

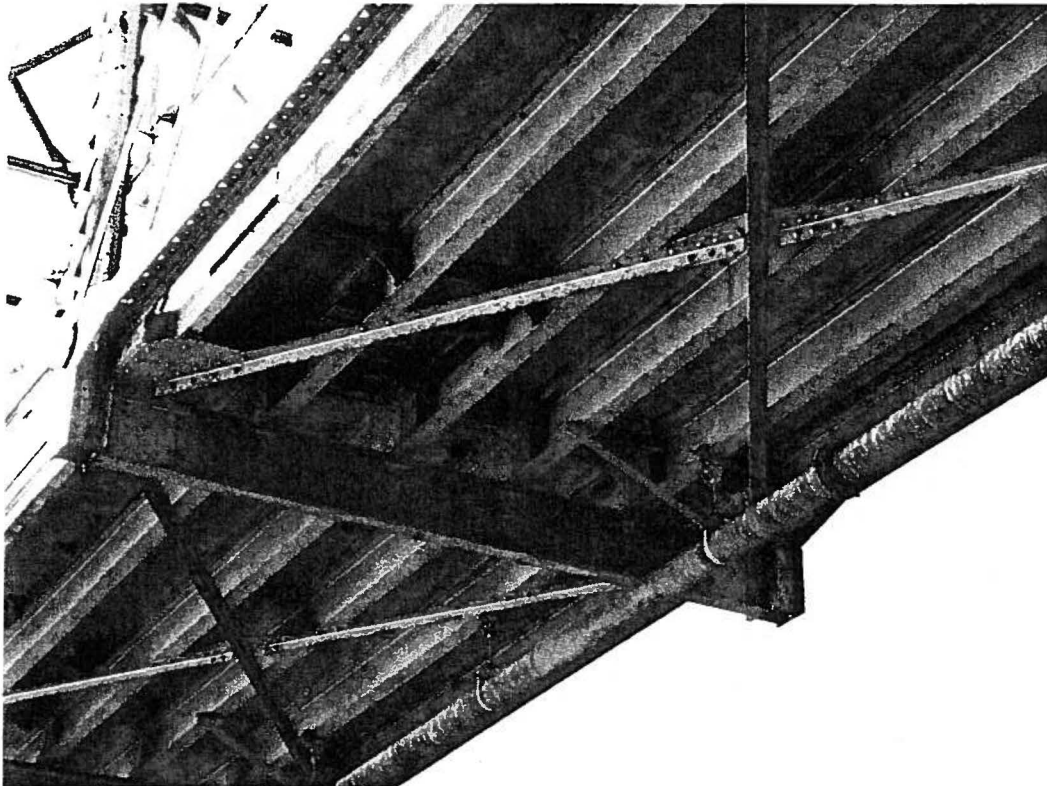
Photo No. 10

Typical paint condition of floorbeams and stringers.

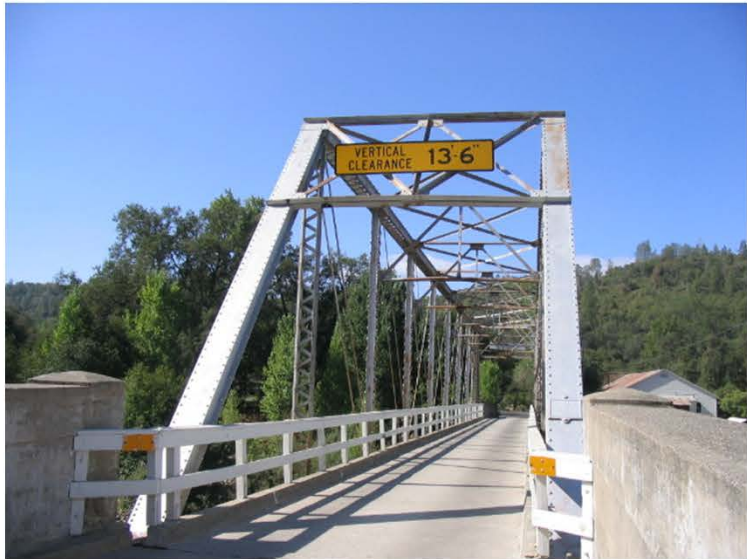
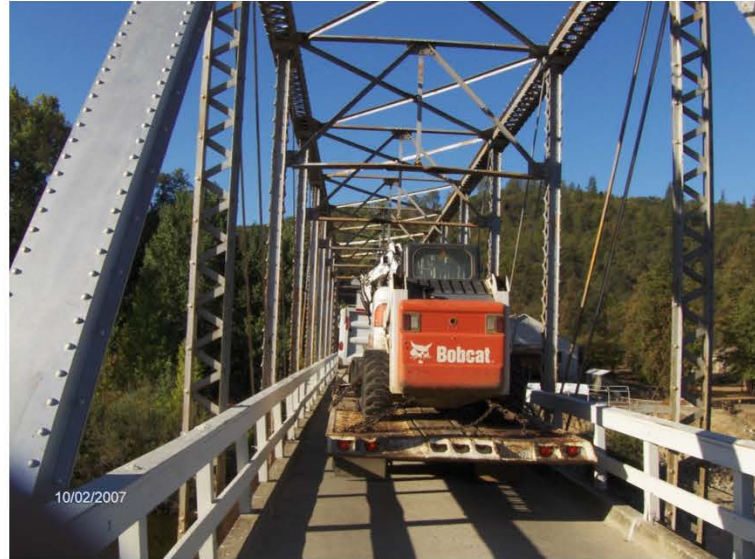
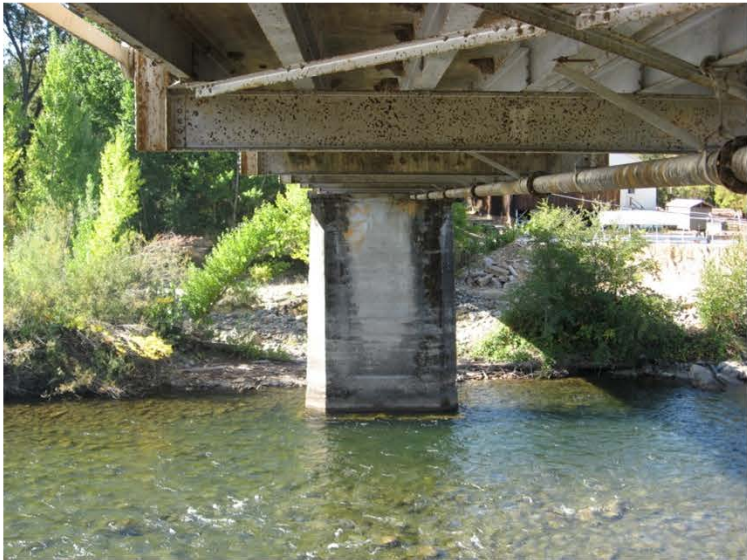
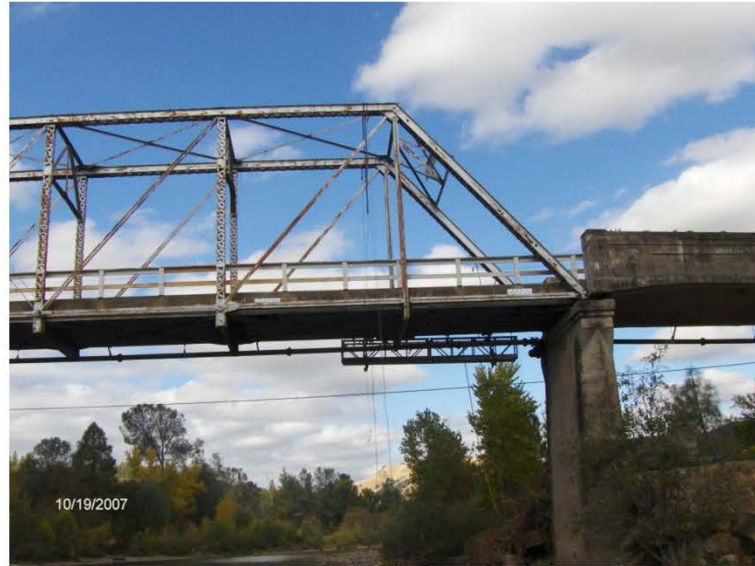
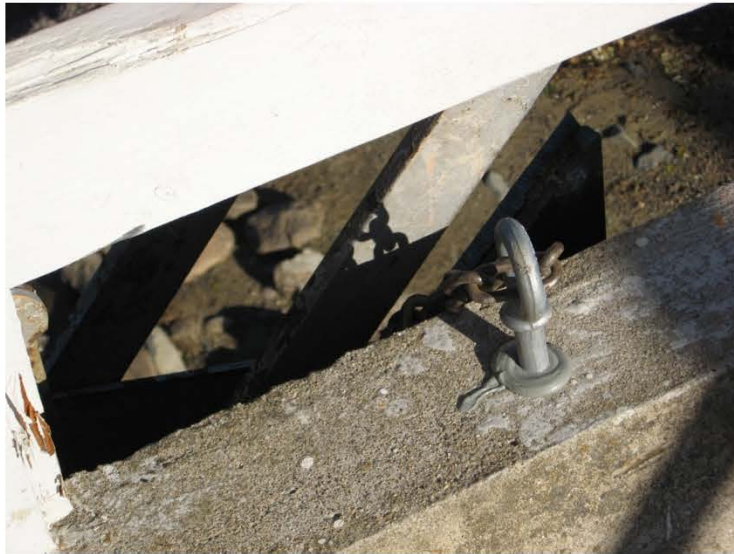
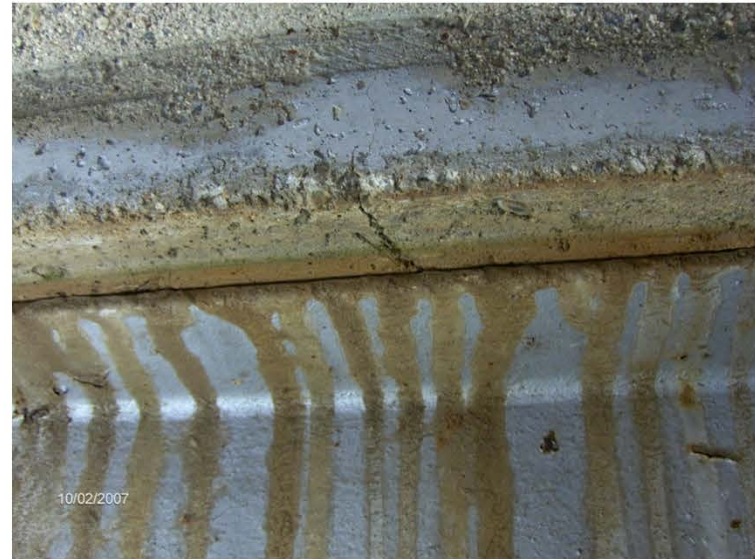
Mt. Murphy Bridge Emergency Deck Repair, Sep-Oct 2007

- Routine maintenance by County bridge crew – as recommended per Caltrans inspection reports
- Sept 2007 – crew found one deck section slid 4 inches sideways; required immediate inspection and repair

Emergency repair cost \$90K, took about 3 weeks of 530 man hours to complete
