2009 SMARA MINE INSPECTION Somerset Sand Mine CA Mine ID No. 91-09-0009

El Dorado County, California October 22, 2009

2009 SMARA Mine Inspection Somerset Sand Mine CA Mine ID No. 91-09-0009 El Dorado County, California

Subject: 2009 SMARA Mine Inspection

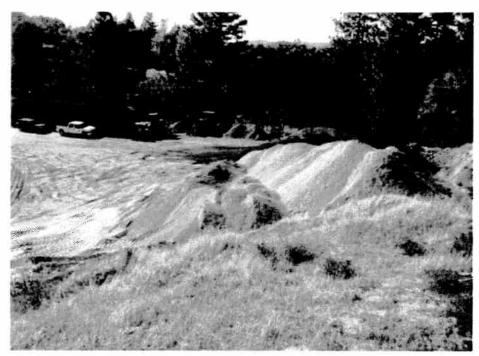
Mining activities were not occurring at time of inspection, although processed material (primarily granitic sand) had recently been stockpiled on site (Photograph Nos. 1, 3, and 4).

Photograph No. 1. Overburden stockpile (foreground), processed sand stockpile, equipment maintenance and storage building, imported aggregate and recyclable asphaltic material stockpiles, equipment staging area and truck loading area (viewing west).

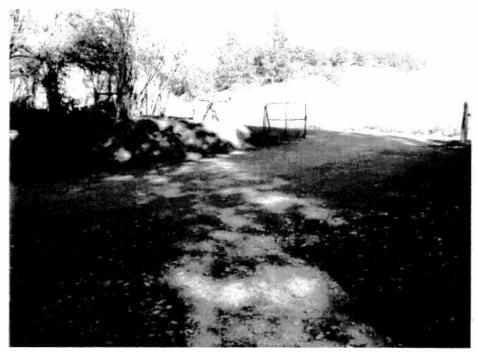
Photograph No. 2. Site entrance and equipment staging area adjacent to maintenance building along western site boundary. Portion of imported soil stockpile visible at upper right (viewing northeast).

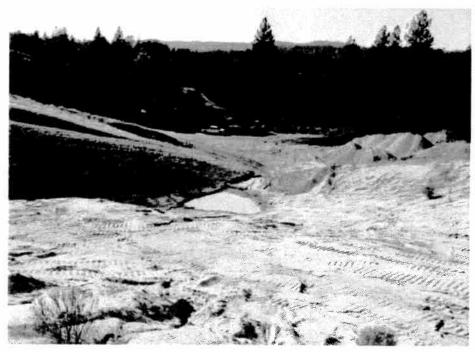
Very few small gullies and rills were noted on the mine extraction slopes at time of inspection (Photograph Nos. 3 and 7 through 10). Such erosional features measured up to six inches deep, up to eight inches wide, and up to 20 feet long. Upper portions of erosional features noted in previous years that were not disturbed during the past year exhibited the onset on natural revegetation by grasses, and sandy material mobilized from these features is contained on the guarry floor.

Winterizing Activities: The Reclamation Plan (page 21) states that "By October 15 of each year temporary erosion control features that are necessary to prevent damage during the forthcoming winter season shall be constructed and functioning. All storm runoff will be contained within the project in a detention pond. Excavation areas are to be protected from erosion and the resulting siltation by various temporary erosion control measures. These measures include but shall not be limited to lined drainage ditches to prevent water inflow into flow joint systems with wedge failures, filter fabric fences to filter silt from runoff, and earth berms, straw bales or appropriate grading to direct drainage away from sensitive areas. On the southwestern steep cut-slope straw wattles may be used." Erosion control and winterizing measures were in place and deemed adequate at time of inspection (Photograph Nos.3, 5, 7 through 9, and 11).

Photograph No. 3. Overview of quarry floor with sediment settling area in center, straw- and mulch-covered imported soil on left, material stockpiles at right, equipment maintenance and staging areas at center, and recent extraction area in foreground (viewing west-southwest).

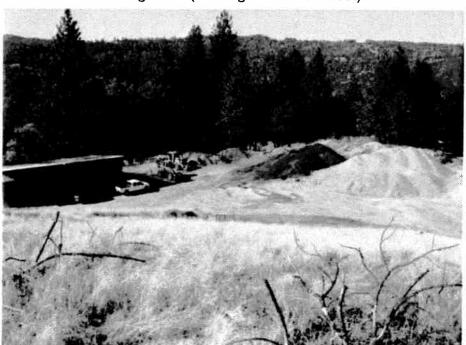
Photograph No. 4. Overview of northwest quarry floor showing material stockpiles, equipment shed and loading area. Vegetated surface of imported soil stockpile in foreground (viewing northwest).

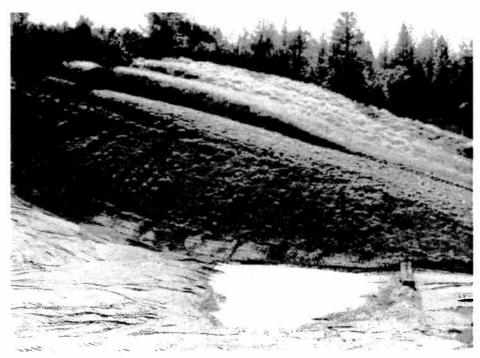
Photograph No. 5. View of imported and graded soil stockpile and sediment retention area. Toe of recent extraction area visible at lower left (viewing south).

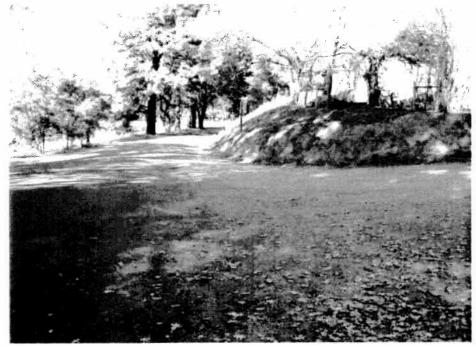
Photograph No. 6. Site entrance, equipment staging area, and maintenance building (upper right) immediately east of Sand Ridge Road (viewing north).

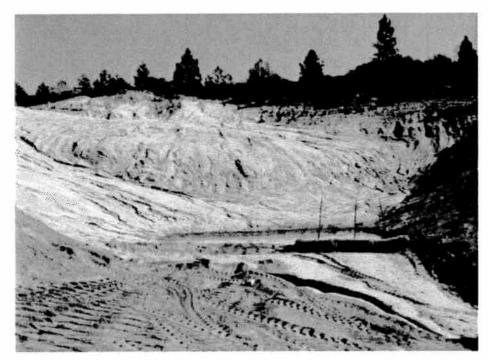
Cut slopes range from about 3H:1V to slightly steeper than 1H:1V on the southeastern portion of the working face, where more resistant rock is exposed (Photograph Nos. 7 through 10). Youngdahl Consulting Group, Inc. has been retained by EDCDOT to perform annual reviews of slope stability for the site. No evidence of active slope instability has been noted in the past several years, including during the most recent review which was conducted on October 15, 2008. No signs of slope instability were noted at time of inspection.

Photograph No. 7. Central pit showing working face of recent extraction area and sediment retention structures at center (viewing east).

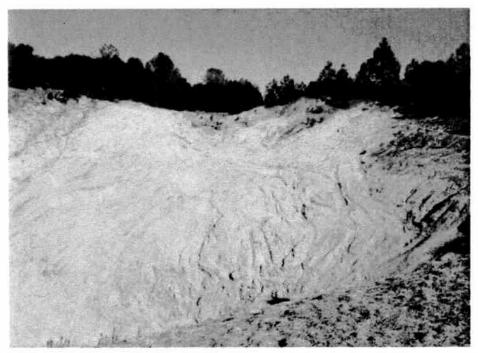
Photograph No. 8. View of upper working face in northeast corner of site (viewing northeast).

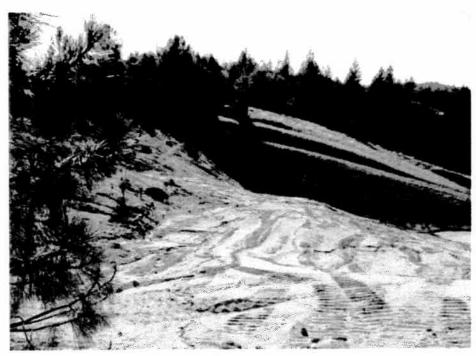
Photograph No. 9. Overview of southeastern portion of active pit. Imported soil stockpile at right (viewing southwest).

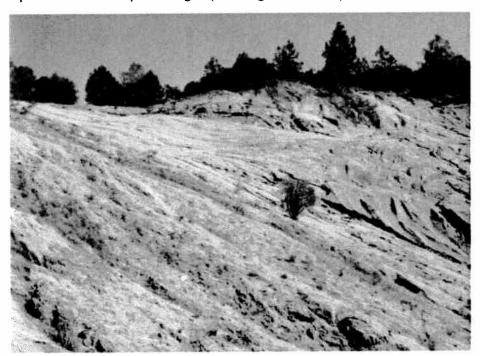
Photograph No. 10. View of minor erosional feature development on upper eastern working face. Slope at lower left showing signs of natural vegetation establishment by grasses (viewing east-northeast).

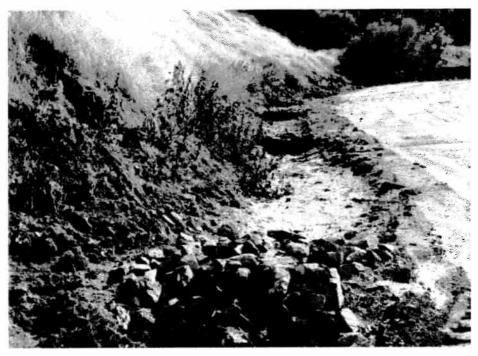
Photograph No. 11. Sediment check dams in drainage ditch at base of topsoil stockpile in western portion of quarry (viewing west).

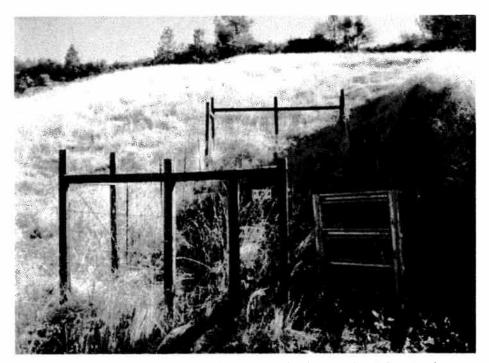
convenient area at the northwestern toe of the imported soil stockpile in the west-central portion of the site (Photograph No. 12). Monitoring of the revegetation test plot was conducted from 2003 through 2008, at which time active irrigation and maintenance ceased. At time of inspection, the plot was observed to be grown over with vegetation similar to the surrounding slopes. It is recommended that the operator provide a summary of revegetation test plot findings for review in order to determine if further test plot activities should be conducted.

Photograph No. 12. Revegetation test plot located on the northwest slope of the imported soil stockpile (viewing southwest).

It is recommended that the operator provide a summary of revegetation test plot findings for review in order to determine if further test plot activities should be conducted.
