CUP23-0007 Durock Road AM/PM

Exhibit N - Oak Resources Technical Report

OAK RESOURCES TECHNICAL REPORT

Re: BCE #21863; Arco; 4100 Durock Road; APN 109-080-001; County of El Dorado, California

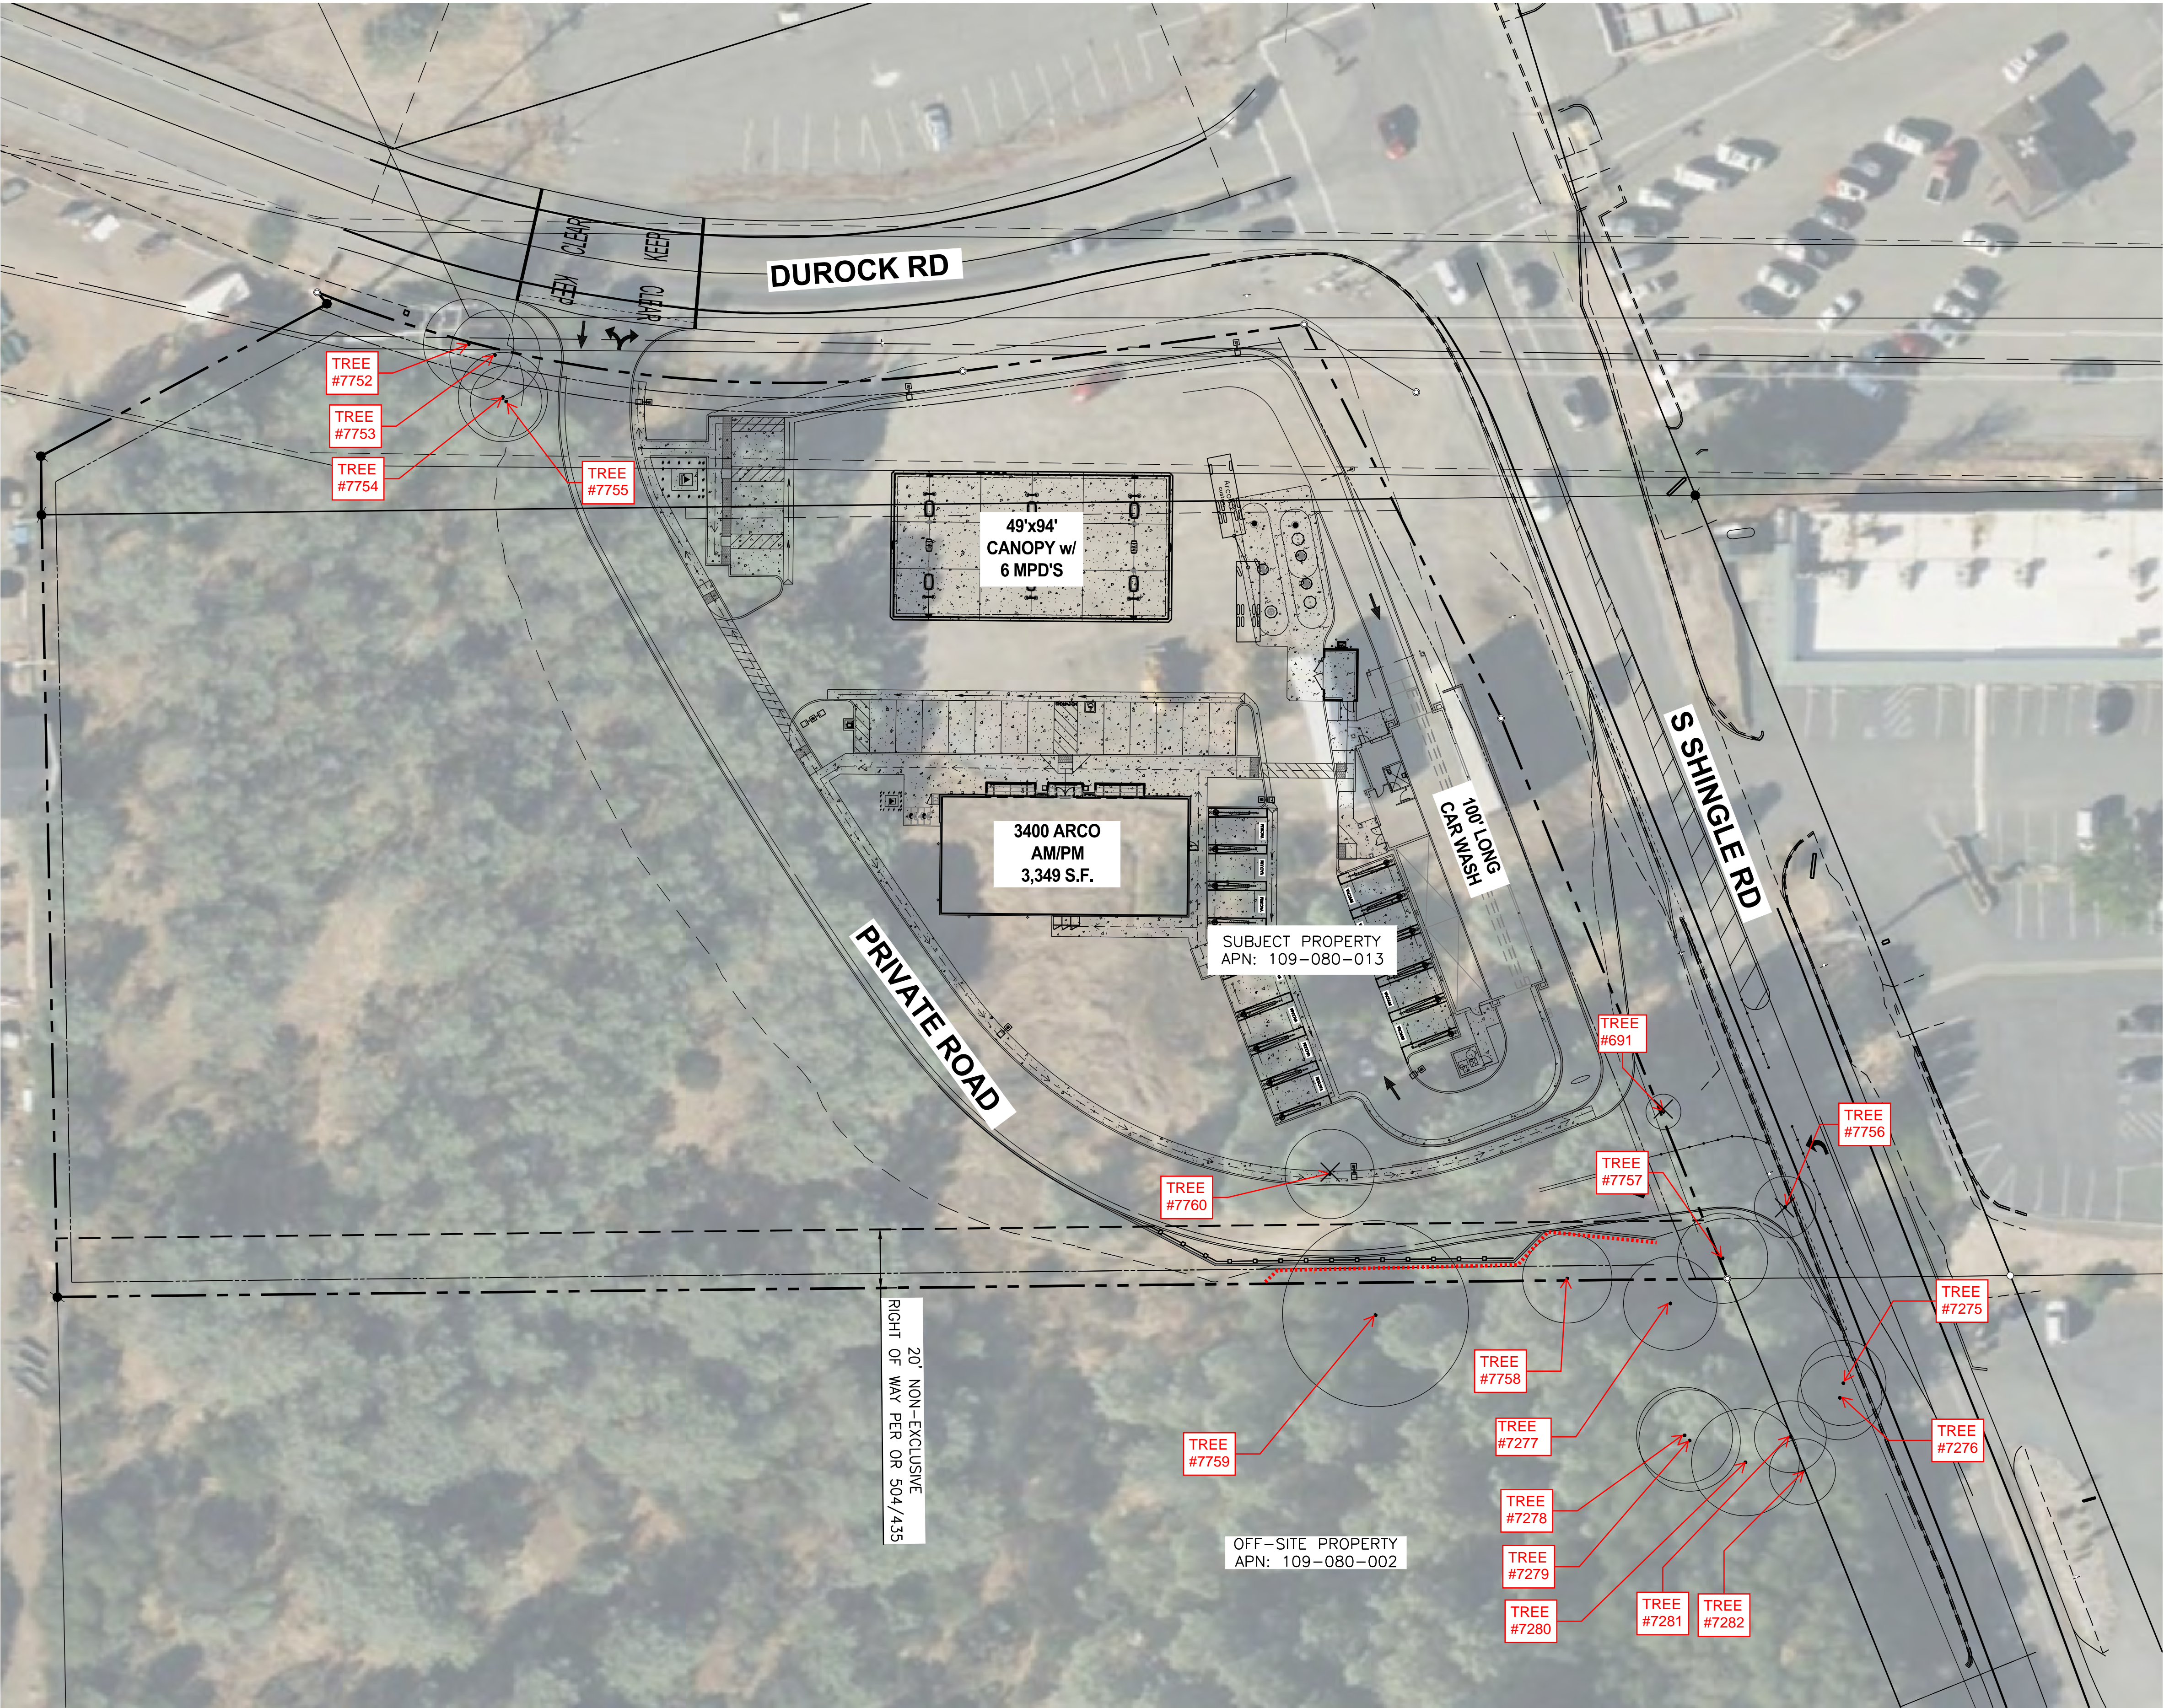
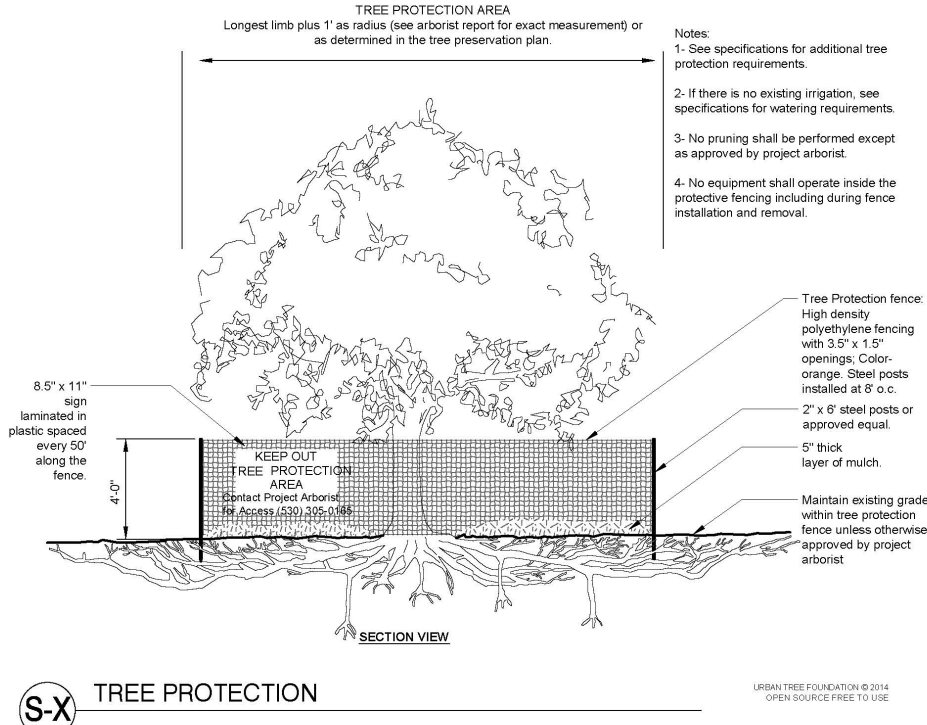
..... Tree Protection Fencing

Due to the proximity of the proposed work to the protected trees and the property line, tree protective fencing will be installed on the property line.

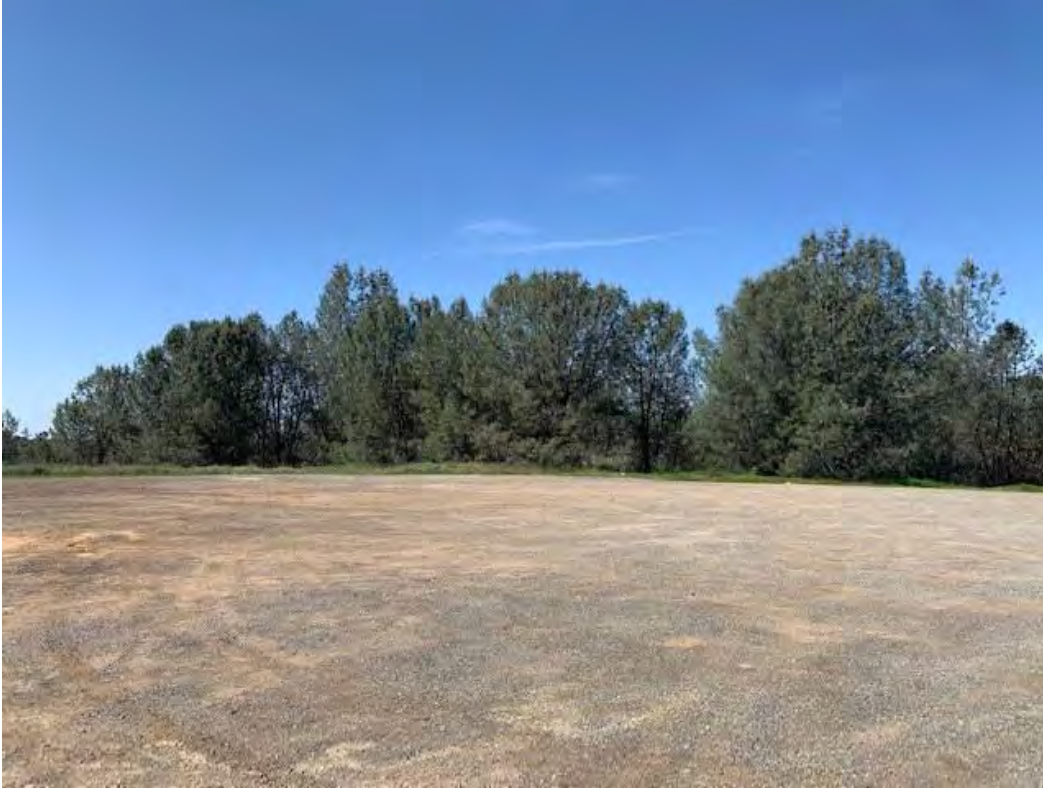
View of gravel pad area and tree line facing west.

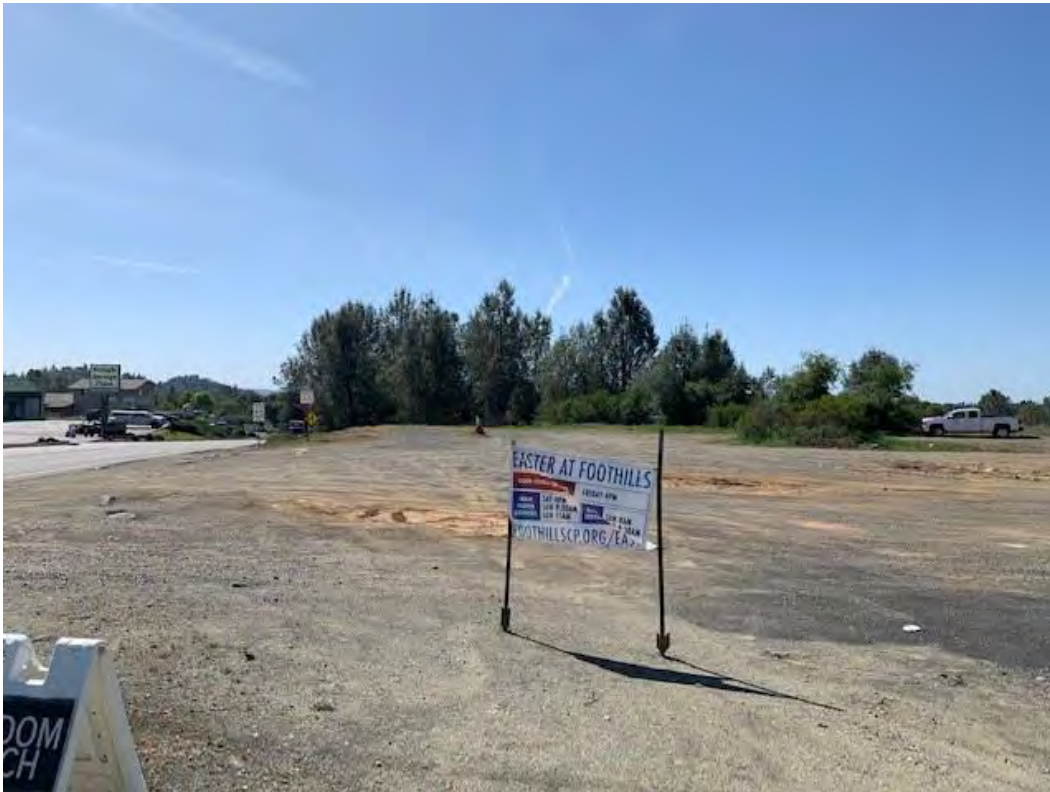
View of gravel pad area and tree line facing south.

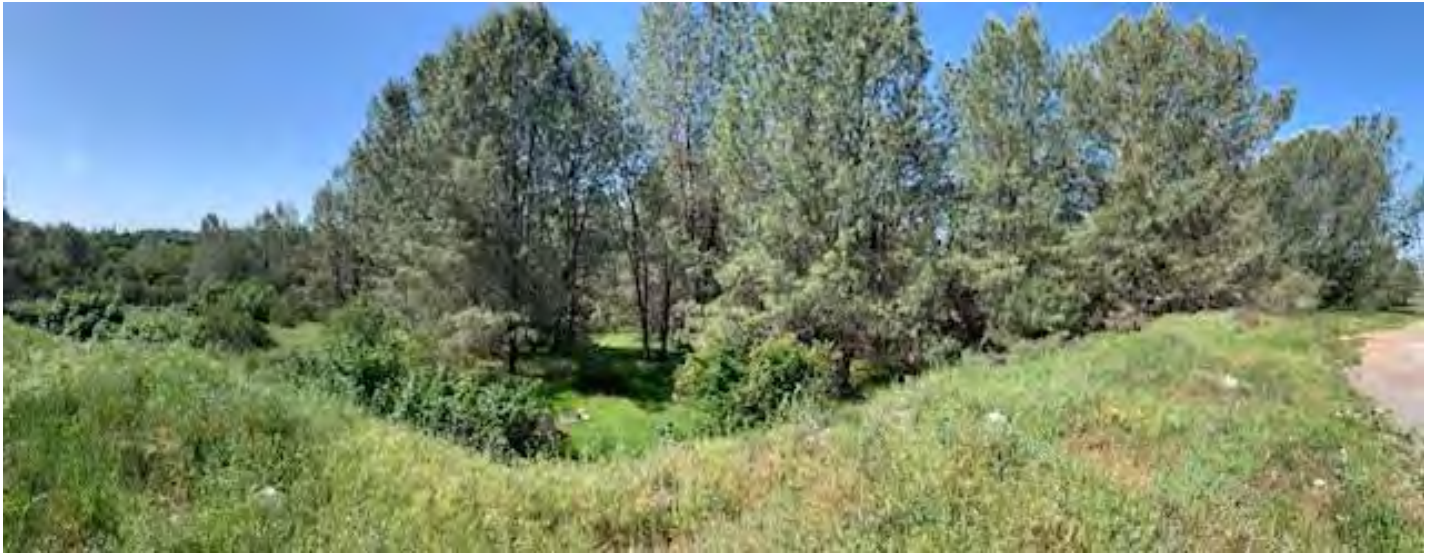
View south of gravel pad area facing west.
