California Tree and Landscape Consulting, Inc.

January 8, 2025, Revised July 28, 2025

OAK RESOURCES TECHNICAL REPORT

Re: BCE #21863; Arco; 4100 Durock Road; APN 109-080-001; County of El Dorado, California

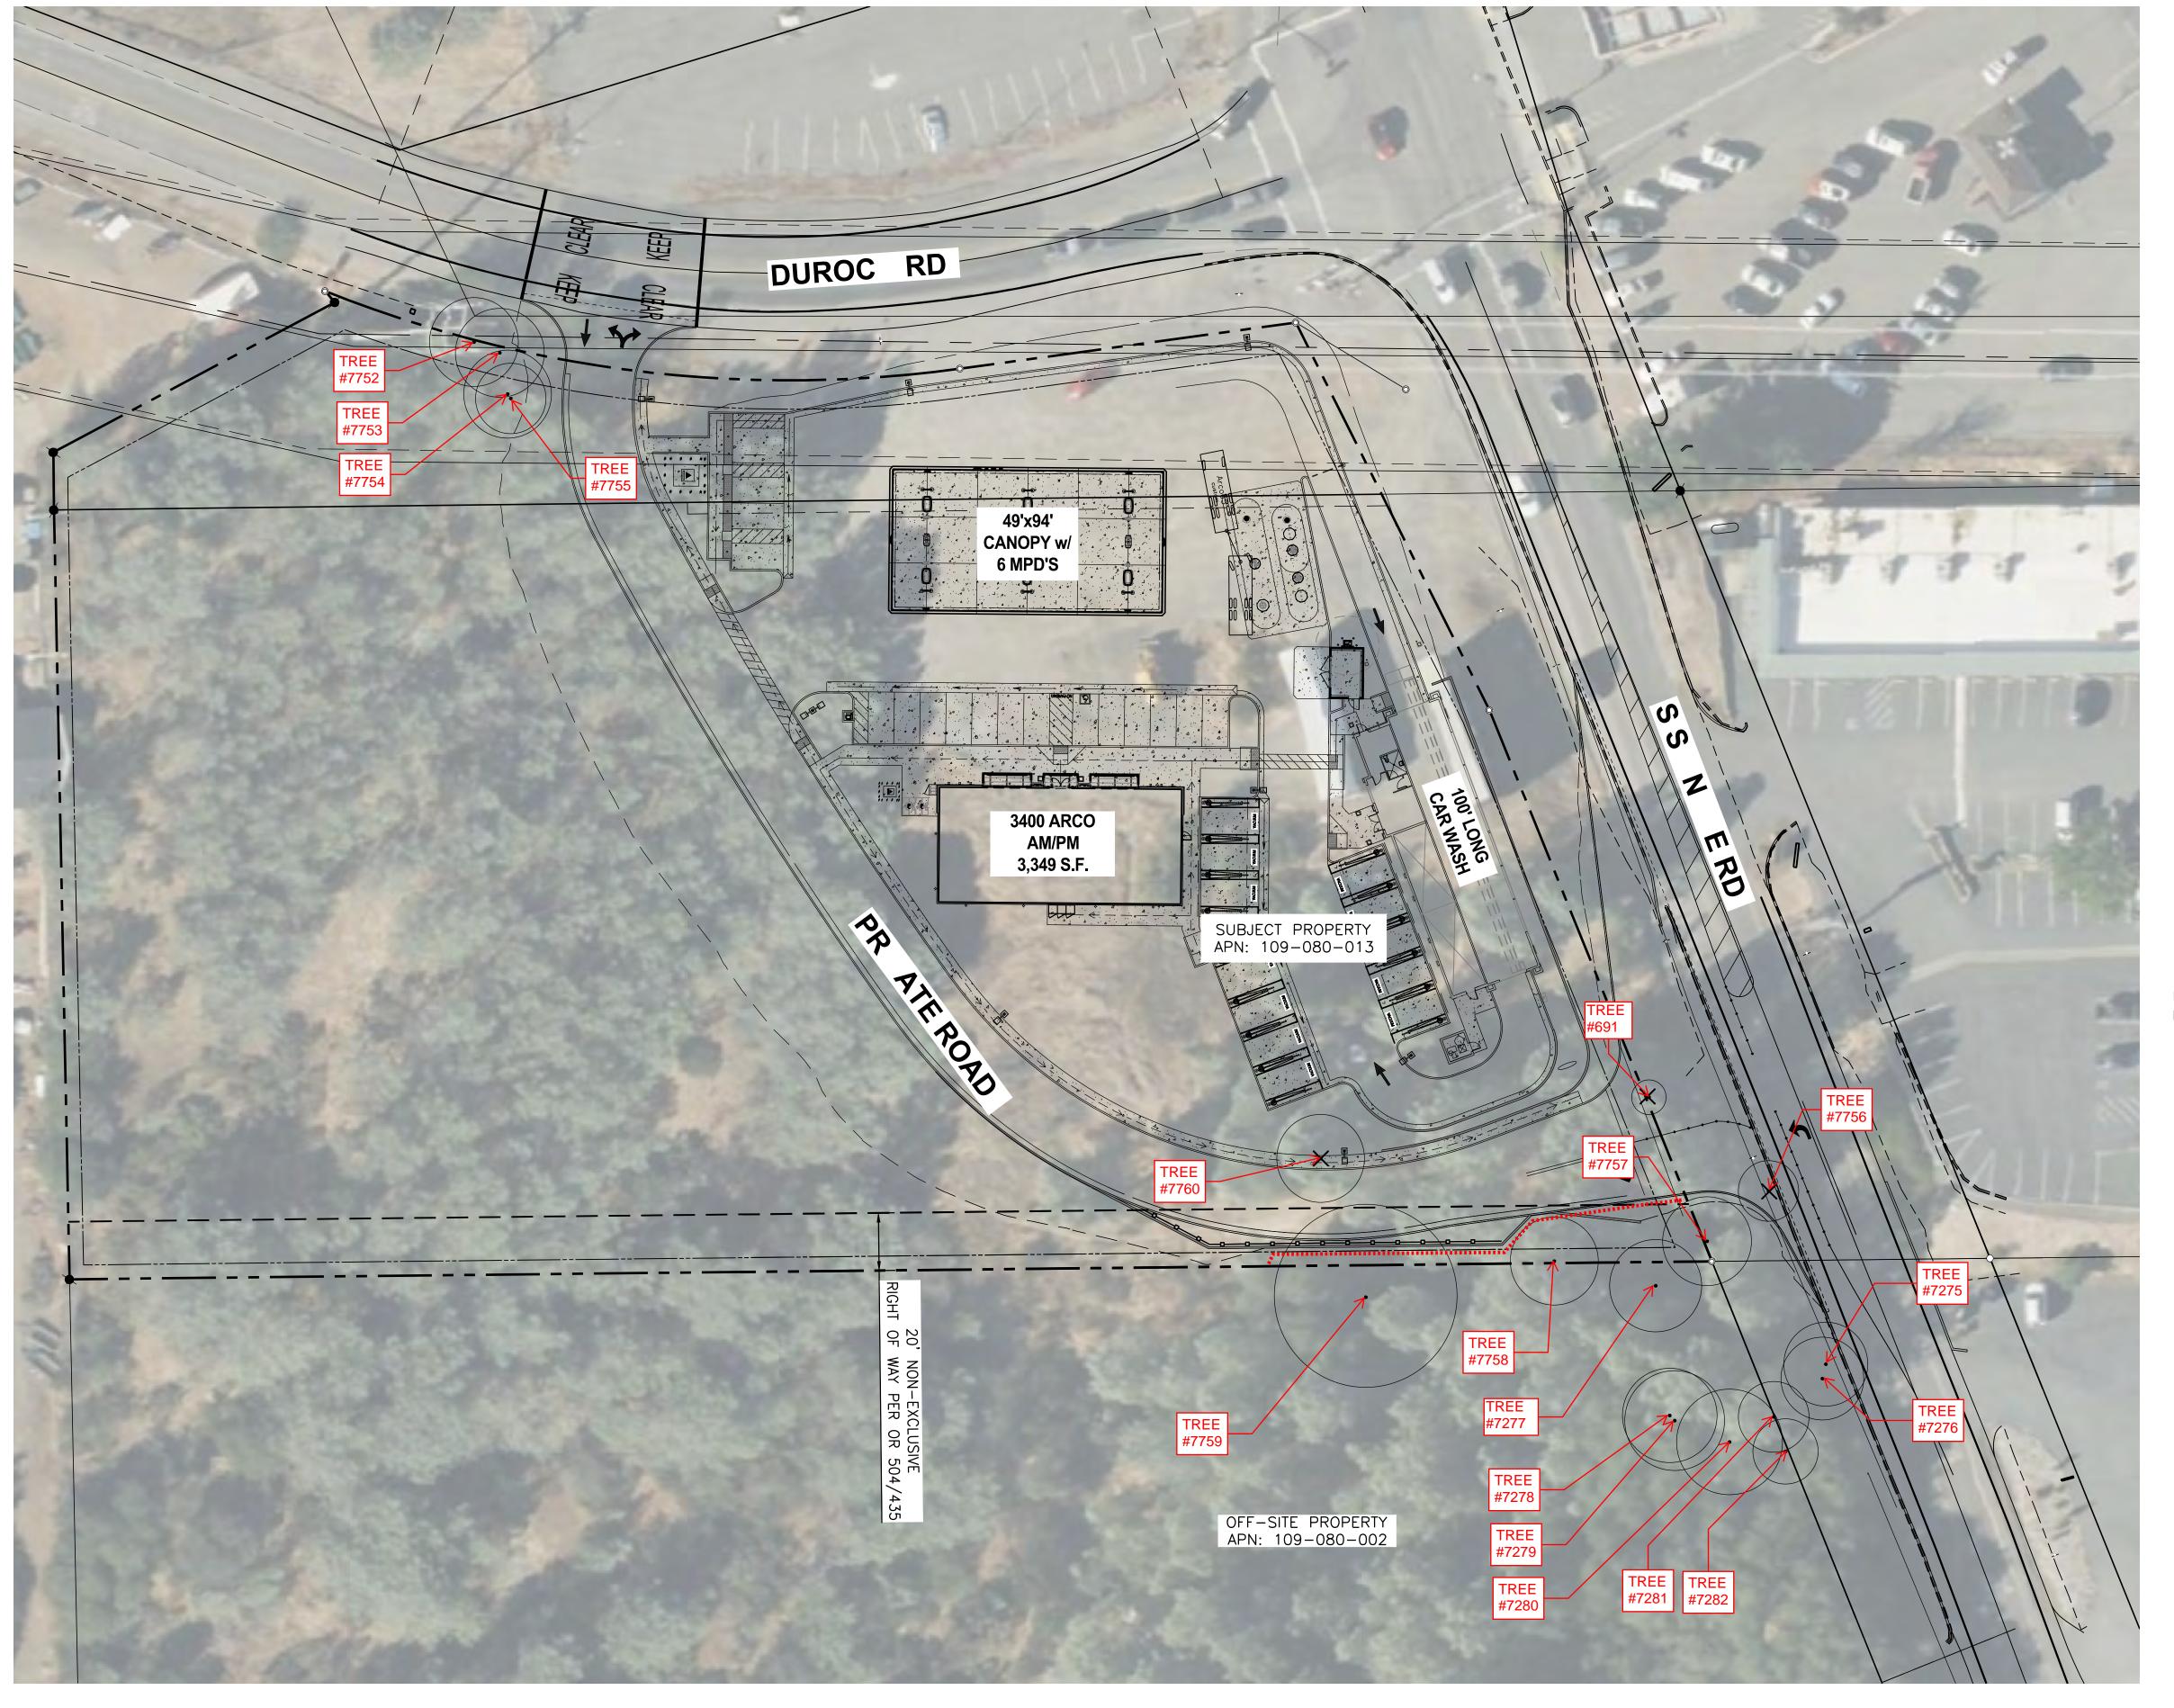
TREE IMPACT EXHIBIT

While the total encroachment for Tree #7759 is estimated at ~25% the remainder of the tree is undisturbed and with proper excavation monitored by the project arborist and root pruning the tree should not suffer any adverse effects.

Due to the proximity of the proposed work to the protected trees and the property line, tree protective fencing will be installed on the property line.

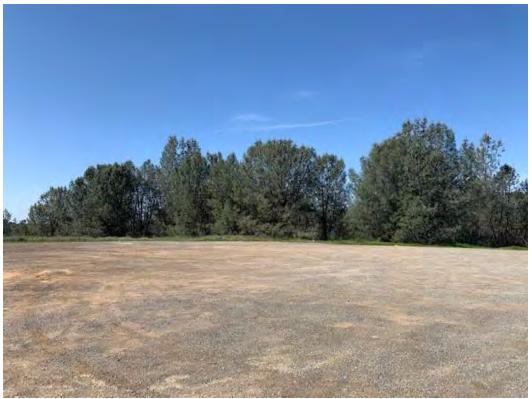
View of gravel pad area and tree line facing west.

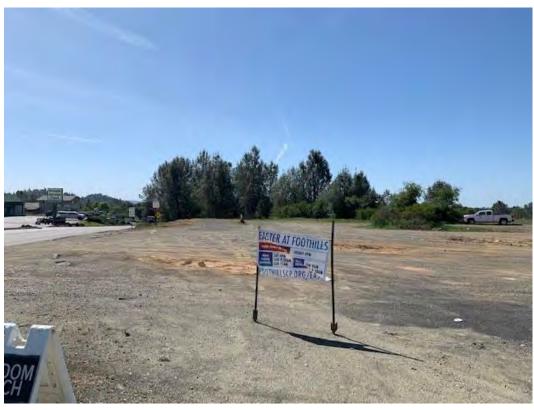
View of gravel pad area and tree line facing south.

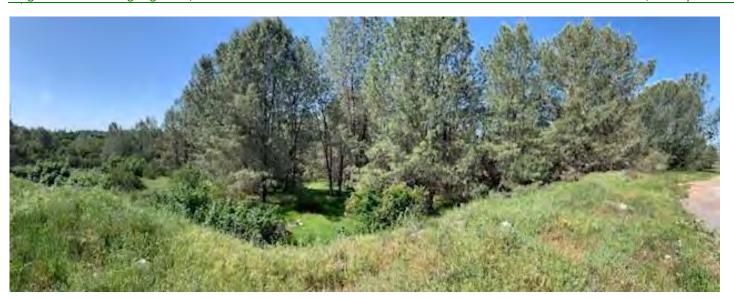
View south of gravel pad area facing west.

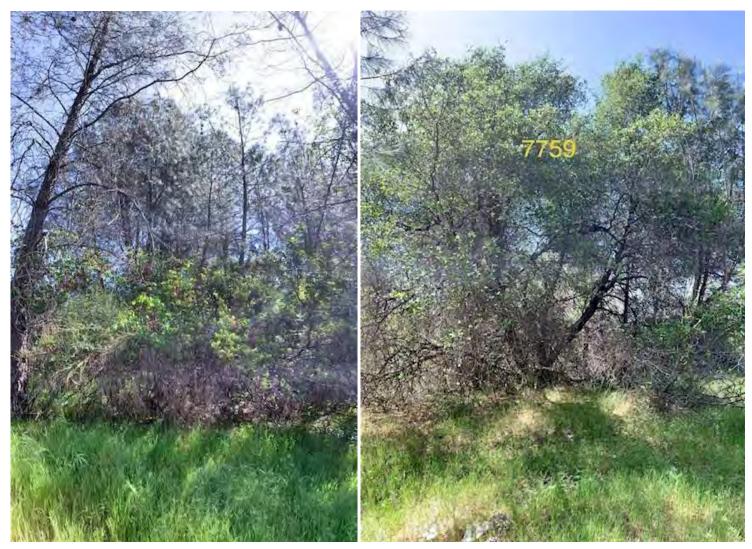
The majority of the site consisted of Gray Pine with understory trees and shrubs; including sporadic undersized native oaks.

Off site heritage-size interior live oak located adjacent to the south property line.

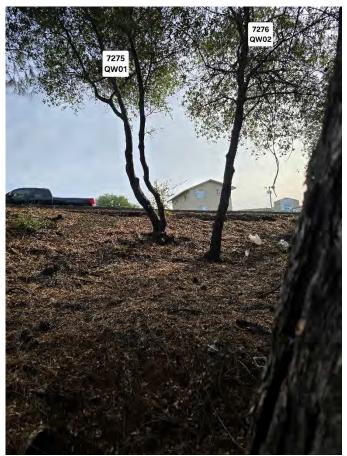
Shows Trees #7275 & #7276, from left to right

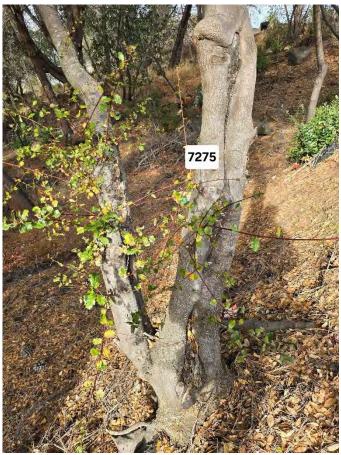
Shows Tree #7275

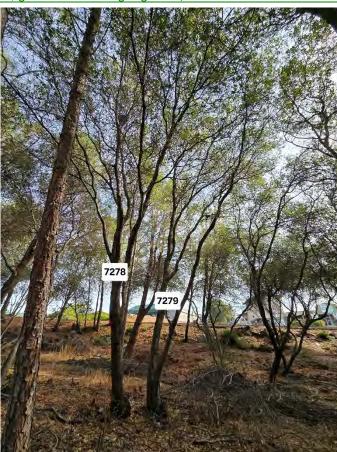
Shows Trees #7278 & #7279, from left to right

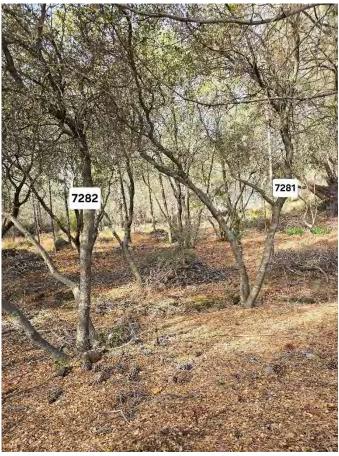
Shows Trees #7282 & #7281, from left to right
