January 8, 2025, Revised July 28, 2025

### OAK RESOURCES TECHNICAL REPORT

Re: BCE #21863; Arco; 4100 Durock Road; APN 109-080-001; County of El Dorado, California

**CUP23-0007 Durock Road AM/PM**  
**Exhibit N - Oak Resources Technical Report**

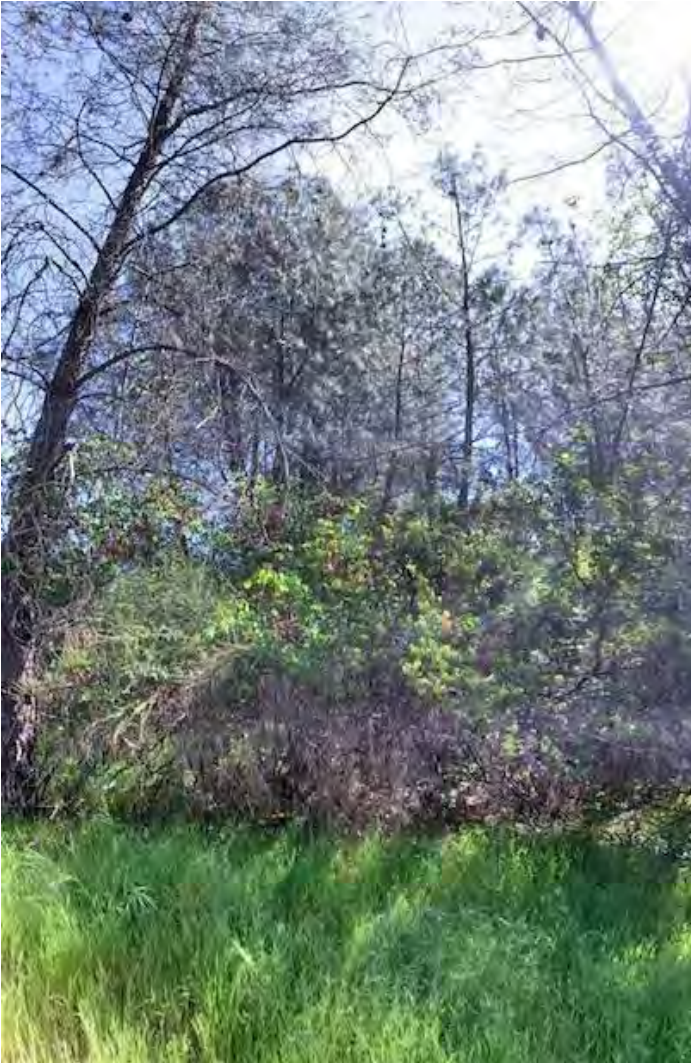
The majority of the site consisted of Gray Pine with understory trees and shrubs; including sporadic undersized native oaks.

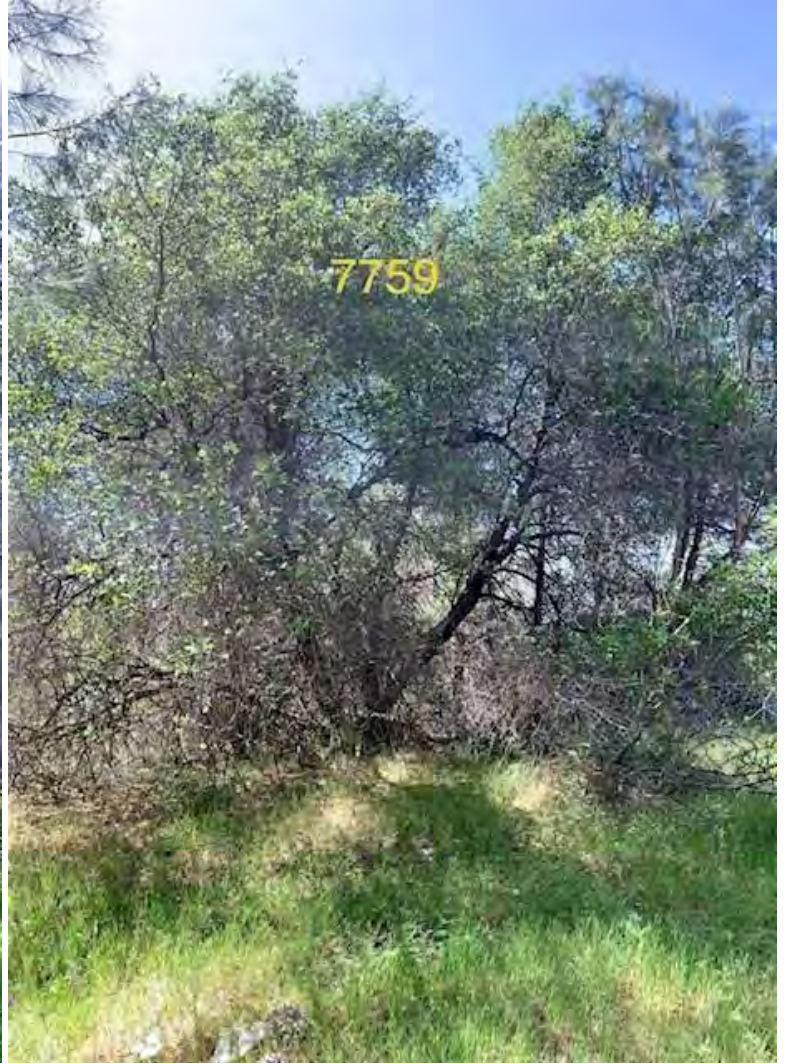
<sup>3</sup> Tree #7759 is an off-site Heritage tree (42" Total Diameter). An additional \$19,278.00 in mitigation fees will be required if the required protection zone shown in Appendix 1 cannot be met. In addition, since this tree does NOT belong to the subject property, permission from the property owner would be required for removal of the tree.

While the total encroachment for Tree #7759 is estimated at ~25% the remainder of the tree is undisturbed and with proper excavation monitored by the project arborist and root pruning the tree should not suffer any adverse effects.

Off site heritage-size interior live oak located adjacent to the south property line.

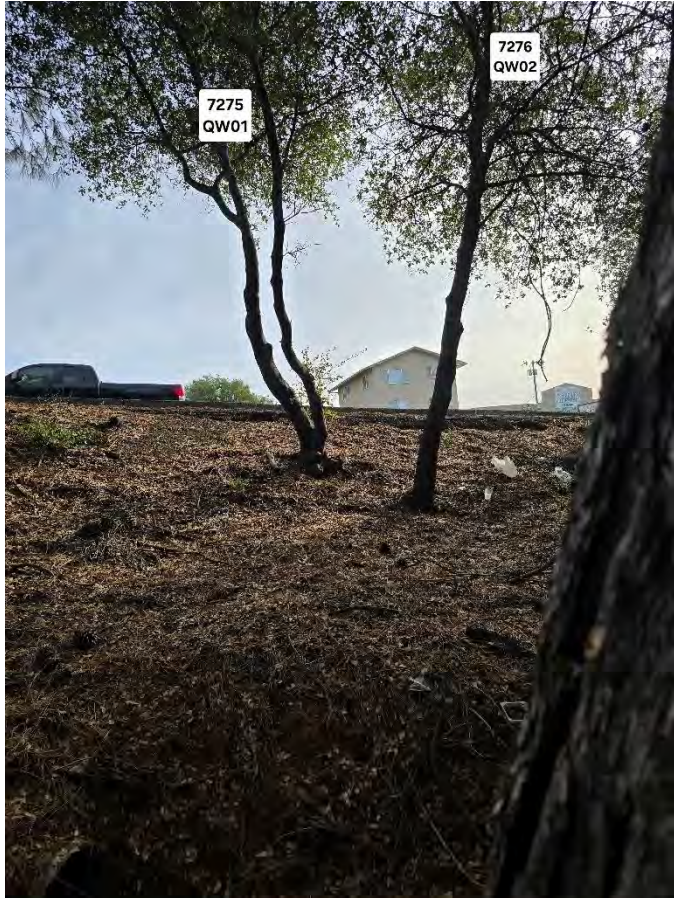
| Tag # | SWCA Tag # | Protected By Code | Significant Oak Trees >24"-35" | Heritage Oak Trees >36" | Offsite | Species Common Name | Species Botanical Name | DBH (in.) | DBH Multi-Stem (in.) | Measured At (in.) | Canopy Radius (ft.) | Arborist Rating | Notes | Dvlpmnt Status |
|---|---|---|---|---|---|---|---|---|---|---|---|---|---|---|
| 7275 | QW01 | Yes | No | No | | Interior live oak | <i>Quercus wislizeni</i> | 14 | 9, 5 | 54 | 14 | 2-Major Structure or health problems | Slotted for removal. On slope, 5 feet from S Shingle Rd. Codominant at 1 foot, inclusion and 20% bark loss present. Unbalanced main stems with moderate bark loss throughout. Poor taper/balance. Fair foliage health. Crown moderately suppressed. | No encroachment depicted. |
| 7276 | QW02 | Yes | No | No | | Interior live oak | <i>Quercus wislizeni</i> | 9.5 | | 54 | 14 | 3-Minor Problems | Slotted for removal. On slope. Good base, structure and vigor. Moderately suppressed crown. | No new encroachment depicted, existing curb and pavement within CRZ. |

Shows Trees #7275 & #7276, from left to right

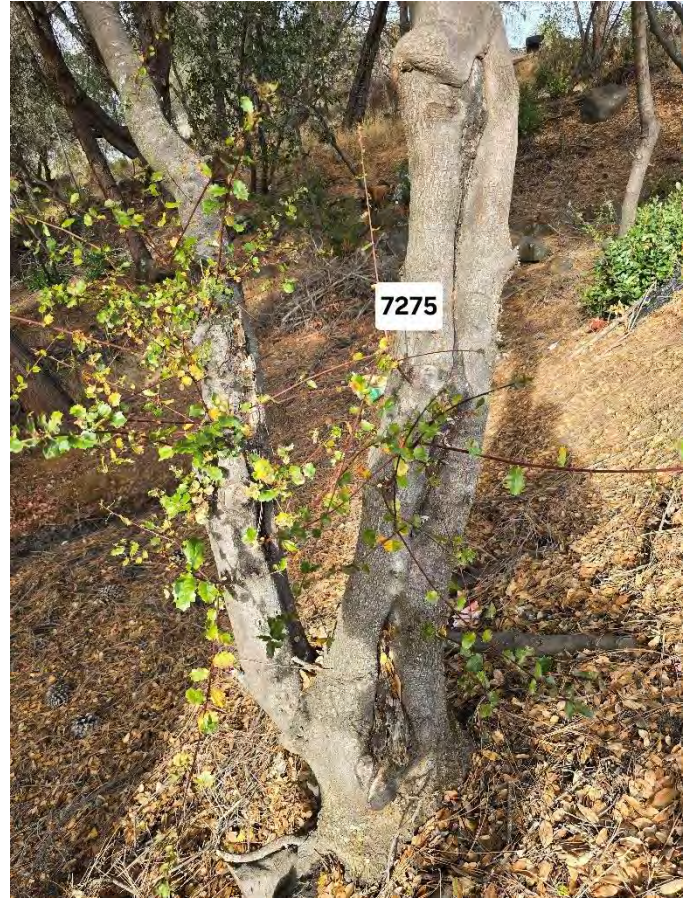
Shows Tree #7275

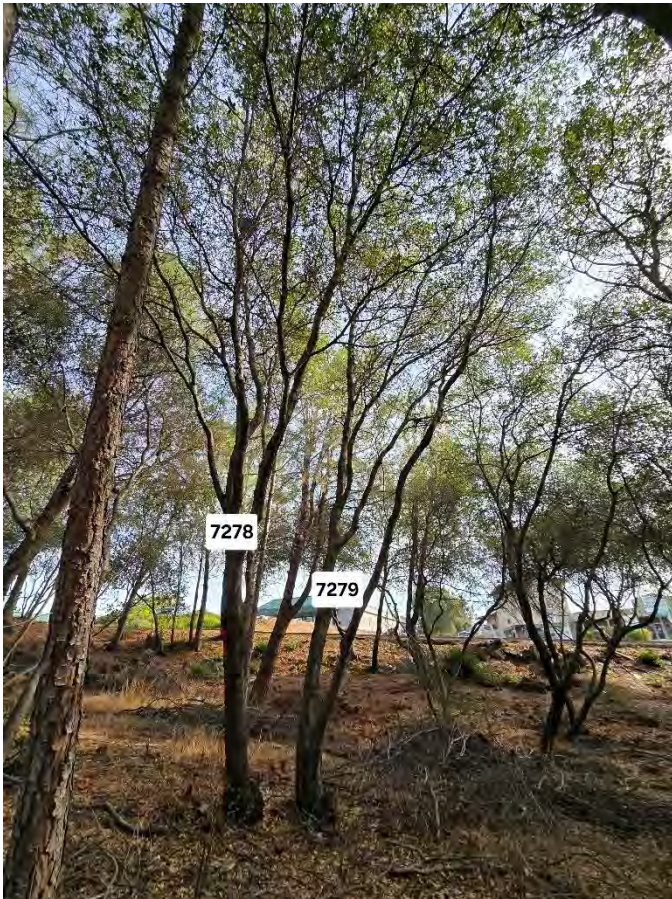
Shows Trees #7278 & #7279, from left to right

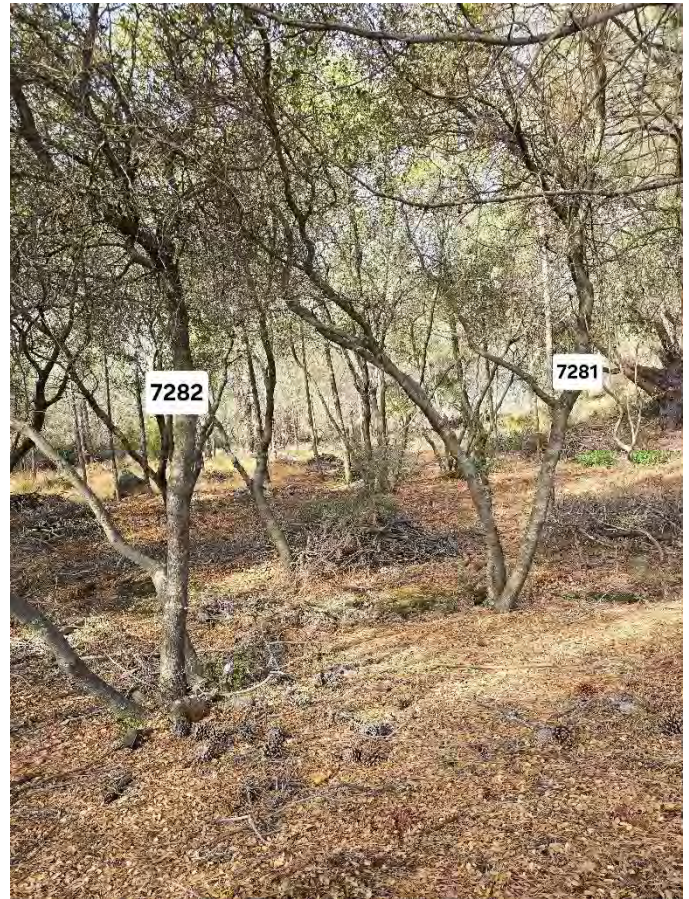
Shows Trees #7282 & #7281, from left to right
