EL DORADO COUNTY
DEPARTMENT OF TRANSPORTATION
Contract Change Order

CCO No.	Suppl. No.	Contract No.	Contract Name	Federal Number(s)
3		8597 Project No. 36204002	Patterson Drive Emergency Culvert Repair Project	NA

EXHIBIT C - DETAIL SHEETS (3 OF 4)

Contract Change Order #3 - Sheet 4 of 5

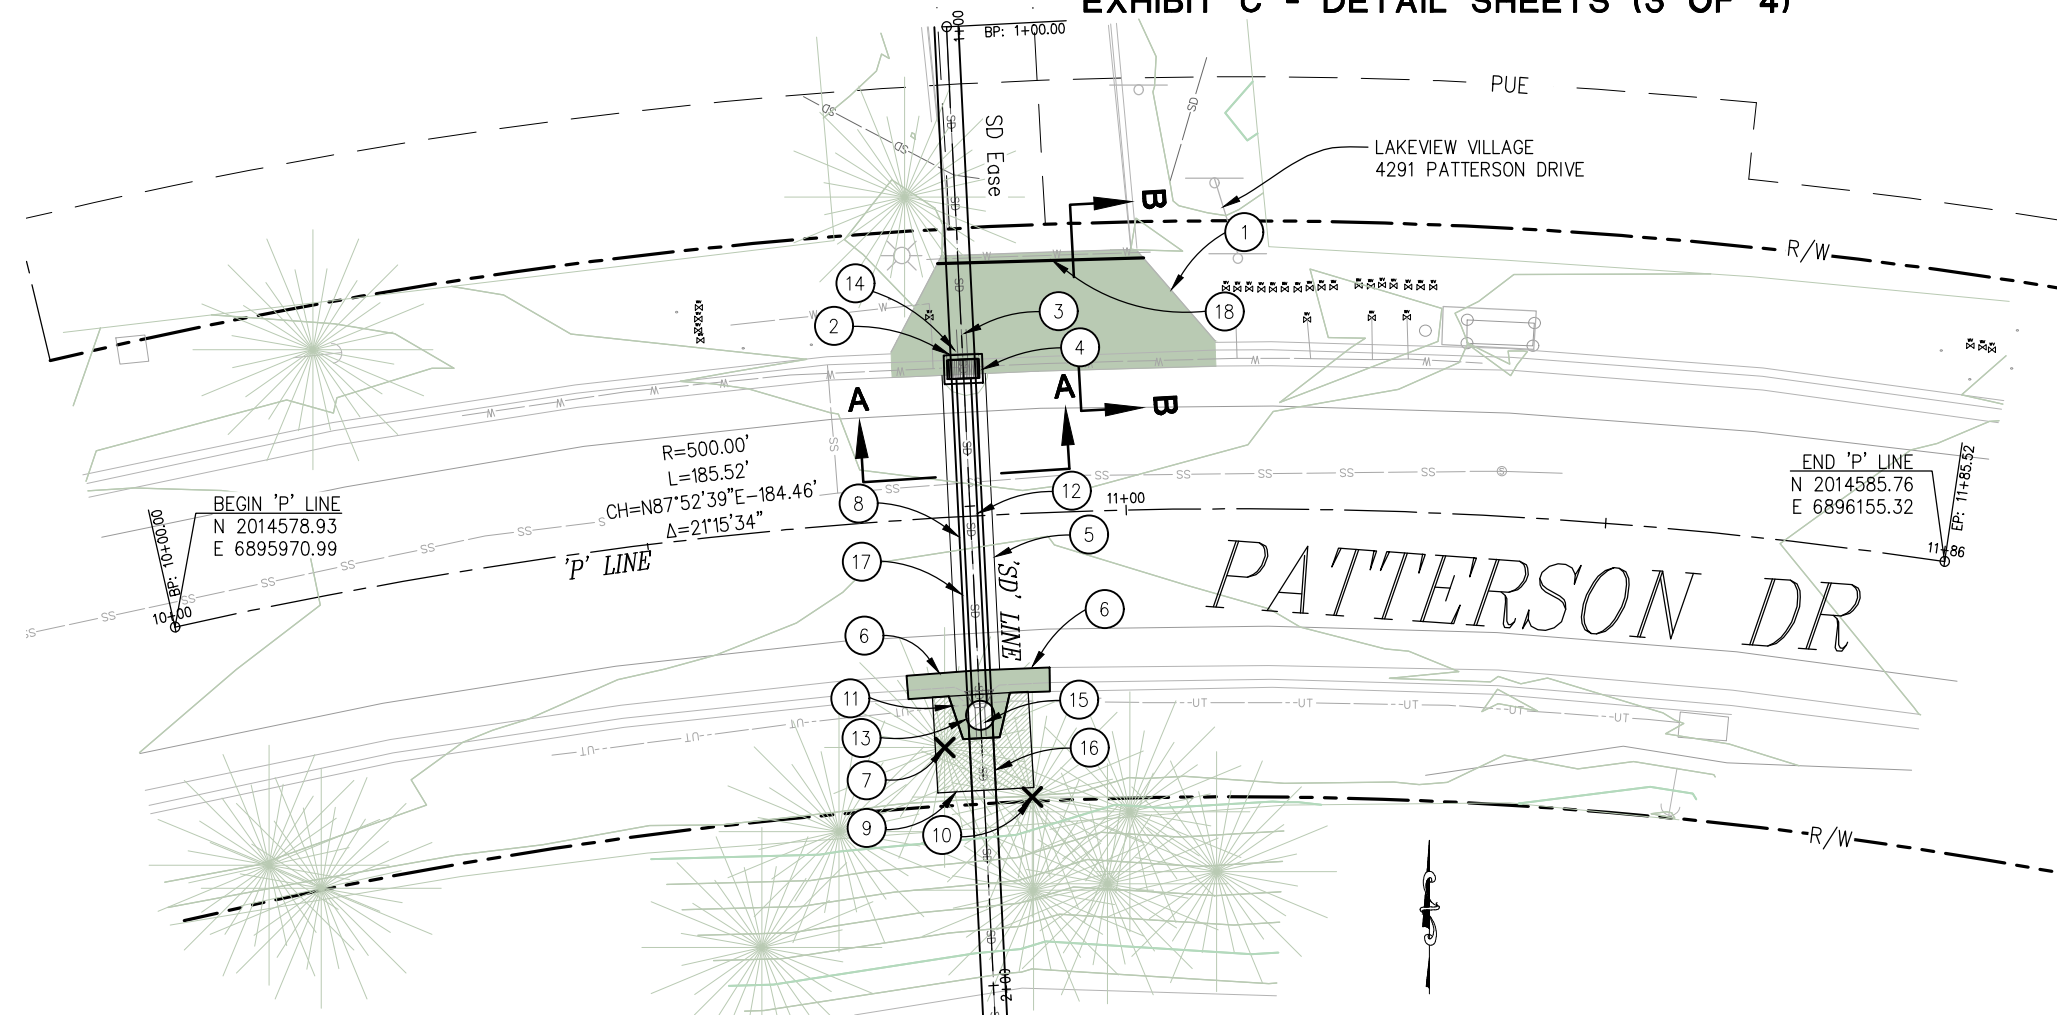
PLAN LAYOUT - IMPROVEMENTS

- 14 - CC03 - REMOVE SATURATED MATERIAL BELOW PIPE - CAST NEW PIPE FLOWLINE WITH 6-SACK CONCRETE REINFORCED WITH 6" WELDED WIRE MESH AS DIRECTED BY ENGINEER.

- 18 - CC03 - REPLACE UNMARKED EXISTING $\frac{3}{4}$ " IRRIGATION LINES WITH 4" PVC CONDUIT CONTAINING TWO $\frac{3}{4}$ " IRRIGATION LINES TIED INTO EXISTING LINES ON EACH SIDE OF DRIVEWAY.

- 6 - CC03 - REMOVE AND REPLACE CURB AND/OR GUTTER (MATCH EXISTING) 20 LF BOTH SIDES OF DI. SLOPE TO DRAIN TO DI.
- 7 - REMOVE 18" STUMP.
- 8 - REMOVE 39 LF 30" CMP. REPLACE W/ 36 LF 30" HDPE (TYPE S) AND CONNECT TO GCP.

- 9 - CC03 - COVER DISTURBED GROUND WITH LEAF MULCH AND CHIP STOCKPILED PRIOR TO EXCAVATION.
- 10 - CC02 - REMOVE 12" DBH OAK TREE AND ROOT BALL.
- 11 - CC01 - TIE-IN CONCRETE APRON AND 6" CURB AND GUTTER.
