RE: Biological Site Assessment for the Cameron Ranch Project, Cameron Park, CA.

Subject: Oak Canopy Analysis and Replacement Plan for the Cameron Ranch Project, El Dorado County, CA.

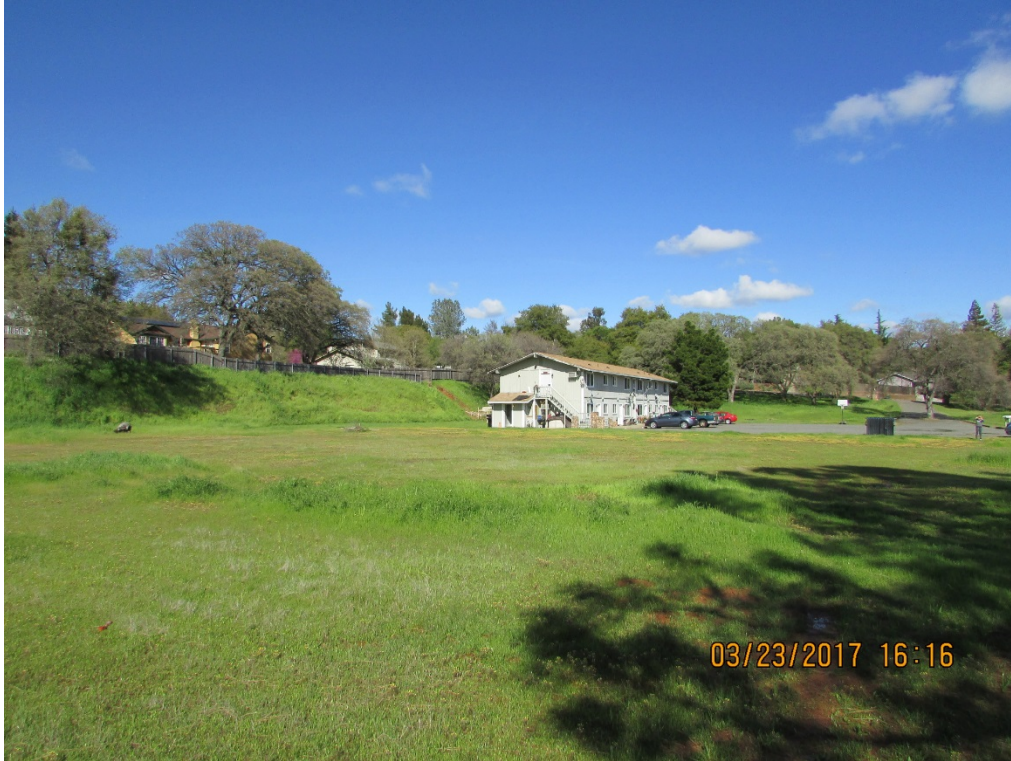
Photo 1: View of the eastern portion of the site showing cleared/leveled areas with ruderal vegetation and an apartment building and parking lot in the background.

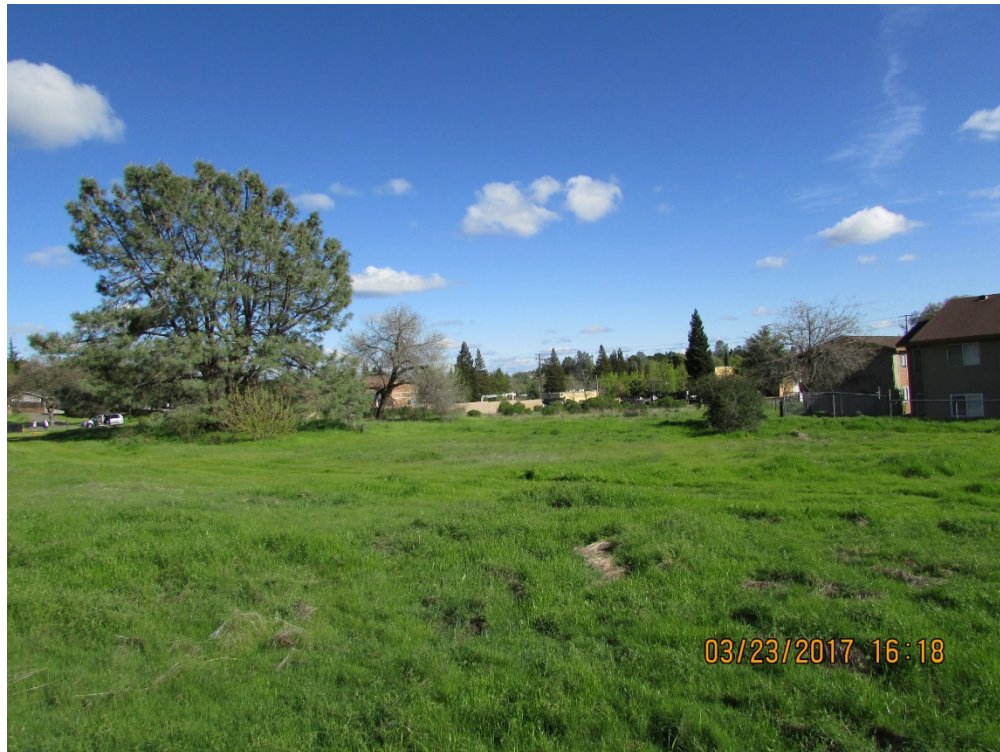
Photo 2: View of the western portion of the site showing non-native annual grassland and an adjacent residential development.

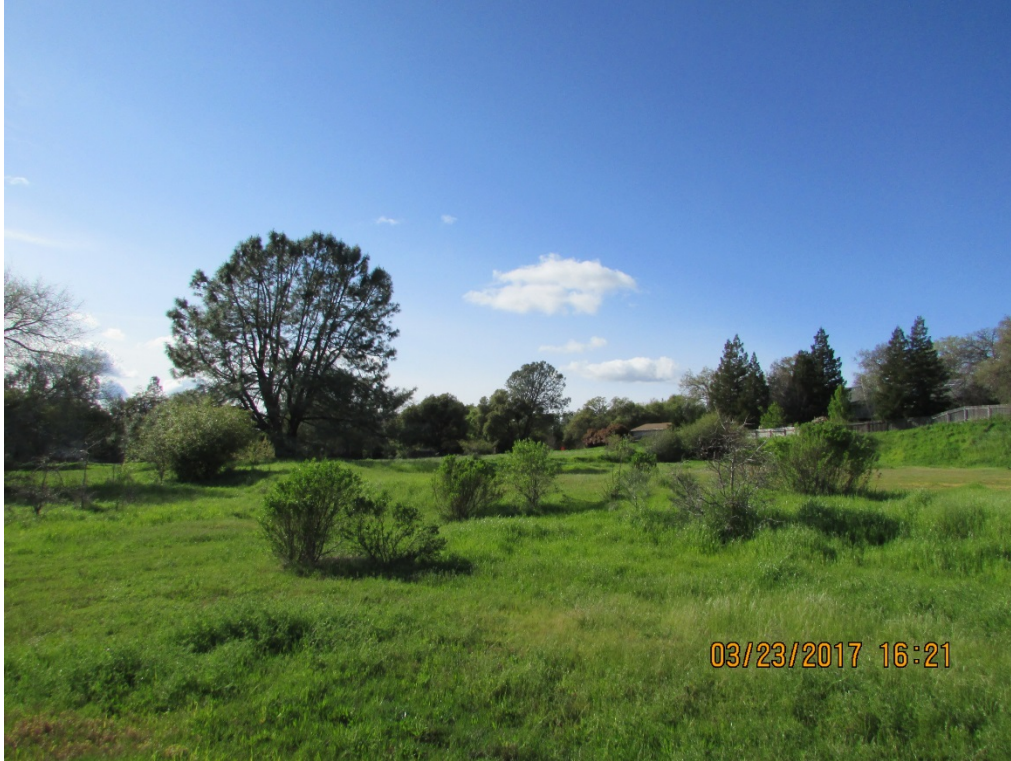
Photo 3: View of the southern portion of the site showing non-native annual grassland with scattered coyote bush.

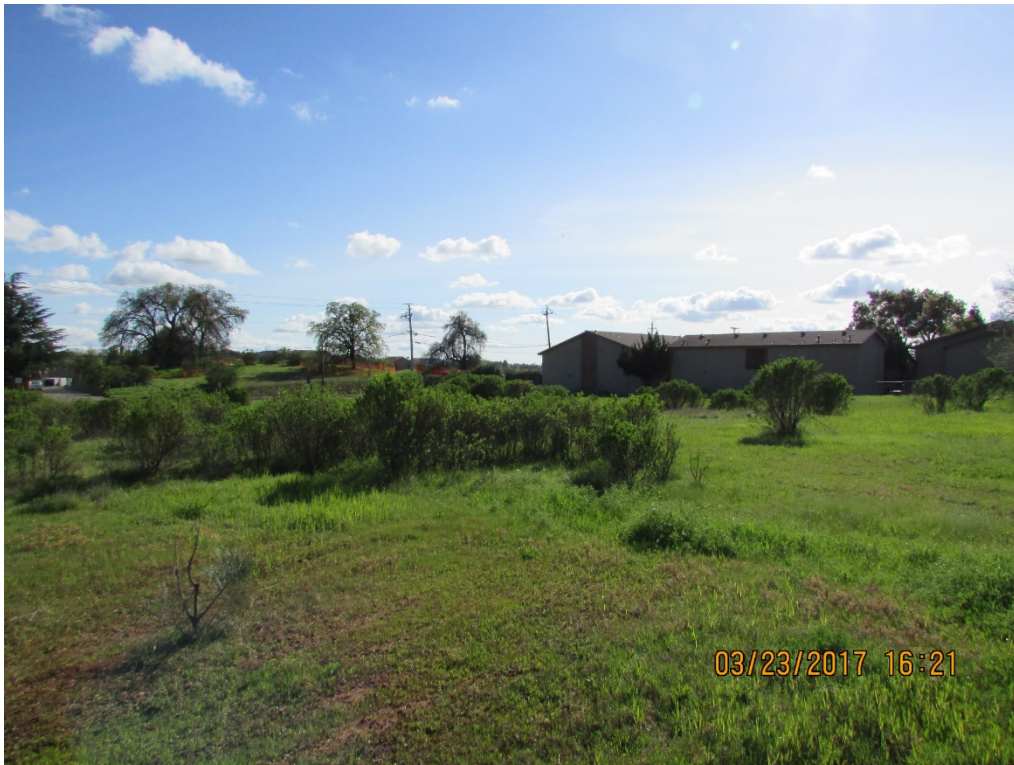
Photo 4: View of the central portion of the site showing disturbed soil areas, ruderal vegetation, and scattered coyote bush.

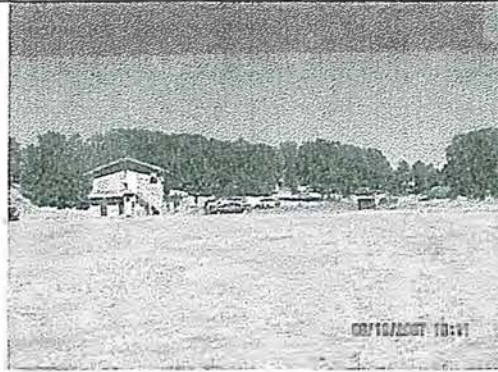
Photo 1. View of the northern portion of the property looking east from the west side of the property.

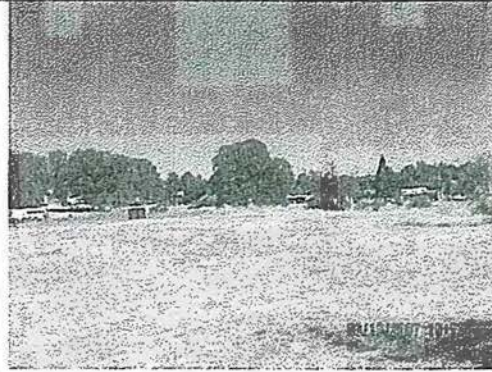
Photo 2. View of the southern portion of the property looking east from the west side of the property.

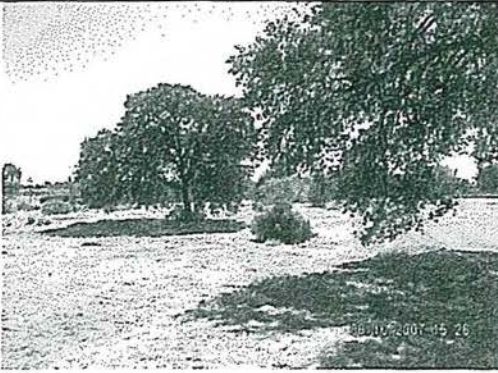
Photo 3. View of the southern portion of the property looking west from the east side of the property.

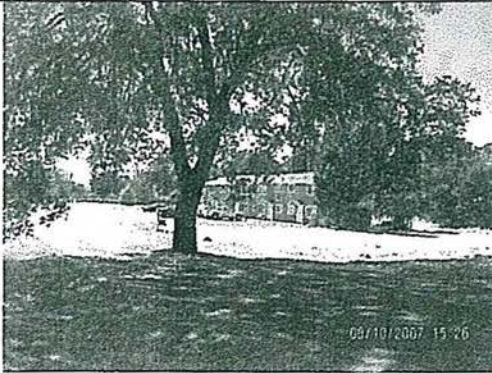
Photo 4. View of the northern portion of the property looking west from the east side of the property.

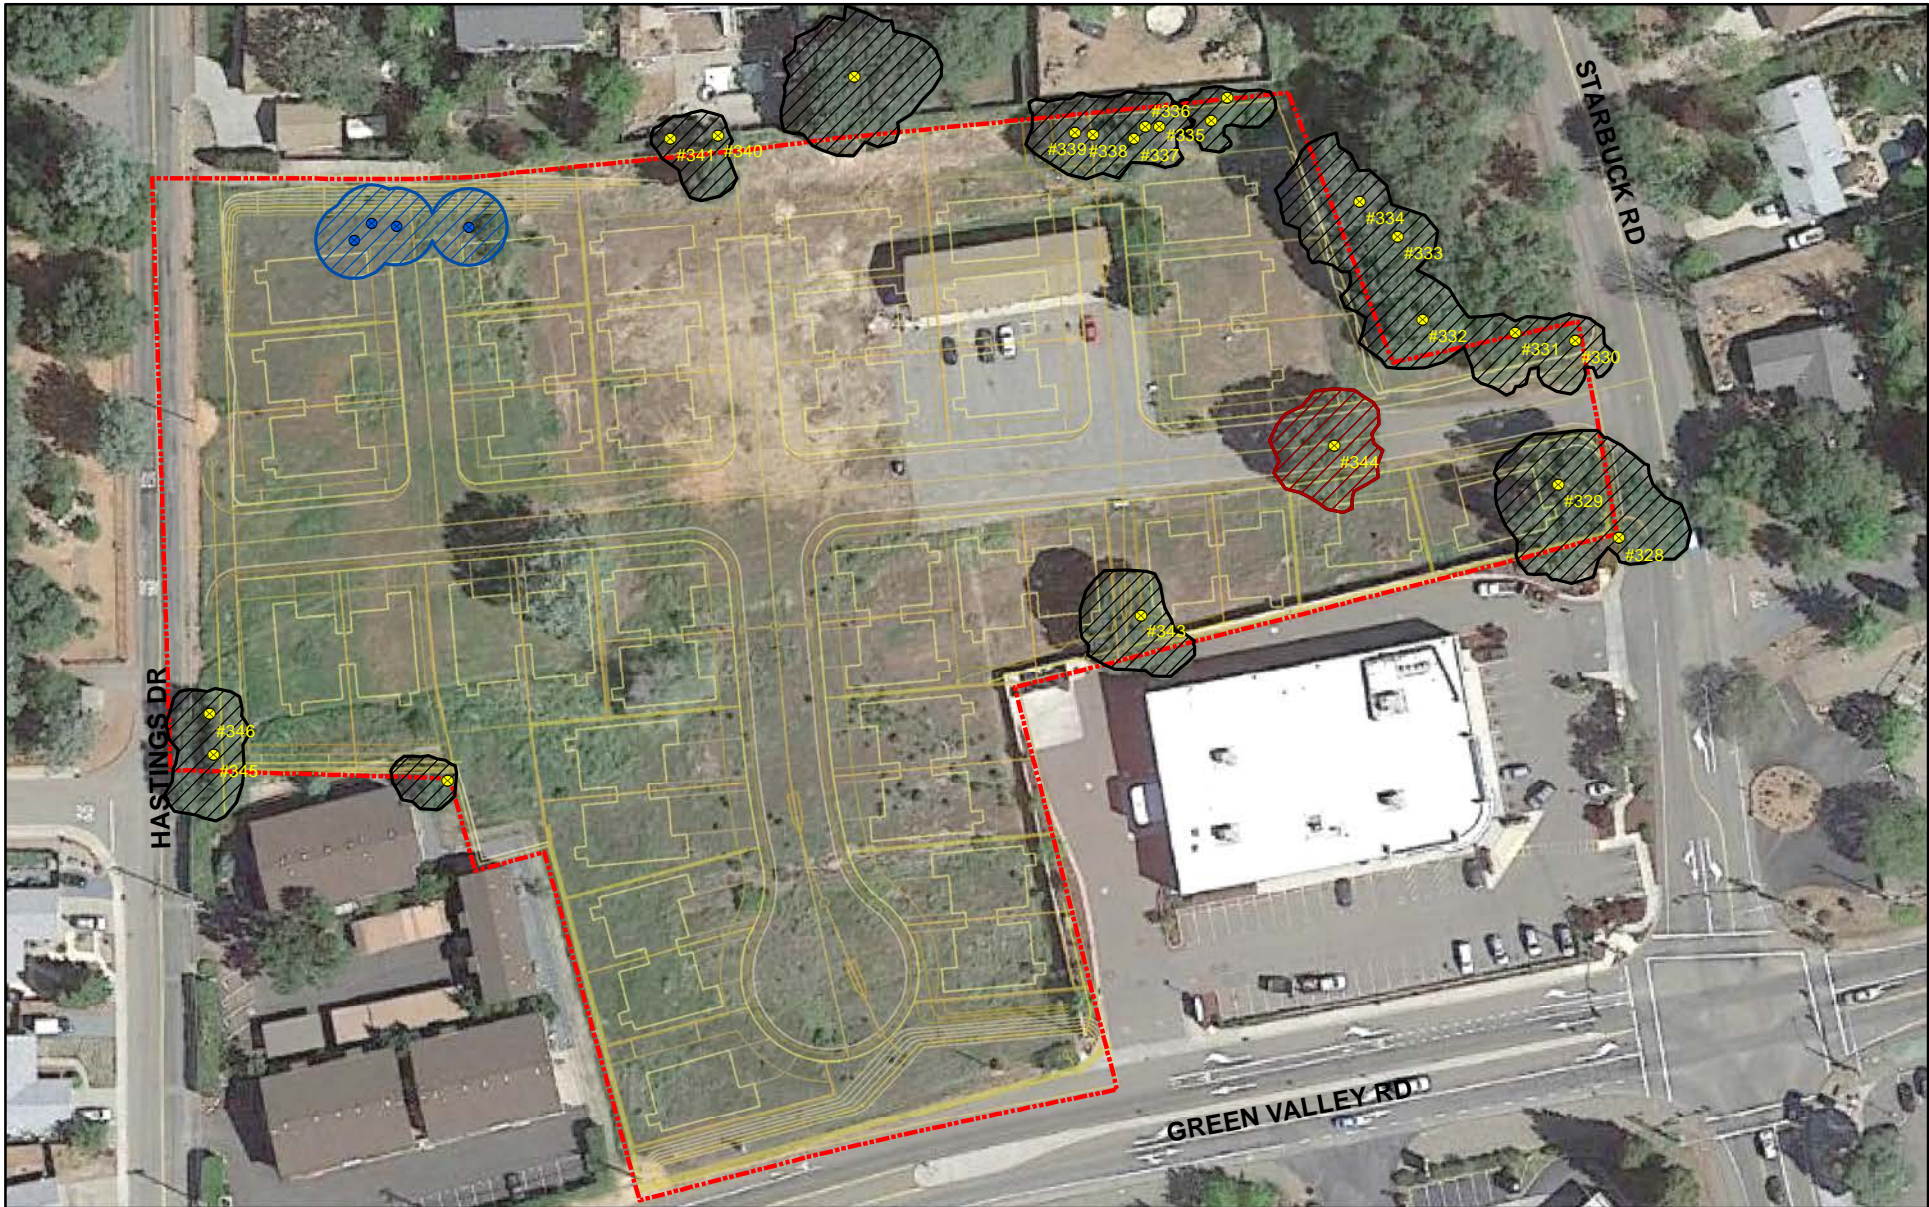
Attachment B. Oak Canopy Impacts

Replacement Oak Canopy (0.079 ac)
-

Attachment B demonstrates one suitable location for native oak replacement. Other on-site locations are also suitable. I recommend native valley oaks (*Quercus lobata*) as the replacement trees. Valley oaks are recommended because they grow relatively quickly when young and are tolerant of some disturbance from surrounding urban land use. Interior live oaks (*Q. wislizeni*) and blue oaks (*Q. douglasii*) are also appropriate for the area. The measures below are recommended for replacement native oak trees.

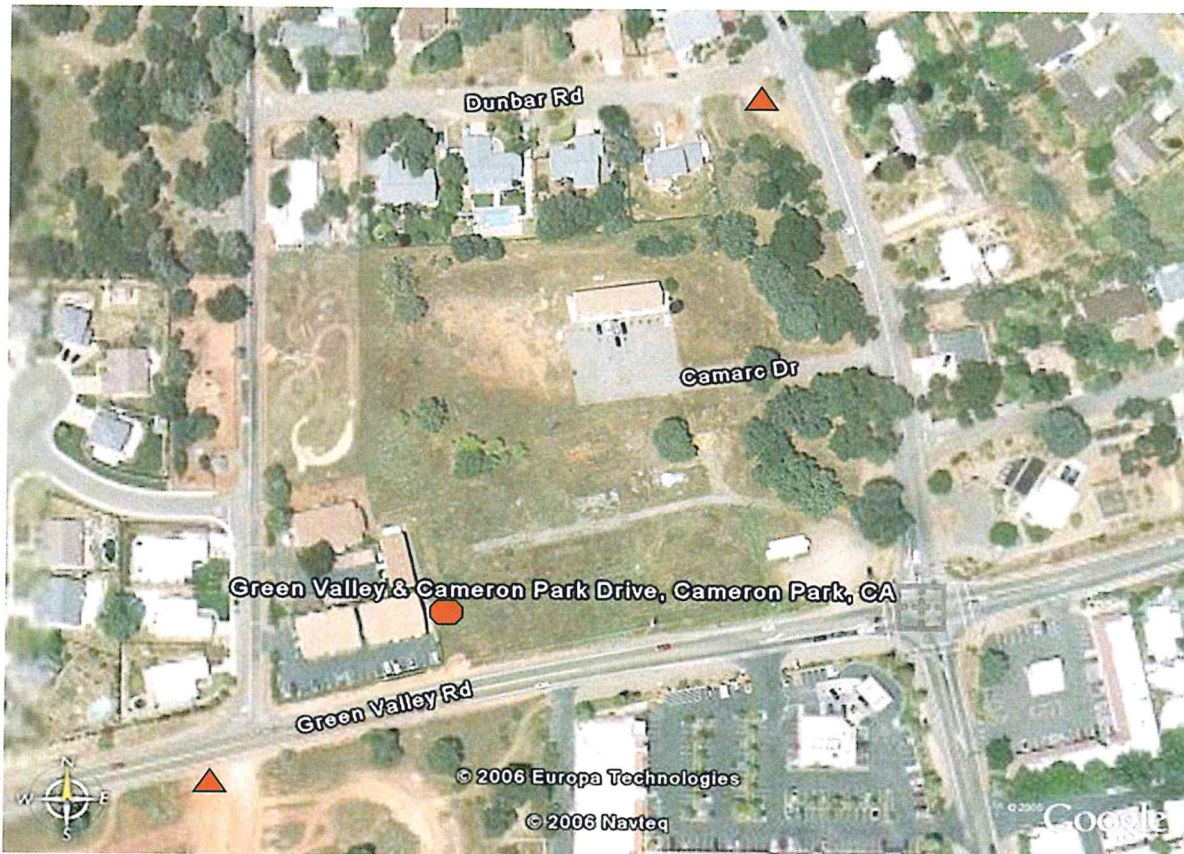
FIGURE 2
Noise Measurement Locations
Cameron Ranch, Cameron Park, California

- ▲ Short-term Traffic Noise Measurement Site
- 24-hour Continuous (Ambient) Noise Measurement Site

The FHWA model over-predicted the measured Green Valley Road traffic noise level by 0.1 dB at a height of five feet, and under-predicted the traffic noise level by 2.1 dB at the fifteen-foot height. For Starbuck Road, the model under-predicted the traffic noise levels by 1.1 dB at the five-foot height, and by 2.8 dB at the fifteen-foot height. Given the close agreement between measured and modeled traffic noises levels at the 5-foot microphone height for both roadways, no offset was applied to the FHWA model. Based on WJVA file data and experience, noise levels at the 15-foot (second floor) height are typically 3 dB higher than the ground floor receiver. This is due to less ground attenuation at that height.
