EL DORADO COUNTY

FEASIBILITY STUDY

PUBLIC ACCESS TO THE NORTH FORK OF THE COSUMNES MINE RIVER AT BUCKS BAR BRIDGE

Prepared by the El Dorado County Department of Transportation

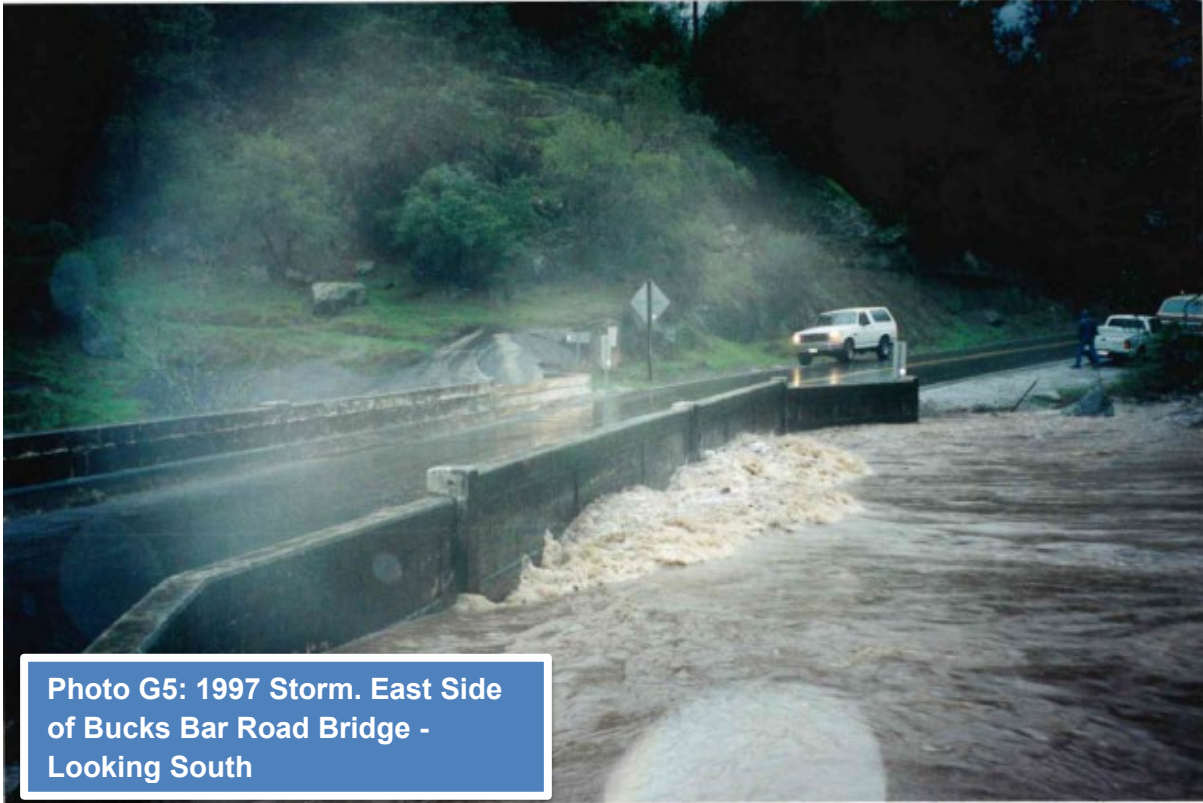
Photo G5: 1997 Storm. East Side of Bucks Bar Road Bridge - Looking South

Recent hydraulic analysis shows that the bridge cannot accommodate 100-year or 50-year storm events, with overtopping observed during major storms in 1997 and near-overtopping in subsequent years. Debris accumulation within the substructure during high-flow events further obstructs hydraulic flows.

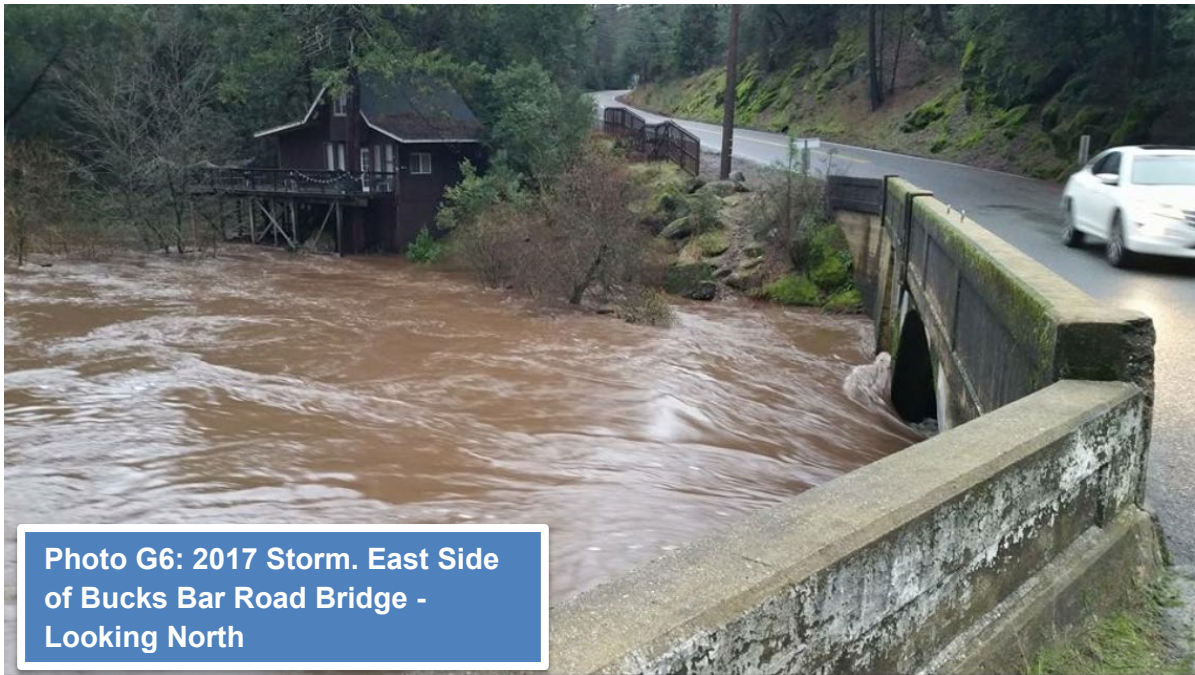
Photo G6: 2017 Storm. East Side of Bucks Bar Road Bridge - Looking North
