El Dorado Apartments

Biological Resources Report and

Wetland Delineation

EcoSynthesis Scientific & Regulatory Services, Inc.

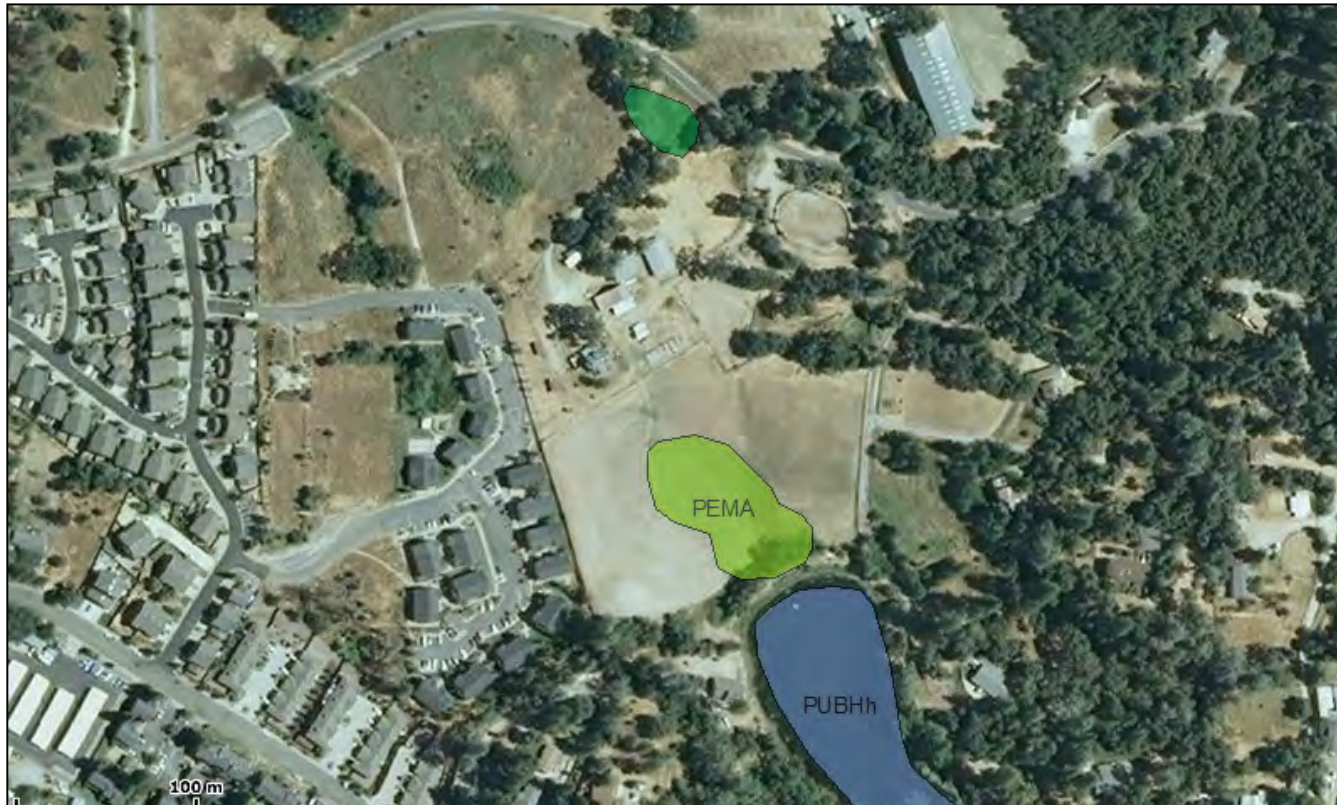
Diamond Springs
(portion)

Wetlands

- Freshwater Emergent
- Freshwater Forested/Shrub
- Estuarine and Marine Deepwater
- Estuarine and Marine
- Freshwater Pond
- Lake
- Riverine
- Other
