TM21-0002 SIERRA VIEW ESTATES
EXHIBIT A - LOCATION MAP

**South Shingle Road - Parcel 3, 41/PM/65
APN: 109-340-069 - El Dorado County, CA
November 2021 Updated June 2023**

Tentative Subdivision Map

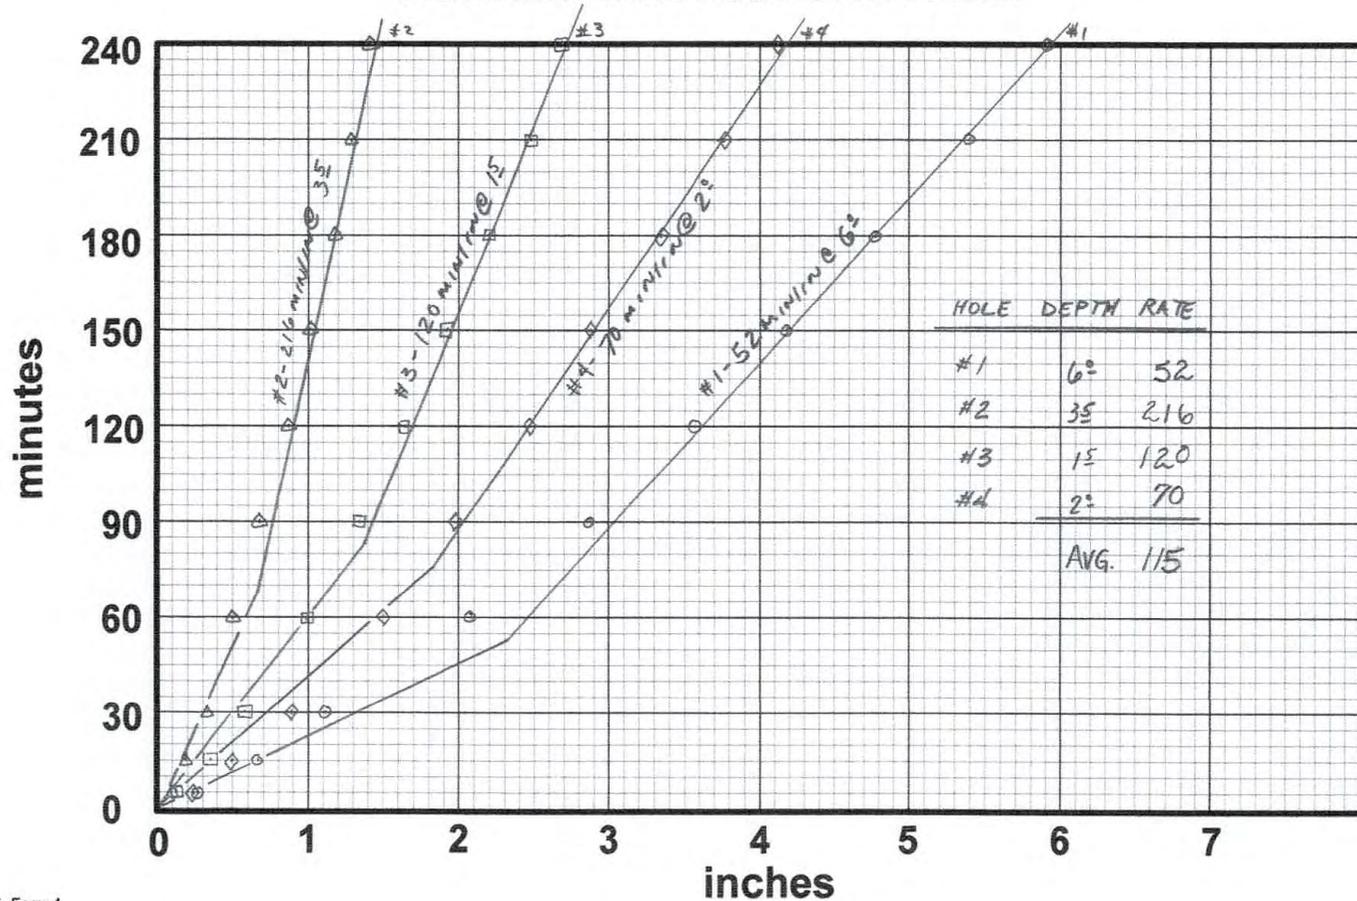
PERCOLATION TEST DATA PLOT

AVERAGE PERCOLATION RATE 115 minutes / inch

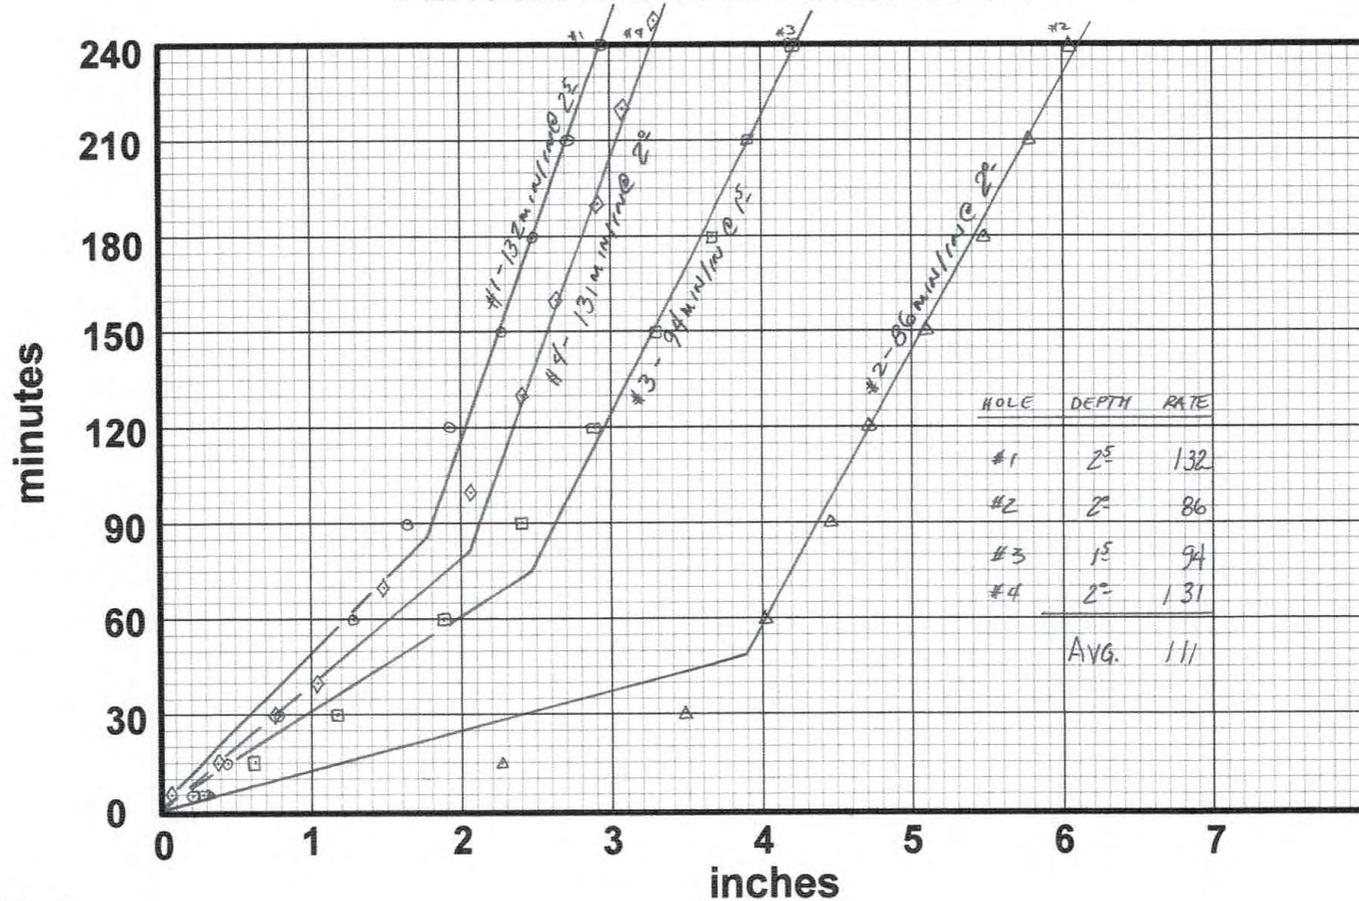
PERCOLATION TEST DATA PLOT

AVERAGE PERCOLATION RATE 111 minutes / inch

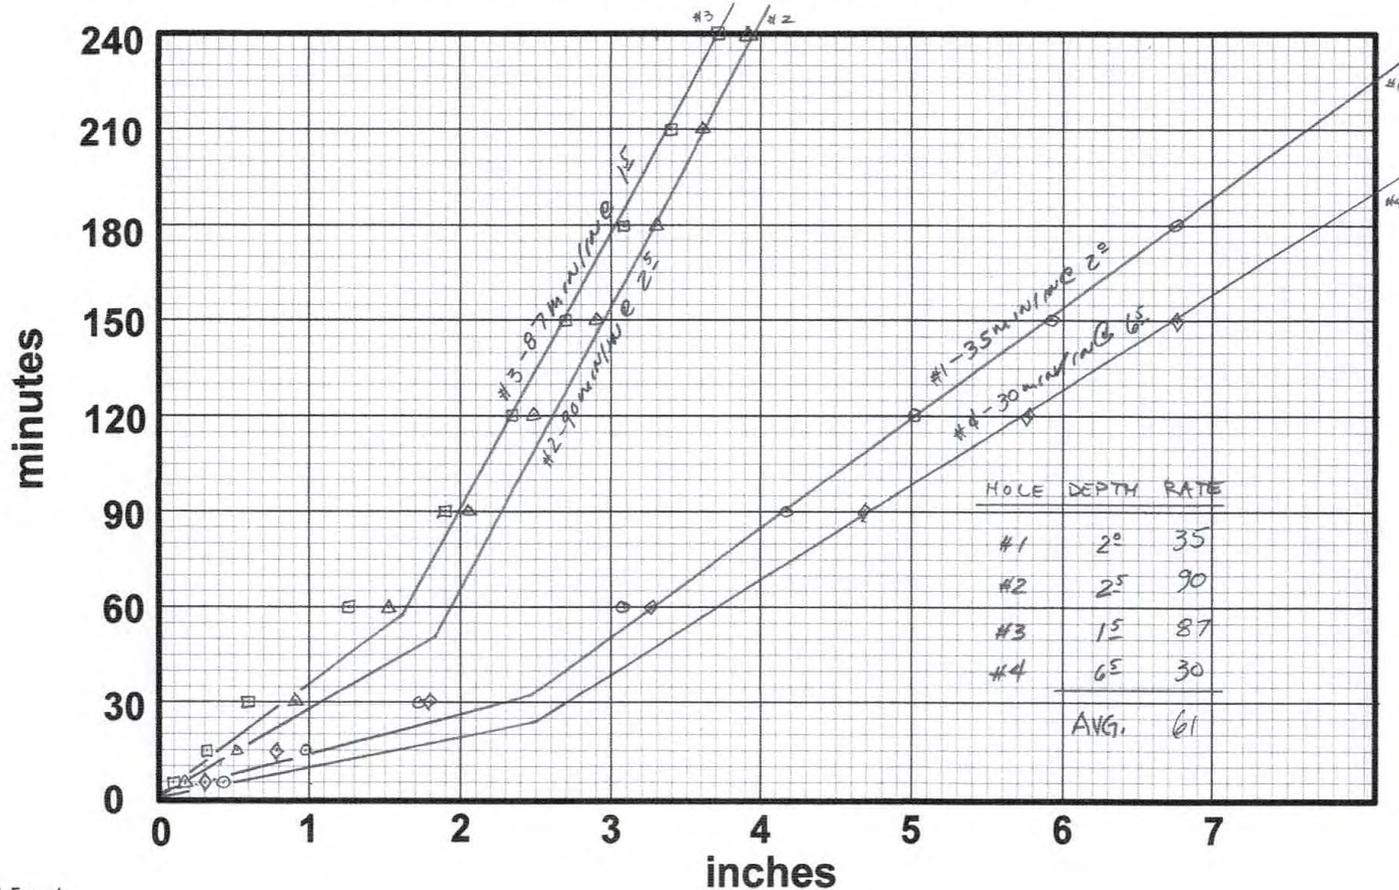
PERCOLATION TEST DATA PLOT

AVERAGE PERCOLATION RATE 61 minutes / inch

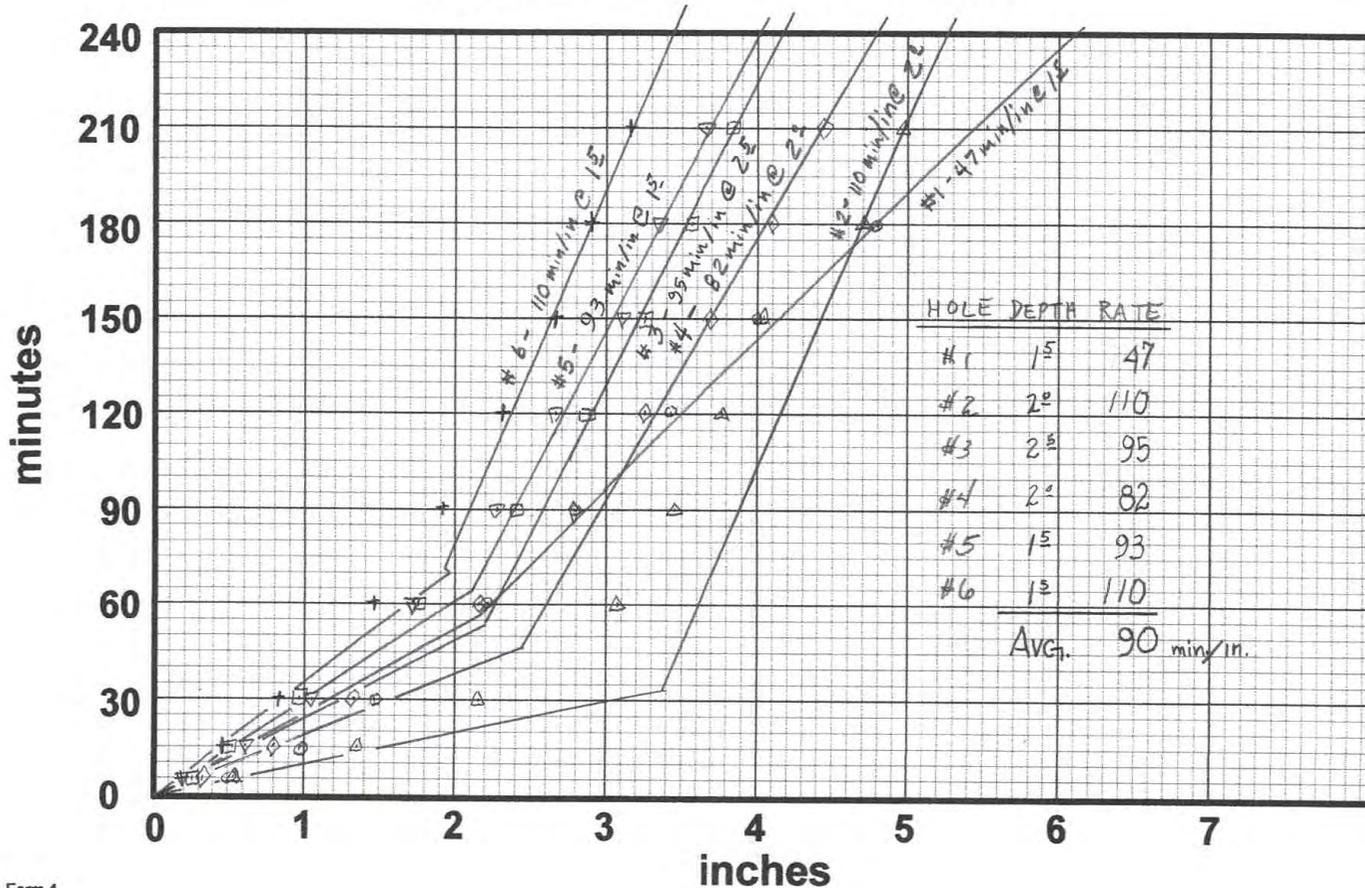
PERCOLATION TEST DATA PLOT

AVERAGE PERCOLATION RATE 90 minutes / inch

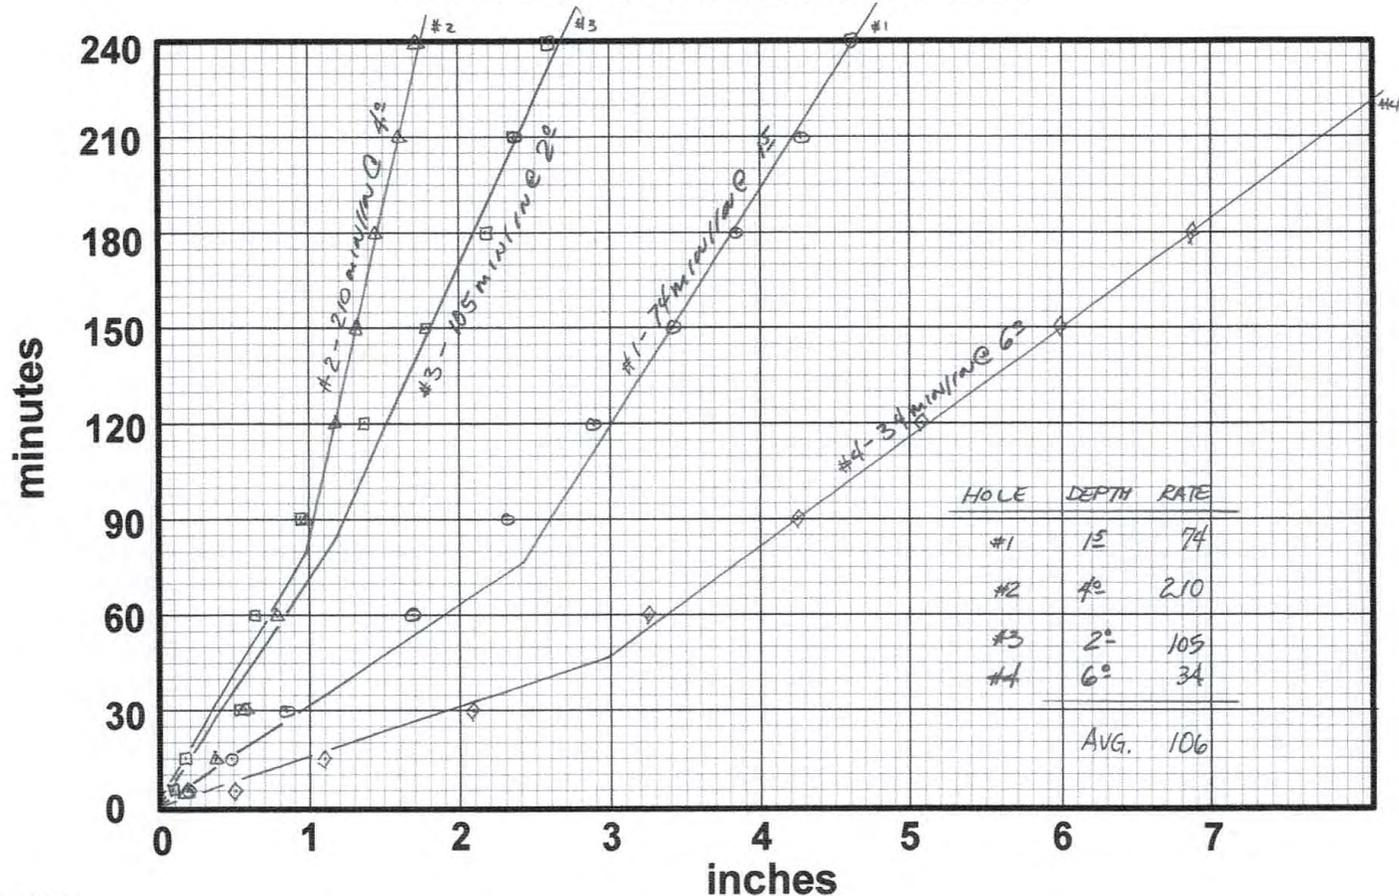
PERCOLATION TEST DATA PLOT

AVERAGE PERCOLATION RATE 106 minutes / inch

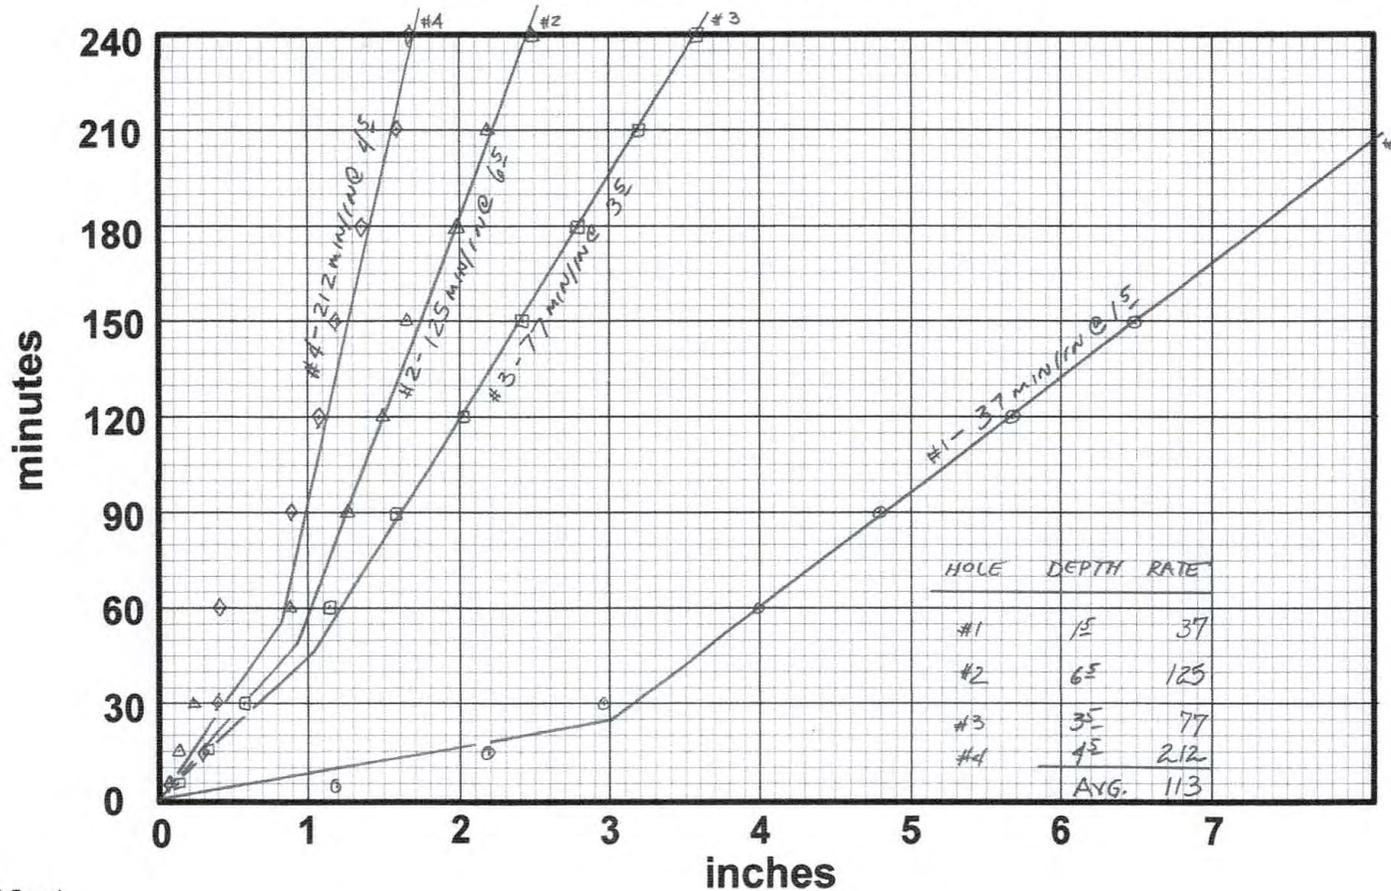
PERCOLATION TEST DATA PLOT

AVERAGE PERCOLATION RATE 113 minutes / inch

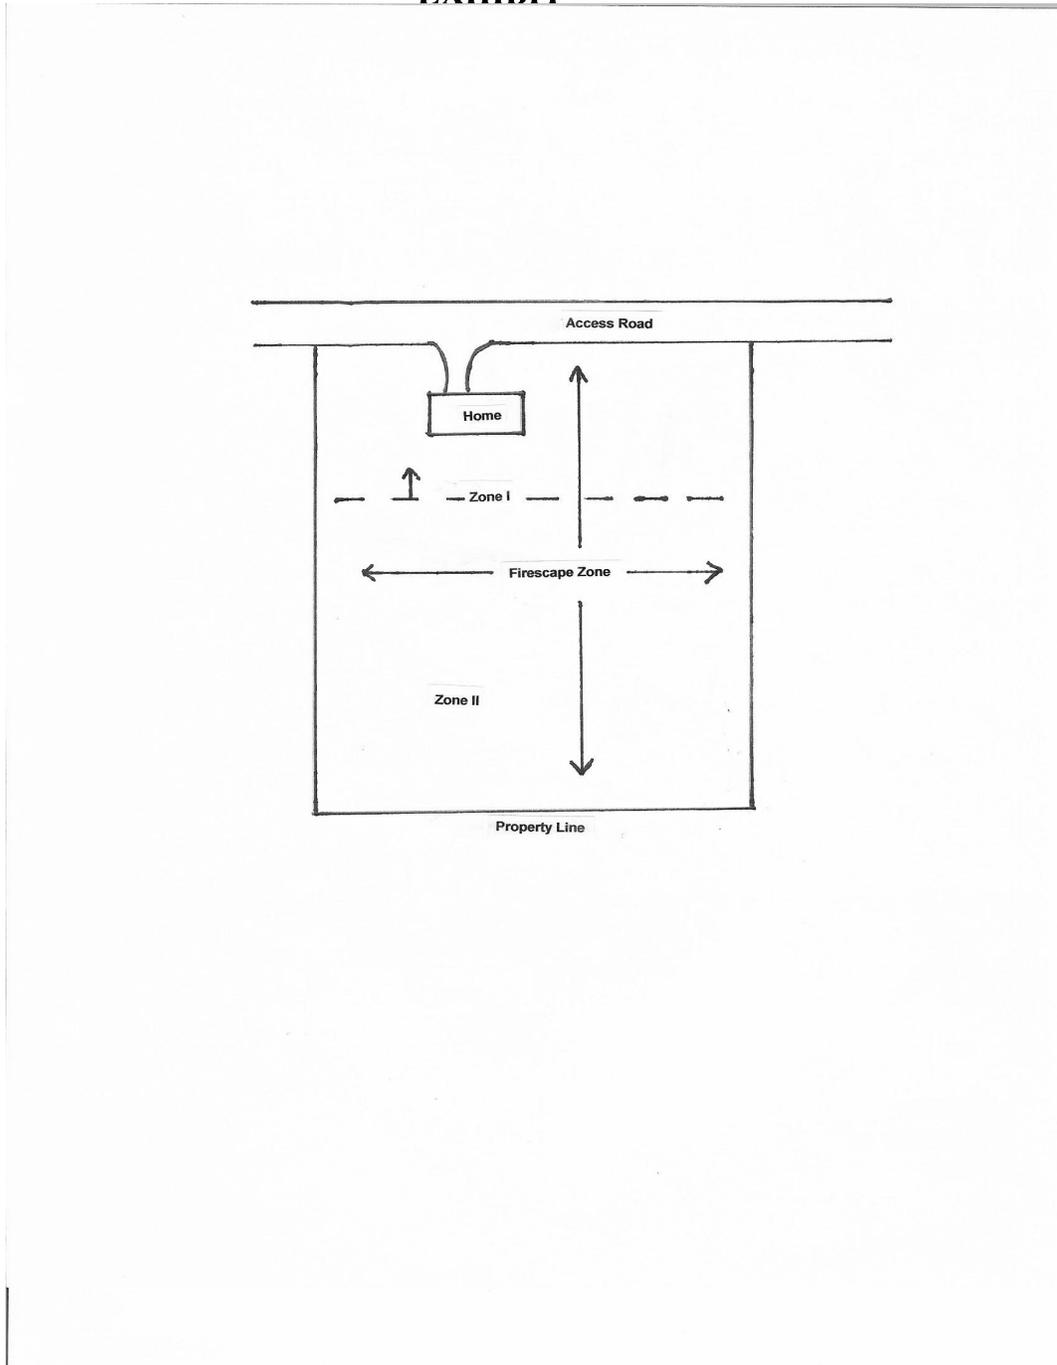
APPENDIX A-1
FIRESCAPING ZONES
EXHIBIT

Typical Lot in Oak Woodland
(SCHEMATIC, NOT TO SCALE)

Firescaping is an approach to landscaping to help protect homes from wildland fires. The goal is to create a landscape that will slow the advance of a wildfire and create a Defensible Space that provides the key point for fire fighting agencies to defend the home. This approach has a landscape zone surrounding the home containing a balance of native and exotic plants that are fire and drought resistant, help control erosion, and are visually pleasing. Firescaping is designed not only to protect the home but to reduce damage to oaks and other plants.

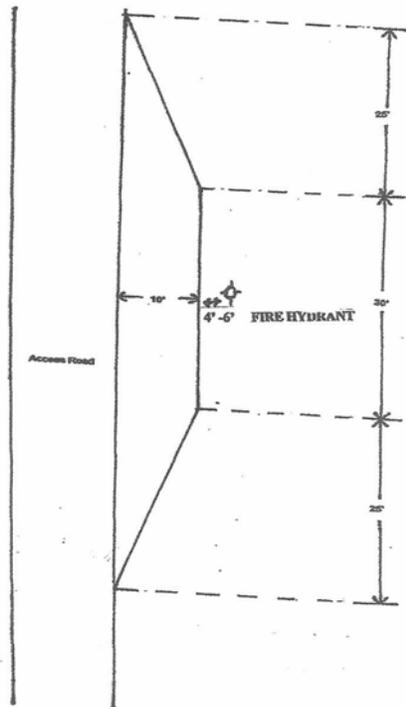
DIAGRAM A
TURNOUT WITH FIRE HYDRANT
(SCHEMATIC NOT TO SCALE)

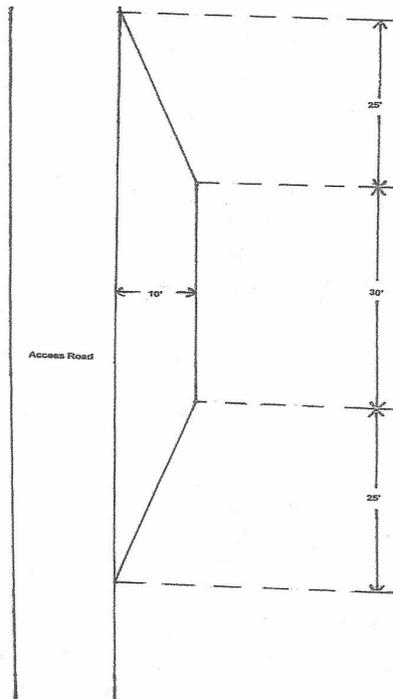
DIAGRAM B

DRIVEWAY TURNOUT
DIAGRAM
(NOT TO SCALE)

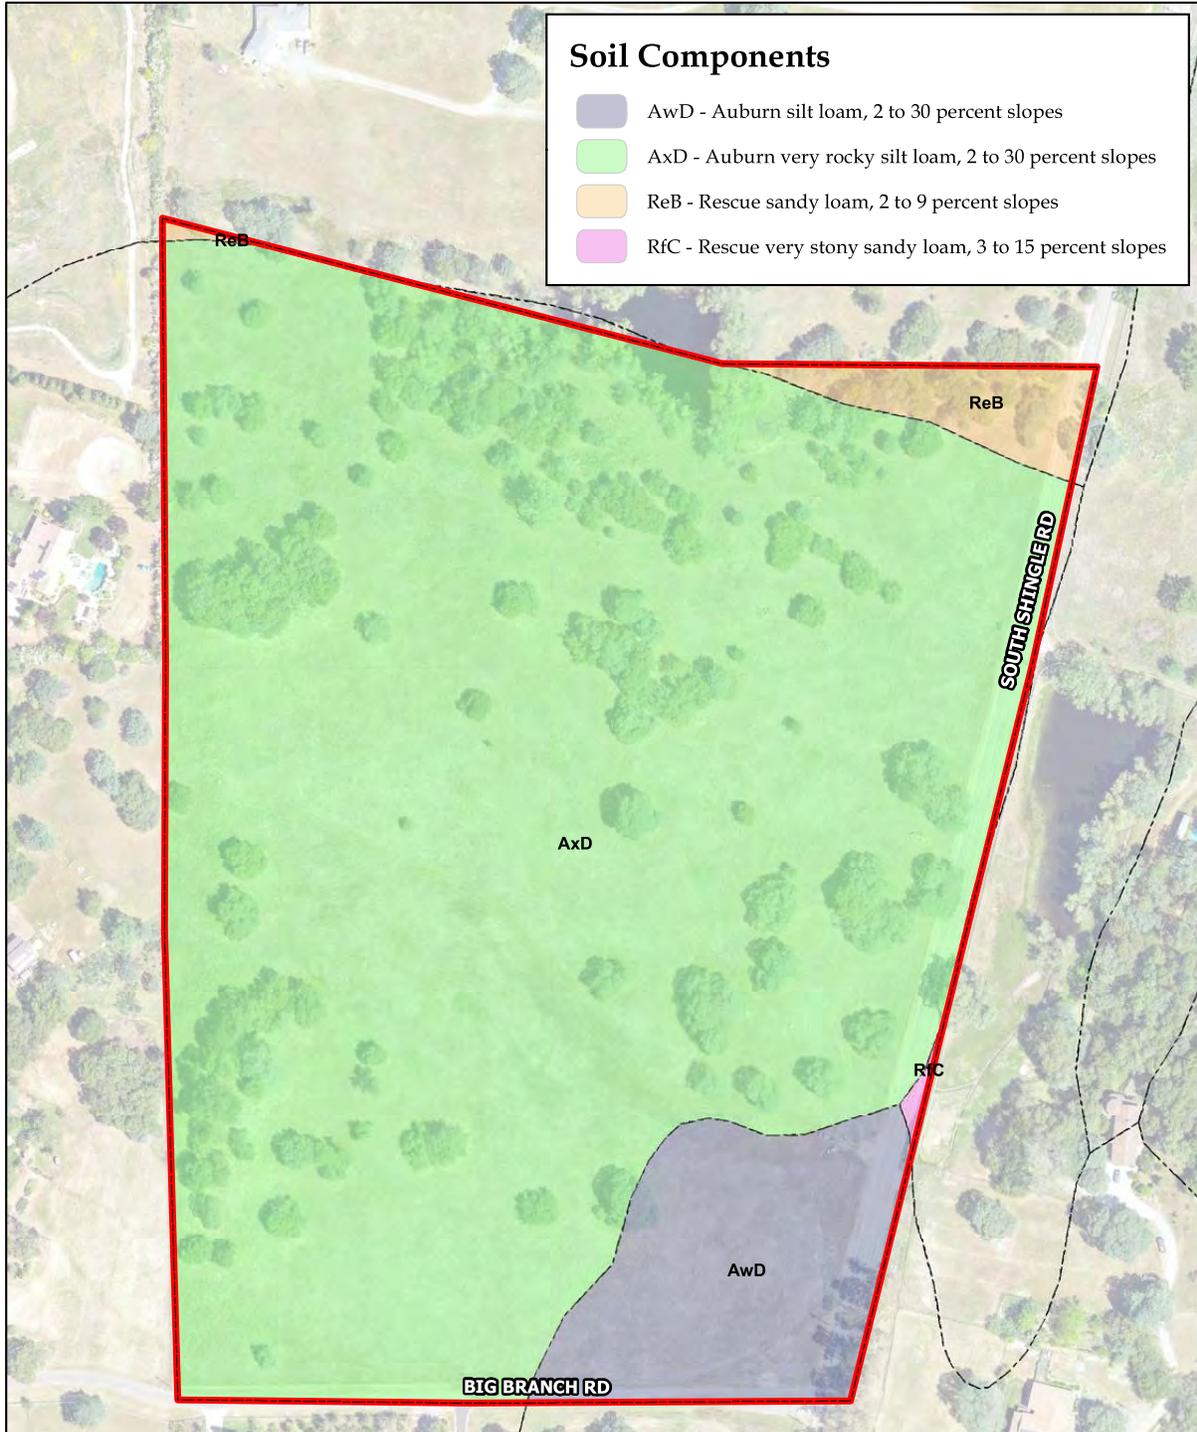
As illustrated in Figure 3, four soil units have been identified on the site. Most of the site is Auburn very rocky silt loam, 2 to 30 percent slopes, and a small portion of the site in the southeast corner is Auburn silt loam, 2 to 30 percent slopes. Very small areas of Rescue sandy loam, 2 to 9 percent slopes are found along the northern boundary, and a tiny sliver of Rescue very stony sandy loam, 3 to 15 percent slopes is located along the southeastern boundary.

As noted in the Soils section above, most of the study area is mapped as Auburn very rocky silt loam, 2 to 30 percent slopes, which is not a serpentinite/gabbroic soil (Figure 3). However, due to the presence of small areas of the Rescue series soils that occur within the site, the study area is included in the County's rare plant Mitigation Zone 1, which is defined as lands in the “rare soils study area” but outside ecological preserves. Therefore, some small areas of the site provide substrates that would support the special-status plant species dependent on these soils. These areas were carefully examined during the floristic survey that was conducted as part of this assessment. These plants are listed in Table 2, along with several other special-status plants with any potential to occur. The eight species that are reported to occur within a 5-mile radius of the study area (Figure 6a) are marked with an asterisk (*) in the table and are briefly discussed following the table.
