**PRELIMINARY EQUESTRIAN SITE PLAN**  
**ESSENTIAL PROPERTIES GROUP, INC.**  
**2400 GREEN VALLEY ROAD**  
 RESCUE, CALIFORNIA 95672  
 APN 115-410-05-100

**Figure 1**  
 Springs Ranch Event Center - El Dorado County, California  
 Project Area and Nearest Noise-Sensitive Receptors

# PRELIMINARY WETLAND EXHIBIT SPRINGS RANCH EQUESTRIAN CENTER EL DORADO COUNTY

**PRELIMINARY TREE PRESERVATION PLAN & MITIGATION AREA  
SPRINGS RANCH EQUESTRIAN CENTER  
EL DORADO COUNTY**

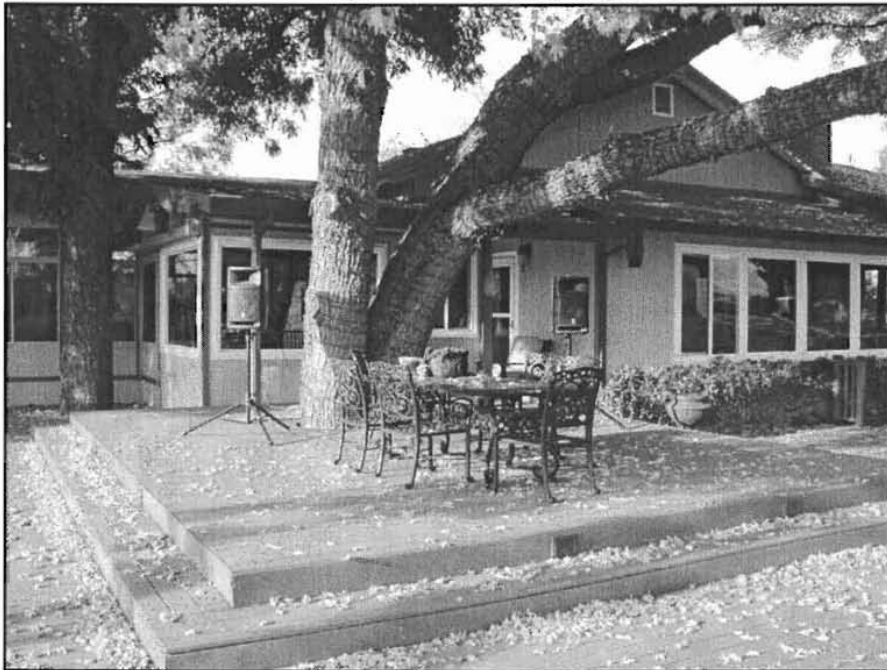
**Figure 3 – Ranch House Deck Speaker Placement (reception location)**

According to project applicants, the speaker system at the reception area would be located on the deck of the residence facing southeast. At the arena area, the speakers would reportedly be pointed to the northeast, away from the residences on Deer Valley Road. The 2011 measurement sites were chosen to represent worst-case property-line exposure relative to speaker orientation. Figures 3 and 4 show photos of the 2011 simulation sound system setup and speaker test orientations. The sound system was adjusted to produce sound levels typical of what would be produced at outdoor events at this facility.

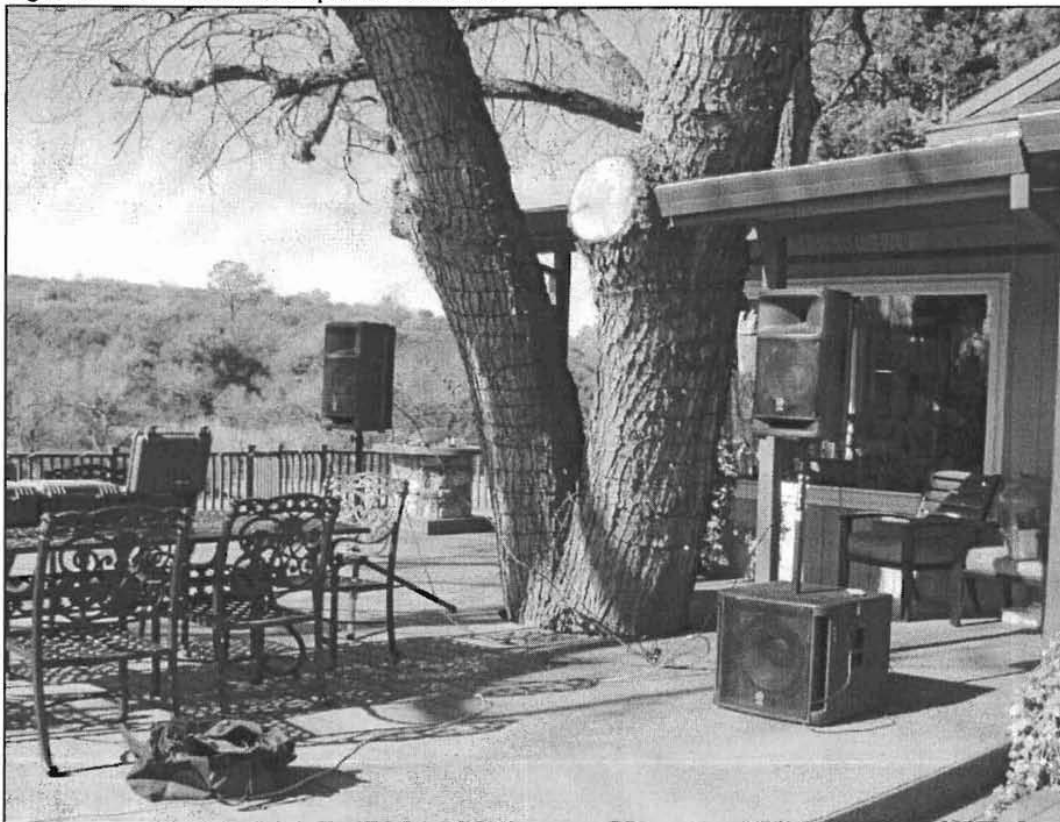
**Figure 5 – 2014 Simulation Speaker Locations**

While music was being played from the proposed reception area on the deck of the ranch house (Figure 5), BAC staff conducted a series of sound level measurements from the deck of the residence located at 2010 Deer Valley Road. During the simulation, the owner of that residence and a nearby neighbor were present to conduct their own sound level measurements and observations. Figure 6 shows the sound level measurement position on the deck of the residences, including the sound level meter used by BAC (tripod) and the meter used by the nearby resident (deck railing). The approximate location of that noise monitoring site is identified as noise measurement location "Z" on Figure 2. Figure 7 shows a more precise illustration of the relationship of the 2010 Deer Valley Road residence to the simulation area.
