RE: **Request for Review - Conditional Use Permit CUP24-0011 (Kuhl)
Residence on Property Zoned Timber Production Zone (TPZ)
Assessor's Parcel Numbers (APNs) 011-030-055 and 011-030-058**

The Planning Division is processing an application request for a Conditional Use Permit, CUP24-0011 (Kuhl) to allow a single-unit residence on property zoned Timber Production Zone (TPZ), and requests the project be scheduled for review and recommendation by the Agricultural Commissioner/Commission.

PROJECT NAME/REQUEST: (Describe proposed use) Kuhl Conditional Use Permit to placed residential house on Timber Preserve Zoned property.

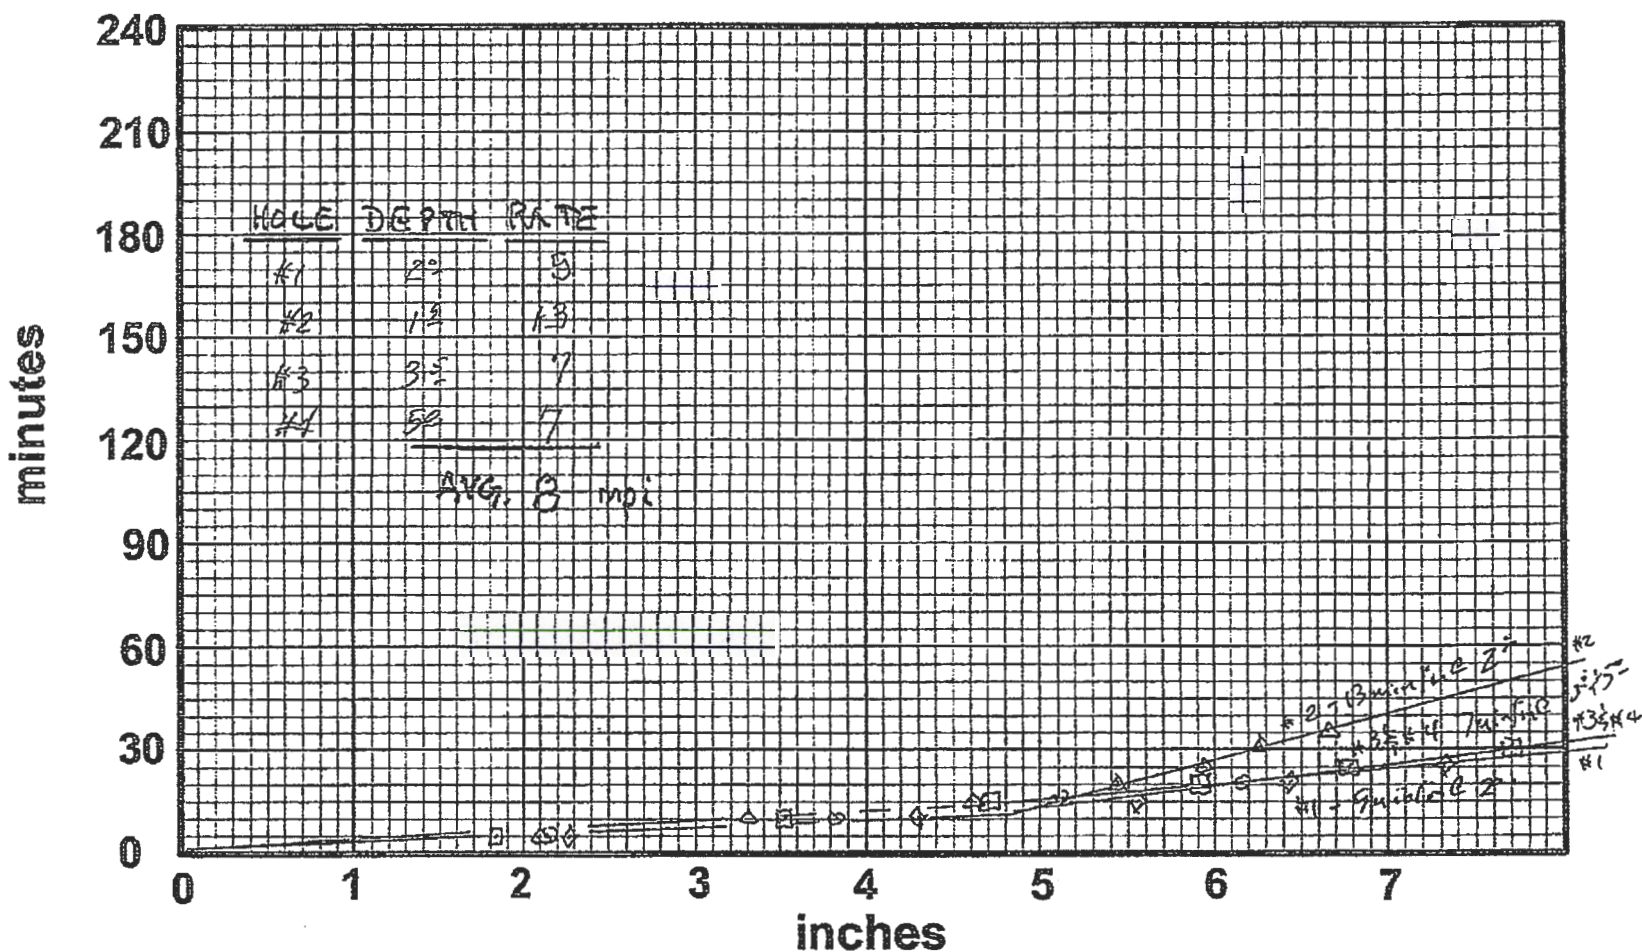
PERCOLATION TEST DATA PLOT

AVERAGE PERCOLATION RATE 8 minutes / inch

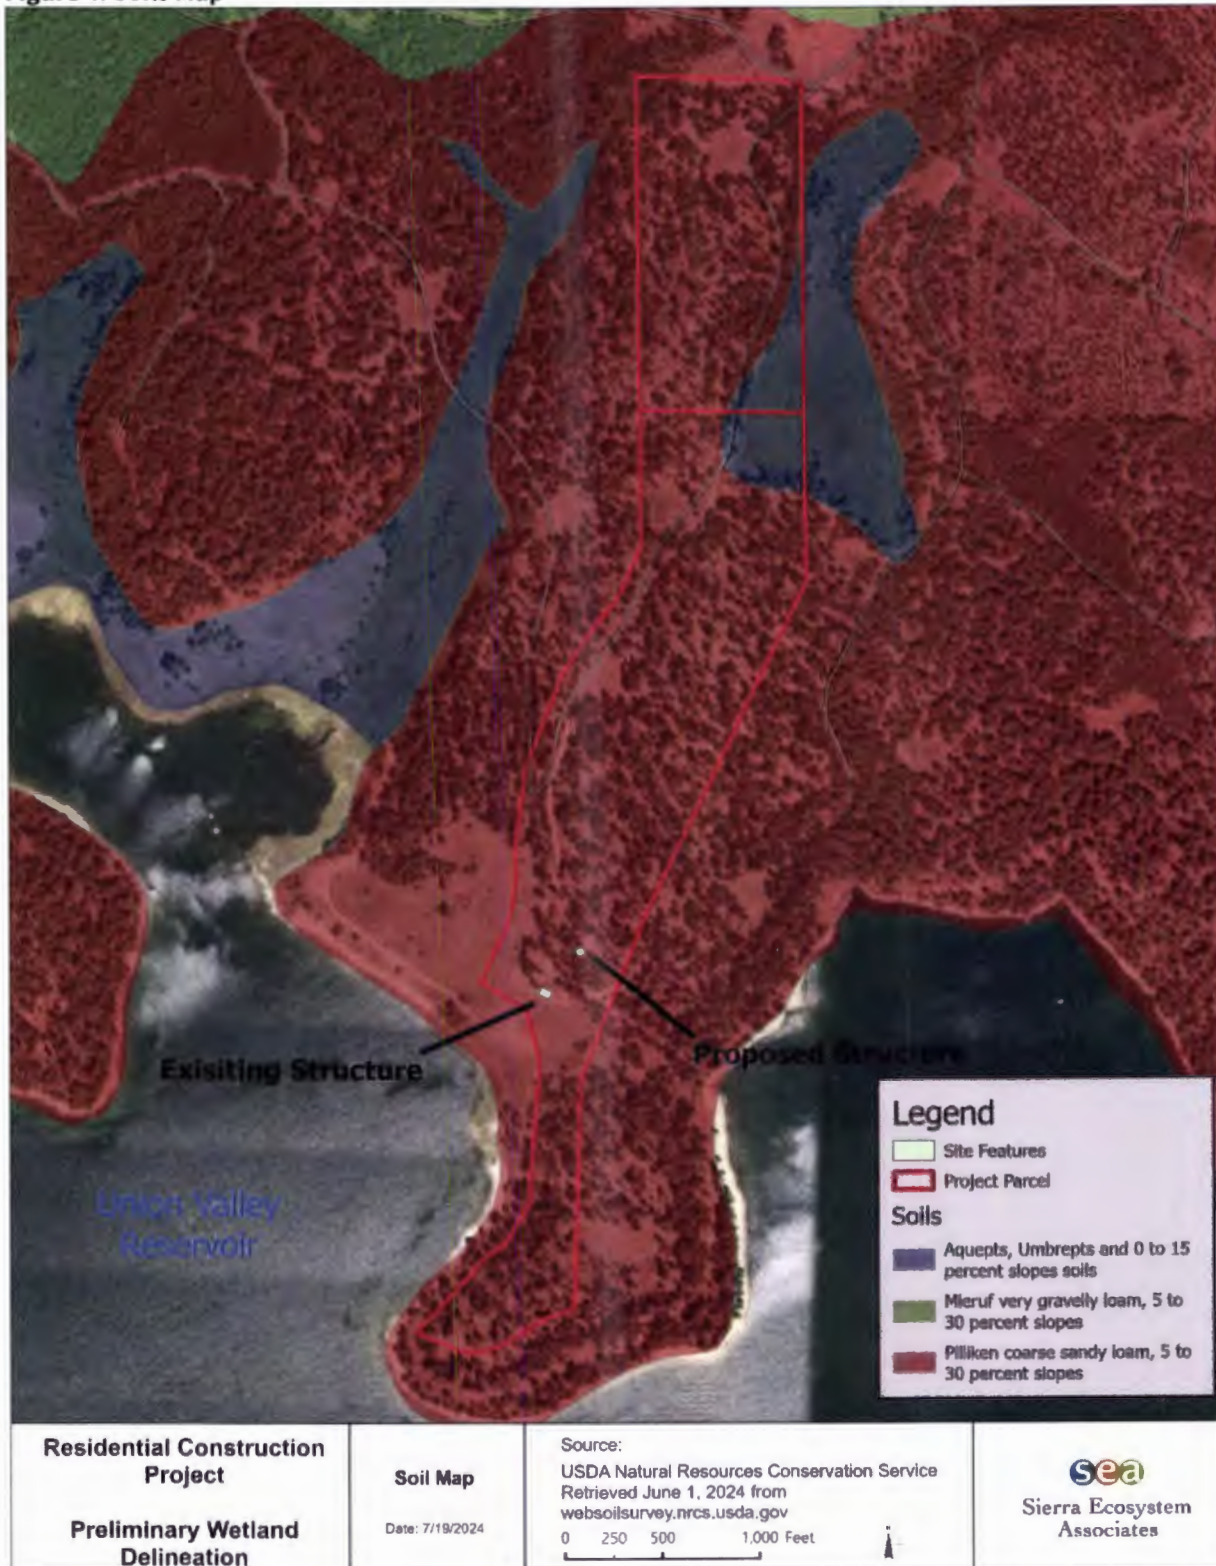
Figure 4. Soils Map

The Project is in the USDA Land Resource Region (LRR) 22A, Sierra Nevada Mountains, which is characterized by hilly to steep mountain relief and occasional mountain valleys.
