SACRAMENTO-PLACERVILLE TRANSPORTATION CORRIDOR NATURE TRAIL IMPLEMENTATION PLAN

CULTURAL RESOURCES INVENTORY AND EVALUATION

IRON POINT ROAD (MP 116) TO LATROBE ROAD (MP 126.2) SACRAMENTO AND EL DORADO COUNTIES, CALIFORNIA

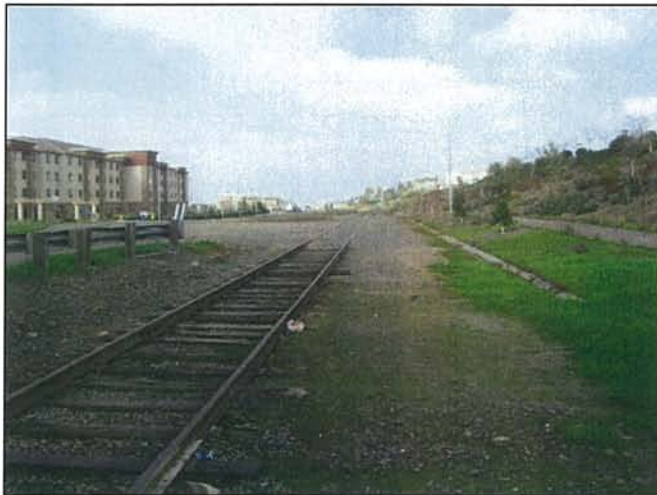
Photo at mile post 116 from US HWY 50 undercrossing.
Facing N. Frame 3298

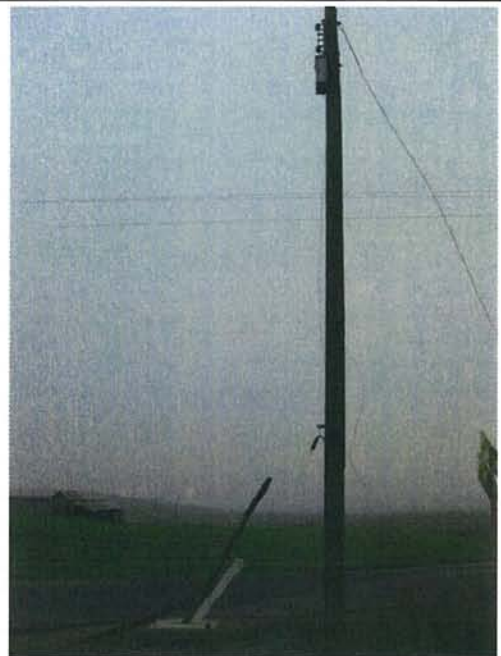
Feature 18: This feature is a concrete foundation and distribution pole for an electrical signal. Facing SW. Frame 3325

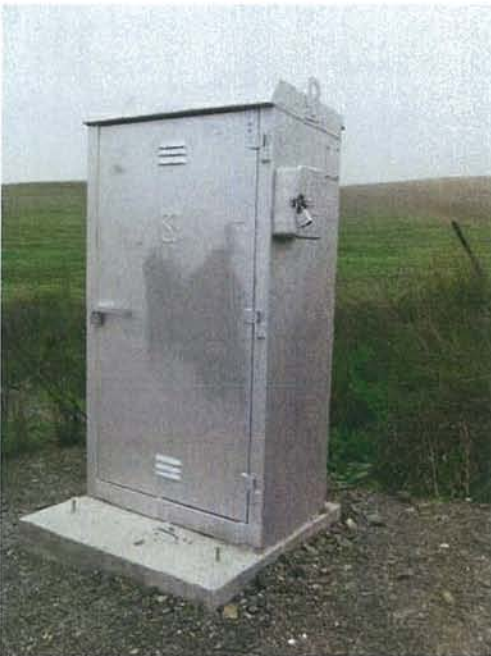
Feature 19: This feature is a box containing electrical signal reader. Facing N. Frame 3326.

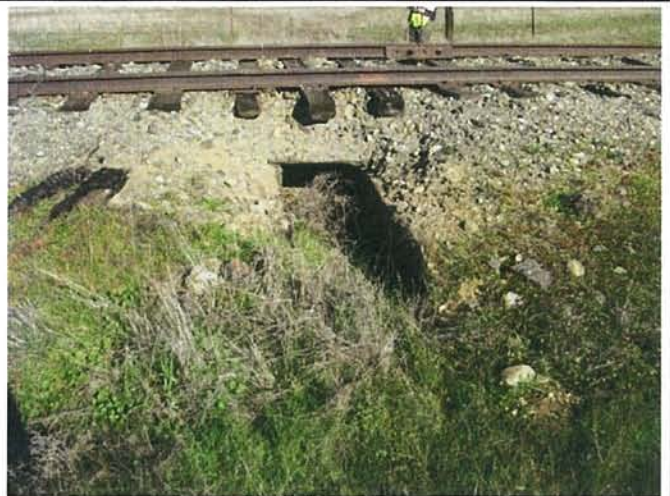
Feature 86: This feature is a burnt out wooden culvert. Facing ENE. Frame 3494.

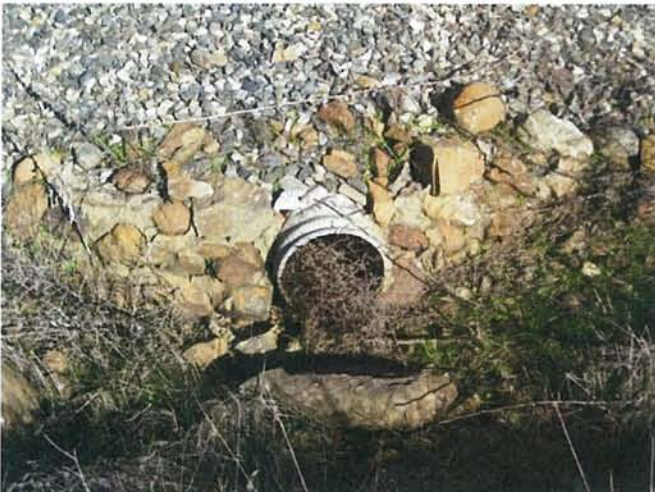
Feature 87: This feature is fieldstone and loose mortar around a corrugated metal culvert. Facing ENE. Frame 3495.

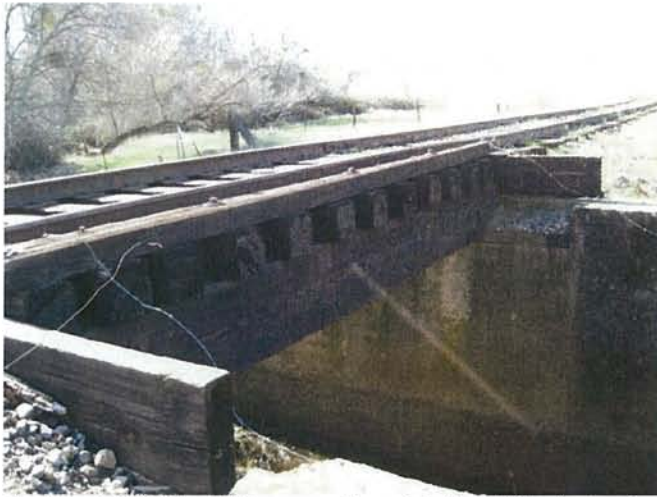
Feature 88: Bridge #07 unnamed creek bridge. This feature is an open deck timber stringer span bridge without walkways on reinforced poured concrete abutments, built in 1904. Track ties of 7 inches x 9 inches x 8 feet rest directly atop the stringers and support in turn tie plates and the two running rails. The track is of conventional bolted rail construction. It is 8 feet wide and 15.5 feet long. Photo facing SSW. Frame 3463.

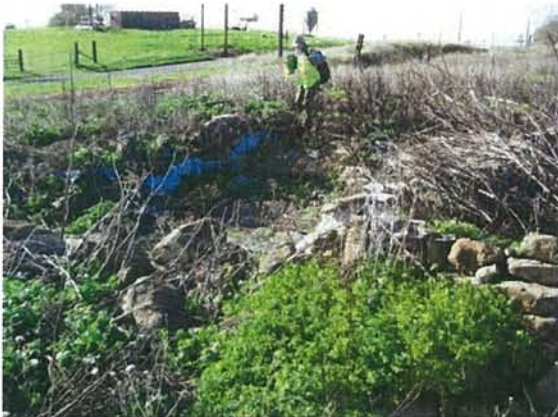
Locus A is in overall poor condition. Impacts include movement of original material, general dereliction, modern dumping events (rock piles), overgrowth of vegetation, and modern trash.

Manmade pool . Photo facing W. Frame 3342.

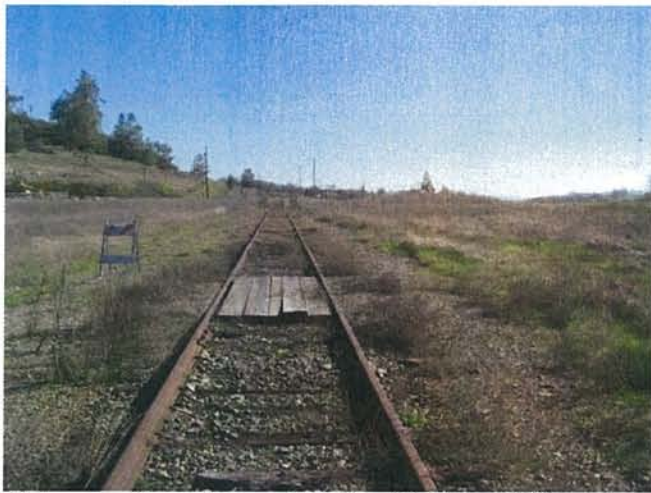
The only other evidence that may have been associated with the station is a siding bed along the north side of the tracks, and 180 feet northwest of the mound, there is a pile of corrugated and uncorrugated rusted sheet metal and hogwire. The locus is in poor condition.

Modern derailer and mound. Facing SE. Frame 3403.

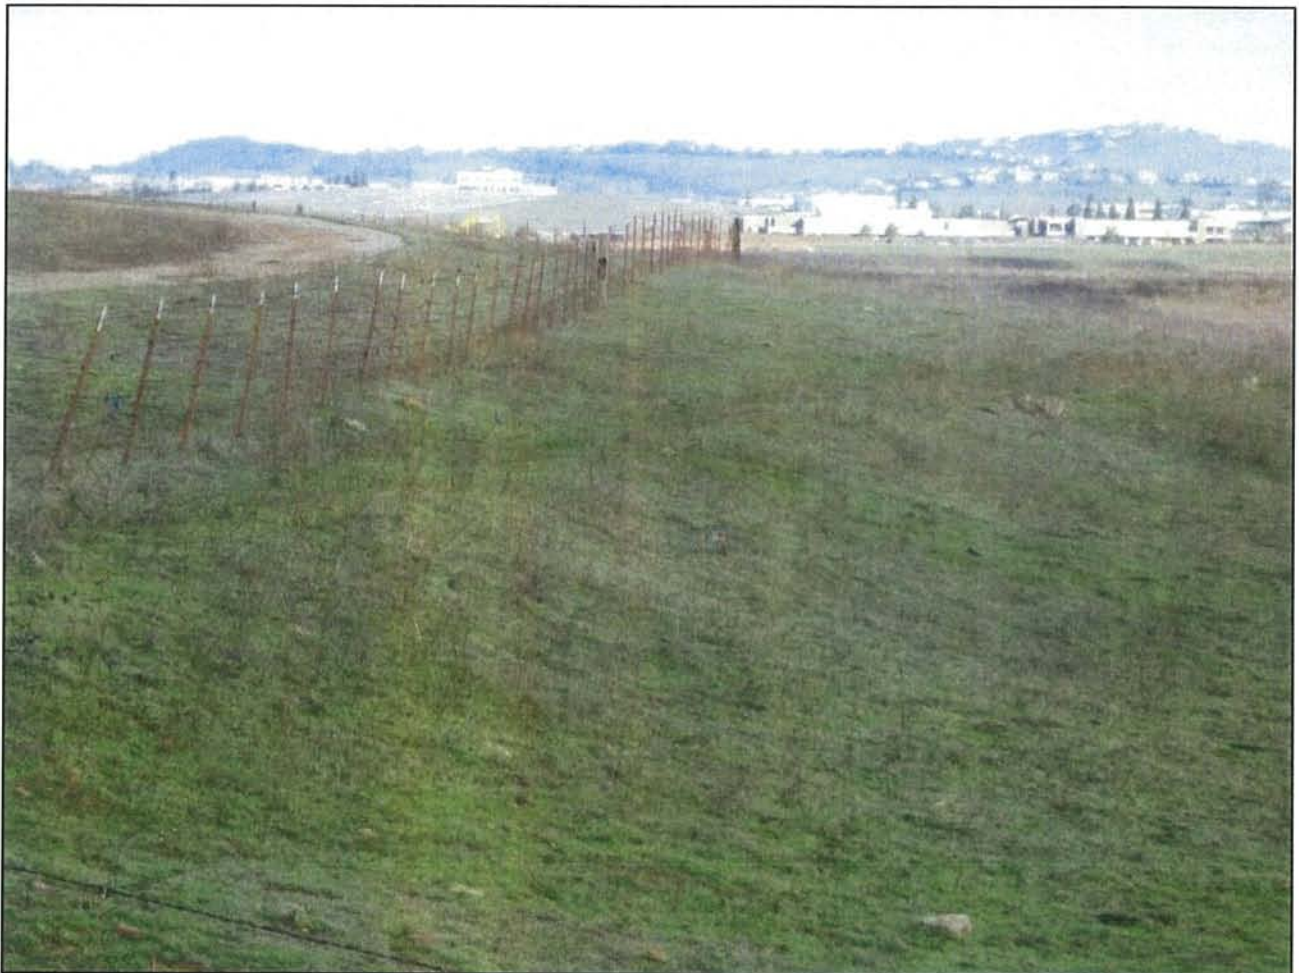
This resource was originally recorded in 1995 as two earthen ditches, CC-LF-1 and CC-LF-3, most likely associated with placer mining circa 1852 to 1864. This continuation is an update for the segment of CC-LF-1 located in our survey corridor: approximately 25 feet of its southern terminus. CC-LF-3 was not relocated; either it has been completely eroded or washed out, or it was incorrectly plotted on the original record. This record does not include an update for the entirety of both ditches as they were recorded in 1995. CC-LF-1 appears to be in the same condition and location as it was in the original record. Aside from the washouts, erosion, and overgrowth, as well as the discontinuity of the ditch due to the construction of the railroad in 1864, CC-LF-1 appears to be in good condition.

Southern terminus of CC-LF-1 (earthen ditch), facing north.
