## **Aquatic Resources Delineation Report**

### **Green Valley and Bass Lake Road Parcel, Town of Skinners, El Dorado County, California**

September 2023  
J-556-02

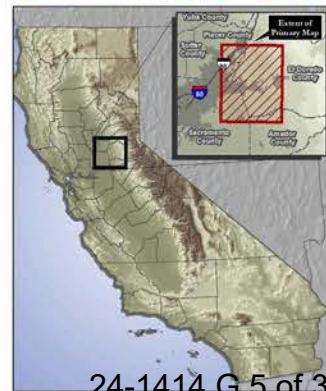
Data Sources: USGS, various | GAP, 1998 | DWR, 2001  
SFEI, 2016 | USHUD, 2018 | ESRI/DigitalGlobe, 2021  
GIS/Cartography by: C. Jasper, K. Chinn, Sep. 2022  
Map File: Vicinity\_556\_02\_B-P\_2023-0915.mxd

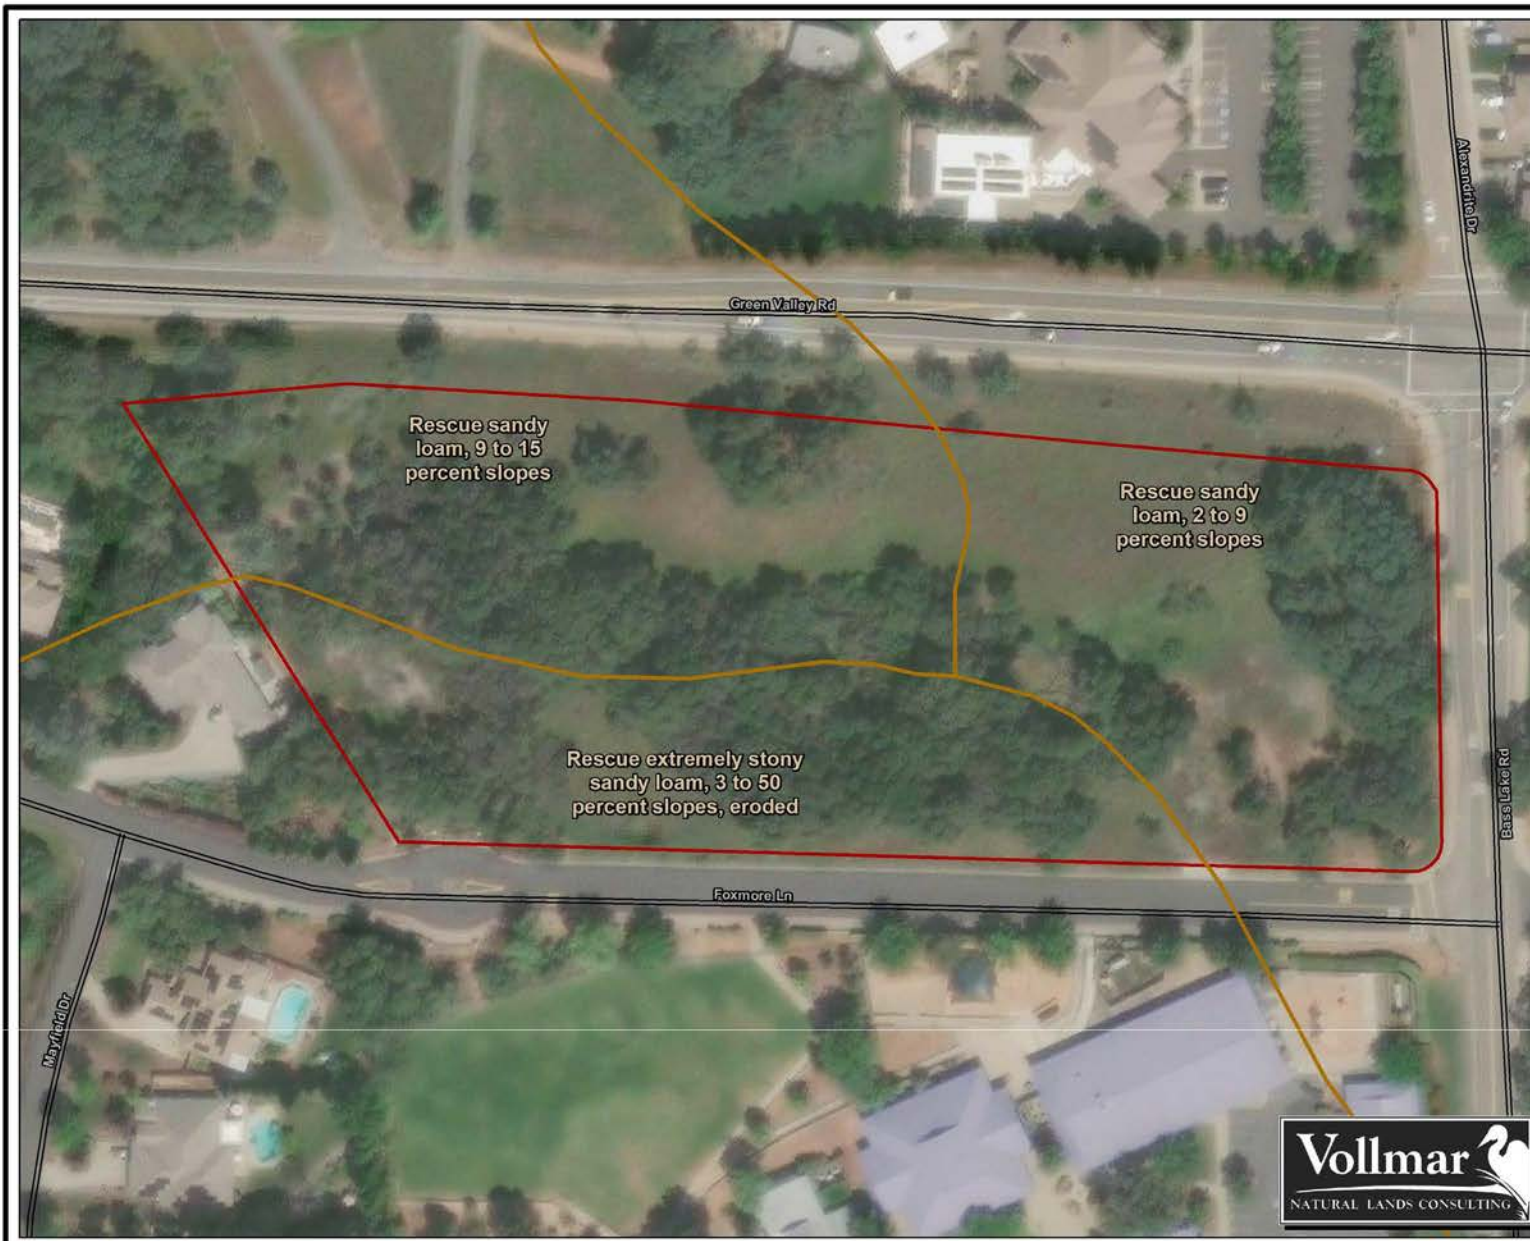
### FIGURE 3 Soil Units Map

Three soil units occur within the Study Area: Rescue sandy loam, 2-9% slopes; Rescue sandy loam, 9-15% slopes; and Rescue extremely stony sandy loam, 3-50% slopes are mapped within the Study Area (**Figure 3**). Rescue sandy loam soils occur on gently sloping to very steep slopes at elevations of 800 to 2,000 feet. (USDA 2023). As indicated in **Table 2**, none of the three soil units are classified as “hydric”, which is consistent with soil texture, slope, dominant vegetation cover, and present water resources.

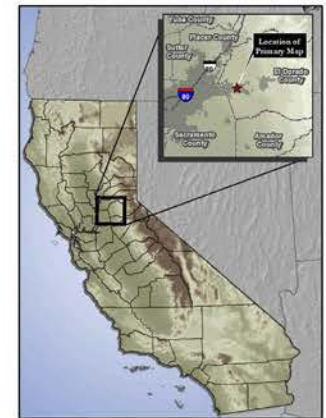
**Legend**

- Local Road
- Study Area
- Soil Unit Boundary

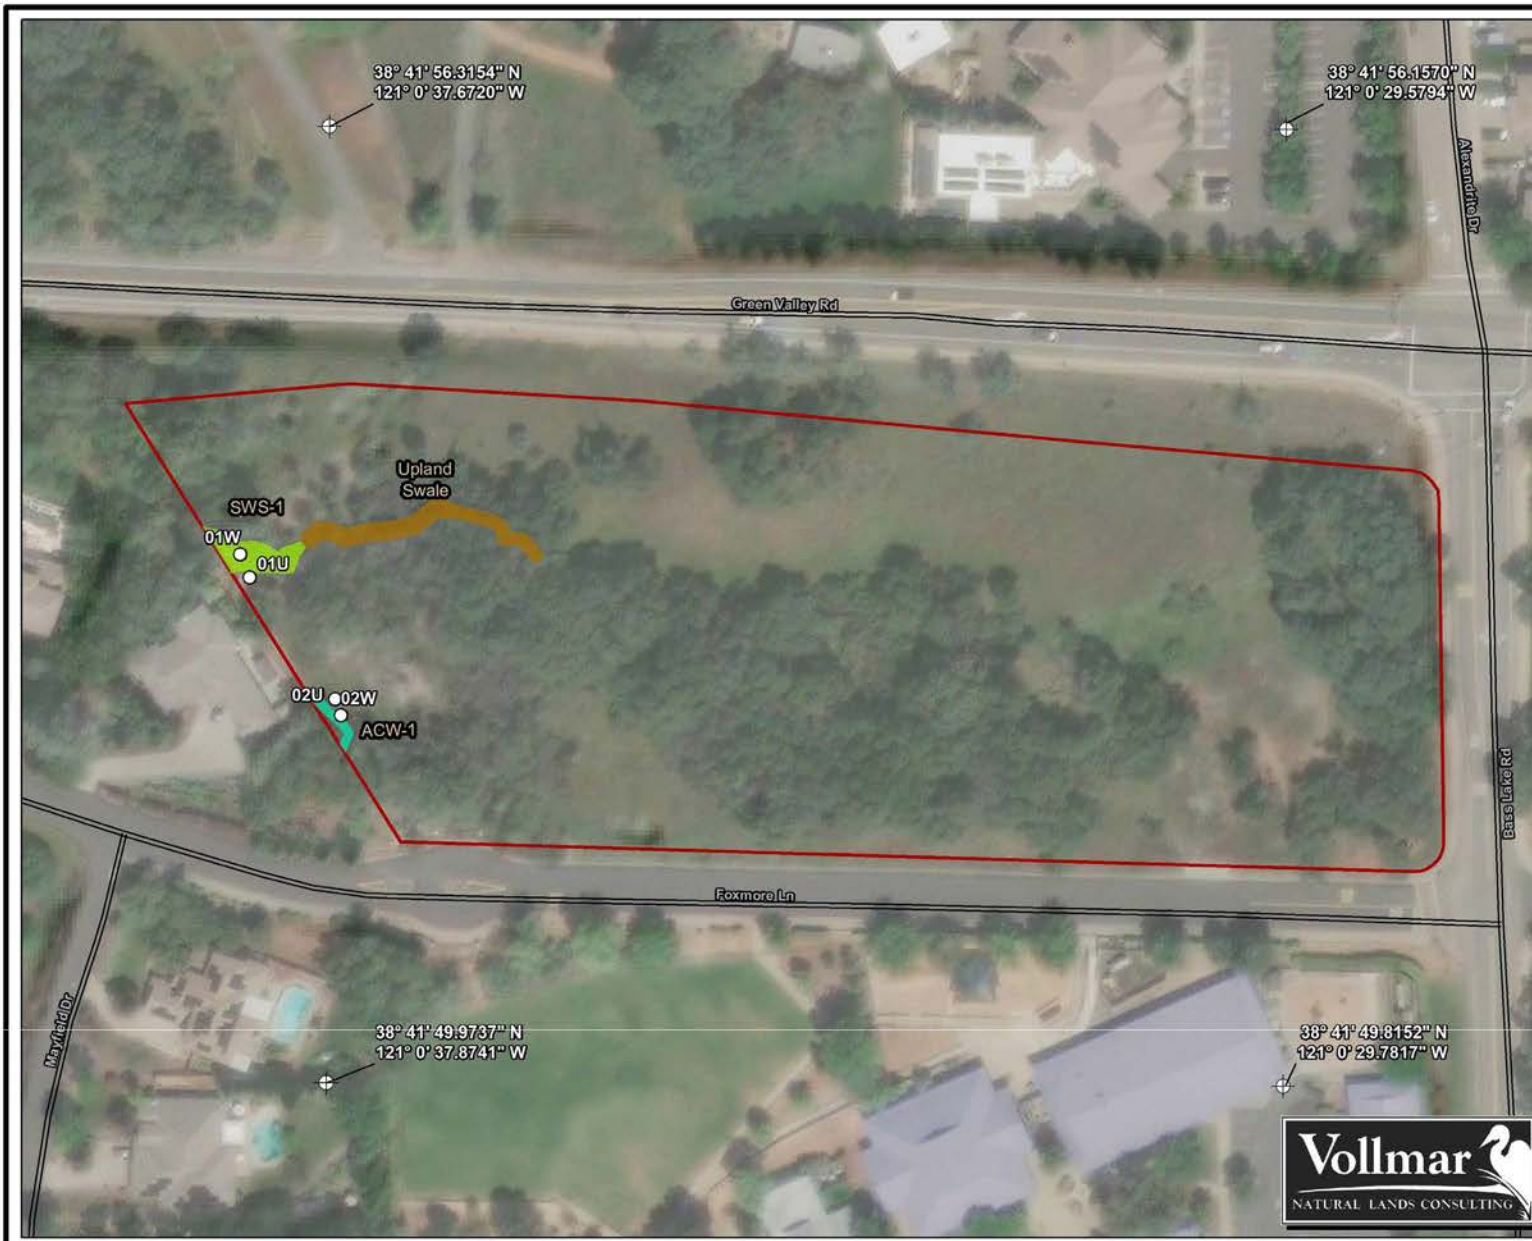
**FIGURE A-1**  
**Aquatic Resource**  
**Delineation Map**  
 Green Valley Road Project  
 El Dorado County, California

The wetland may be classified as a seasonal wetland swale. The seasonal wetland swale was dominated by a patch of wetland indicator vegetation and displayed soil indicators and wetland hydrology, including standing water. The seasonal wetland swale connects with an artificial wetland channel along the western edge of the Study Area, which collects and diverts water during significant storm events. The artificial wetland channel is primarily armored with stones but contains intermittent patches of fill soil which support wetland vegetation and soil and hydrologic indicators. The seasonal wetland swale flows via surface flow to Green Valley Creek, a tributary of the South Fork American River, a TNW.

A 0.027-acre seasonal wetland swale is located at the western border of the Study Area. This swale collects water from an upland swale drainage (see **Section 5.2.5**) and was observed to have standing water during the delineation. The seasonal wetland swale was dominated by disturbance-tolerant, nonnative facultative wetland and upland grasses and forbs. Dominant plant species included barnyard grass (*Echinochloa crus-galli*, FACW), bermudagrass (*Cynodon dactylon*, FACU) and sharp leaved fluellin (*Kicxia elatine*, UPL). Soil in the seasonal wetland swale was mapped as Rescue extremely stony sandy loam, 3-50% Slopes, MRLA 18. The seasonal wetland swale featured a shallow (6-inch) layer of soil underlain with large cobbles, consistent with the mapped soil unit. This soil matrix featured hue in the 10YR range with chroma/value of 4/2; 3% redox concentrations with hue in the 7.5YR range and chroma/value of 4/6 were present, satisfying indicator F3: depleted matrix. The swale featured wetland hydrologic indicators of surface water, saturation, and oxidized rhizospheres along living roots.

A 0.007-acre narrow, artificial wetland channel is present in the southwestern portion of the Study Area. This feature collects water from a culvert located offsite, as well as irrigation runoff from the neighboring property. The artificial wetland channel is armored with large cobbles and is mostly unvegetated. Ditch runoff percolates into its surrounding bank and gives rise to wetland indicators, including hydrophytic vegetation, redoximorphic hydric soil features and hydrology indicators. The herb stratum of the channel bank was dominated by tall flatsedge (*Cyperus eragrostis*, FACW), stinkwort (*Dittrichia graveolens*, NL) and barnyard grass (UPL). Soil in the ditch bank was dark with a hue of 10YR and a value/chroma of 4/2; redox features were observed

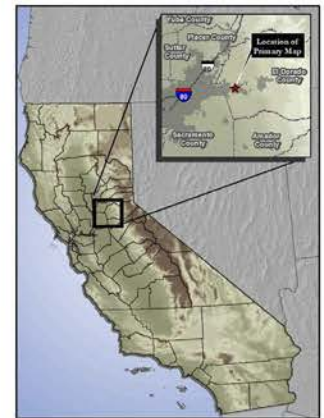
**Legend**

- Location Reference Point
- Delineation Data Point
- Local Road
- Study Area
- Wetland Features**
- Artificial Wetland Channel (0.027 ac.)
- Seasonal Wetland Swale (0.007 ac.)
- Non-Wetland Features**
- Upland Swale (0.049 ac.)

There is a narrow upland swale situated in the central-western portion of the Study Area. This drains to the seasonal wetland swale along the west boundary. The upland swale is a non-wetland feature which was dominated by upland grasses and shrubs found throughout the Study Area and was characterized by slight erosional scour along the channel bed and a poorly defined channel margin. This indicates that the drainage will convey water during storm events but does not collect standing water. It is not treated as an aquatic resource, and is not a potential jurisdictional water.

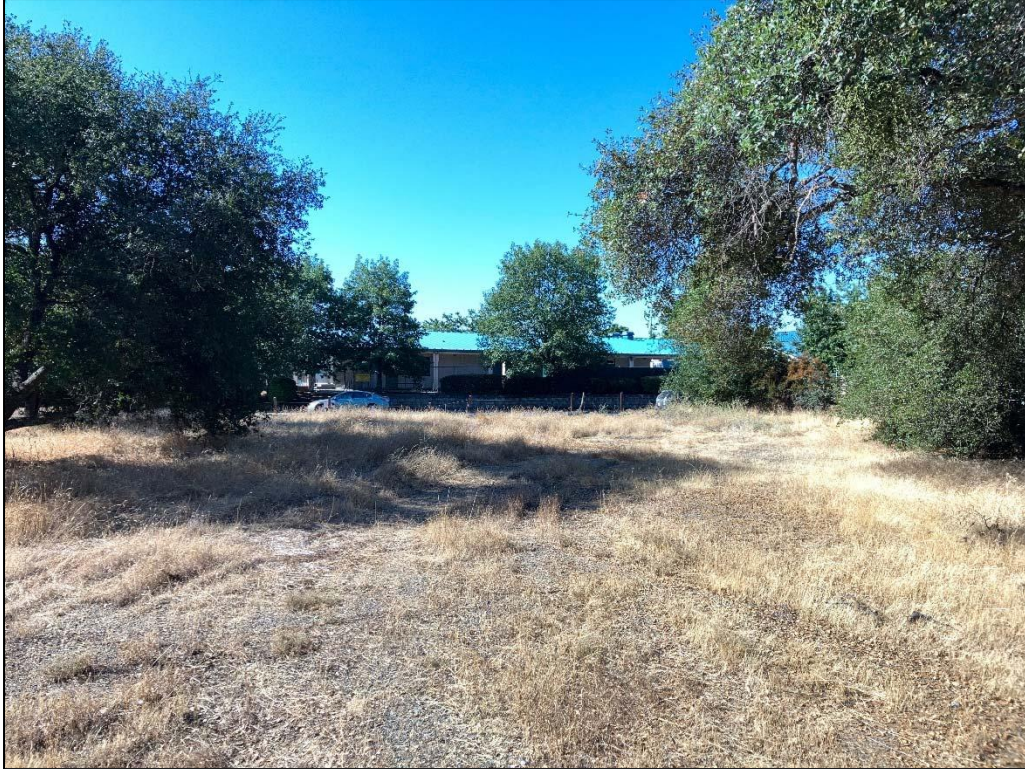
**Photo 1:** Representative upland habitat in Study Area, consisting of annual grassland and mixed oak woodland. (8/8/23)

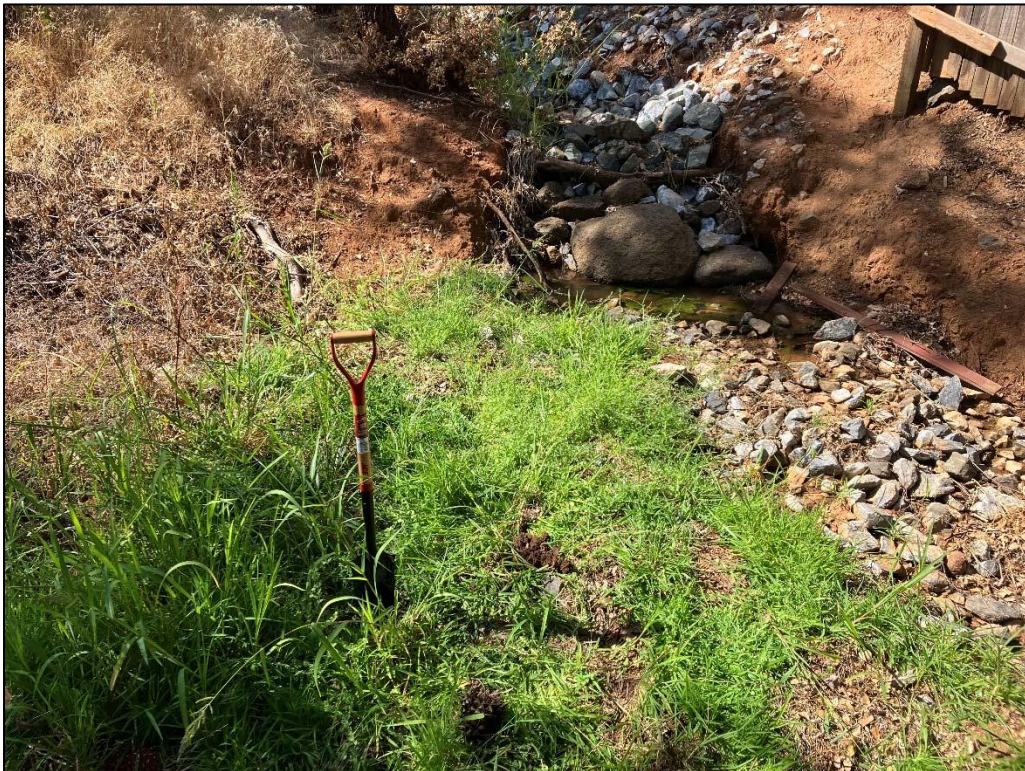
**Photo 2:** Location of delineation data point 01W in Seasonal Wetland Swale. (8/8/23)

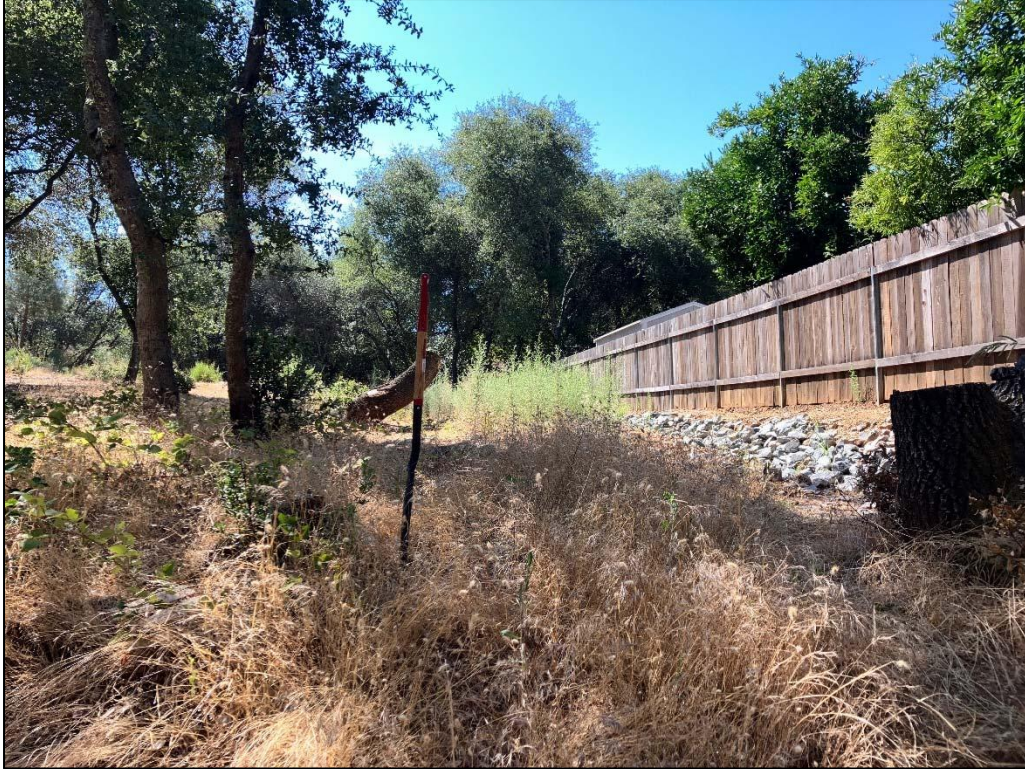
**Photo 3:** Location of delineation data point 01U in upland adjacent to Seasonal Wetland Swale. (8/8/23)

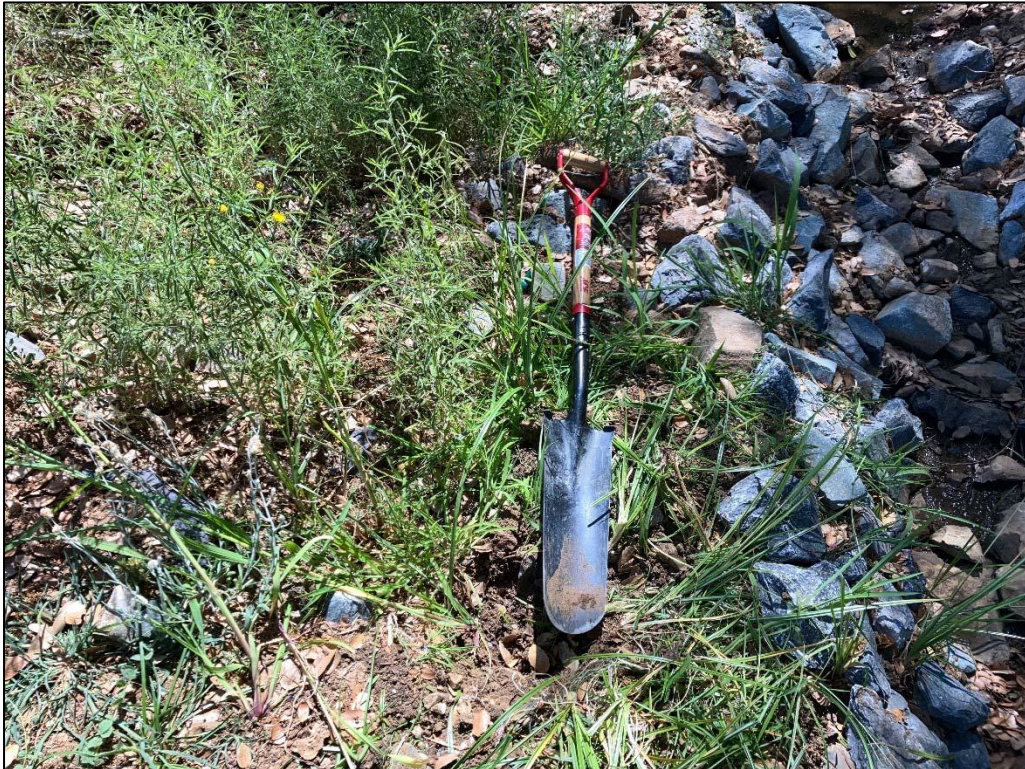
**Photo 4:** Location of delineation data point 02W in Artificial Wetland Channel. (8/8/23)

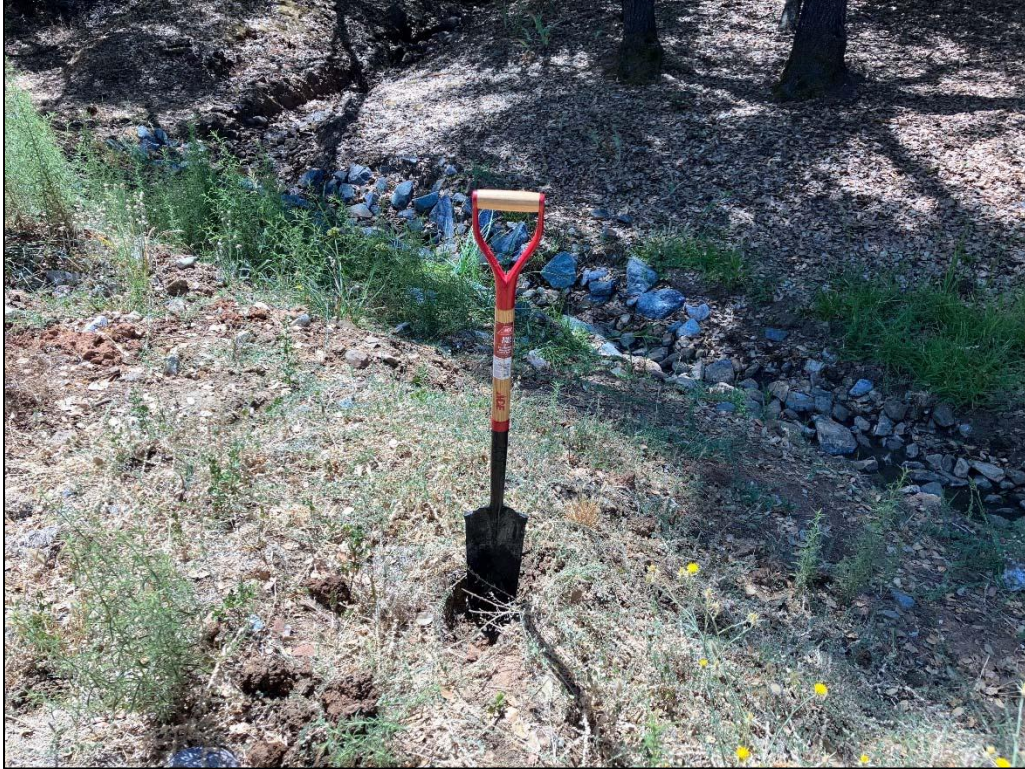
**Photo 5:** Location of upland delineation data point 02U upslope of Artificial Wetland Channel. (8/8/23)

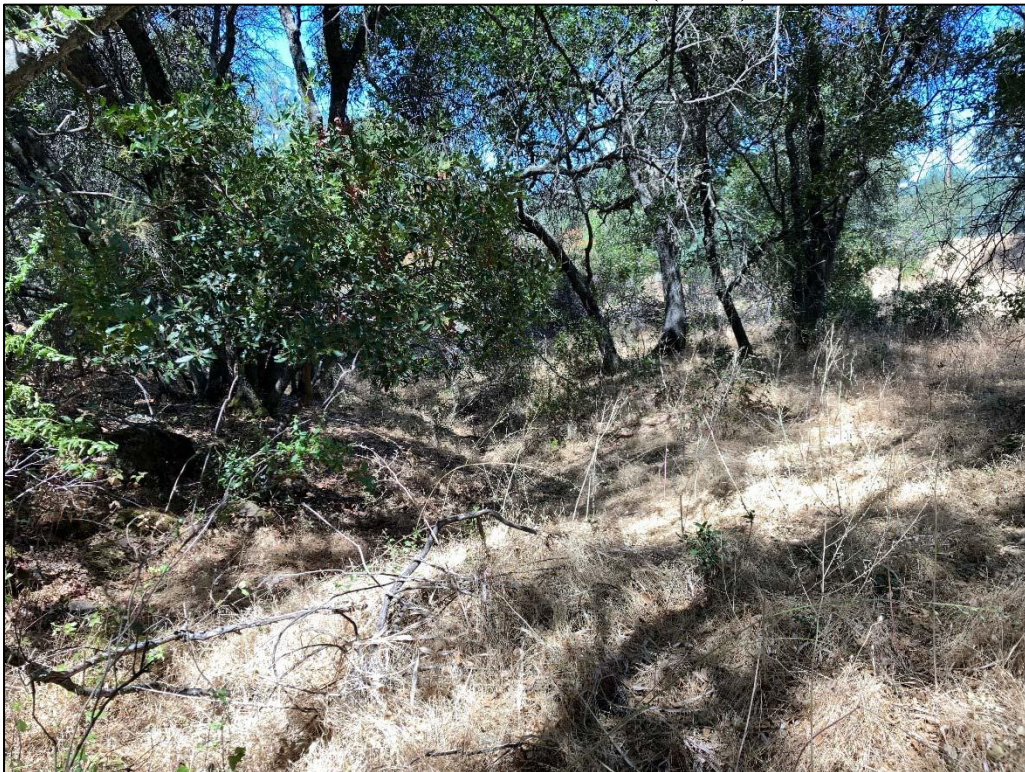
A narrow, upland swale measuring 0.049 acre or 180 feet long, passes through the central-western portion of the Study Area and drains into the Seasonal Wetland Swale described above (**Section 4.2.4**). The vegetation in the herb stratum of this feature supported upland and facultative grasses and forbs common throughout the Study Area, including wild oat species (*Avena* spp., UPL), hairy vetch (*Vicia villosa*, NL), wall barley (*Hordeum murinum*, FACU) and Italian ryegrass (*Lolium multiflorum*, FAC). The shrub stratum included patches of Himalayan blackberry (*Rubus armeniacus*, FAC) and coyote brush (NL). The tree stratum of this feature included valley oak (*Quercus lobata*, FACU), blue oak (*Quercus douglasii*, NL), interior live oak (*Quercus wislizeni*, NL), and gray pine (*Pinus sabiniana*, NL). The feature did not possess indicators of hydric soils or wetland hydrology. The swale likely collects and diverts water during significant storm events but is unlikely to hold water for a considerable time period, if at all. This feature is not treated as an aquatic resource, and is not a potential jurisdictional water.

**Photo 6:** Upland swale in Mixed Oak Woodland vegetation community.
