Subject: Oak Resources Technical Report for the ±4.34-acre Creekside Plaza Project Site, El Dorado County, CA

PD-R21-0002/CUP21-0004/P-E25-0001 CREEKSIDE PLAZA ARCO EXHIBIT P - OAK RESOURCES TECHNICAL REPORT

PRELIMINARY STORMWATER CONTROL PLAN

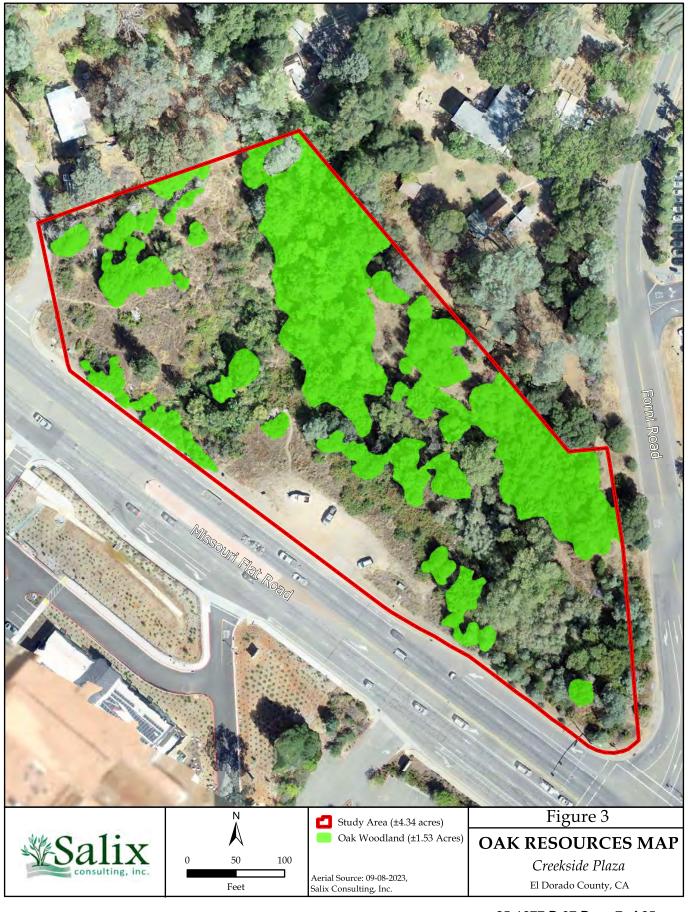
Figure 3 - Existing Oak Woodland

Salix identified a total of ±1.53 acres of oak woodland on site. The oak woodland is embedded within a larger blue oak–foothill pine woodland; however, the foothill pine (*Pinus sabiniana*) was not mapped as part of this analysis. The oak resources are a mix of interior live oak (*Quercus wislizeni*) and blue oak (*Q. douglasii*) and are contiguous with the foothill pines (Figure 3). A few valley oaks (*Quercus lobata*) are present along the riparian corridor that runs through the center of the site. The woodland is dense, and shrubs such as coyote brush (*Baccharis pilularis*) and buck brush (*Ceanothus cuneatus*) are common, particularly where the oak canopy is minimal. North of the stream, buckeye (*Aesculus californica*) is common. Open areas are increasingly filling in with oak and shrubs. The riparian component of the site consists of a dense canopy of narrow-leaved willow (*Salix exigua*), red willow (*S. laevigata*), arroyo willow (*S. lasiolepis*), valley oak, and Fremont cottonwood (*Populus fremontii*). Himalayan blackberry (*Rubus armeniacus*) forms dense thickets within and along the riparian habitat. The remainder of the site is ruderal grassland.

No individual native oak trees occurred outside an oak woodland and no Heritage Trees were present to require identification on the Oak Resources Map (Figure 3).

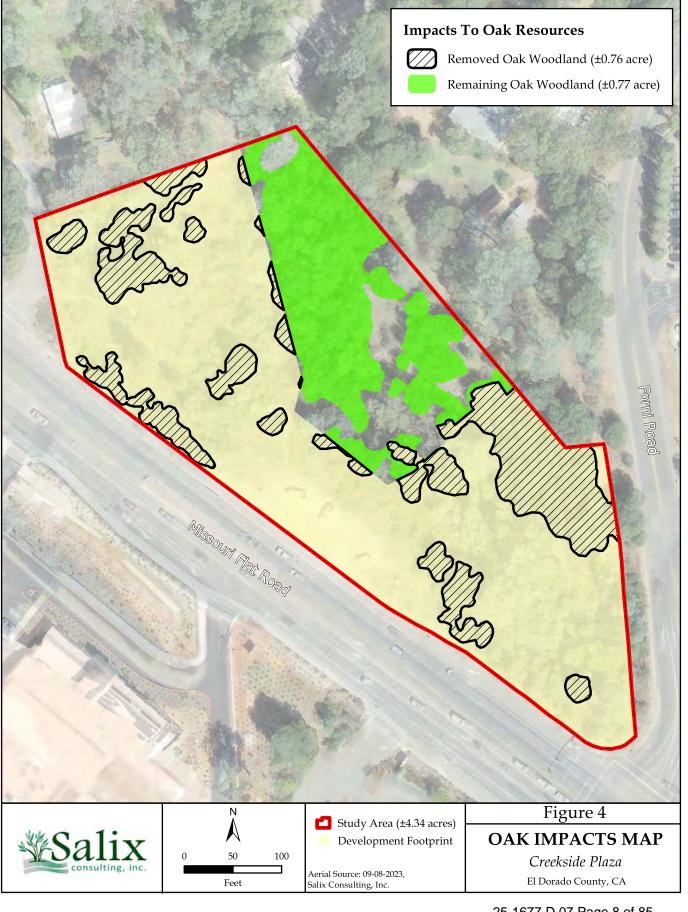
Figure 4 - Proposed Project Impacts to Oak Woodland

planting, and County-approved off-site mitigation. Existing oak woodland onsite totals ± 1.53 acres. The proposed project will impact ± 0.76 acre of oak woodland (49% of the total woodland onsite) and will avoid ± 0.77 acre (Figure 4). The various mitigation options are presented below.

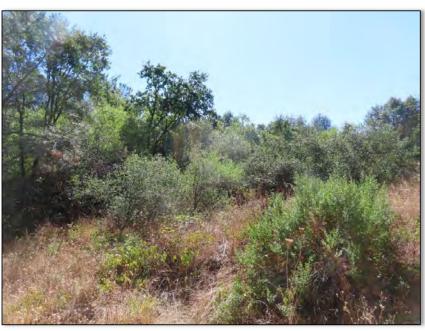
Figure 5a

Looking across interior area of site. *Photo date: September* 12, 2023

Representative ground photos are presented in Figures 5a and 5b and aerials in Figure 5c.

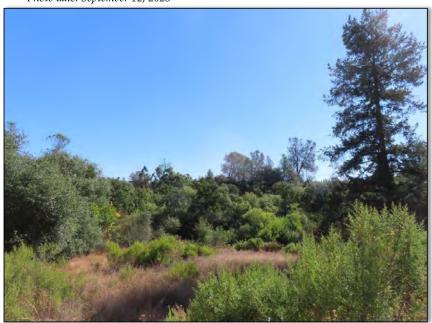
Looking east over western area of site. *Photo date September* 12, 2023

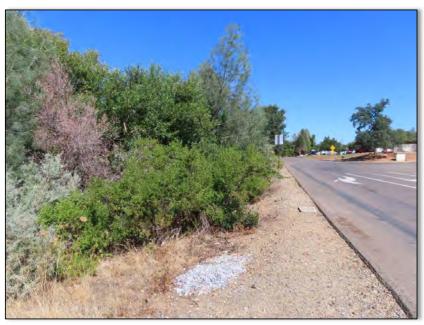
Figure 5b

Looking north along Forni Road frontage. *Photo date: September 12, 2023*

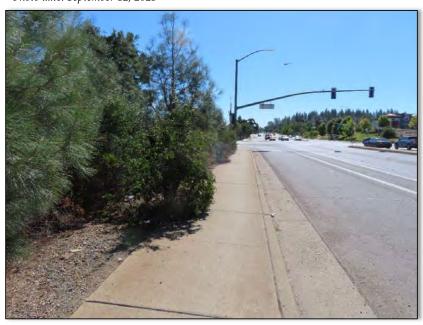
Looking southeast along Missouri Flat Road frontage. *Photo date September* 12, 2023

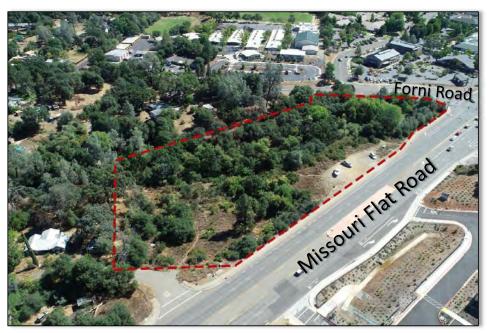
Figure 5c

Looking east over the Study Area with the approximate boundary of the Study Area. *Photo date: September 8, 2023*

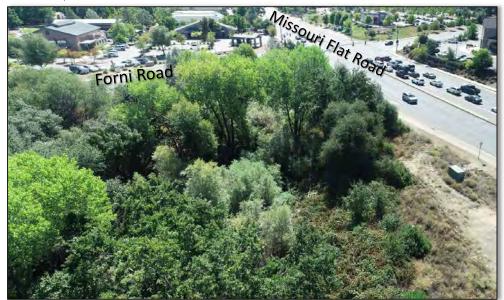
Looking southeast towards the intersection of Missouri Flat Road and Forni Road. *Photo date September 8, 2023*

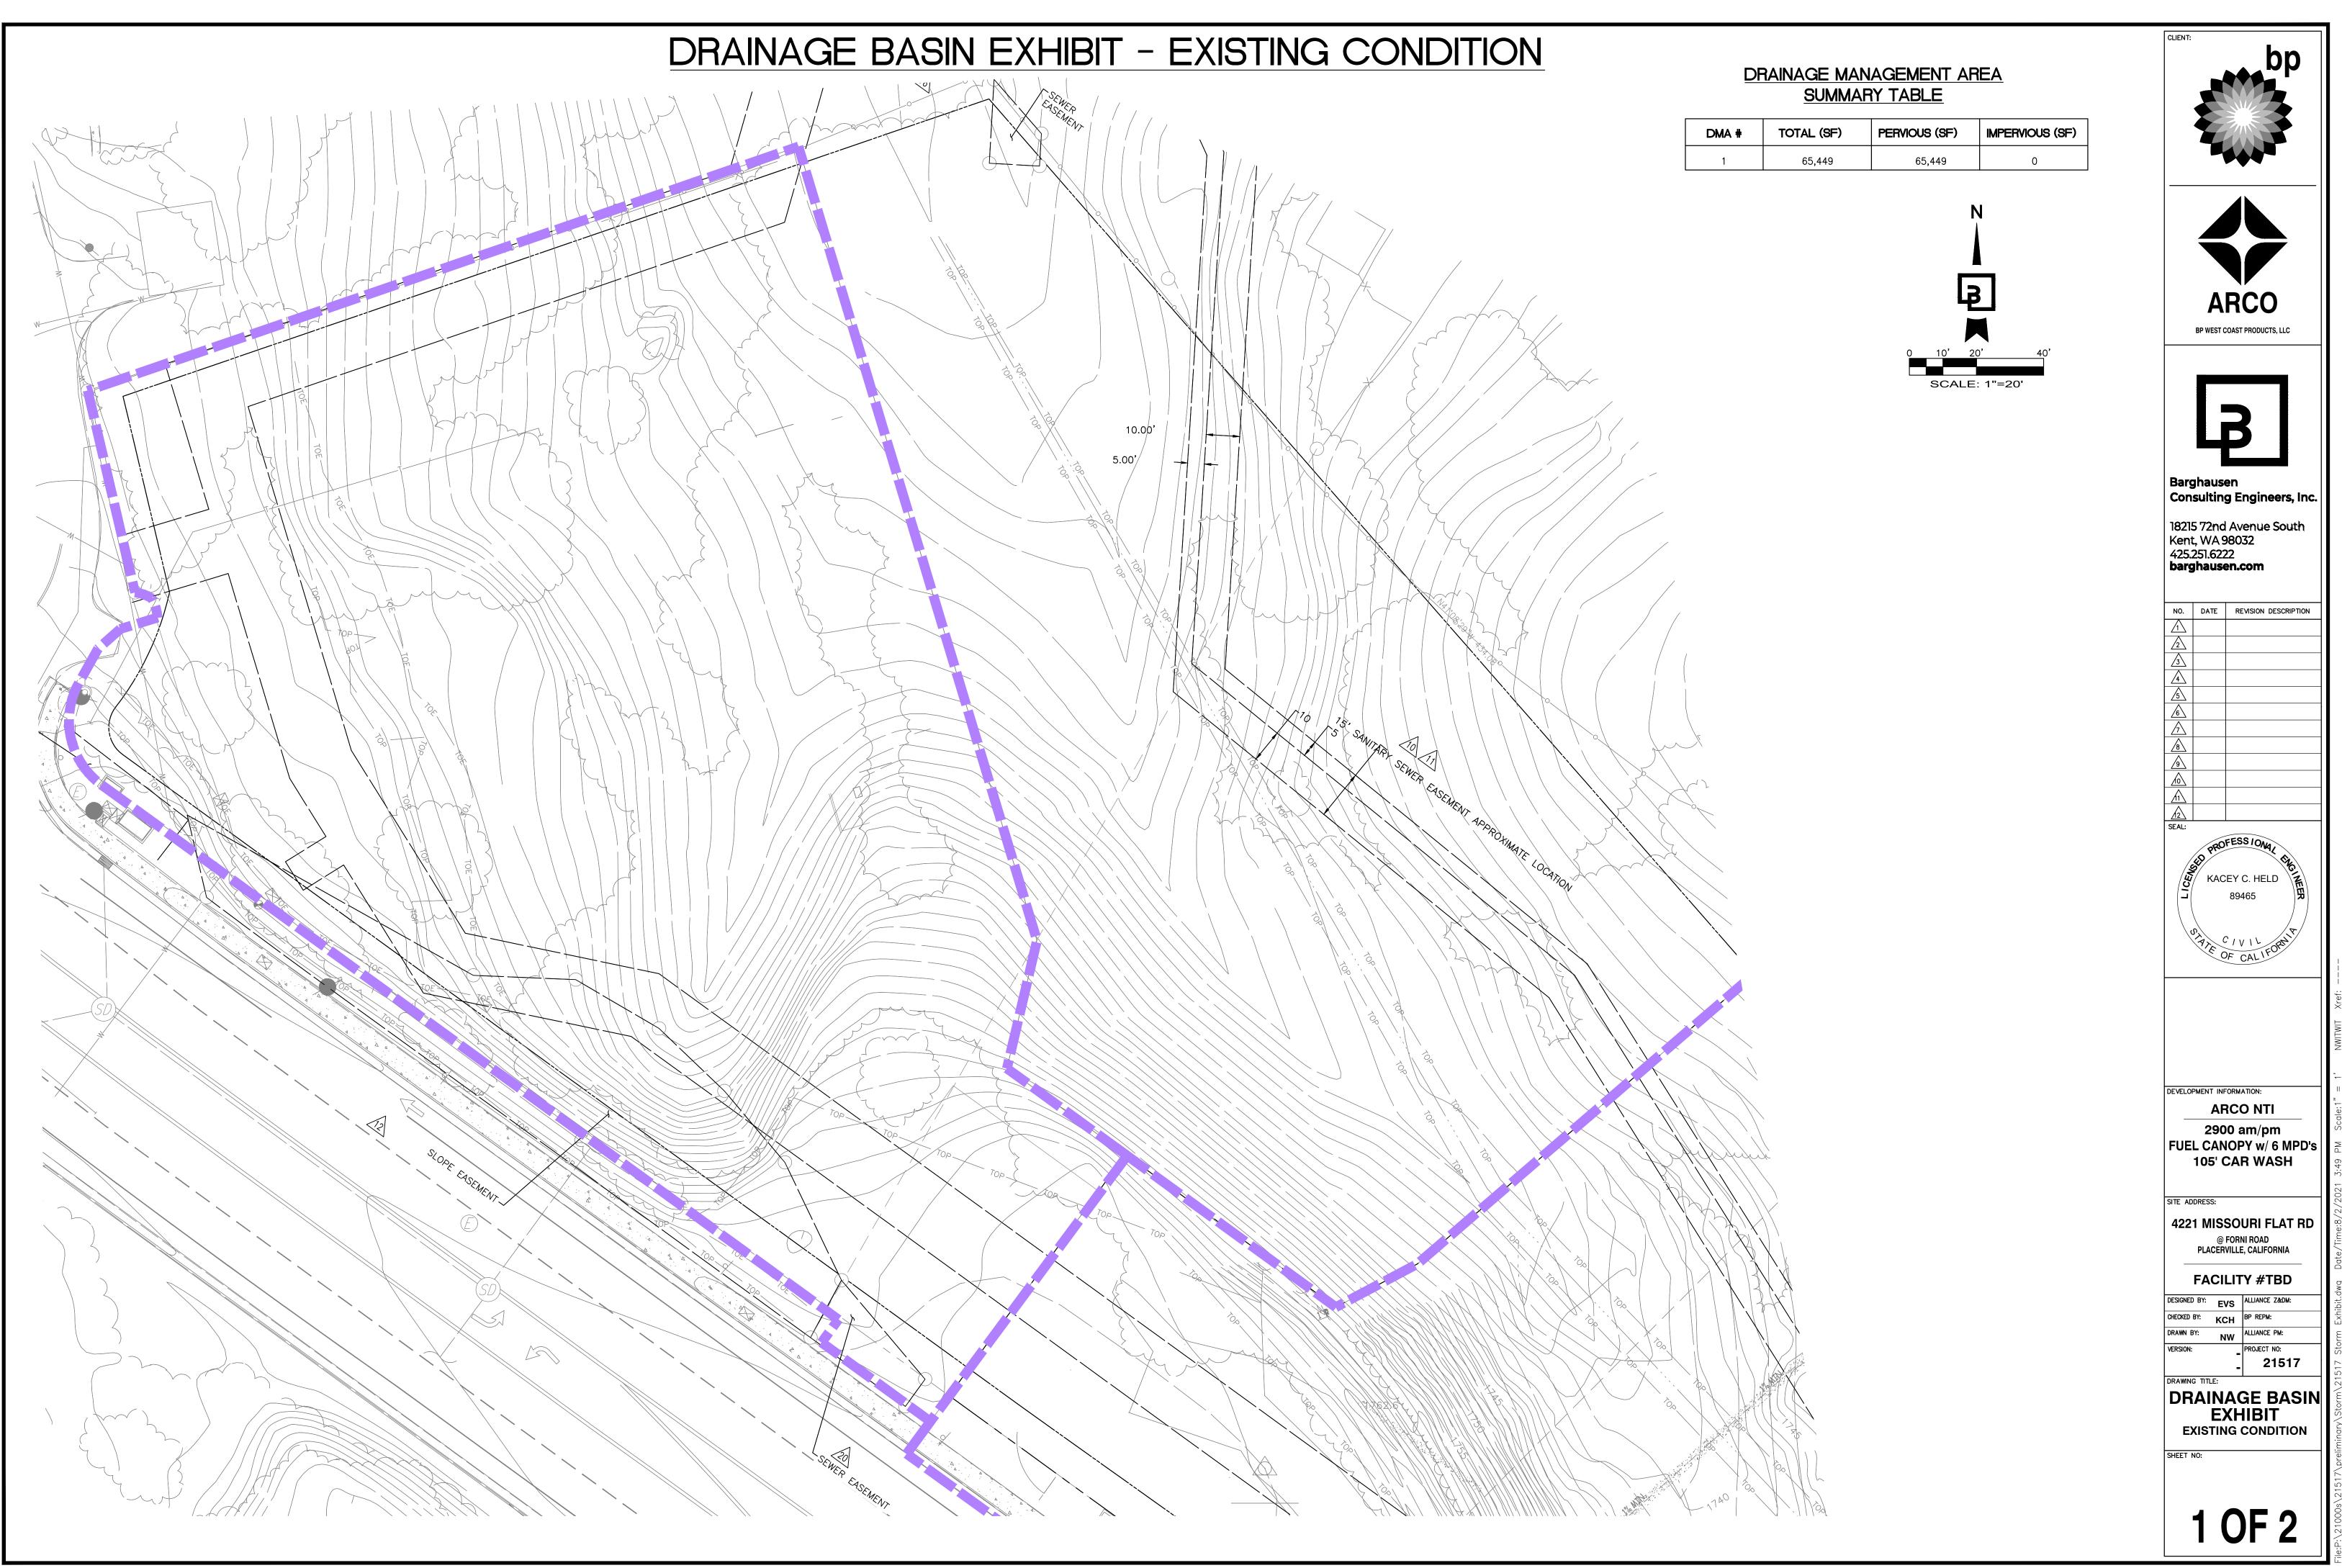
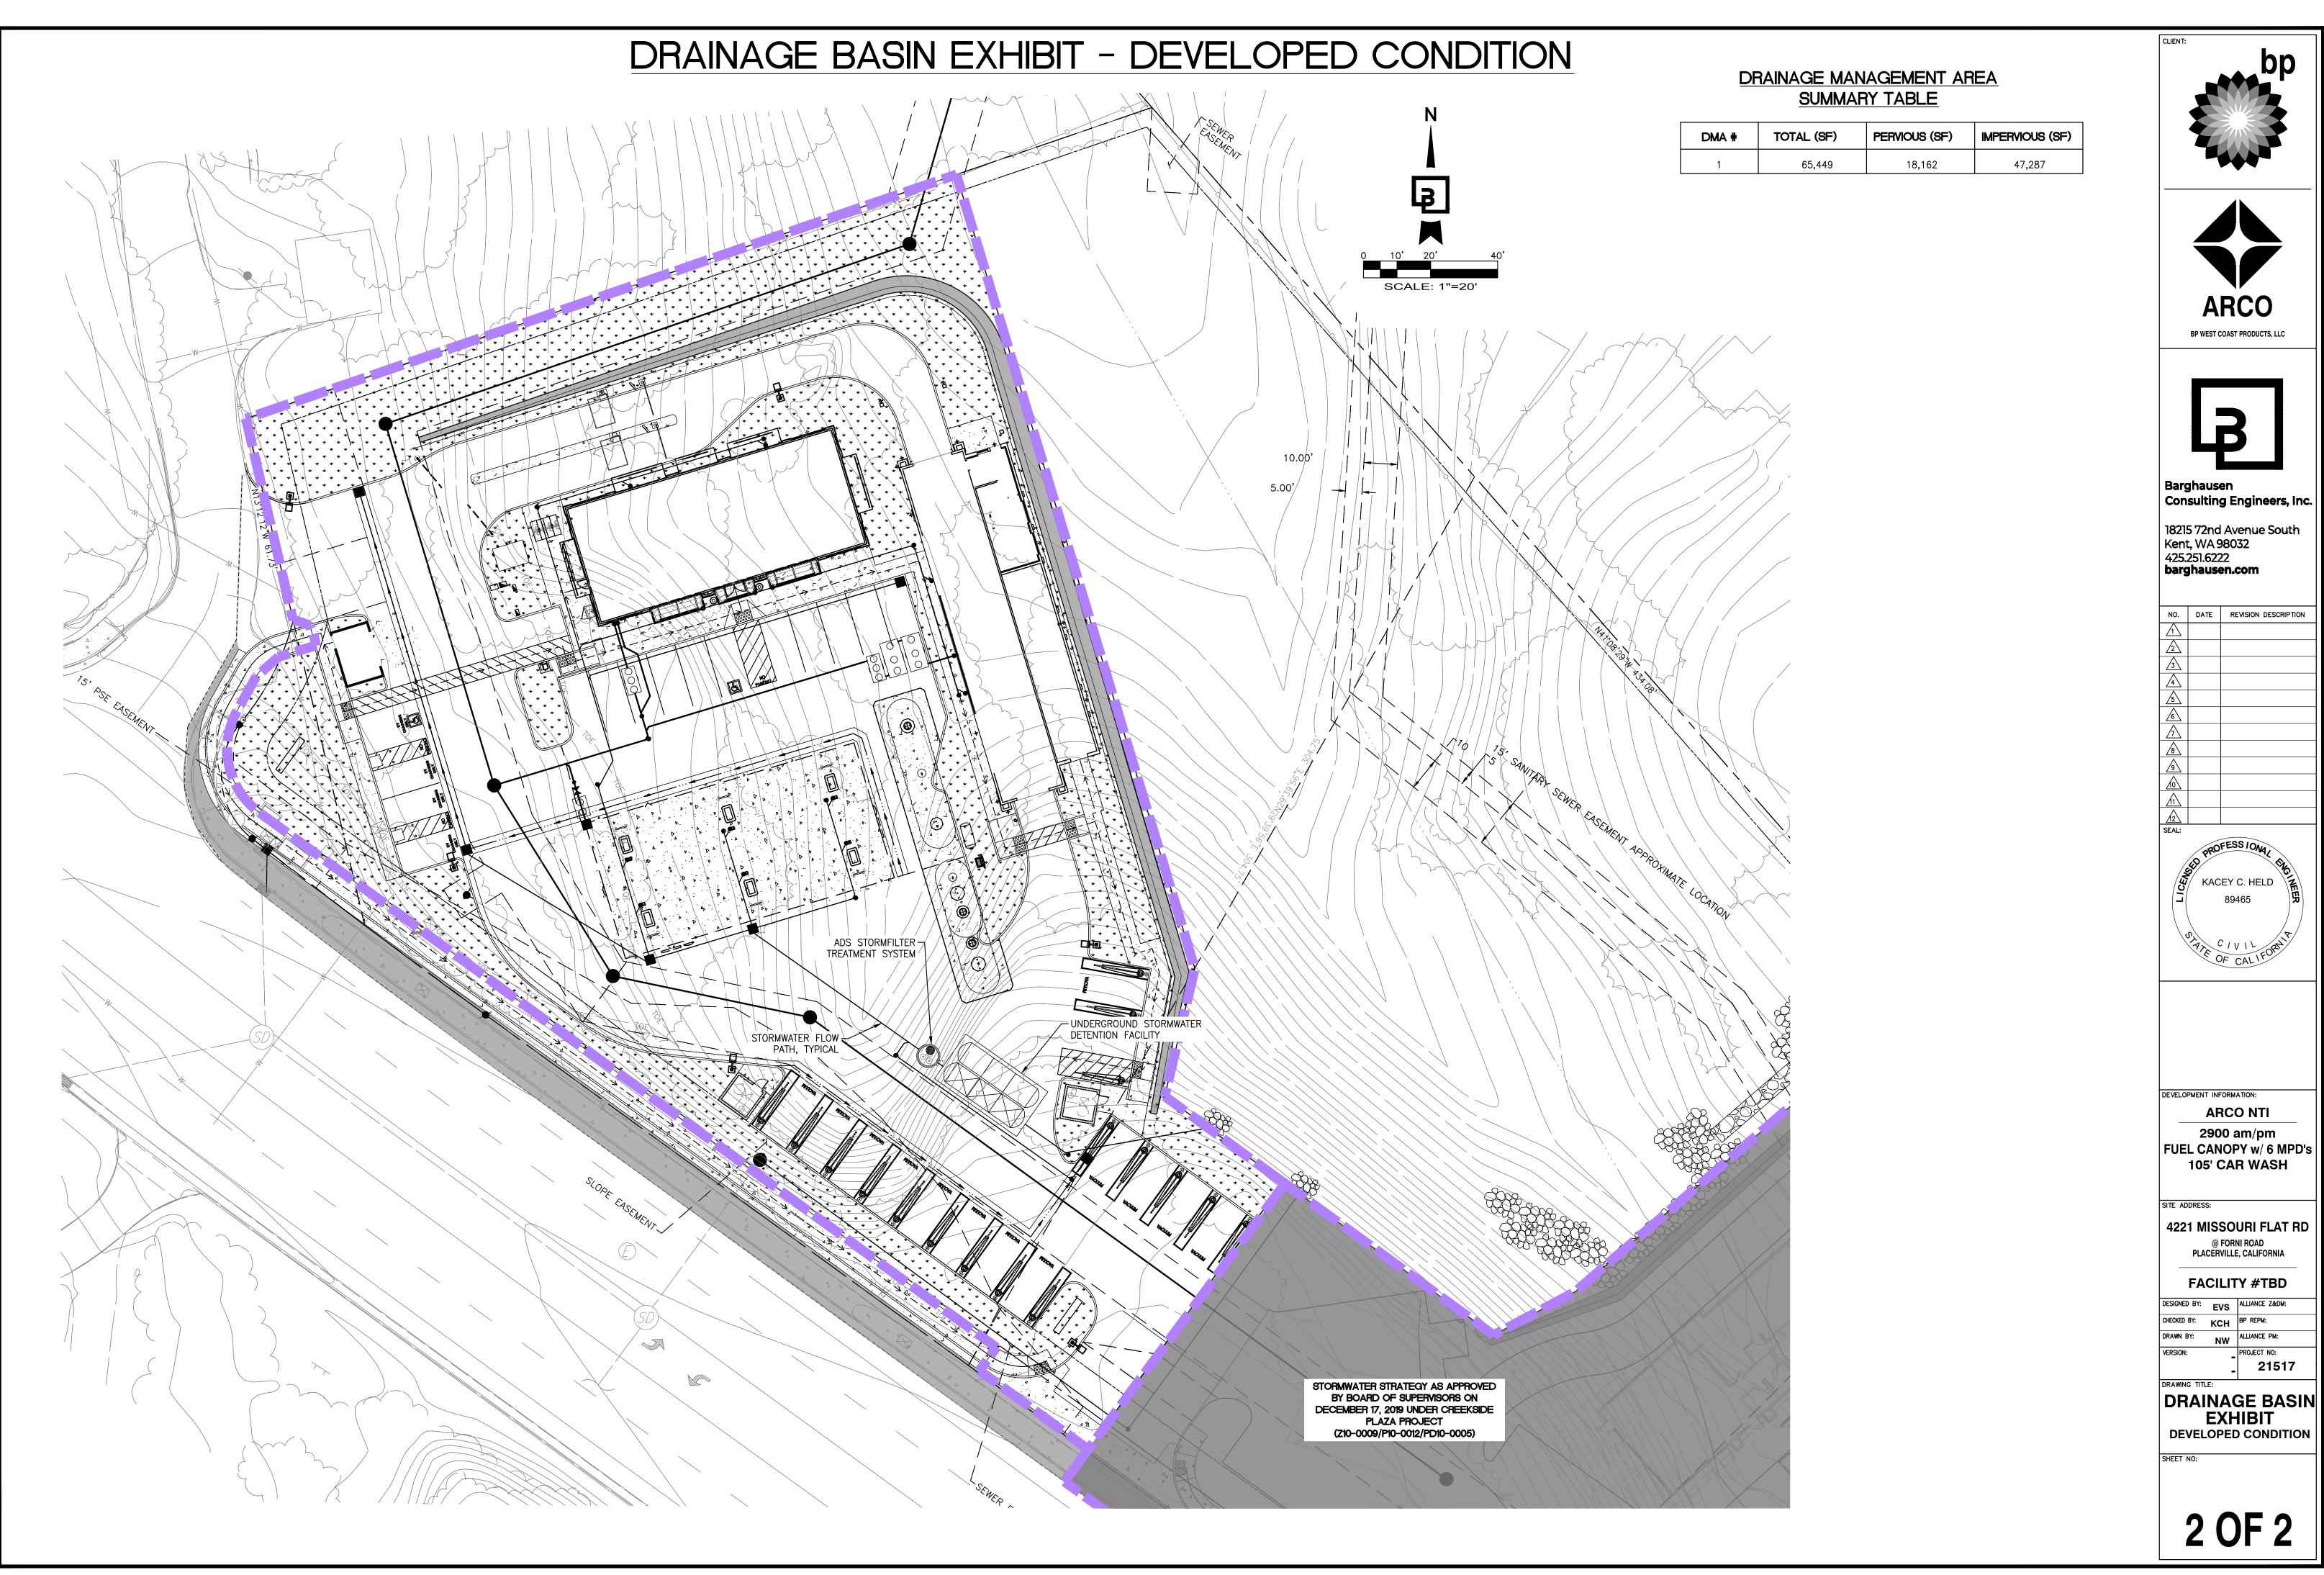
Appendix A Drainage Basin Map

Refer to **Appendix A** for a detailed map of the drainage basin. A brief description of current conditions and the development conditions are as follows:

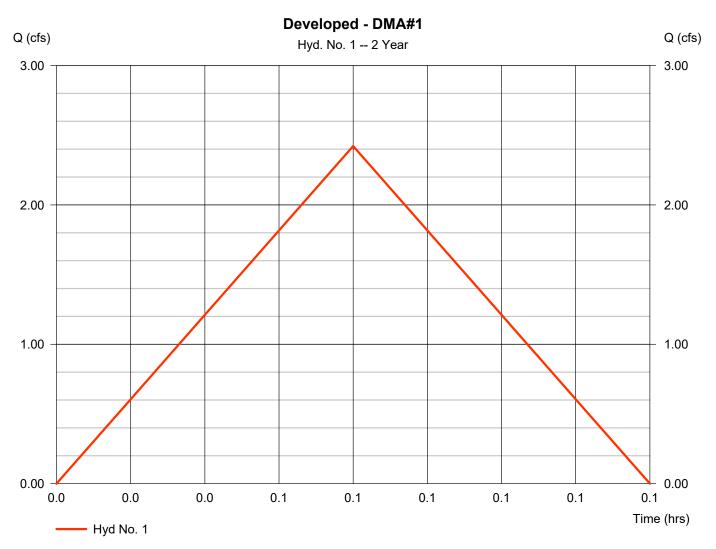
Developed - DMA#1

Hydrograph type = Rational Peak discharge = 2.422 cfsStorm frequency Time to peak = 2 yrs = 0.07 hrsTime interval Hyd. volume = 1 min = 581 cuft Runoff coeff. Drainage area = 1.500 ac= 0.71*= 2.274 in/hrTc by TR55 $= 4.00 \, \text{min}$ Intensity **IDF** Curve = SampleFHA.idf Asc/Rec limb fact = 1/1

^{*} Composite (Area/C) = $[(1.413 \times 0.90) + (0.500 \times 0.20)] / 1.500$

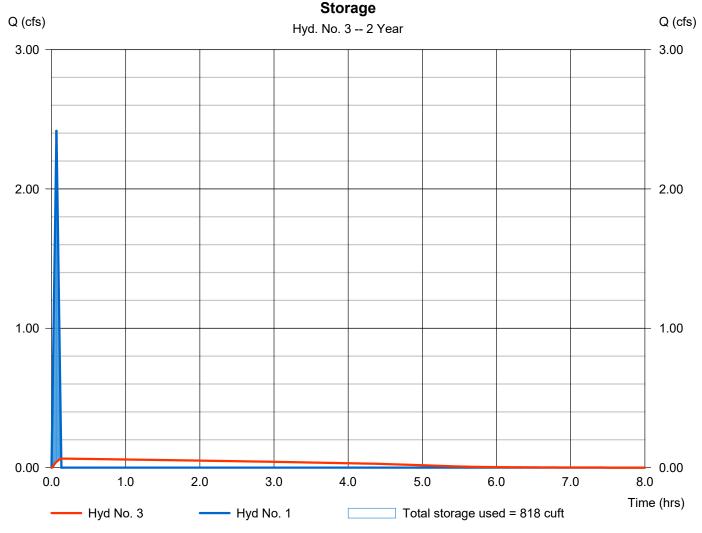
Hydrograph type = Reservoir Peak discharge = 0.065 cfsStorm frequency Time to peak = 2 yrs = 0.17 hrsTime interval Hyd. volume = 1 min = 835 cuft Max. Elevation Inflow hyd. No. = 1 - Developed - DMA#1 = 101.32 ft= Creekside Plaza Reservoir name Max. Storage = 818 cuft

Storage Indication method used.

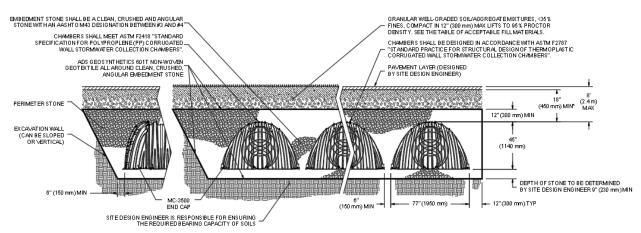
MINIMUM COVER TO BOTTOM OF FLEXIBLE PAVEMENT. FOR UNPAVED INSTALLATIONS WHERE RUTTING FROM VEHICLES MAY OCCUR, INCREASE COVER TO 24"

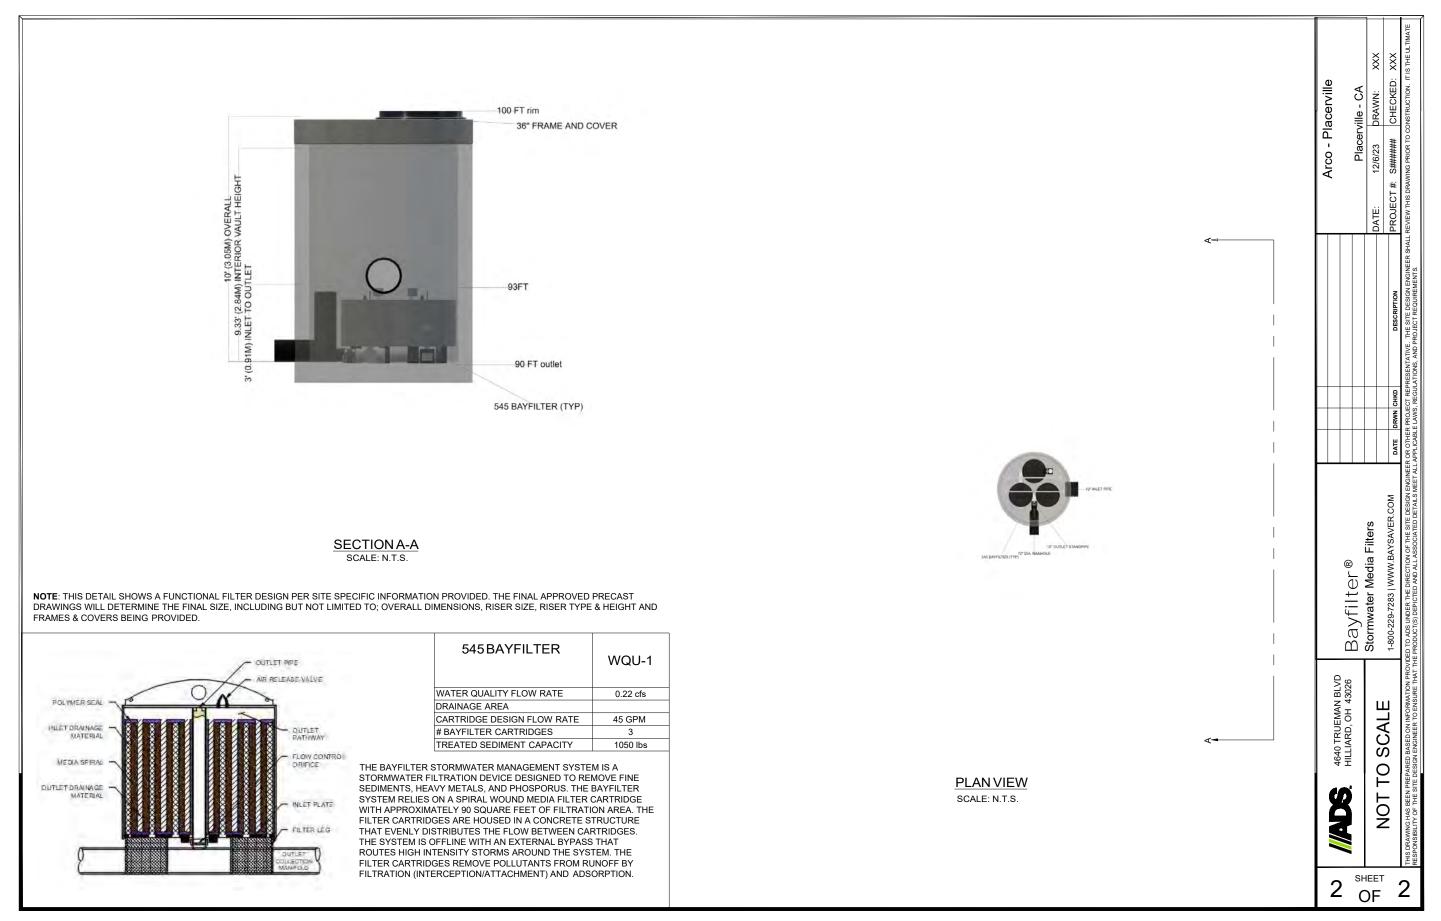
Arco - Placerville

- B. INSTALL THE PVC OUTLET MANIFOLD.
- 9. INSTALL THE PVC OUTLET PIPE IN BAYFILTER VAULT.
- 10. INSTALL THE INLET PIPE TO THE BAYFILTER VAULT.
- AFTER THE SITE IS STABILIZED, REMOVE ANY ACCUMULATED SEDIMENT OR DEBRIS FROM THE VAULT AND INSTALL THE FLOW DISKS, DRAINDOWN MODULES (IF APPLICABLE), AND THE BAYFILTER CARTRIDGES.

- 12. PLACE FULL SET OF HOLD DOWN BARS AND BRACKETS INTO PLACE.
