Final Corridor Analysis Report
GREEN VALLEY ROAD

El Dorado County, California

October 2014

Kittelson & Associates, Inc.
428 J. Street, Suite 500
Sacramento, CA 95814
(916) 266-2190
www.kittelson.com

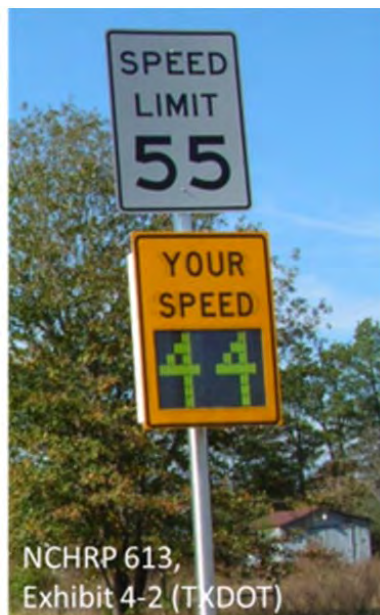
Exhibit 4. Speed Feedback Sign

- Install a dynamic warning sign upstream of the westbound approach at the Mormon Island Drive intersection. Through sensors in the pavement, these signs are activated by the vehicles that exceed a predetermined speed limit (or posted limit) or by potential vehicle conflicts at the intersection. Exhibit 4 and Exhibit 5 are some examples of dynamic warning signs as outlined in the NCHRP Report 613⁴. This treatment is estimated to achieve a speed reduction ranging from 4 to 7 mph, although the benefits may diminish over time as the motorists become aware of the presence and purpose of these signs. Local law enforcement agencies, California Highway Patrol and El Dorado County Sheriff, have programs that utilize speed feedback trailers as “public education.” These speed feedback trailers are available for public use upon request. An example of a speed feedback trailer is shown in Exhibit 6.

- Automated speed feedback signs, as shown in Exhibit 4.
- Gateway treatments such as a sign stating “Welcome to El Dorado Hills”, “Welcome to Cameron Park” and “Welcome to Rescue”. A physical sign or landmark may increase driver awareness for change in environment and corridor context. These signs should be installed in the speed transition zones.
- Transverse rumble strips, as shown in Exhibit 20 below. Rumble strips, or raised pavement markers may be placed in the travel lanes perpendicular to the direction of travel to alert drivers of a change in the environment or corridor context. They may also be installed from higher to lower speed zones.

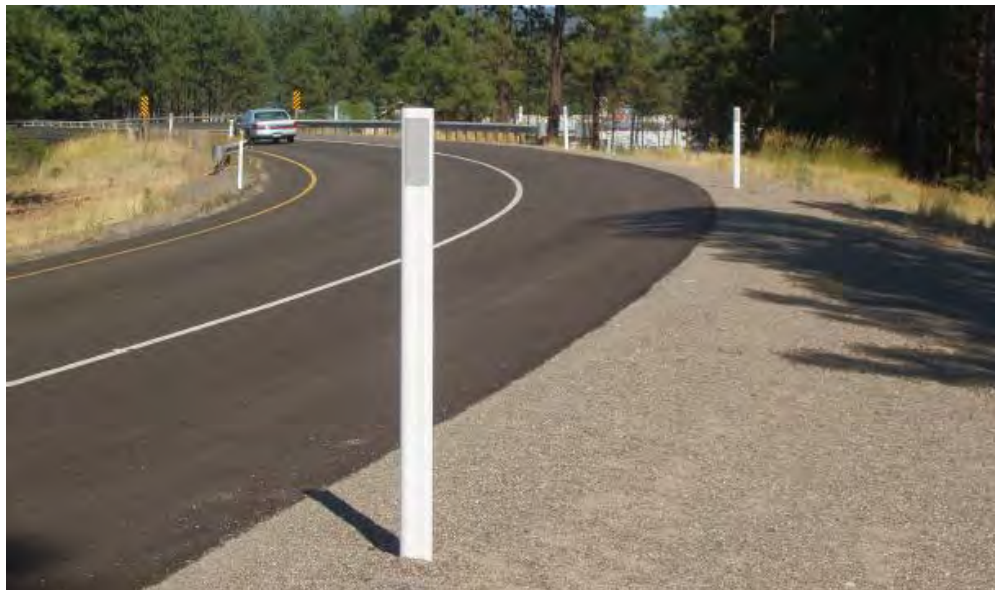
Exhibit 7. Post Mounted Delineator Example

- Install raised or post mounted delineators⁶ along the edge of the pavement, especially at horizontal curves and near intersections with minor streets. An example of post mounted delineators is illustrated in Exhibit 7.

⁶ Delineators are guidance devices and beneficial at locations where the alignment might be confusing or unexpected to motorists.

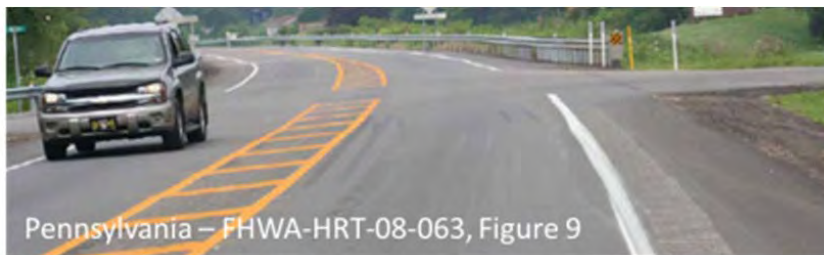
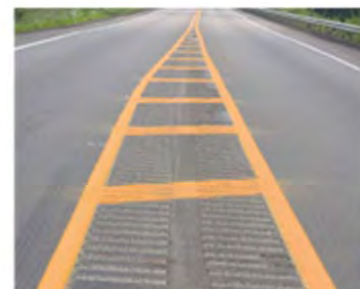
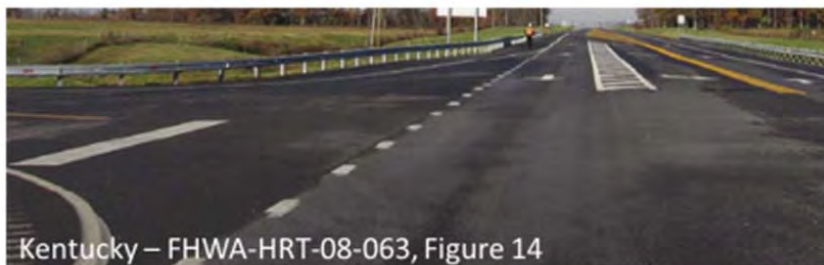
Exhibit 8. Major Road Lane Narrowing Concept

- Traffic calming strategies such as: 1) Lane narrowing concept on the major road approach with pavement markings and rumble strips in the center island; and, 2) Minor road approach splitter island may be considered. The intent of the lane narrowing concept is to increase visibility of the intersection, reduce vehicle speeds on the major road approach, and thereby potentially reduce crashes. The intent of the minor road approach splitter island is to increase visibility of the intersection, improve traffic control compliance and thereby potentially reduce crashes. Exhibit 8 and Exhibit 9 illustrate these two concepts.

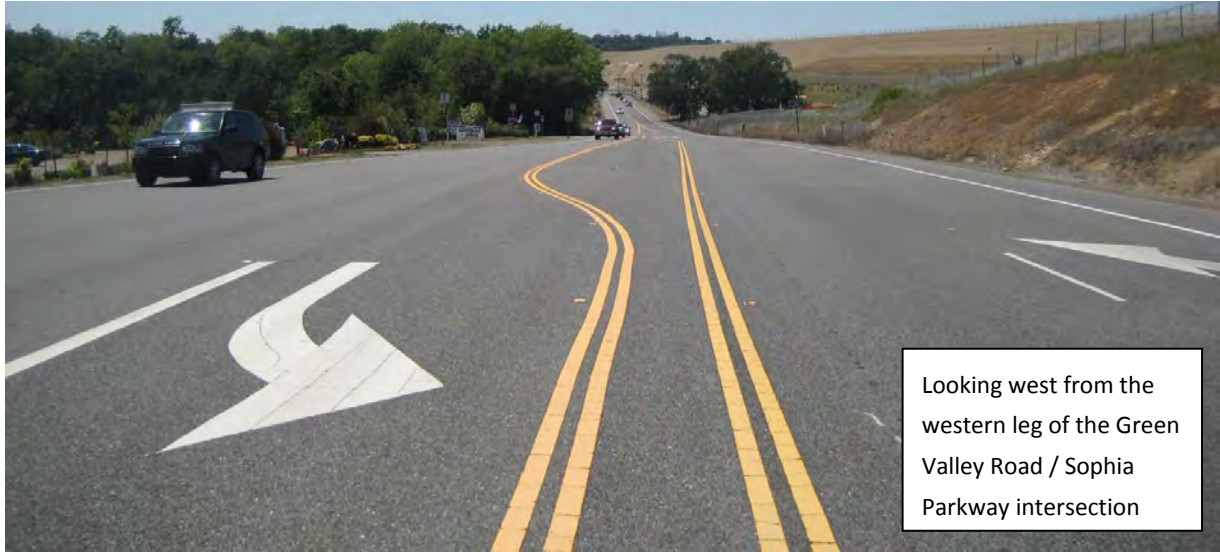
- Observations indicate that motorists inappropriately use the paved median shelter between Sophia Parkway and Shadowfax Lane to turn left into the Green Valley Nursery (see picture below).

- Unsafe left-turning movement into the Green Valley Nursery and Landscape using a median refuge marked by double yellow markings.

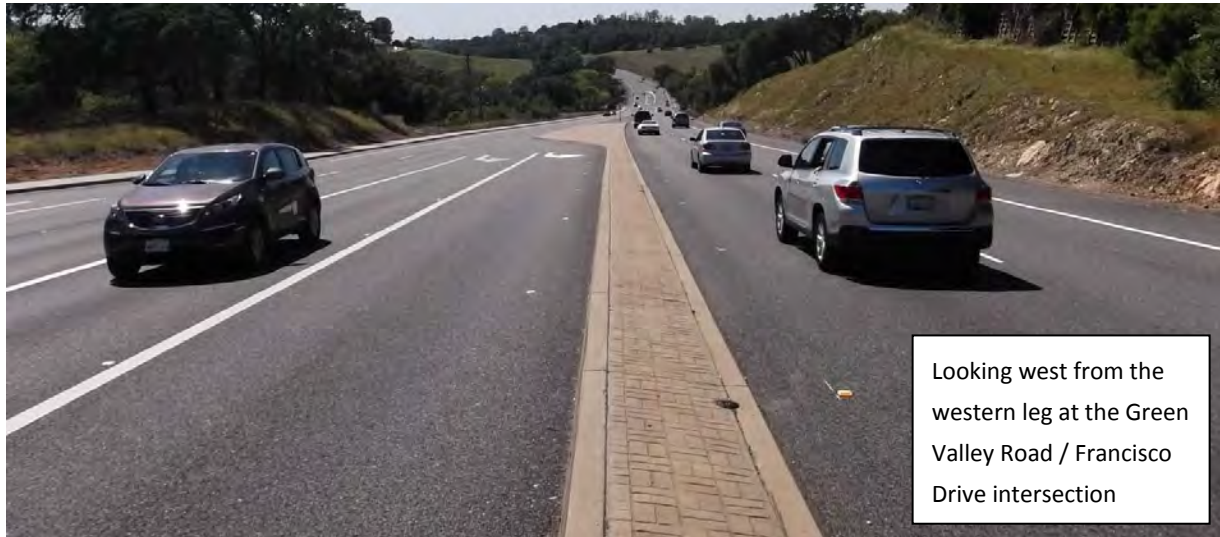
- The western segment is interrupted with two consecutive commercial driveways on either side of the roadway.
- Due to 3% to 5% downgrade in the westbound direction (see picture below), vehicles were observed to travel at speeds that exceeded the posted speed limit.

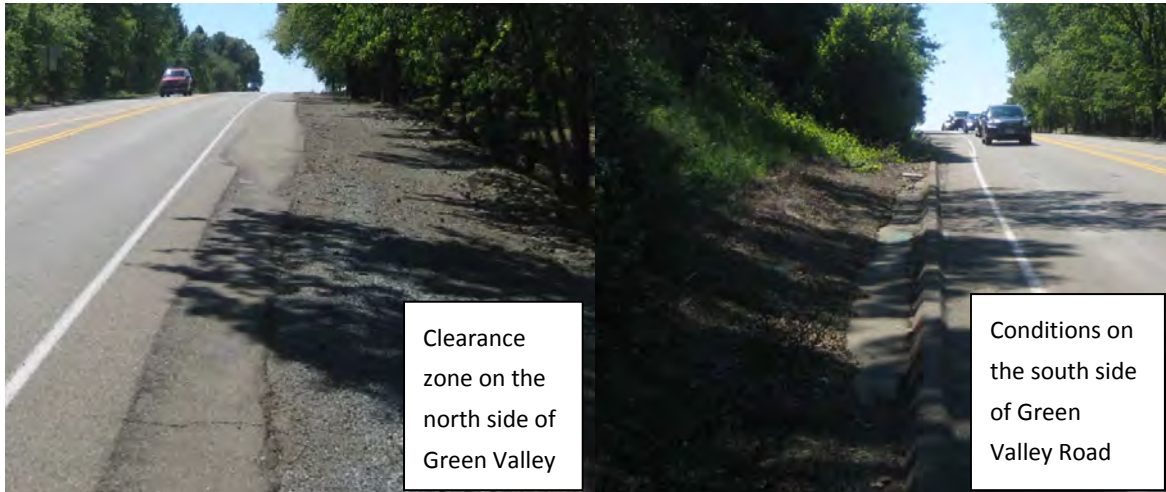
- Beyond the shoulder on the north side, a clearance zone¹² of 8 to 12 feet is present (see picture below on the left). This area may be used to provide recovery of errant vehicles that may run off the road. On the south side, private properties are situated approximately 18 to 20 feet from edge of the shoulder. The area beyond the shoulder on the south side is occupied with vegetation and trees (see picture below), presenting limited recovery opportunities for errant vehicles.

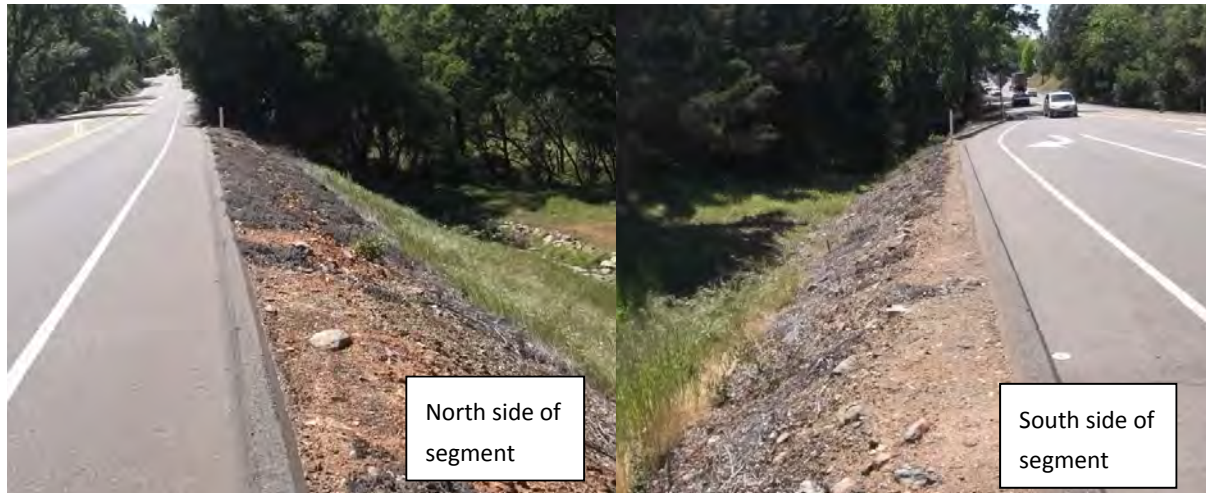
- The 0.17-mile long segment provides one travel lane in each direction with the posted speed limit of 50 mph.
- The typical cross-section provides two 12-foot travel lanes with a 3 to 6-foot wide shoulder on each side.
- The area beyond shoulders is recessed on both sides and occupied with trees and vegetation. A continuous curb is provided on either side of Green Valley Road to prevent errant vehicles from running off the road (see pictures below).

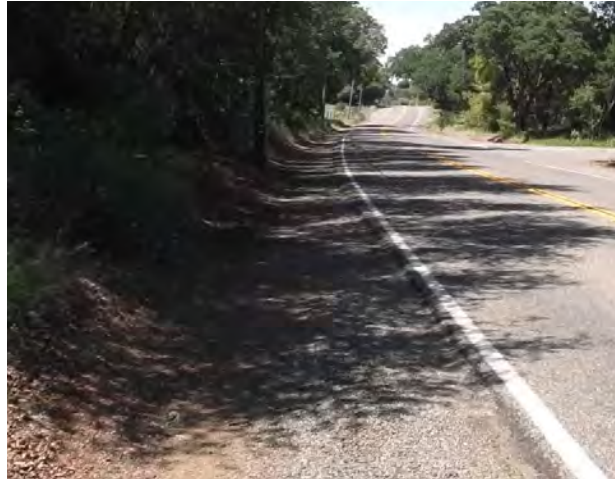
- The 3.04-mile long undivided segment provides one travel lane in each direction with the posted speed limit of 50 mph west of the Rescue Elementary School. The posted speed drops to 40 mph east of the Rescue Elementary School. In the vicinity of the school, the reduced speed of 25 mph is enforced when children are present.
- Within the Cameron Park area, the typical cross-section includes two 12-foot travel lanes with a 6-foot wide shoulder on each side. Within the rural area (east of Cameron Park), the segment provides two 10- to 11-foot wide travel lanes with either soft (containing gravel, sand, etc.) shoulder or no shoulder (see picture below).

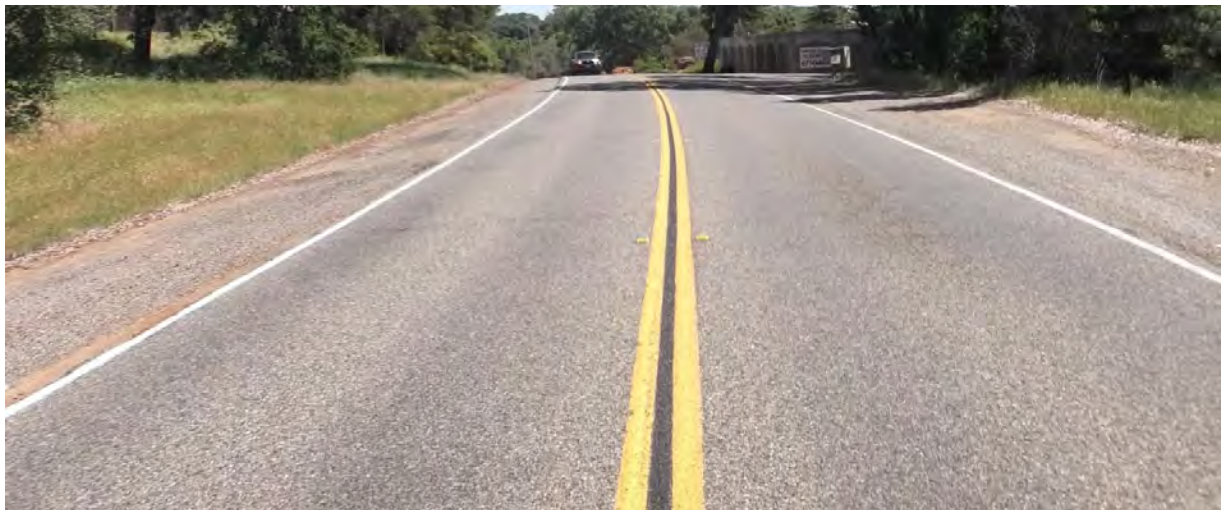
- The 0.49-mile long undivided segment provides one travel lane in each direction with the posted speed limit of 40 mph.
- This segment provides two 10-11 foot wide travel lanes with either soft (containing gravel, sand, etc.) or no shoulder on either side (see below).

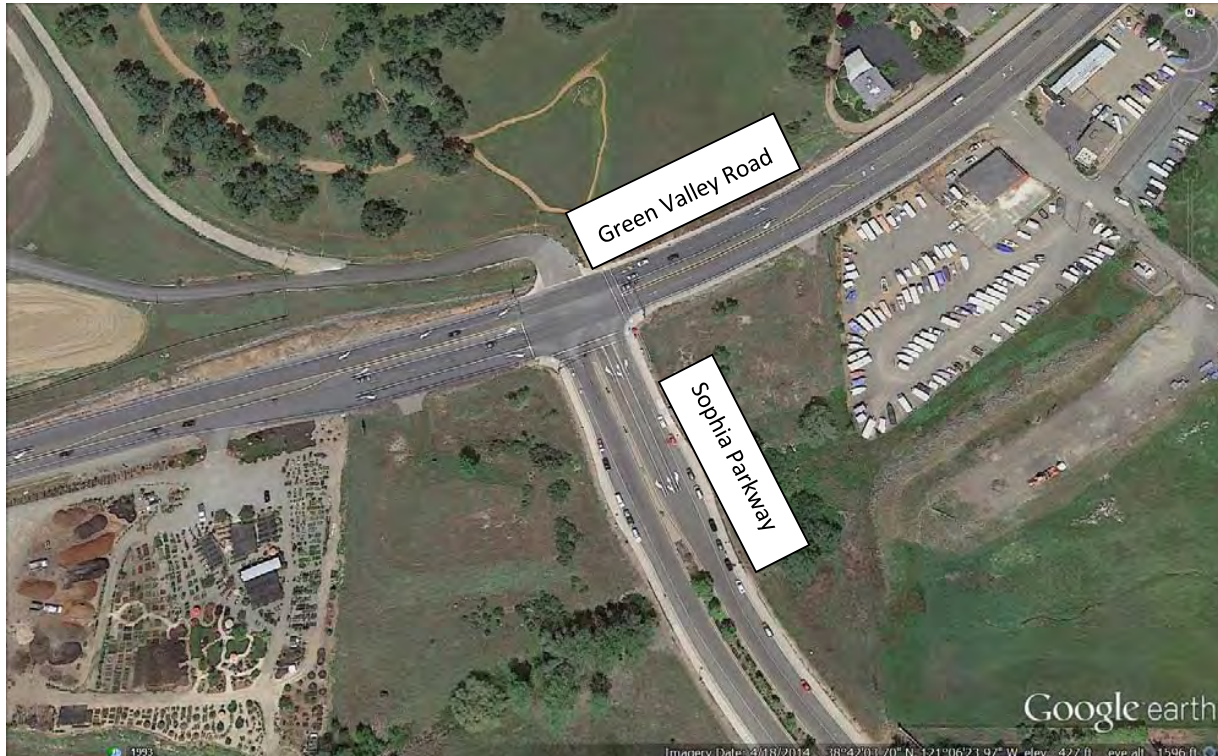
Exhibit 22. Green Valley Road and Sophia Parkway Intersection

The Sophia Parkway intersection is a four-legged signalized intersection. Exhibit 22 shows an aerial of this intersection.

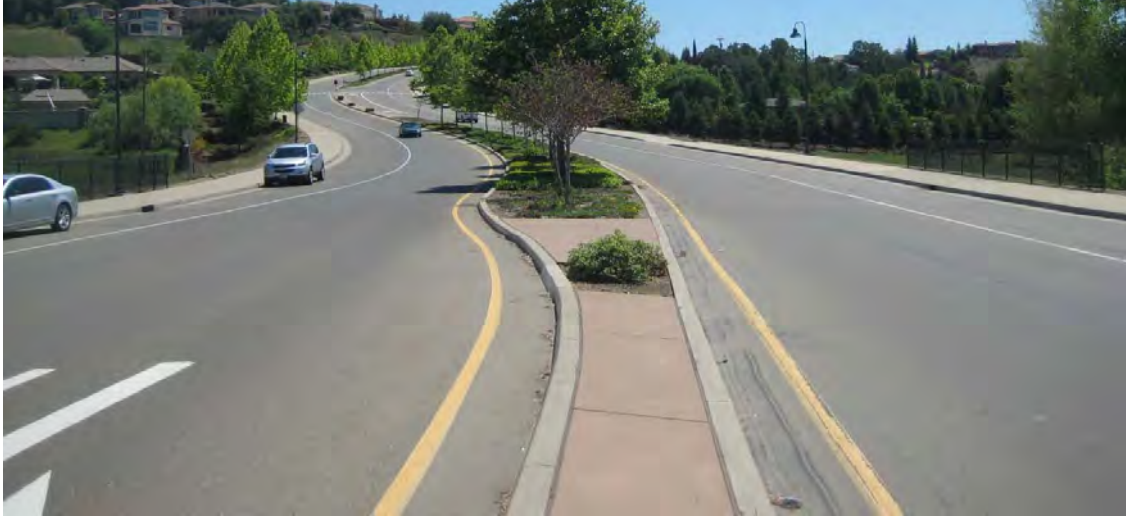
- A large number of pedestrians and bicyclists negotiate this intersection to access the Browns Ravine Recreation Area trails on the north side of Green Valley Road. This often leads to pedestrian conflicts with right-turning vehicles from Sophia Parkway. A “Yield to Pedestrians” sign is posted on the signal pole to educate motorists about an impending conflict with pedestrians within the crosswalk.
- Sophia Parkway provides wide shoulders south of Green Valley Road. These shoulders are being utilized as an on-street parking area by the motorists who typically park their cars and walk or bike to the Browns Ravine Recreation Area.

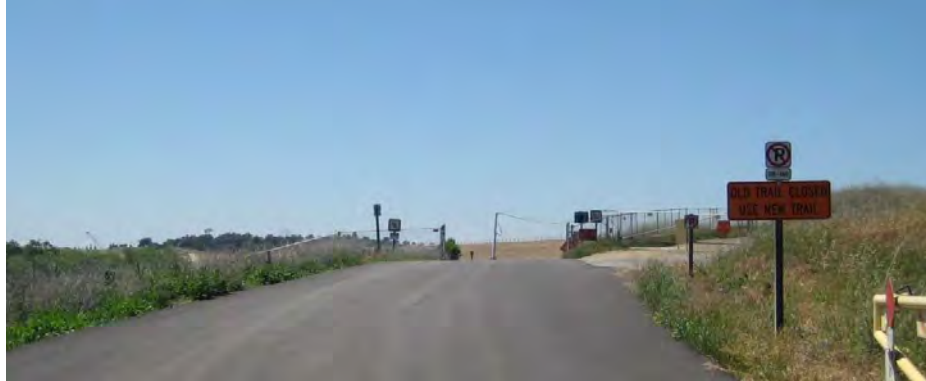
- To access ongoing construction activity at the nearby Folsom Lake Dam (see picture below), a significant volume of heavy-duty trucks utilize this intersection.

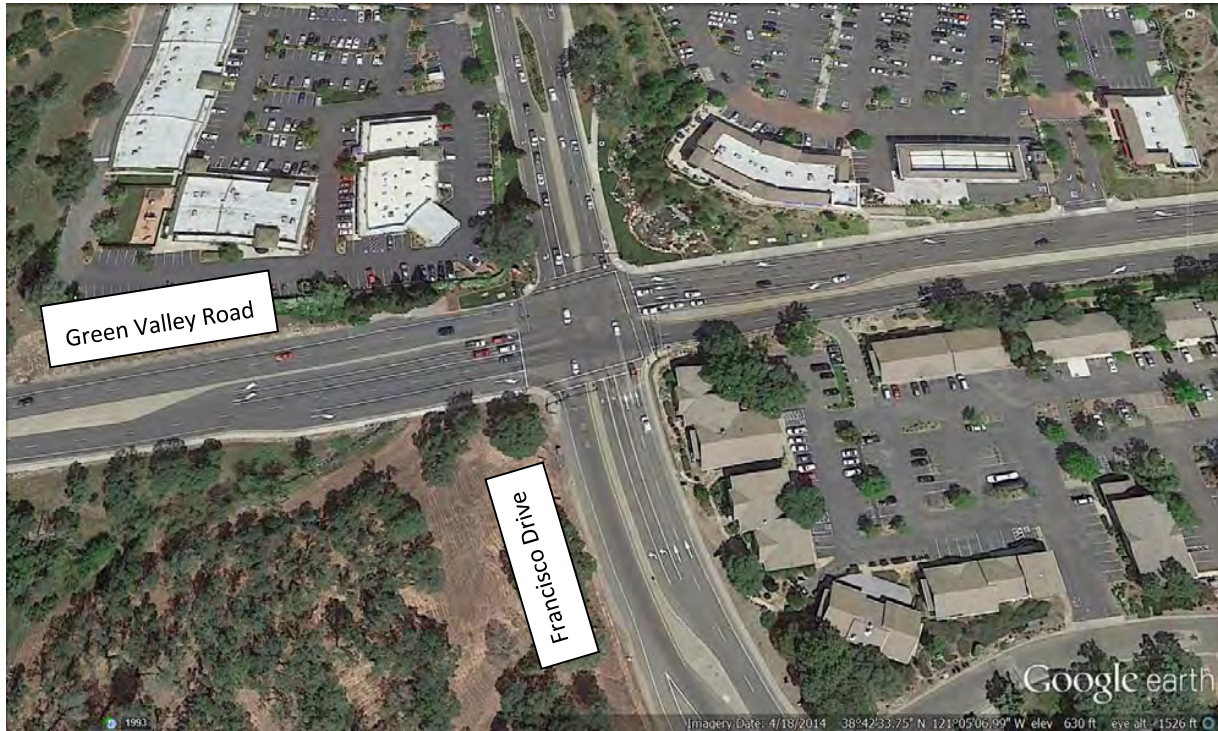
Exhibit 23. Green Valley Road and Francisco Drive Intersection

The Francisco Drive intersection is a four-legged signalized intersection. Exhibit 23 shows an aerial of this intersection.

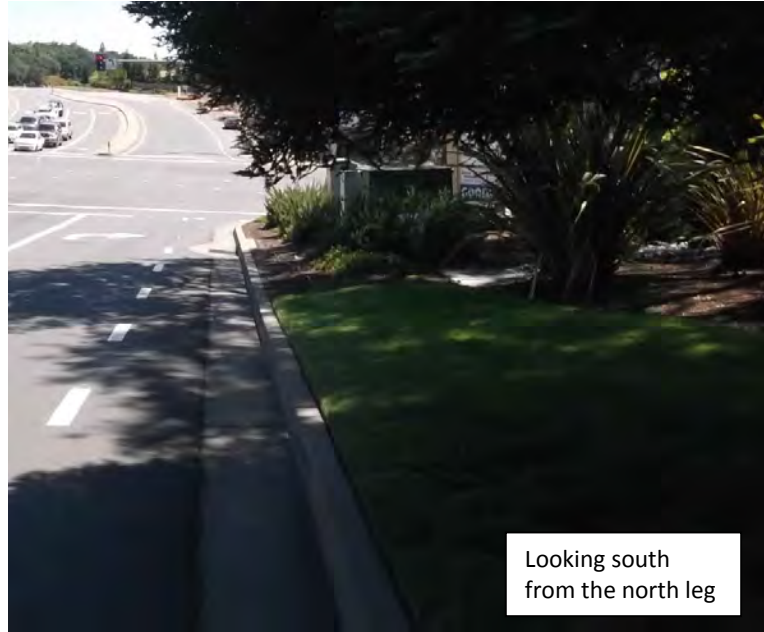
- Pedestrians and bicyclists use this intersection to access the market and village center on the north side of Green Valley Road.
- There are a large number of U-turns from the westbound left-turn lane of Green Valley Road. The majority of U-turn vehicles exited the Safeway shopping center from the driveway located approximately 480 feet east of this intersection. Some U-turns were also destined to the shopping center located in the southeast corner of this intersection.
- There are no sidewalks approaching the northwest corner of the intersection (see picture below).

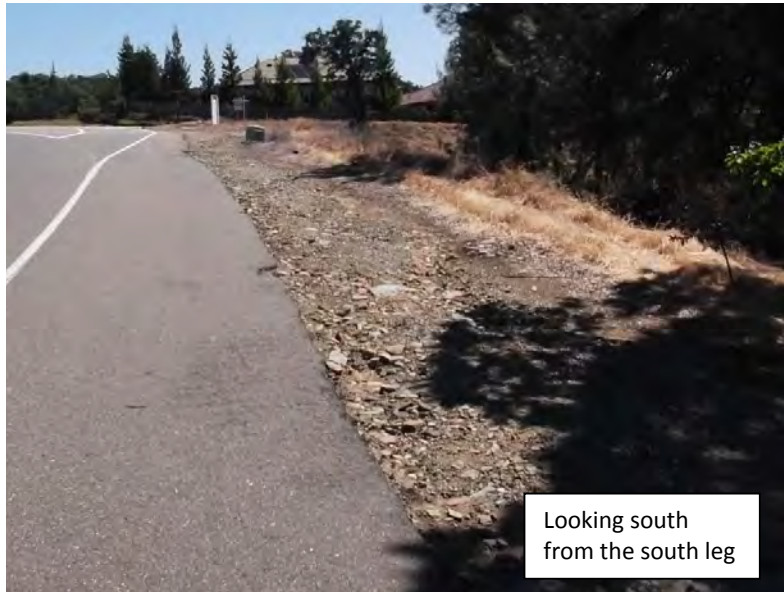
- Sidewalk is not present along the west side of Francisco Drive to the south of the intersection (see picture below).

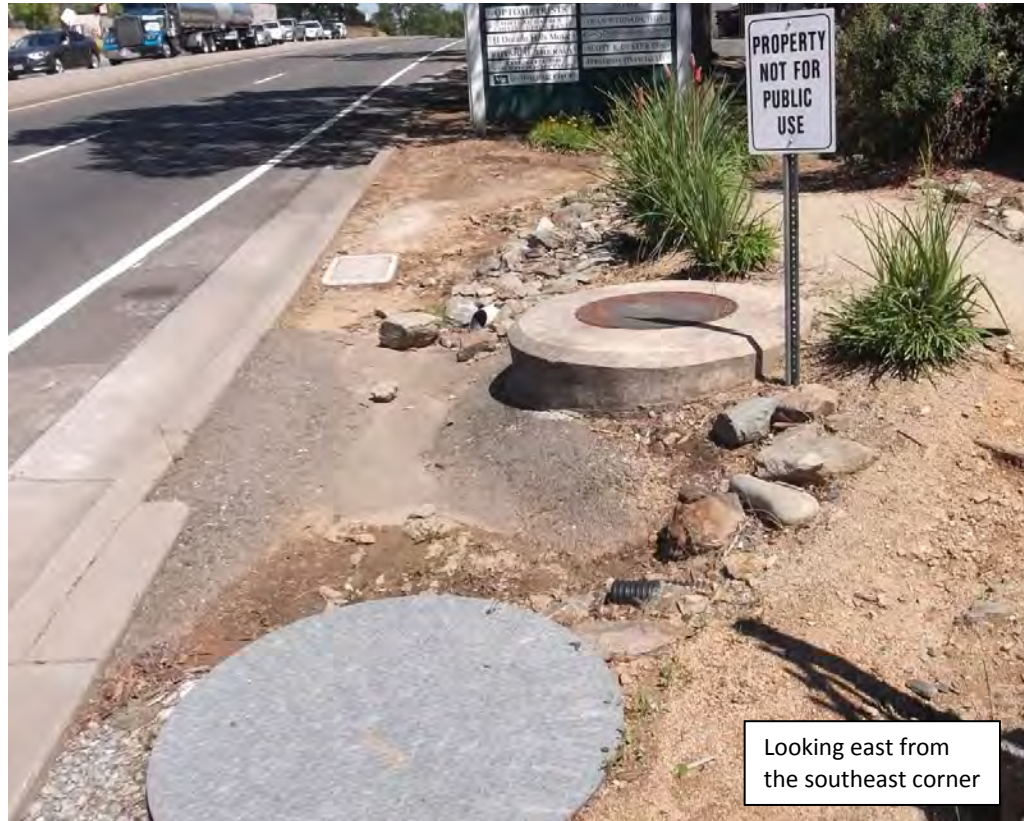
- Sidewalk is terminated from southeast corner of this intersection to the east (see picture below).

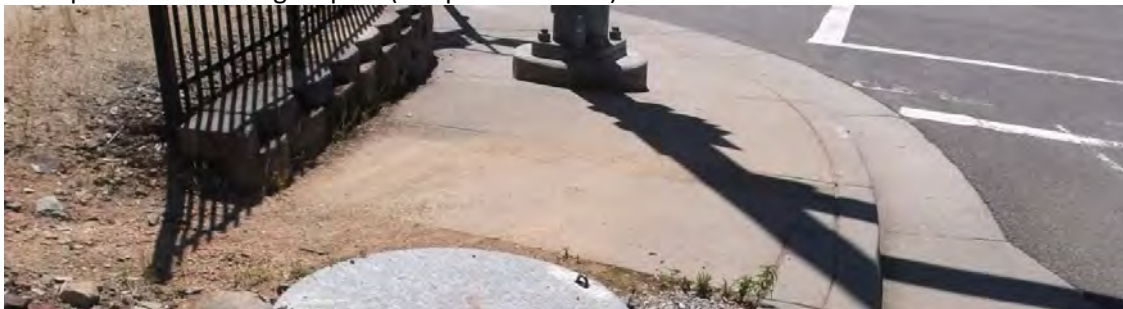
- Sidewalk in the southeast corner does not provide adequate clear width per ADA guidelines due to the placement of a signal pole (see picture below).

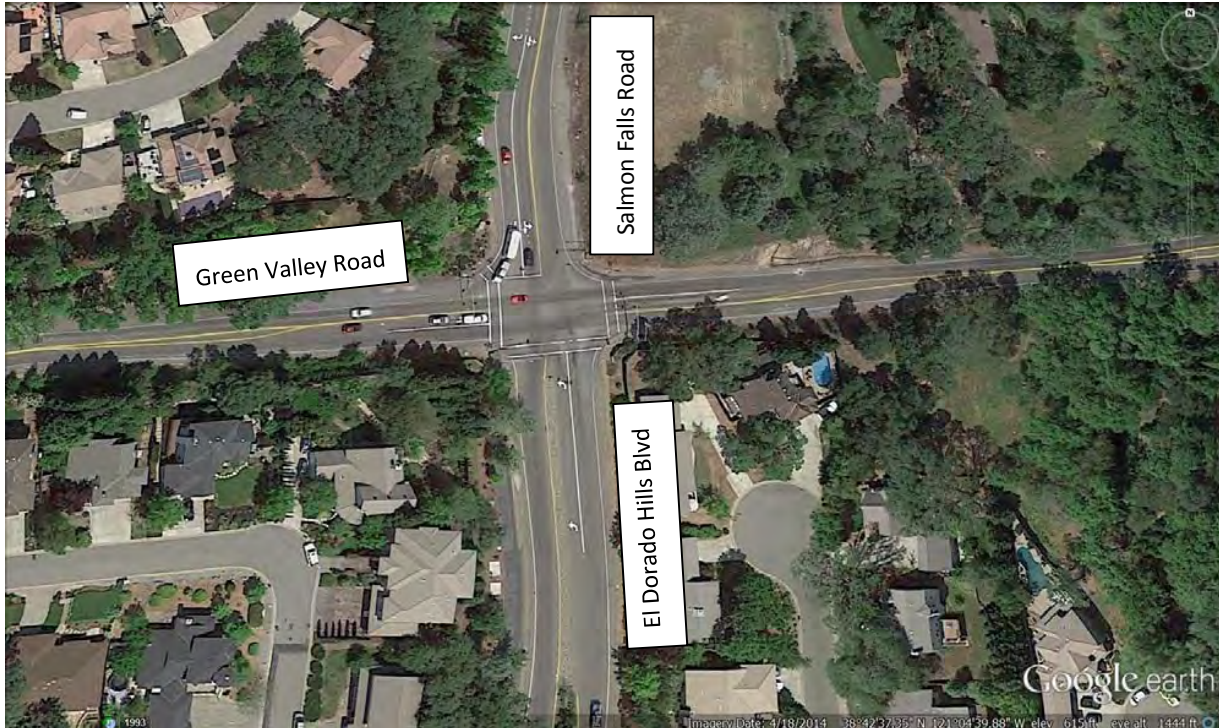
Exhibit 24. Green Valley Road and El Dorado Hills Boulevard/Salmon Falls Road Intersection

The El Dorado Hills Boulevard intersection is a four-legged signalized intersection. Exhibit 24 shows an aerial of this intersection.

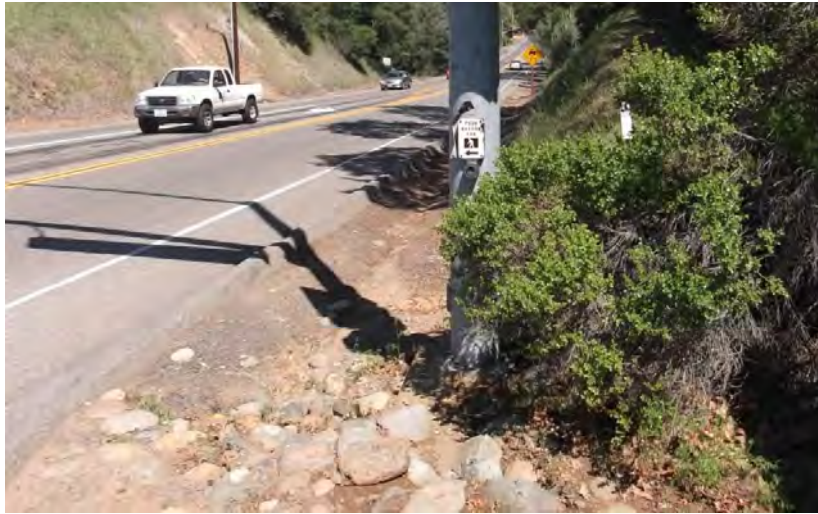
- There are numerous ADA concerns with no detectable warnings at any corner of the intersection, and a lack of pedestrian facilities at each corner (see figure below).

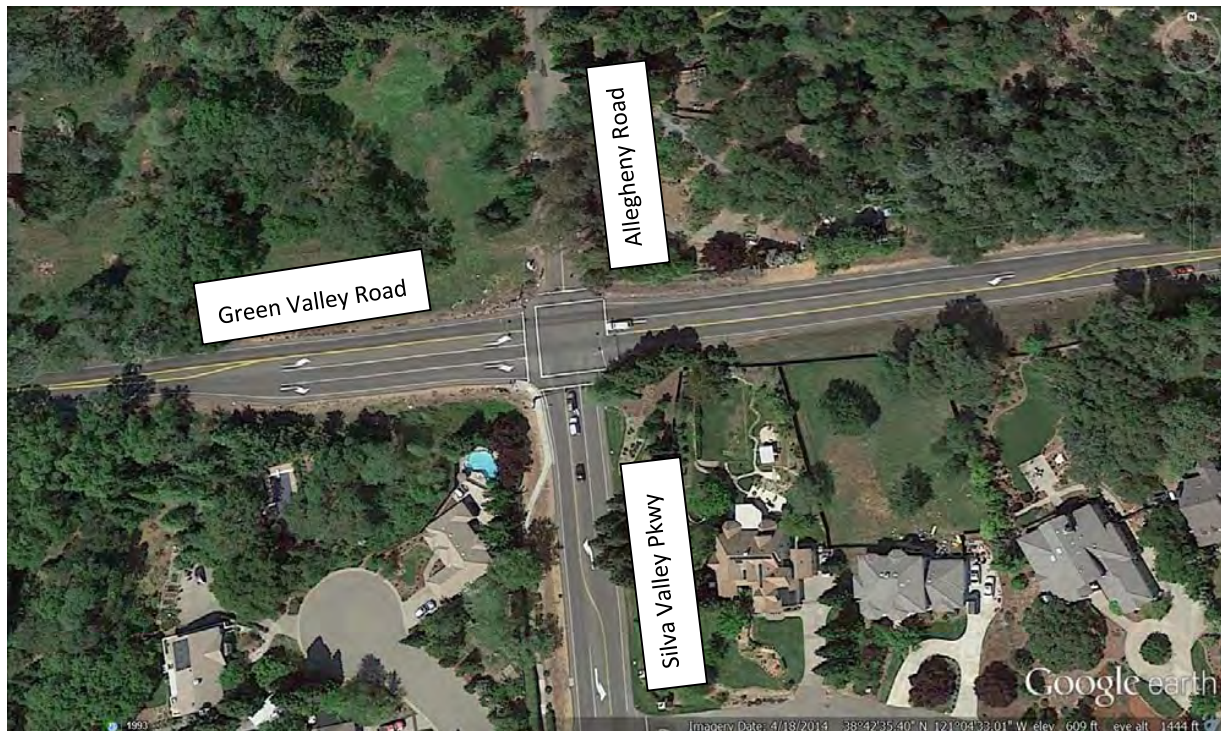
Exhibit 25. Green Valley Road and Silva Valley Parkway/Allegheny Road Intersection

The Silva Valley Parkway intersection is a four-legged signalized intersection. Exhibit 25 shows an aerial of this intersection.

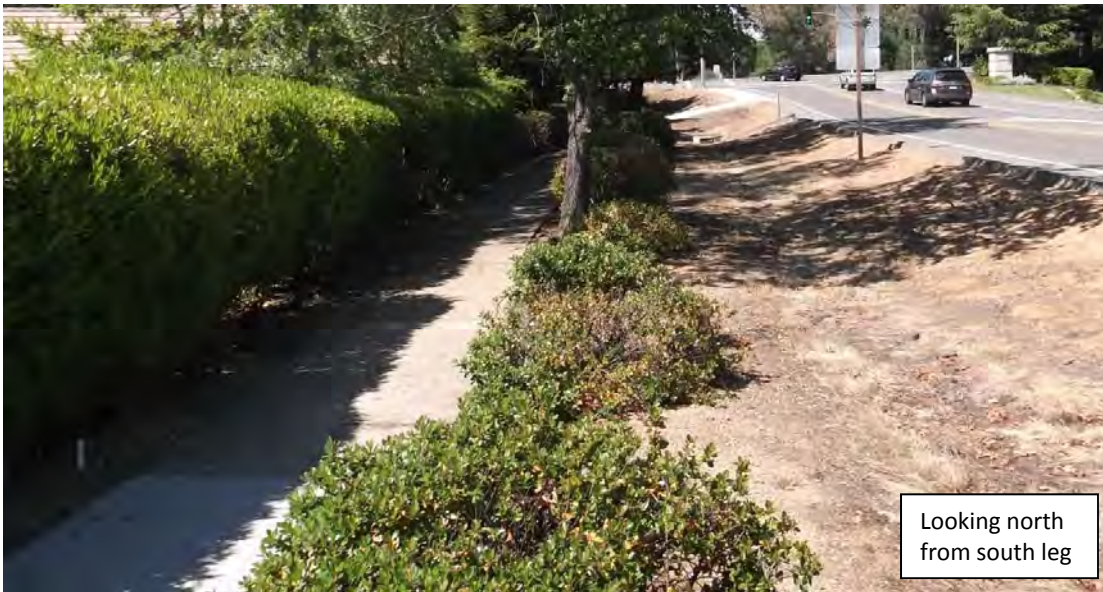
- Neighborhood residents are concerned about cut-through traffic to Salmon Falls Road via Allegheny Road to avoid the El Dorado Hills Boulevard/Salmon Falls Road intersection.
- Pedestrian crossings on Green Valley Road are common.
- There are no sidewalks approaching the intersection other than a pedestrian path approaching the intersection from nearby Timberline Ridge Court.
- Only the southwestern corner of the intersection has been improved to be consistent with ADA guidelines, the other corners lack detectable warnings and pedestrian access to the corner.
- Pedestrian crossings are prohibited across the east leg of the intersection.
- A pedestrian path is present on the west side of El Dorado Hills Boulevard south of this intersection (see picture below).

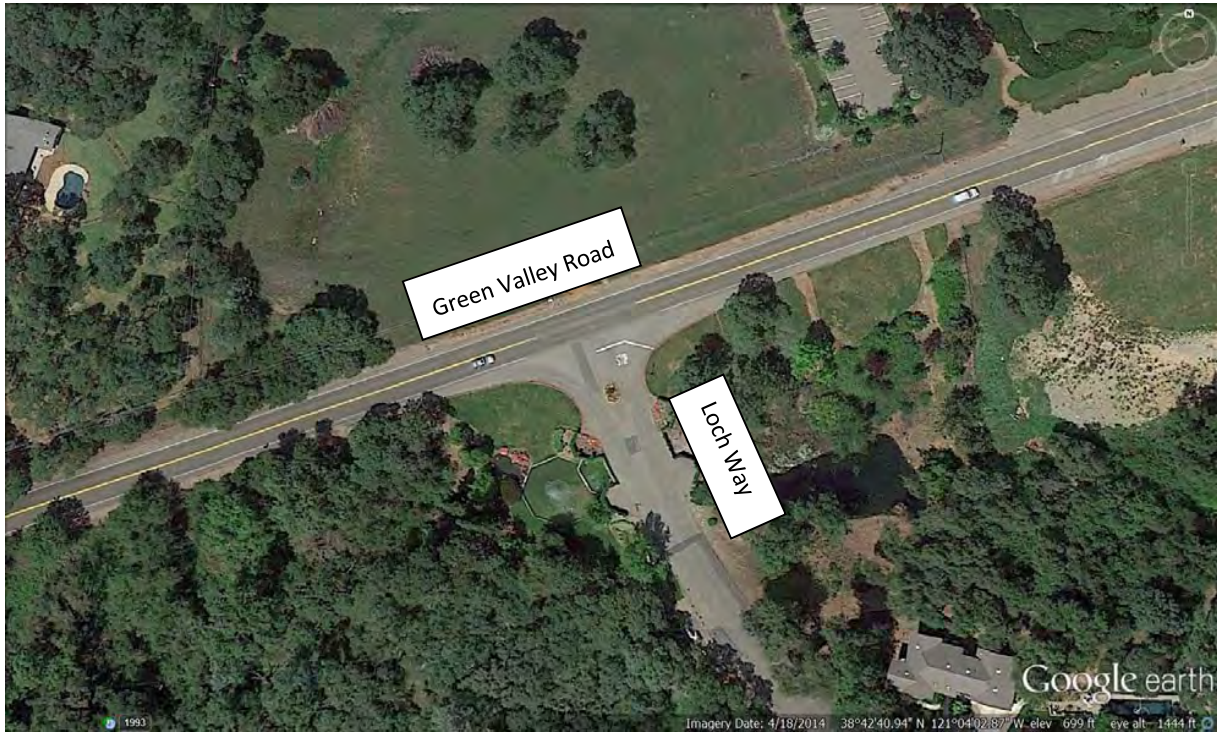
Exhibit 26. Green Valley Road and Loch Way Intersection

The Loch Way intersection is a three-legged intersection with stop-control on the minor (Loch Way) approach. Exhibit 26 shows an aerial of this intersection.

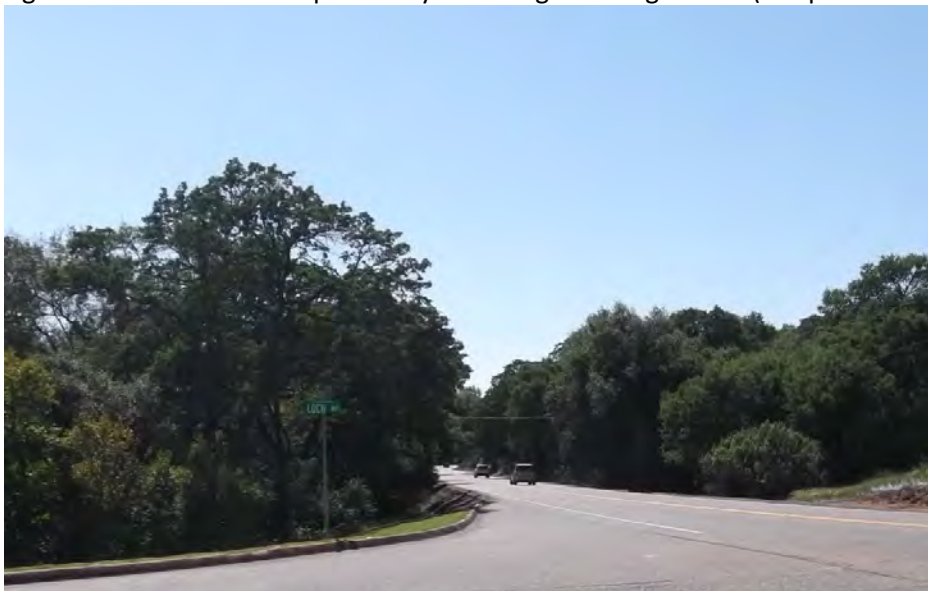
- There are no pedestrian or bicycle facilities at the intersection.
- A photo of the driver's eye view from the stop bar looking west indicates that the Intersection sight distance could be improved by trimming back vegetation (see picture below).

- Intersection sight distance looking west is somewhat limited by continuously growing vegetative foliage.
- While motorists wait for an acceptable suitable gap to turn left into Loch Way, trailing vehicles pass by them using the shoulder on the right. Vehicle skid marks were seen on the roadway surface.
- Higher than posted speeds were observed passing through this intersection.

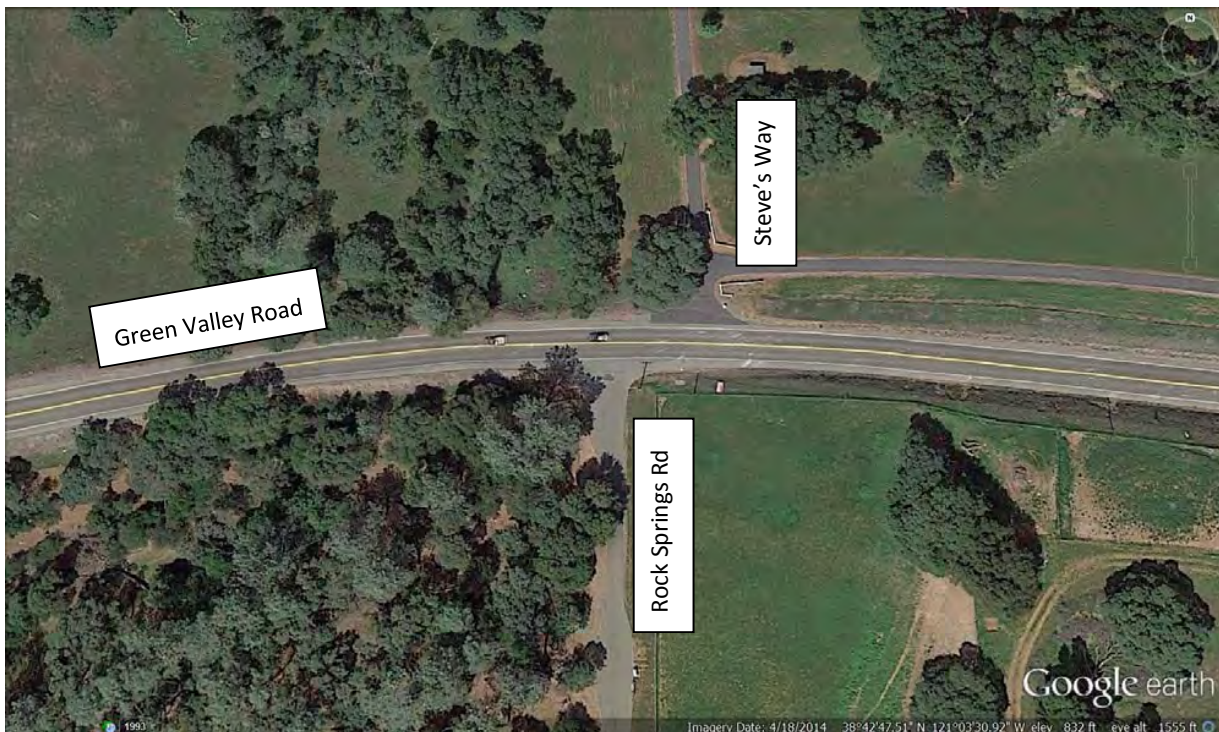
Exhibit 27. Green Valley Road and Rocky Springs Road/Steve’s Way Intersection

The Rocky Springs Road/Steve’s Way intersection is a four-legged offset intersection with assumed stop-control on the minor approaches. Exhibit 27 shows an aerial of this intersection. This is not a County maintained intersection.

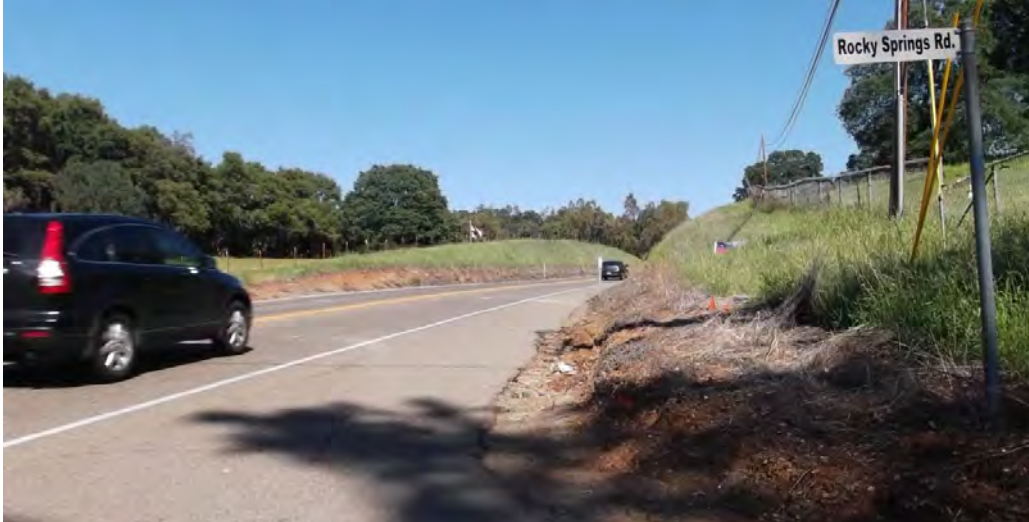
- The intersection does not have a marked stop bar or a stop sign on both Rocky Springs Road and Steve’s Way as they are private roads.

- Both Rocky Springs Road and Steve's Way provide local access to a small number of single family residences.

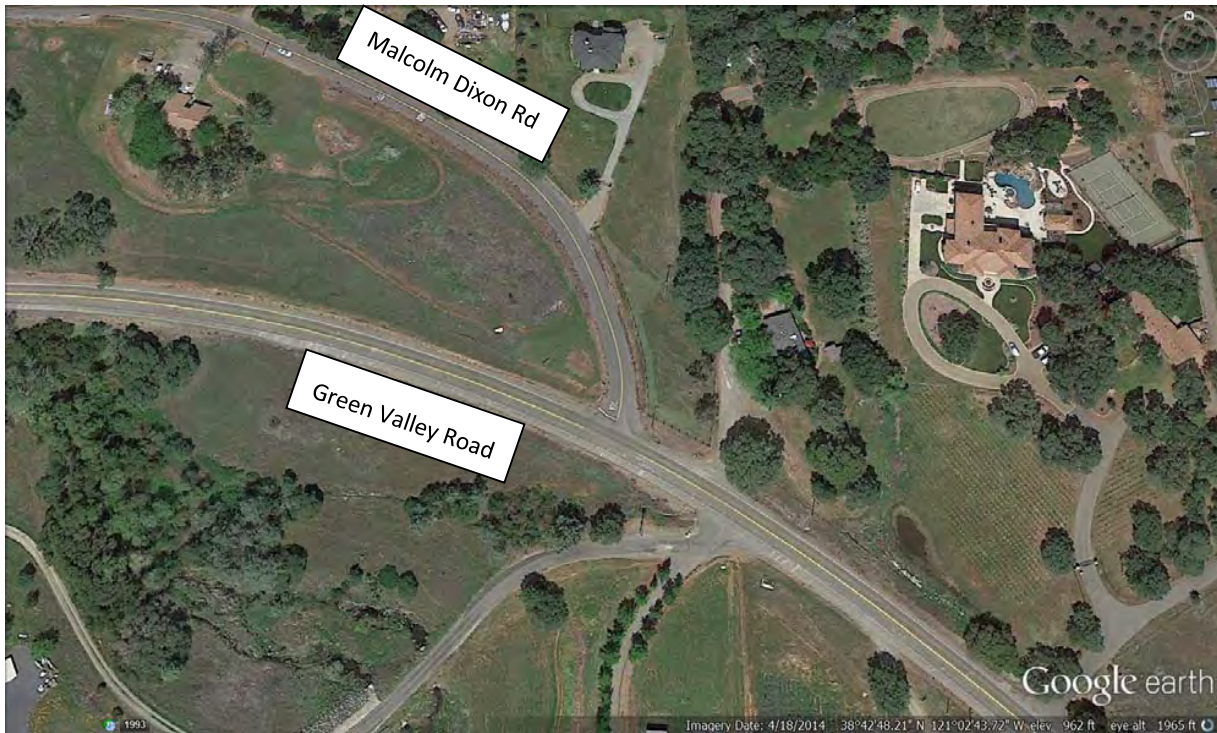
Exhibit 28. Green Valley Road and Malcolm Dixon Road Intersection

The Malcolm Dixon Road intersection is a three-legged intersection with the stop-control on the minor approach. Exhibit 28 shows an aerial of this intersection.

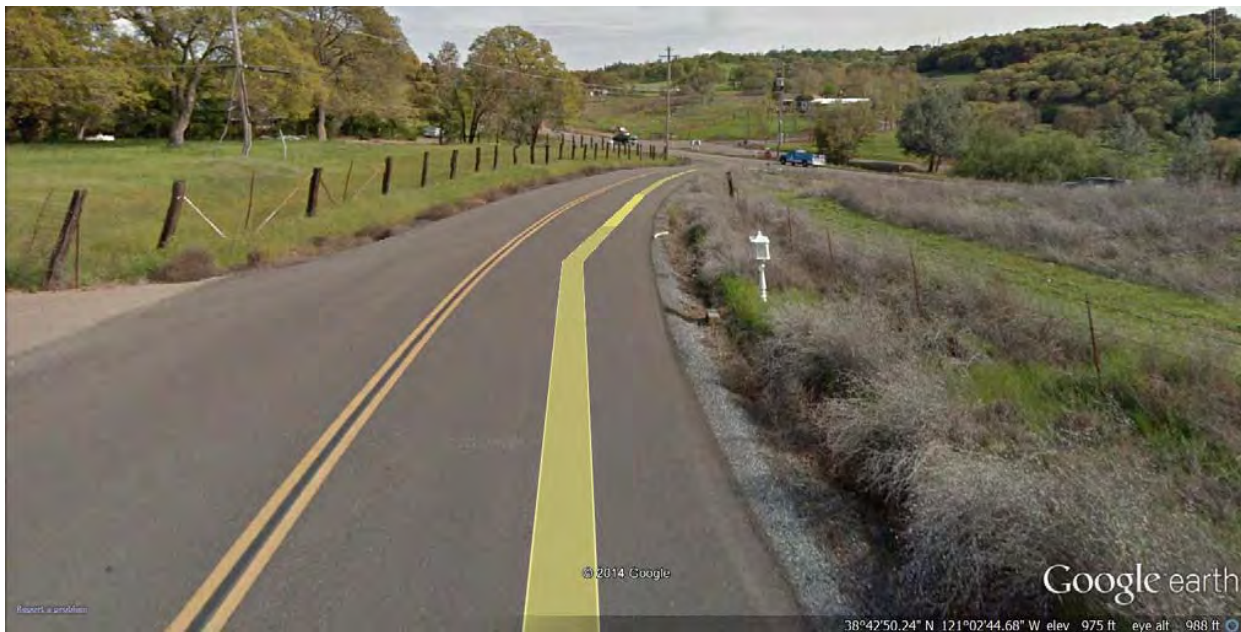
- Due to the wide curve combined with an upgrade on Malcolm Dixon Road, vehicles typically slow down to make a left-turn onto Malcolm Dixon Road. This can present safety issues for the trailing motorists (see picture below).

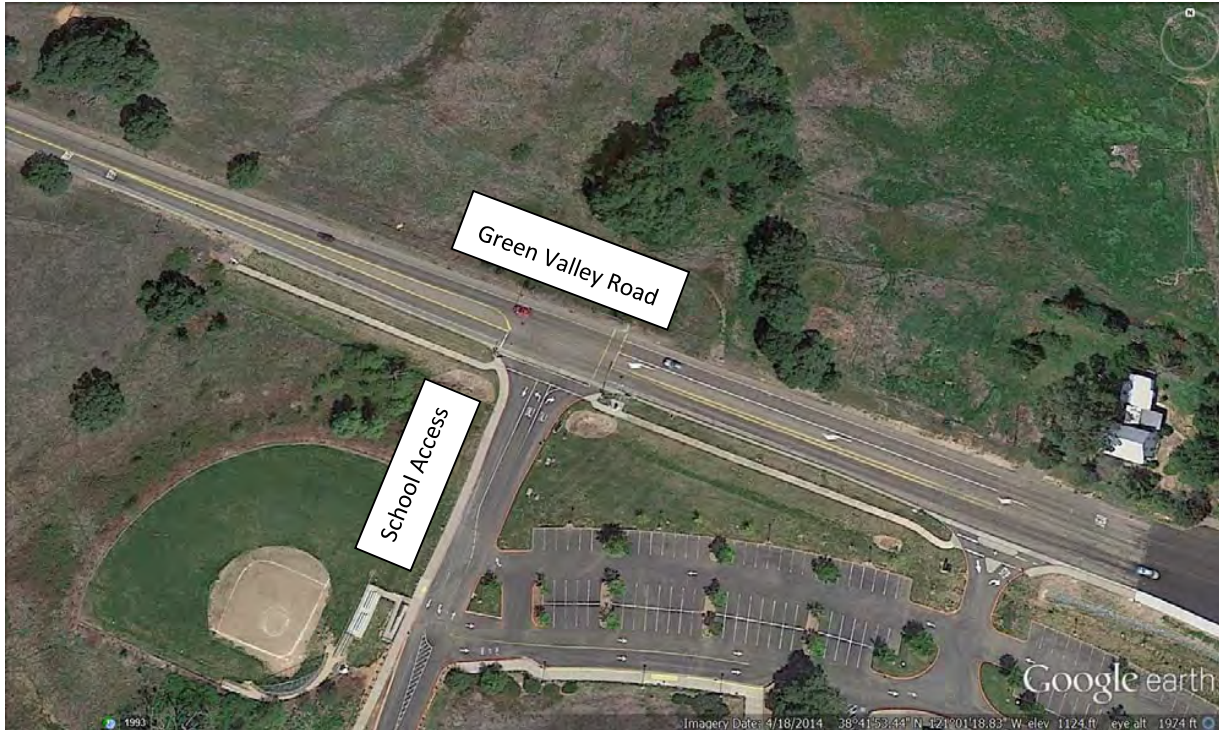
Exhibit 30. Green Valley Road and Pleasant Grove Middle School Intersection

The Pleasant Grove Middle School main access intersection is a three-legged signalized intersection. Exhibit 30 shows an aerial of this intersection. A detail discussion related to school traffic is included in the *Pleasant Grove Middle School* section.

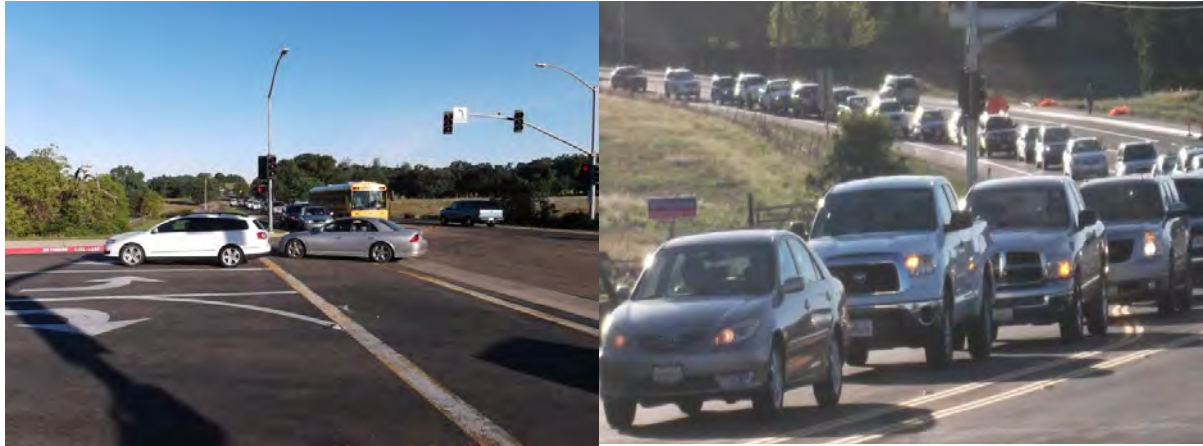
- There are significant operational issues at the intersection, which serves as the primary entrance to Pleasant Grove Middle School during the AM peak hour.
 - Most the school traffic travels to/from the east (Cameron Park).
 - 10-12 cars stack up internally for the drop-off activity. This prevents left-turning vehicles and right-turning vehicles from Green Valley Road from entering the school driveway despite a very long left-turn phase. This leads to queues of 25+ vehicles on Green Valley Road (see pictures below).

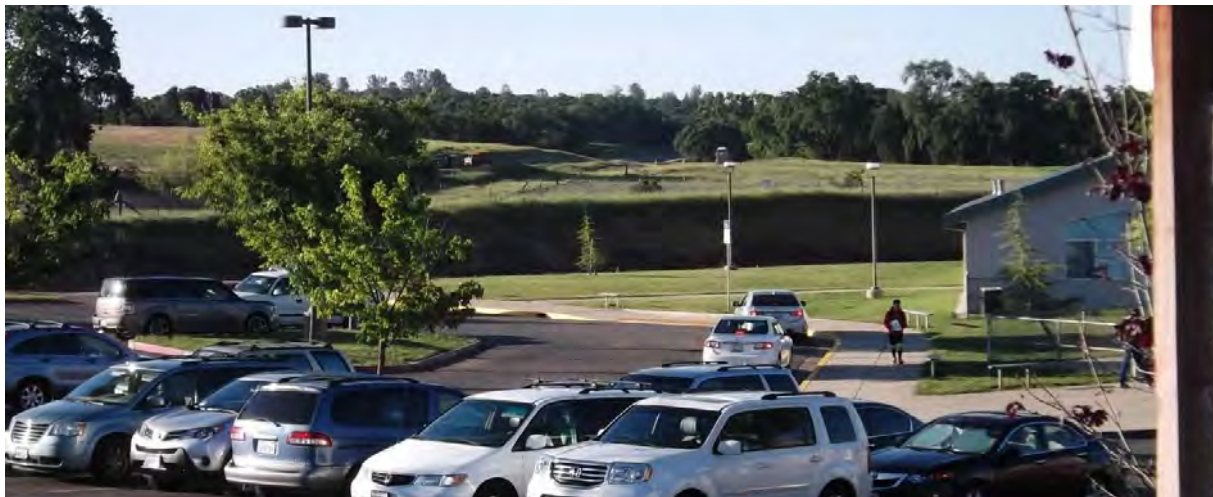
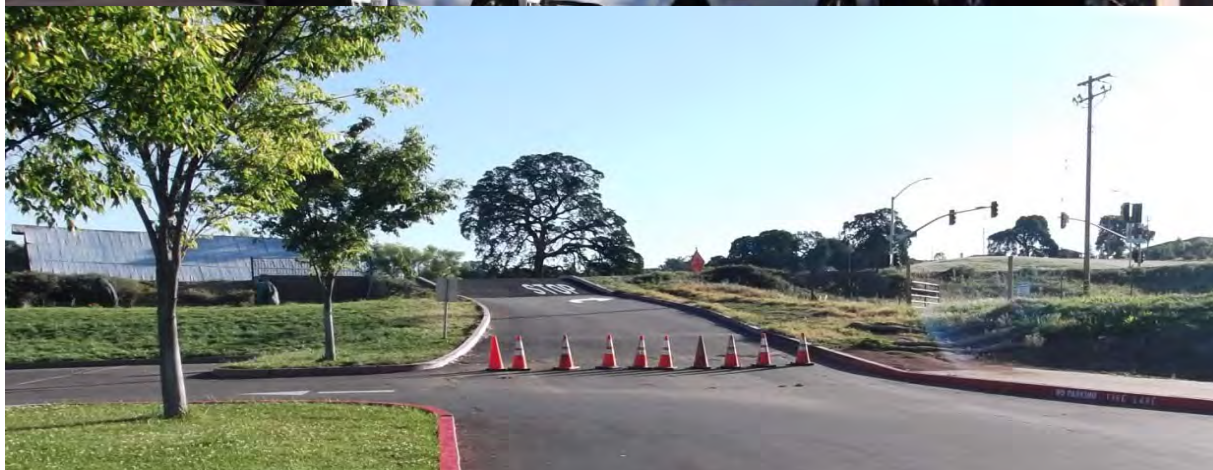
- Westbound vehicles can't access the secondary drop-off due to the driveway geometrics and striping along Green Valley Road. Vehicles accessing the school using the primary access were unable to drive down to the secondary drop-off area to the east due to not only internal queuing, and possibly the current closure of the eastern right-out exit (see pictures below).
