Final Corridor Analysis Report
GREEN VALLEY ROAD

El Dorado County, California

October 2014

Kittelson & Associates, Inc.
428 J. Street, Suite 500
Sacramento, CA 95814
(916) 266-2190
www.kittelson.com

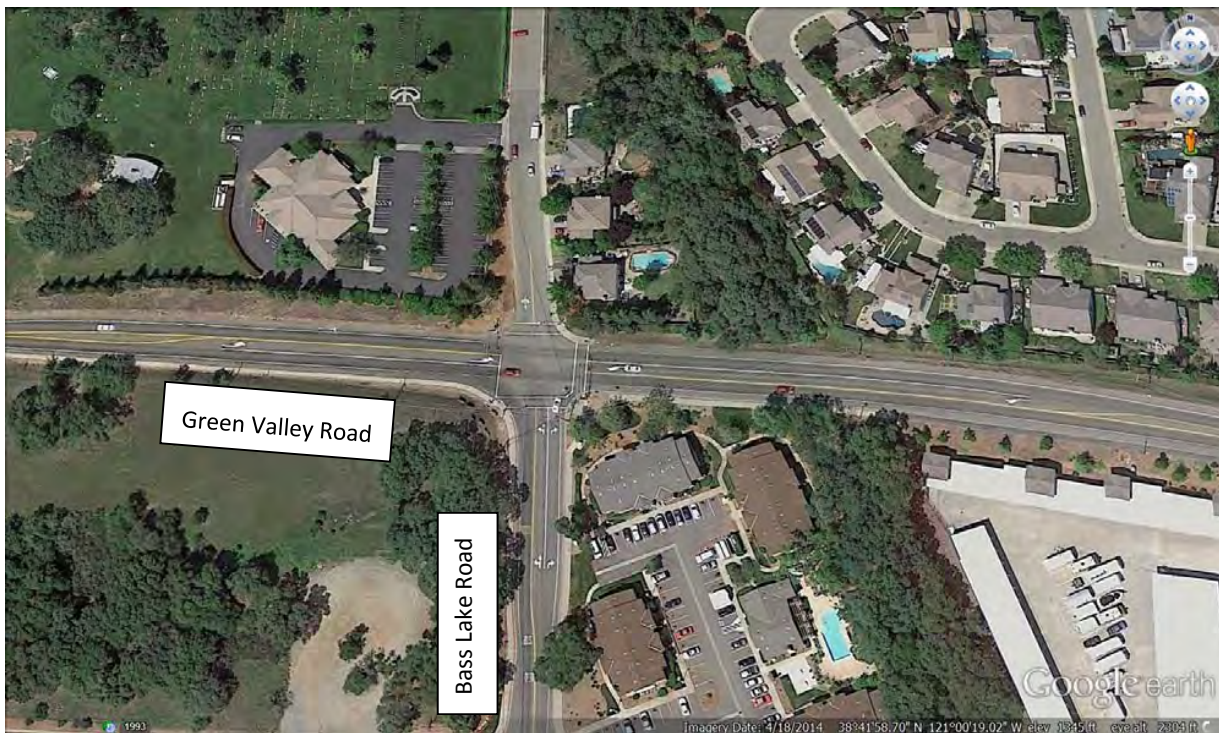
Exhibit 31. Green Valley Road and Bass Lake Road Intersection

The Bass Lake Road intersection is a four-legged signalized intersection. Exhibit 31 shows an aerial of this intersection.

- The intersection has a fair amount of pedestrian activity given Green Valley Elementary School is located just south of the intersection and Pleasant Grove Middle School is west of the intersection.
- The northwest corner of the intersection presents ADA concerns and does not have sidewalks from either approach.
- Pedestrian crossings are prohibited across the west leg of the intersection.
- The northbound and southbound approaches operate with split signal phasing. That means, all movements originating from one direction followed by all movements from the opposing direction.
- There are Class II bicycle lanes on Green Valley Road in both directions approaching and departing the intersection.

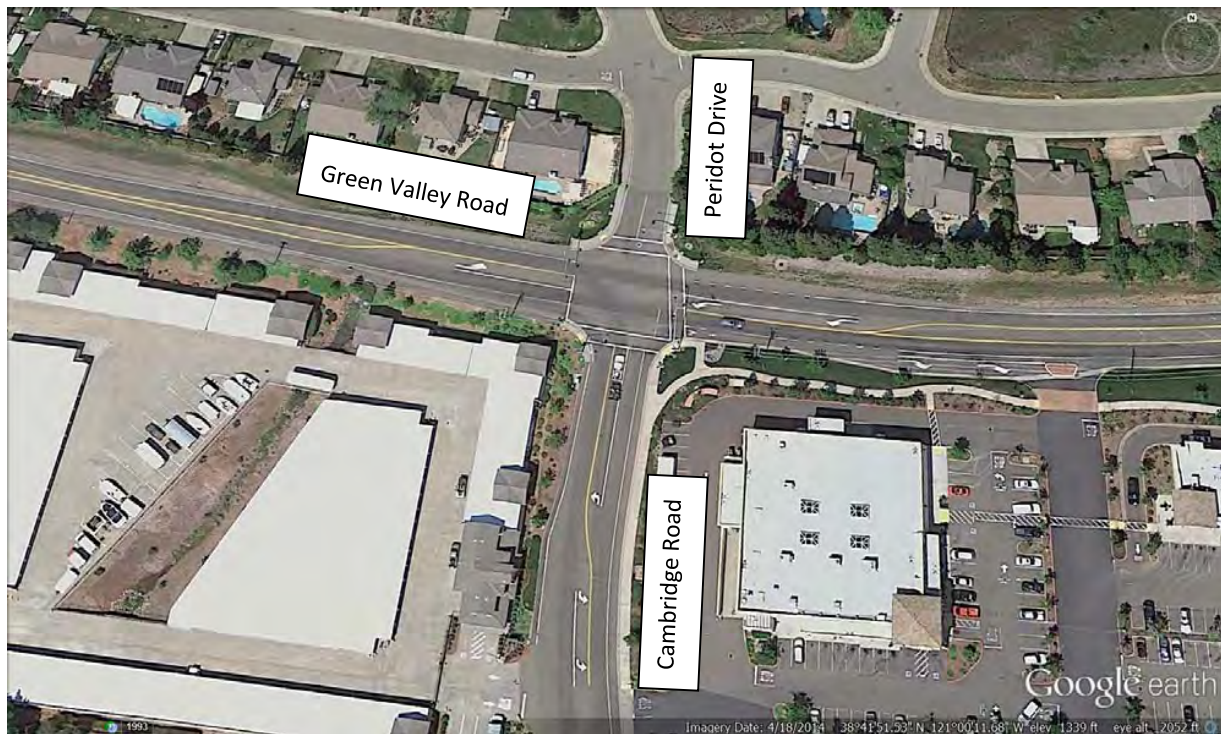
Exhibit 32. Green Valley Road and Cambridge Road/Peridot Drive Intersection

The Cambridge Road/Peridot Drive intersection is a four-legged signalized intersection. Exhibit 32 shows an aerial of this intersection.

- There are Class II bicycle lanes on Green Valley Road in both directions approaching and departing the intersection but no bicycle facilities on Cambridge Road or Peridot Drive.

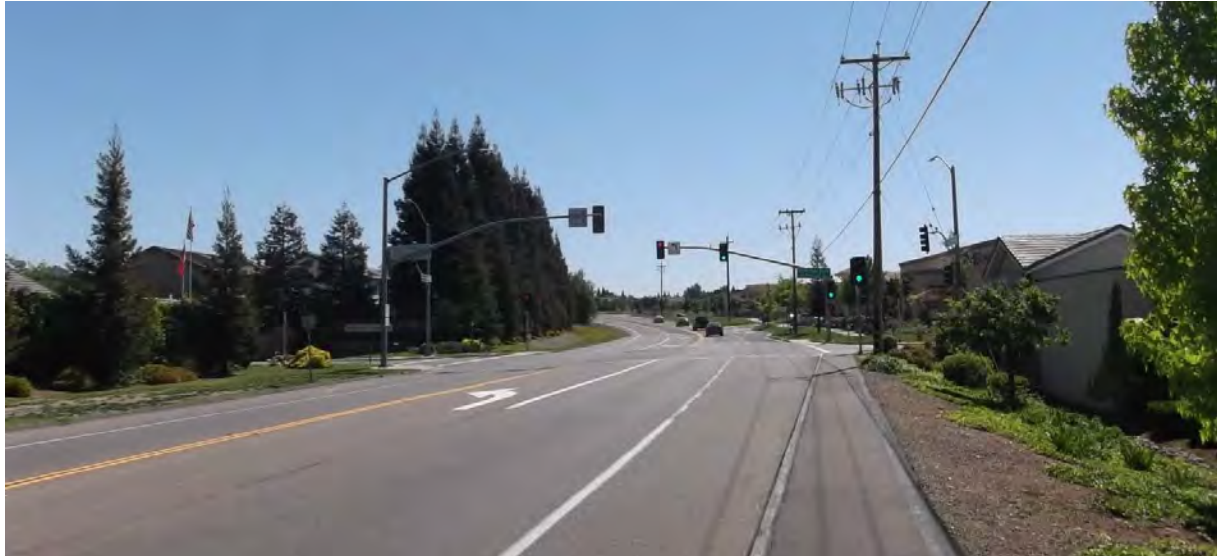
- While the corners of the intersection have been improved and are ADA compliant, there are no sidewalks approaching or departing the intersection on the north side of Green Valley Road. Minimal asphalt paths are provided on the west side of Cambridge Road and the south side of the Green Valley Road approach (see picture below).

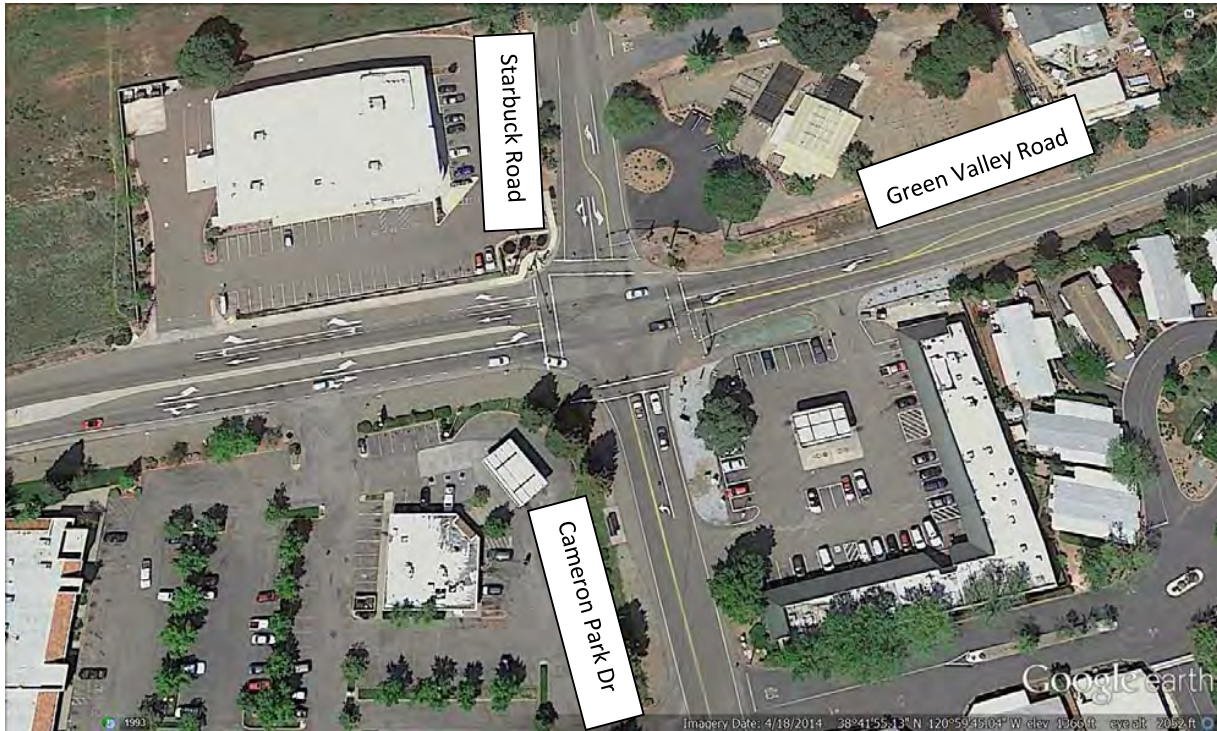
Exhibit 33. Green Valley Road and Cameron Park Drive/Starbuck Road Intersection

The Cameron Park Drive/Starbuck Road intersection is a four-legged signalized intersection. Exhibit 33 shows an aerial of this intersection.

- East of the intersection, Green Valley Road narrows and loses shoulders on both sides.
- There are Class II bicycle lanes on the west leg of the intersection, but no bicycle facilities on any of the other approaches.
- There are sidewalks in the northwest quadrant. The other corners have either no pedestrian facilities or very poorly maintained asphalt paths that are not ADA compliant.
- There is a bus stop on the west side of the Cameron Park Drive approach with no sidewalk (see picture below).

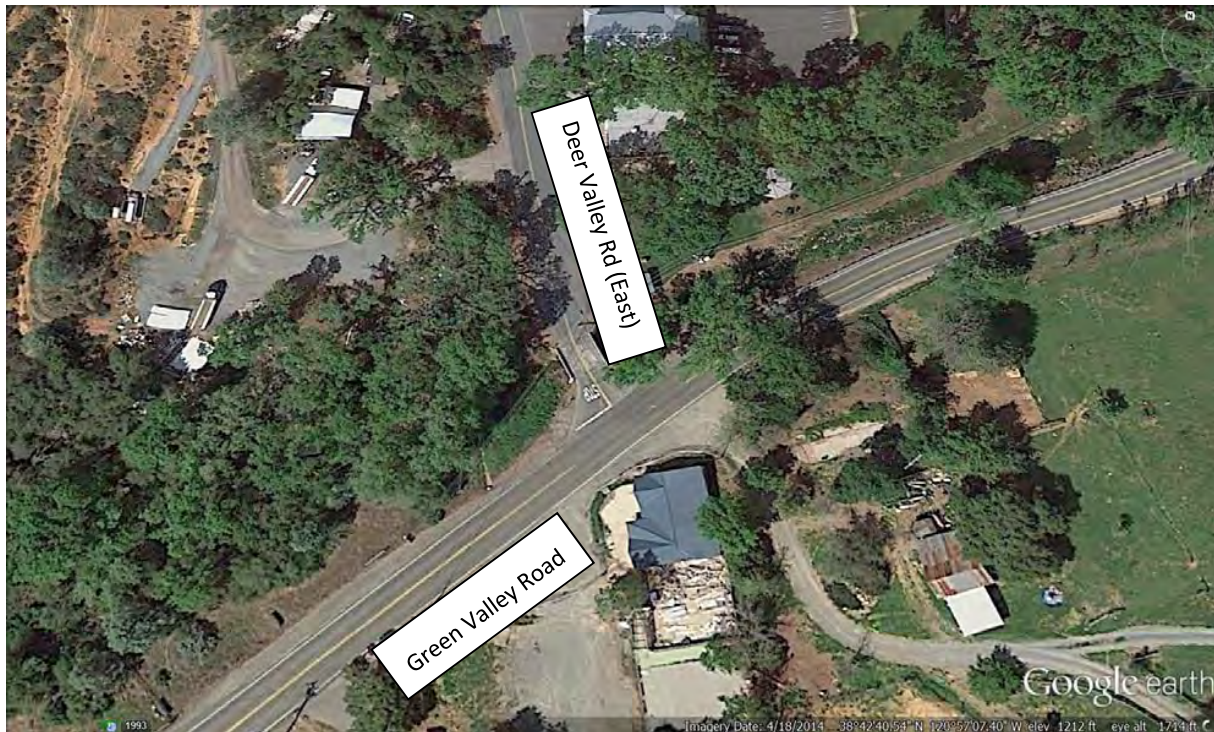
Exhibit 34. Green Valley Road and Deer Valley Road (East) Intersection

The Deer Valley Road (East) intersection is a three-legged intersection with stop-control on the minor approach. Exhibit 34 shows an aerial of this intersection.

- Advance intersection warning signs are installed in both directions on Green Valley Road.
- Green Valley Road is approximately 21-22 feet wide at the intersection.
- The bridge on Deer Valley Road approaching the intersection is narrow at 19 feet across with signs of vehicles scraping the bridge sides in the past (see picture below).

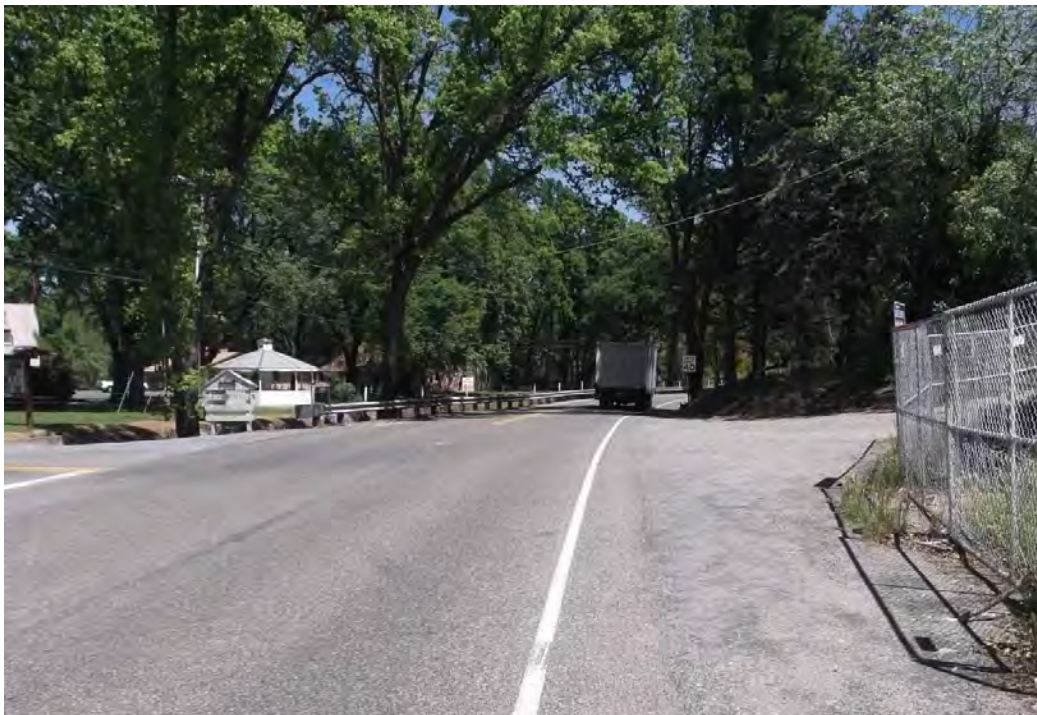
- There are no shoulders on any approach of this intersection.
- Observations indicate that the stopping sight distance for the southbound motorists is limited due to horizontal curvature (see figure below).

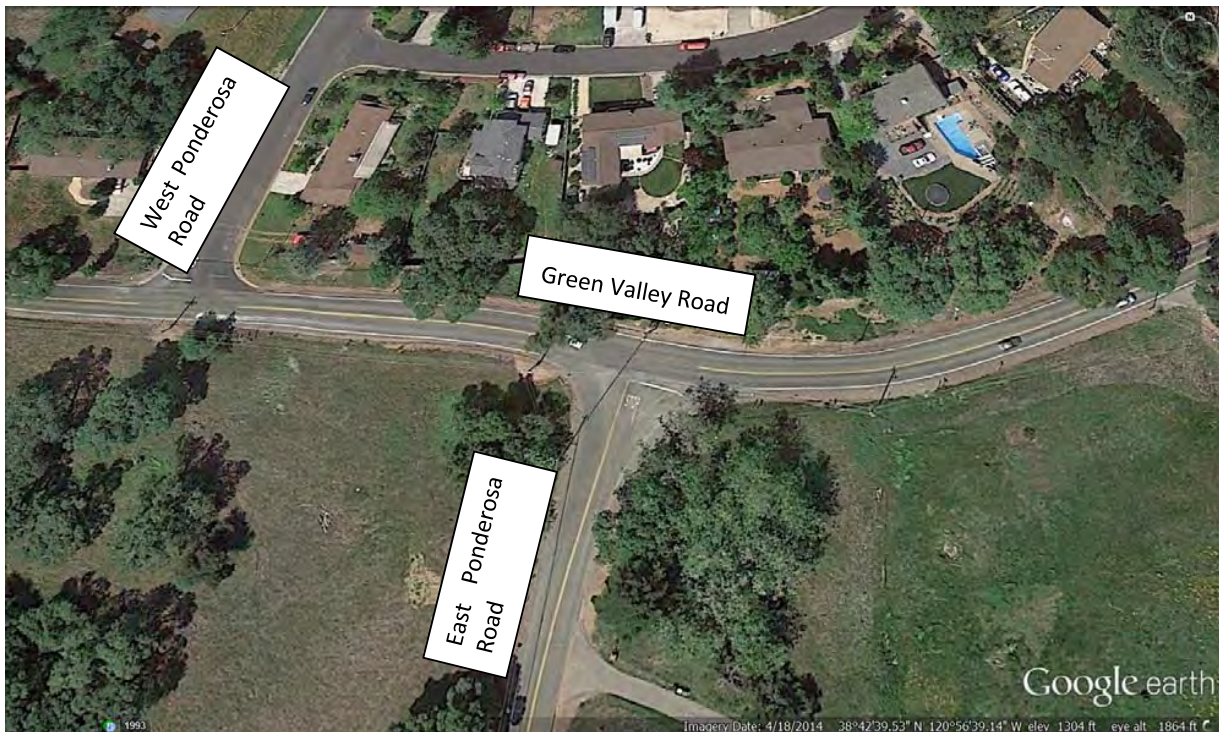
Exhibit 35. Green Valley Road and Ponderosa Road Intersection

The Ponderosa Road intersection is a three-legged intersection with stop-control on the minor approach. Exhibit 35 shows an aerial of this intersection.

- Ponderosa Road (West) is located approximately 285 feet east of Ponderosa Road (East). As such, north and south Ponderosa Road creates an offset intersection with Green Valley Road.
- There is no shoulder along Green Valley Road or Ponderosa Road approaching or departing the intersection (see figure below).

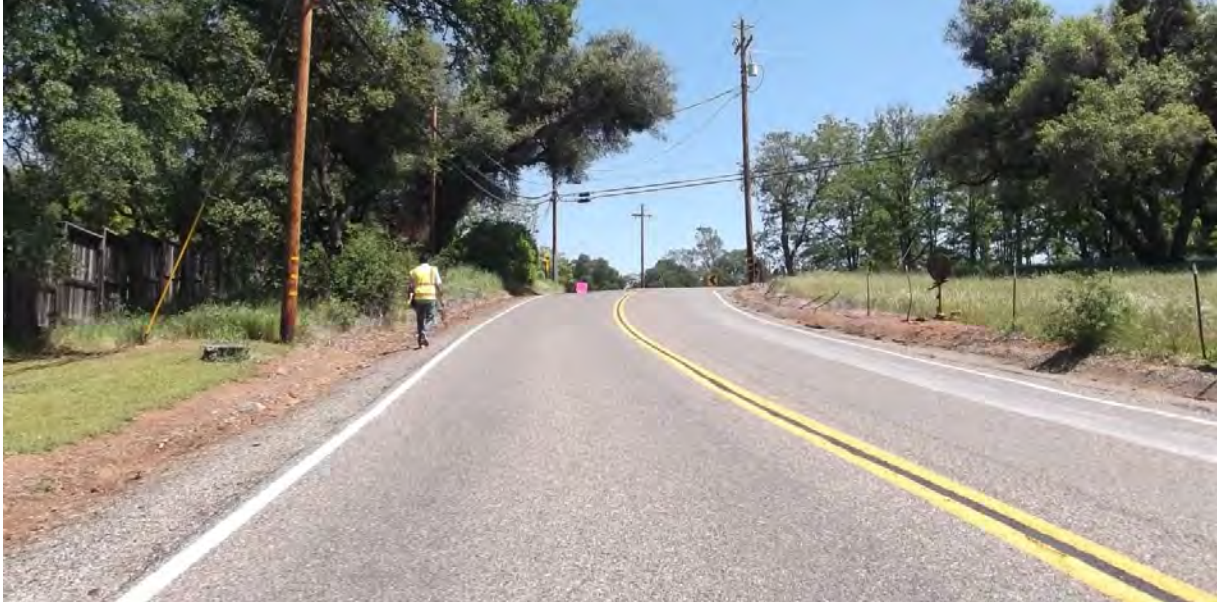
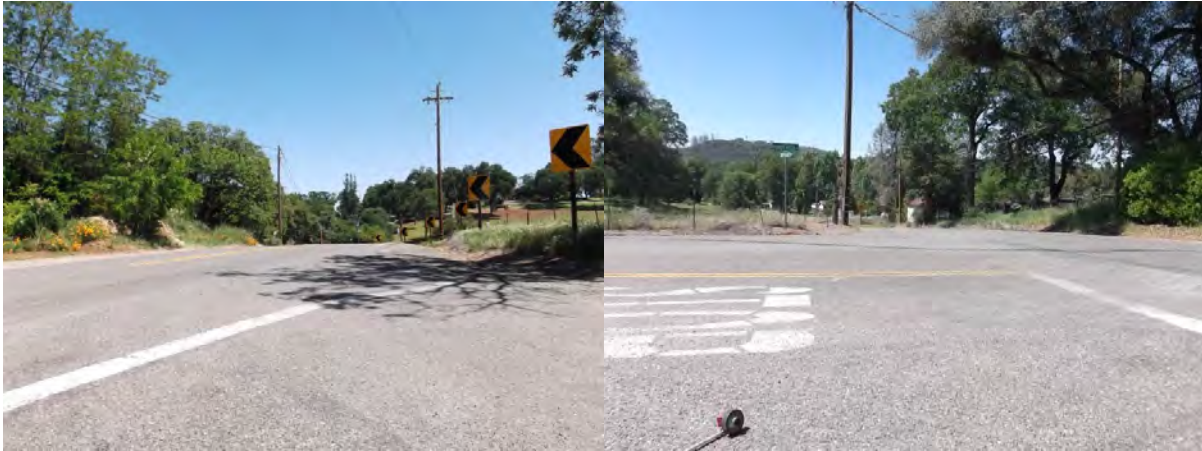
- A traverse rumble strip is installed on the westbound approach to help reduce speeds and increase driver's awareness of the upcoming intersection.
- A vertical crest at the intersection contributes to highly restricted intersection and stopping sight distances at both intersections on Green Valley Road. Green Valley Road has 4.4% and 6.7% grades east and west of this intersection respectively (see figure below).

- Due to the vertical crest and horizontal curvature, several drivers were observed to correct their path of travel once reaching the crest to follow the curve of the road. Chevron signs have been provided to negotiate the path.
- There are no bicycle or pedestrian facilities on any approach of this intersection.
- Green Valley Road is approximately 20-21 feet wide at this intersection.
- Advance intersection warning signs, speed advisory signs, as well as chevron signs are provided on Green Valley Road.
- Delineators are provided in the southwest and southeast corners to define intersection radius. However, there are opportunities to improve them.

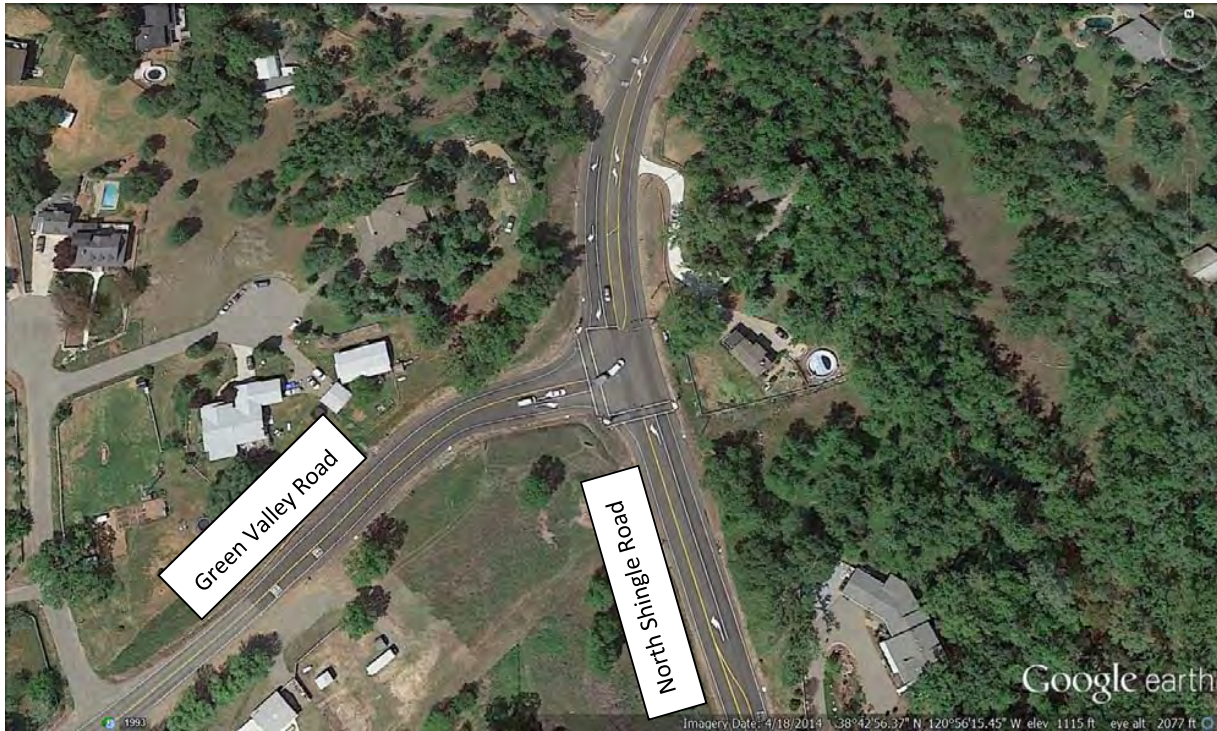
Exhibit 36. Green Valley Road and North Shingle Road Intersection

The North Shingle Road intersection is a three-legged signalized intersection. Exhibit 36 shows an aerial of this intersection.

- Green Valley Road narrows and loses shoulders west of this intersection which is warned by a traffic sign.
- Pedestrian crossings are prohibited on the north leg of the intersection.
- There are no sidewalks on any approach to the intersection beyond a small ADA compliant landing at the corners (see picture below).

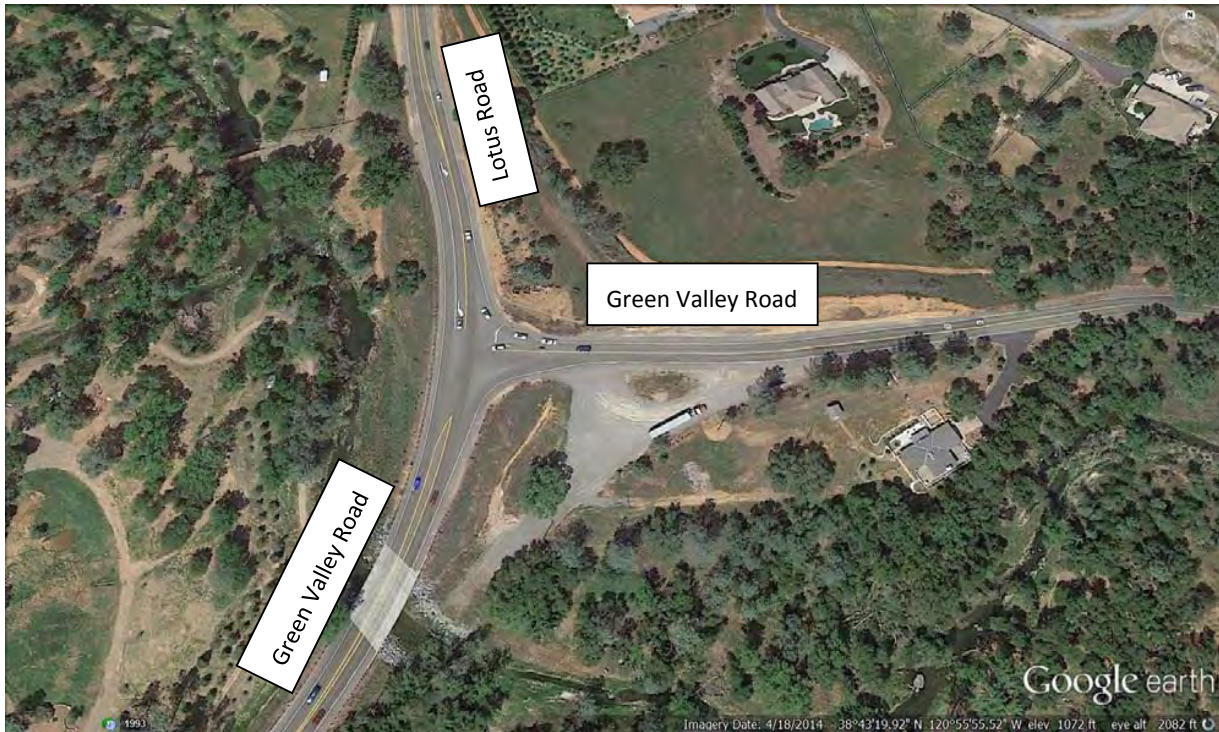
Exhibit 37. Green Valley Road and Lotus Road Intersection

The Lotus Road intersection is a three-legged intersection with stop-control on the westbound Green Valley Road approach. Exhibit 37 shows an aerial of this intersection.

- There are no bicycle or pedestrian facilities on any approach to the intersection;
- Observations indicated that the intersection sight distance from the westbound Green Valley Road approach looking right is limited due to horizontal curvature (see picture below).

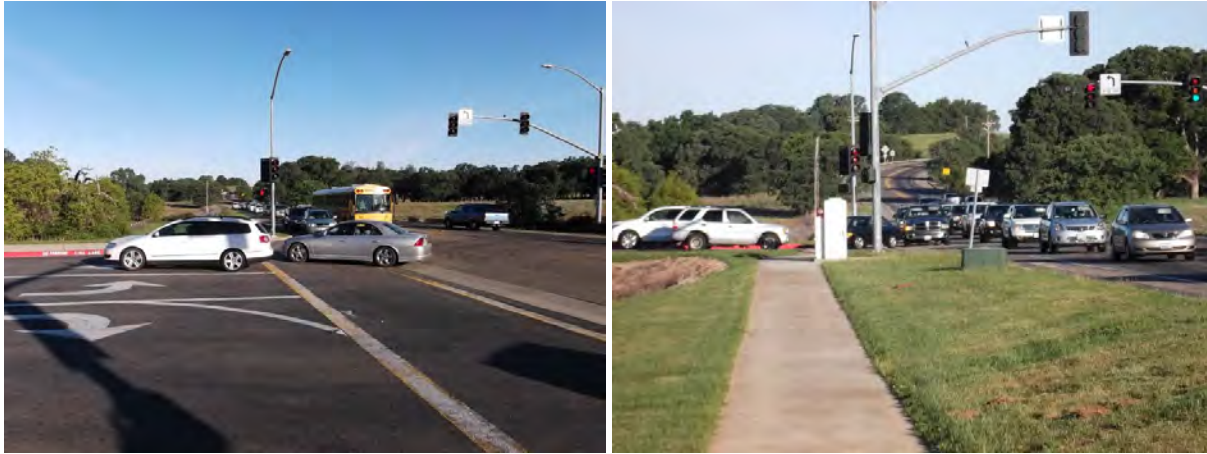
- Most the motorists access the school from the east. Given the western drop-off area is closer to the primary school access, a higher number of parents use this location. Approximately 10 to 12 vehicles were observed to queue up in this area occupying not only the assigned drop-off lane, but also the adjacent pass-by lane. Approximately 10 to 12 vehicles were observed to queue up in the driveway blocking the access the Green Valley Road (see figure below). These queues can also delay the buses from accessing their assigned loading/unloading area.

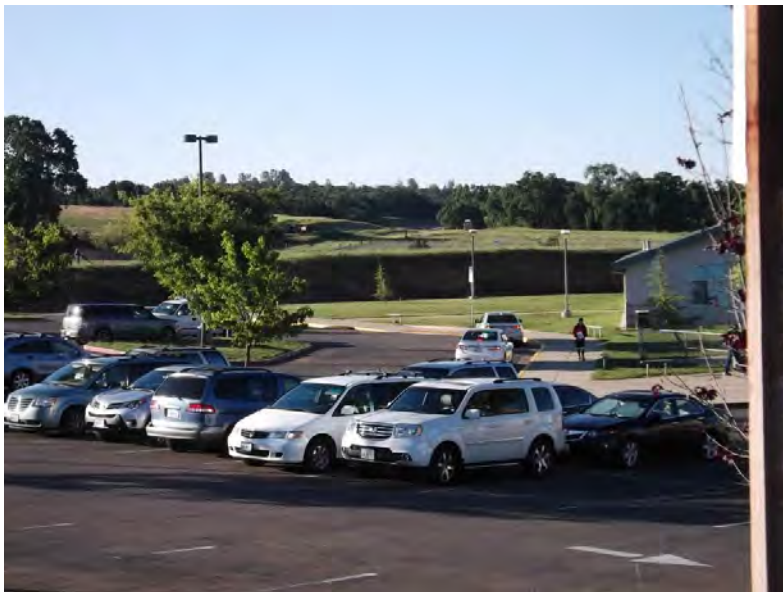
- When the internal circulation activities peak, parents were observed using the pass-by lane at the western drop-off location as well as parking areas. Some parents were also observed to park vehicles and walk their kids to the curbside.
- The eastern drop-off area is relatively underutilized (see picture below). Use of the eastern drop-off location is also possibly influenced by the current closure of the eastern right-out exit only driveway.

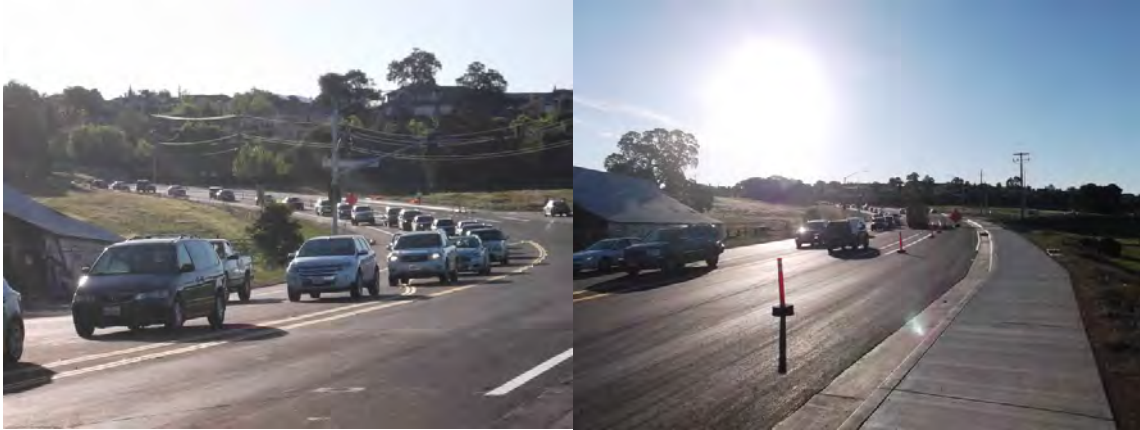
- Some vehicles were using the “red-curbed zone” (where drop-off activities are not allowed) to unload kids.
- Most of traffic exits the school by turning right at the RIRO driveway. Motorists destined to the west must use the signalized driveway.
- While County staff have modified the signal timing of the Pleasant Grove Middle School access to provide a longer green time for the westbound Green Valley Road left-turn phase (current timing sheets provide a maximum of 25 seconds of green time), there are still significant operational issues at this intersection. The westbound Green Valley Road left-turn queues at the

primary school access extend beyond the newly constructed Silver Springs Parkway. The queues lengths sometimes reach Bass Lake Road (see pictures below) which is three-quarters of a mile east of the primary school access. According to Rescue Union School District Superintendent and staff, additional internal striping has been added to the school site since the field review and the westbound left-turn queues in the AM peak have noticeably decreased.

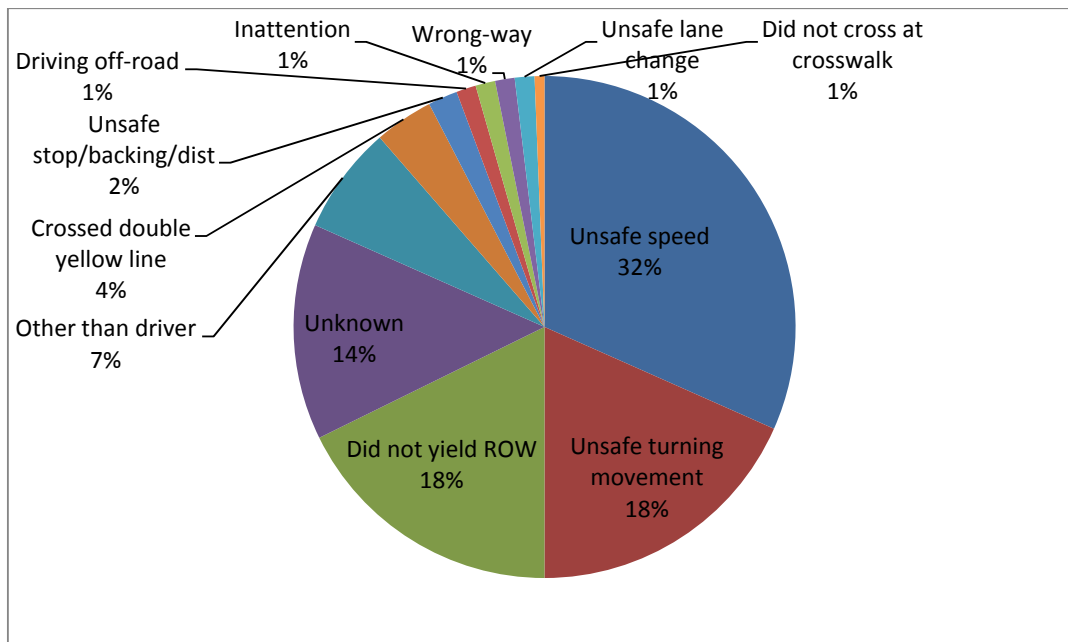
The crash data includes 12 contributing factors for crashes along the corridor. Approximately one-third of crashes along the corridor cited “unsafe speed” as a contributing factor for the crash. Unsafe speed was cited as the contributing factor for approximately 70 percent of all reported rear-end crashes, the most common crash type. “Unsafe turning movement” and “Did not yield right of way (ROW)” accounted for 36 percent of reported crashes. These crashes generally involved vehicles making left or right turns at intersections. “Other than driver” is noted as a crash factor when the police officer determined that the crash was unavoidable or did not result from the driver’s fault. Eighty percent of the “Other than driver” crashes note hitting an animal as a factor contributing to the incident. Contributing factors of crashes on the roadway segments and at the intersections are discussed further in the Contributing Factors by Location section of the report.
