Caltrans Wildlife Connectivity Studies in El Dorado County

Caltrans North Region Environmental

Reconnecting Northern California Terrestrial Habitats: Caltrans North Region Wildlife Connectivity Projects

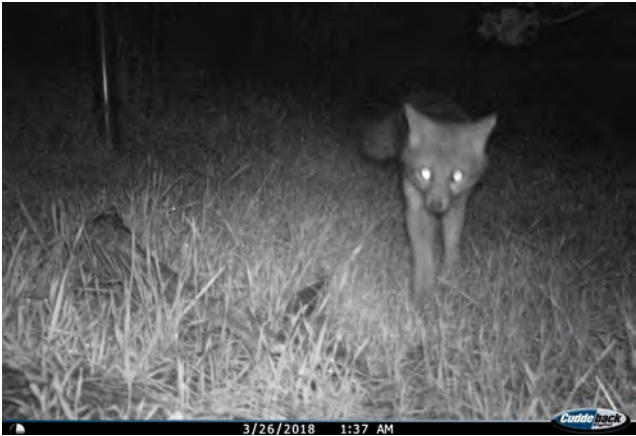
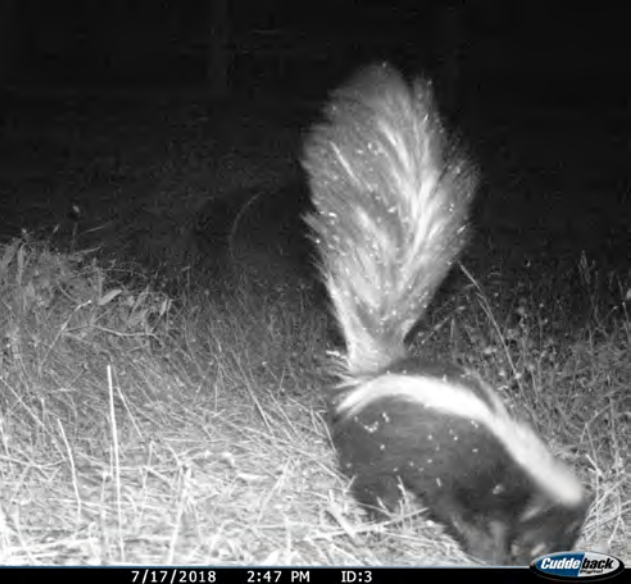
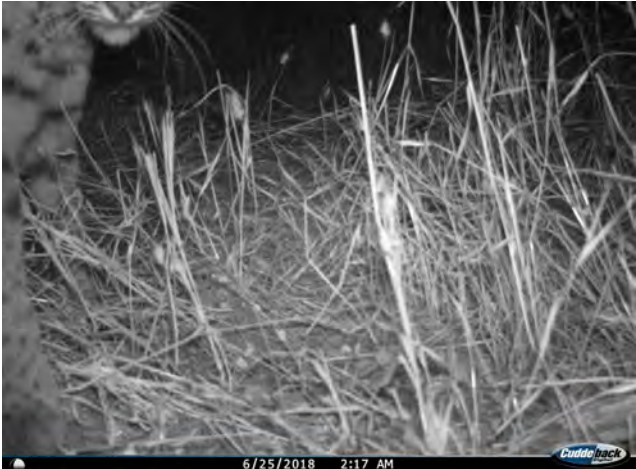
Wildlife camera studies

- Study several potential wildlife crossing locations over several years during the project planning stage
- Install permanent cameras after wildlife crossing is constructed to monitor success

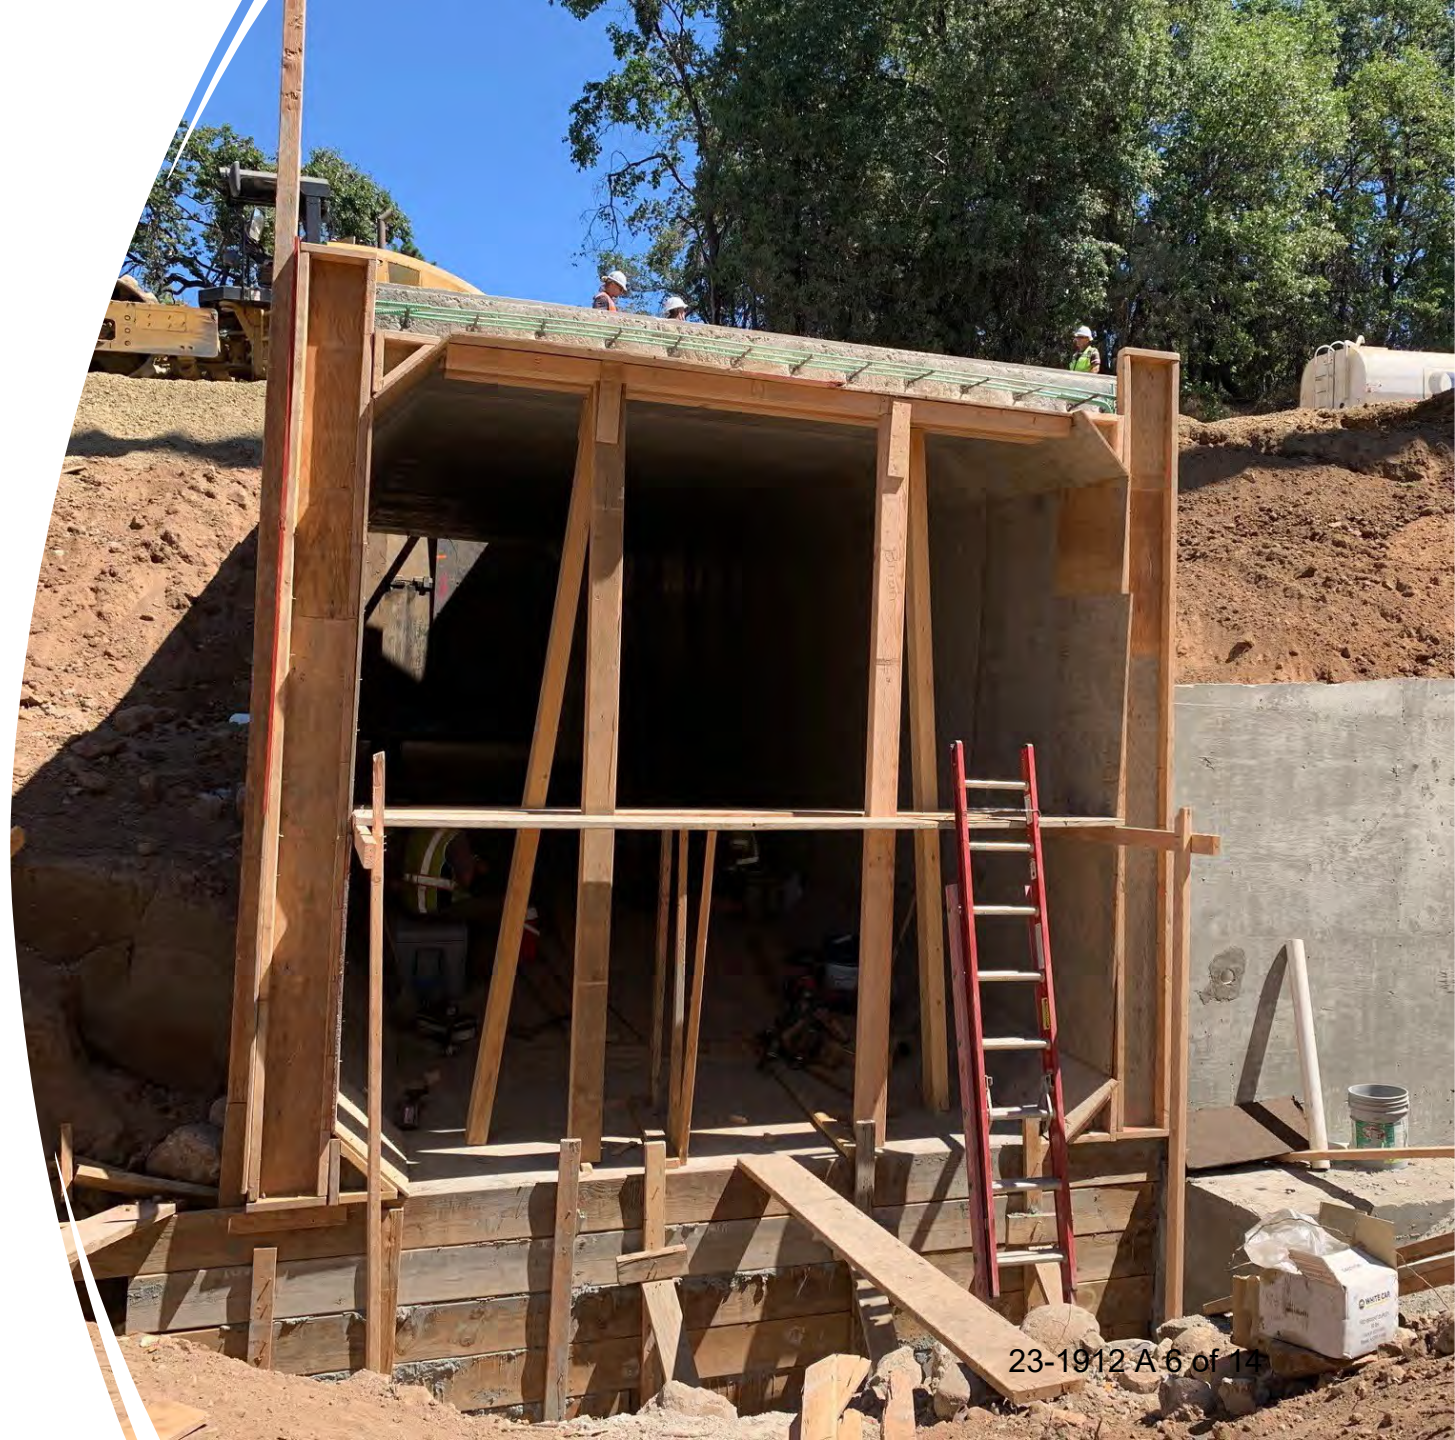
How do we design crossings?

- Design elements:
 - 12'x12' box culverts are most common (we also use bridges, overcrossings, and other culvert sizes)
 - Wildlife fencing
 - Wildlife escape ramps
 - Wildlife passageways in median barrier
 - Wildlife cameras (monitoring)
- Design/location considerations:
 - Topography
 - Surrounding land use
 - Habitat type
 - Project limits

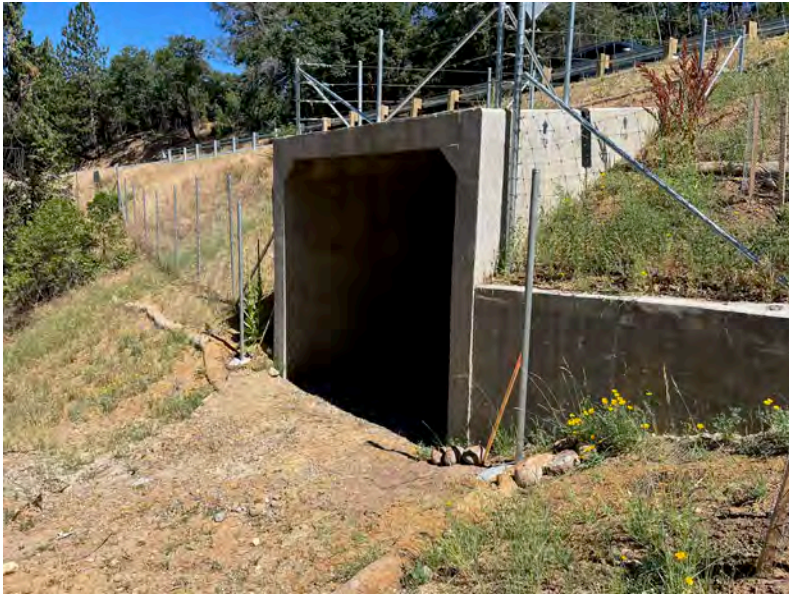
Wildlife undercrossing (12'x12')

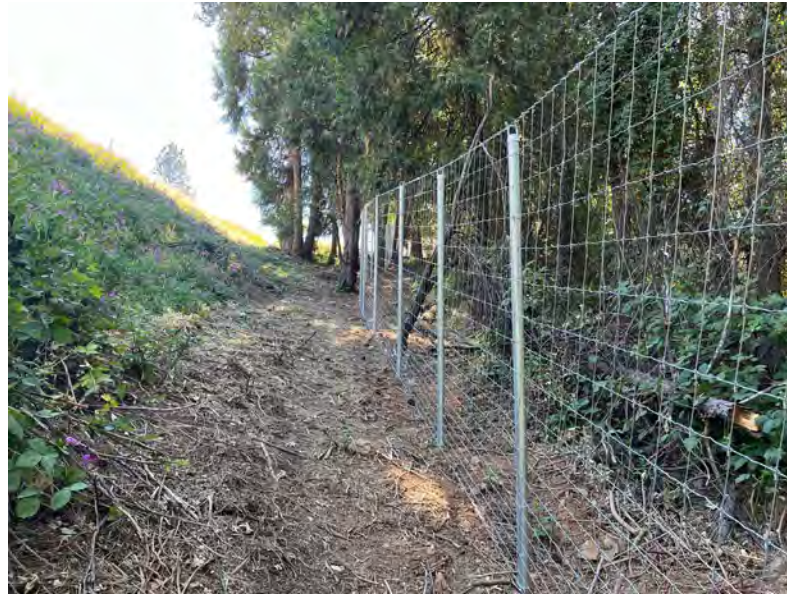
8' tall wildlife fence

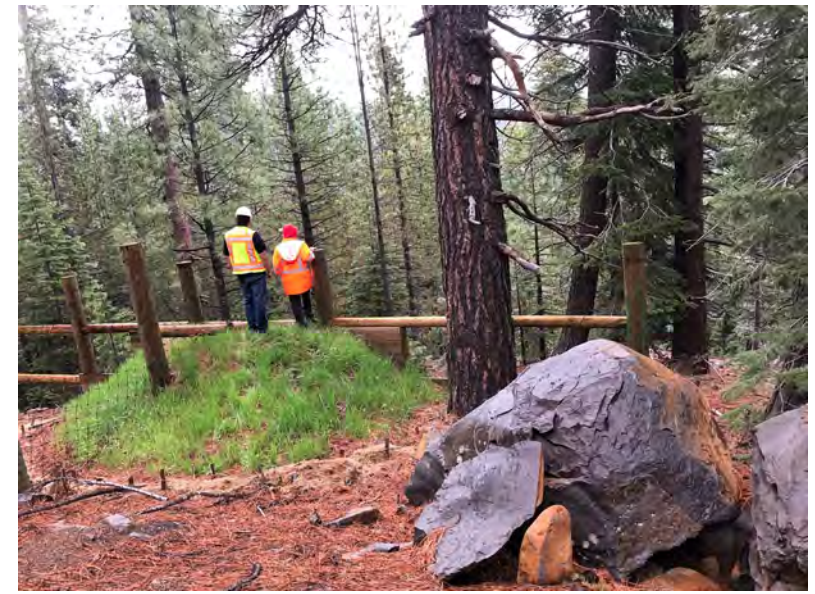
Escape ramps or "jump outs"

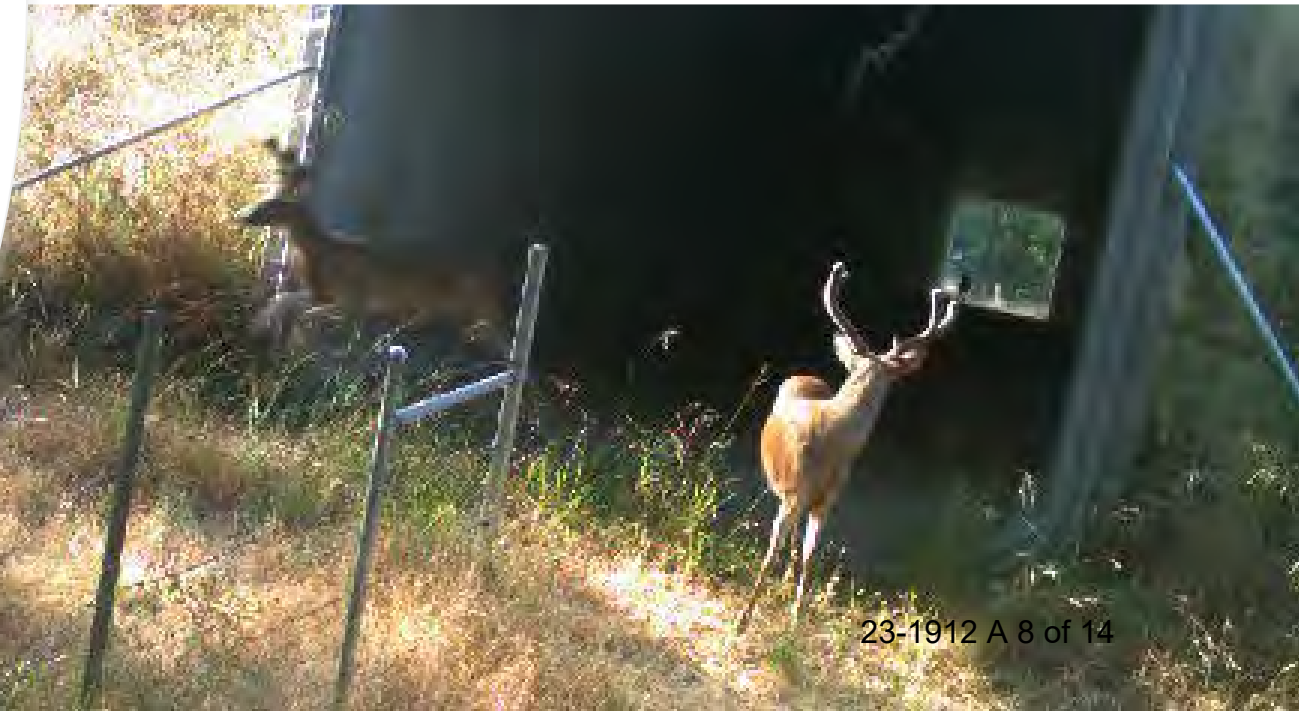
Greenstone Crossing

- Construction was completed September 2012
 - 12'x12'x200' box culvert
 - 8' tall wildlife fencing
- UC Davis monitored crossing 2012-2018
- Species:
 - Deer (over 2,000 observations)
 - Raccoon
 - Skunk
 - Turkey
 - Fox
 - Bobcats
- New: bats!
- Caltrans began monitoring again in 2023

Greenstone
Location: ED 50 – PM 13.47
Type: Reinforced Concrete Box Culvert
Constructed in 2012

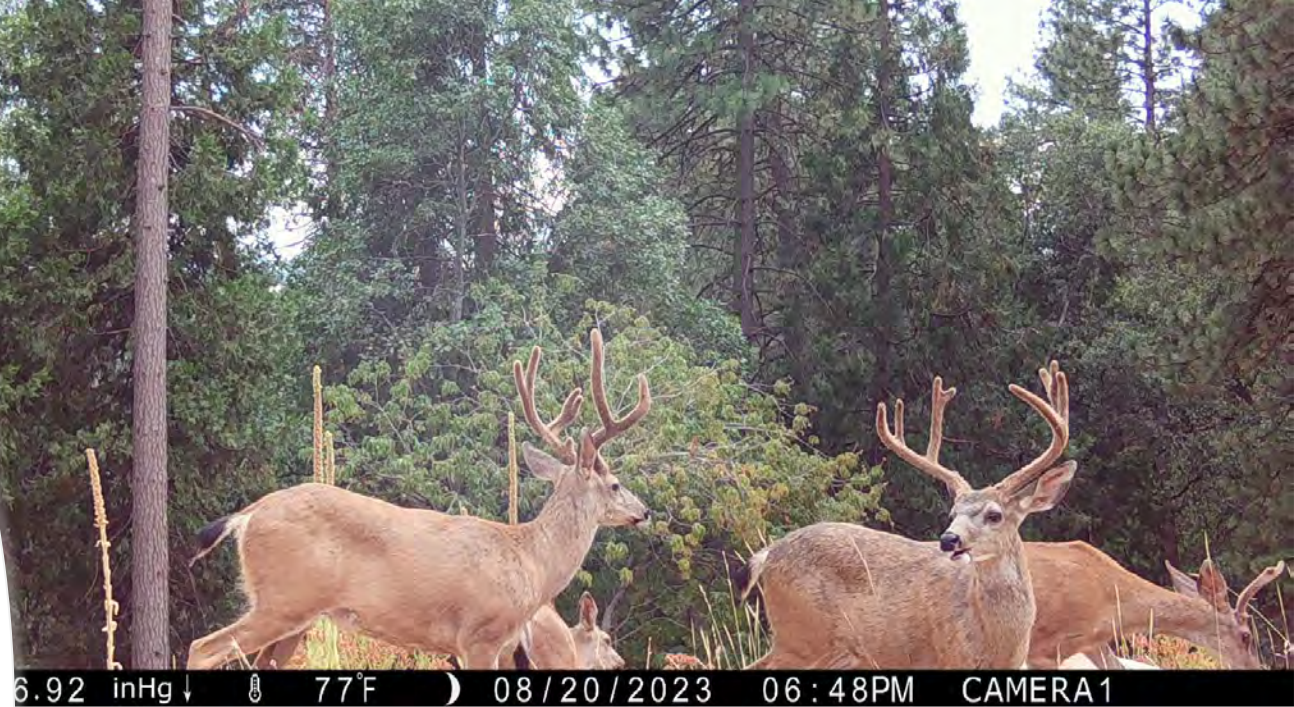
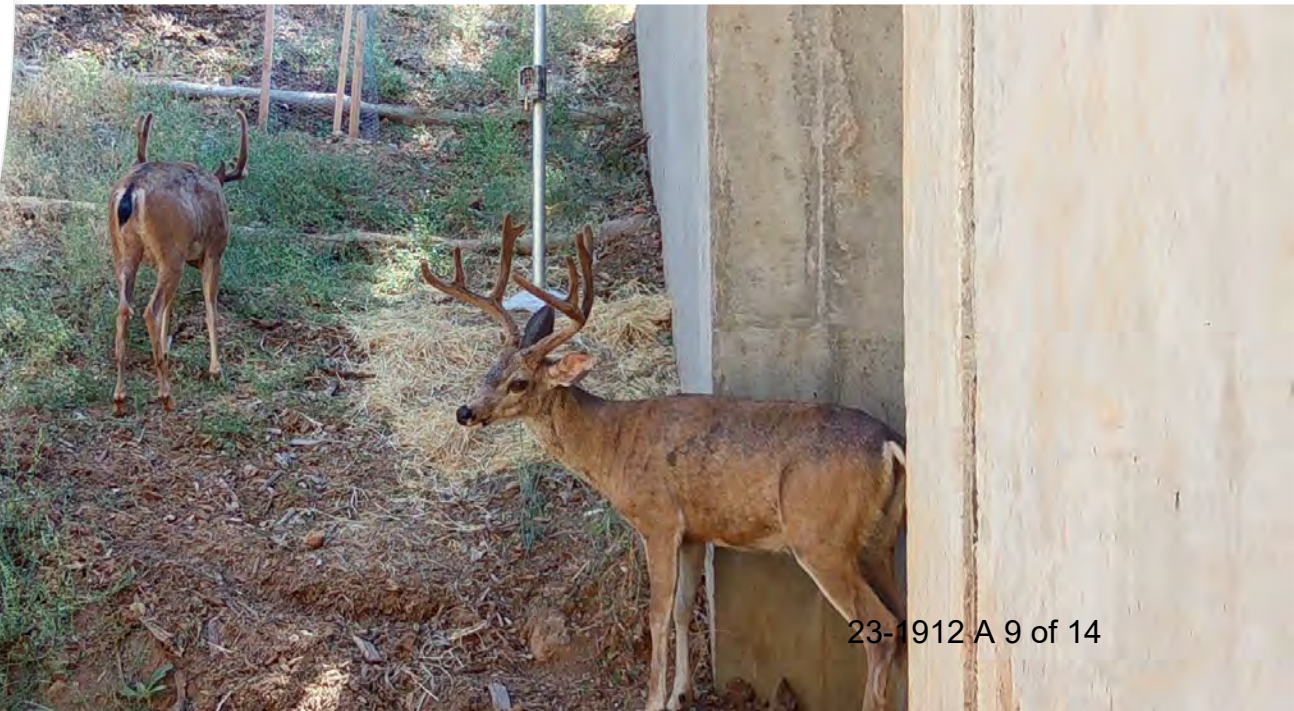
Camino Crossing

- Construction completed 2023
- Camera monitoring began August 2023
- Successful: daily use from deer
- Design elements:
 - 12'x12'x110' box culvert
 - 2 escape ramps
 - 6 permanent wildlife camera posts
 - 8' tall wildlife fencing
 - Wildlife passages in concrete median barrier

Camino Safety Project
Location: ED 50 – PM 22.56
Type: Reinforced Concrete Box Culvert
Currently in Construction
