MUP25-0002 Hasser Spa Exhibit D: Record of Survey

MUP25-0002 Hasser Spa
Exhibit E: Site Plan

MUP25-0002 Hasser Spa
Exhibit F - Biological Report

Final Biological Evaluation for Spa Electrical Connection Installation Project
Assessor ID Number 105-080-08

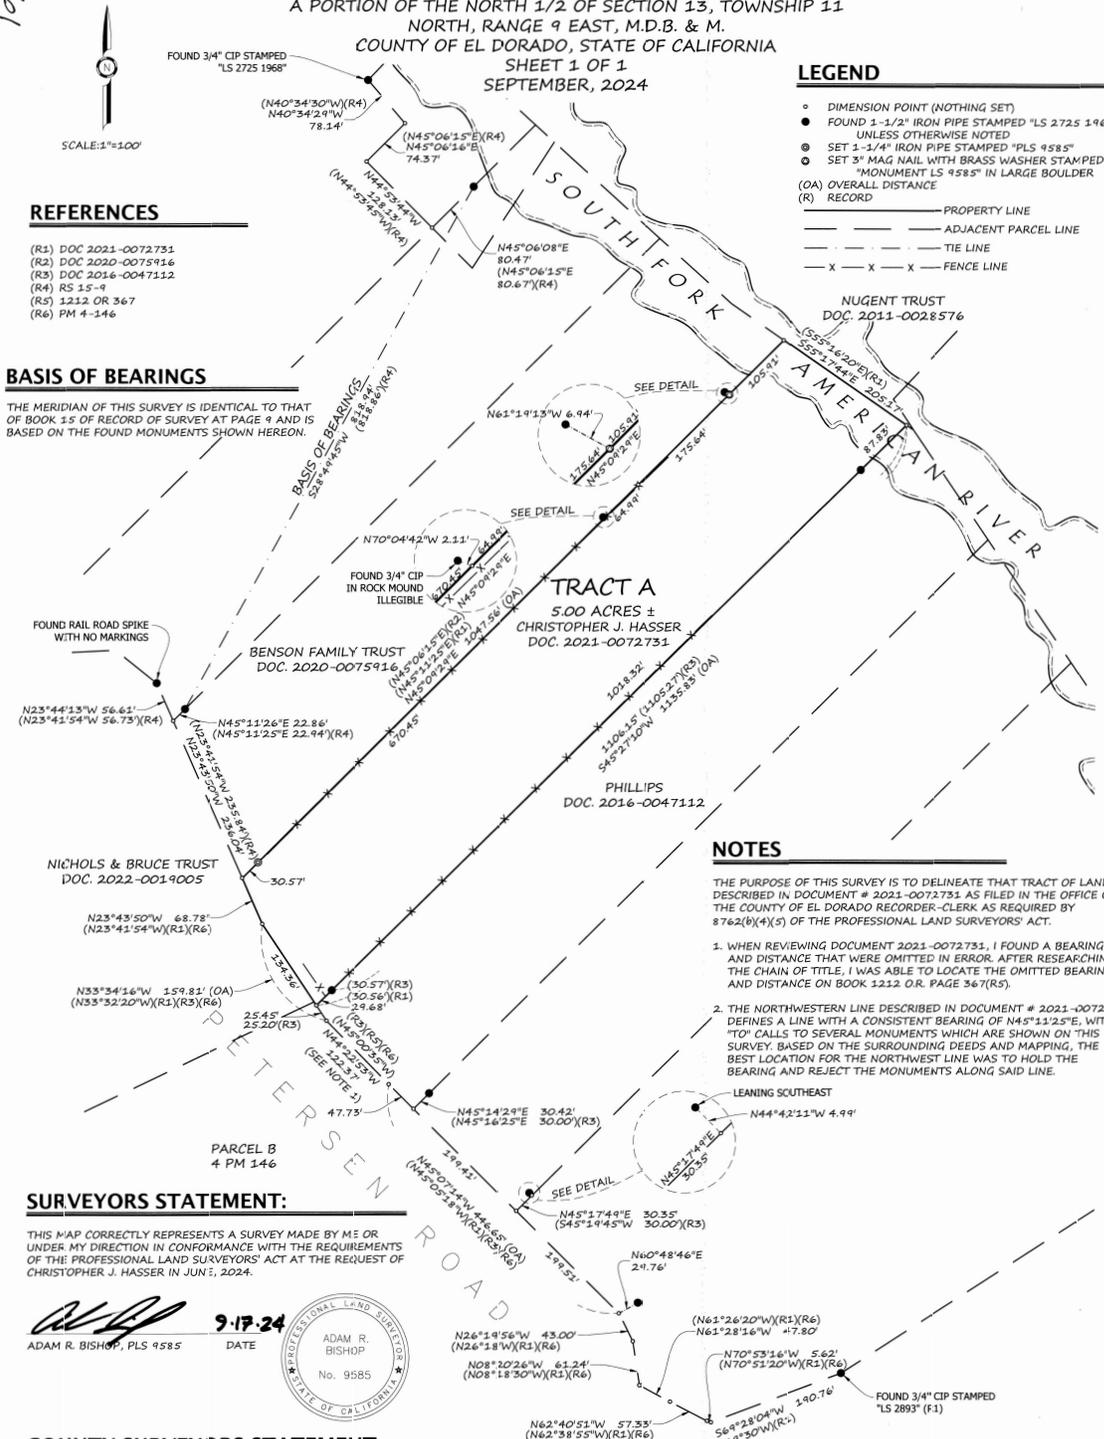
RECORD OF SURVEY

A PORTION OF THE NORTH 1/2 OF SECTION 13, TOWNSHIP 11 NORTH, RANGE 9 EAST, M.D.B. & M. COUNTY OF EL DORADO, STATE OF CALIFORNIA SHEET 1 OF 1 SEPTEMBER, 2024

- THE PURPOSE OF THIS SURVEY IS TO DELINEATE THAT TRACT OF LAND DESCRIBED IN DOCUMENT # 2021-0072731 AS FILED IN THE OFFICE OF THE COUNTY OF EL DORADO RECORDER-CLERK AS REQUIRED BY 8762(b)(4)(5) OF THE PROFESSIONAL LAND SURVEYORS' ACT.
1. WHEN REVIEWING DOCUMENT 2021-0072731, I FOUND A BEARING AND DISTANCE THAT WERE OMITTED IN ERROR. AFTER RESEARCHING THE CHAIN OF TITLE, I WAS ABLE TO LOCATE THE OMITTED BEARING AND DISTANCE ON BOOK 1212 O.R. PAGE 367(R5).
 2. THE NORTHWESTERN LINE DESCRIBED IN DOCUMENT # 2021-0072731 DEFINES A LINE WITH A CONSISTENT BEARING OF N45°11'25"E, WITH "TO" CALLS TO SEVERAL MONUMENTS WHICH ARE SHOWN ON THIS SURVEY. BASED ON THE SURROUNDING DEEDS AND MAPPING, THE BEST LOCATION FOR THE NORTHWEST LINE WAS TO HOLD THE BEARING AND REJECT THE MONUMENTS ALONG SAID LINE.

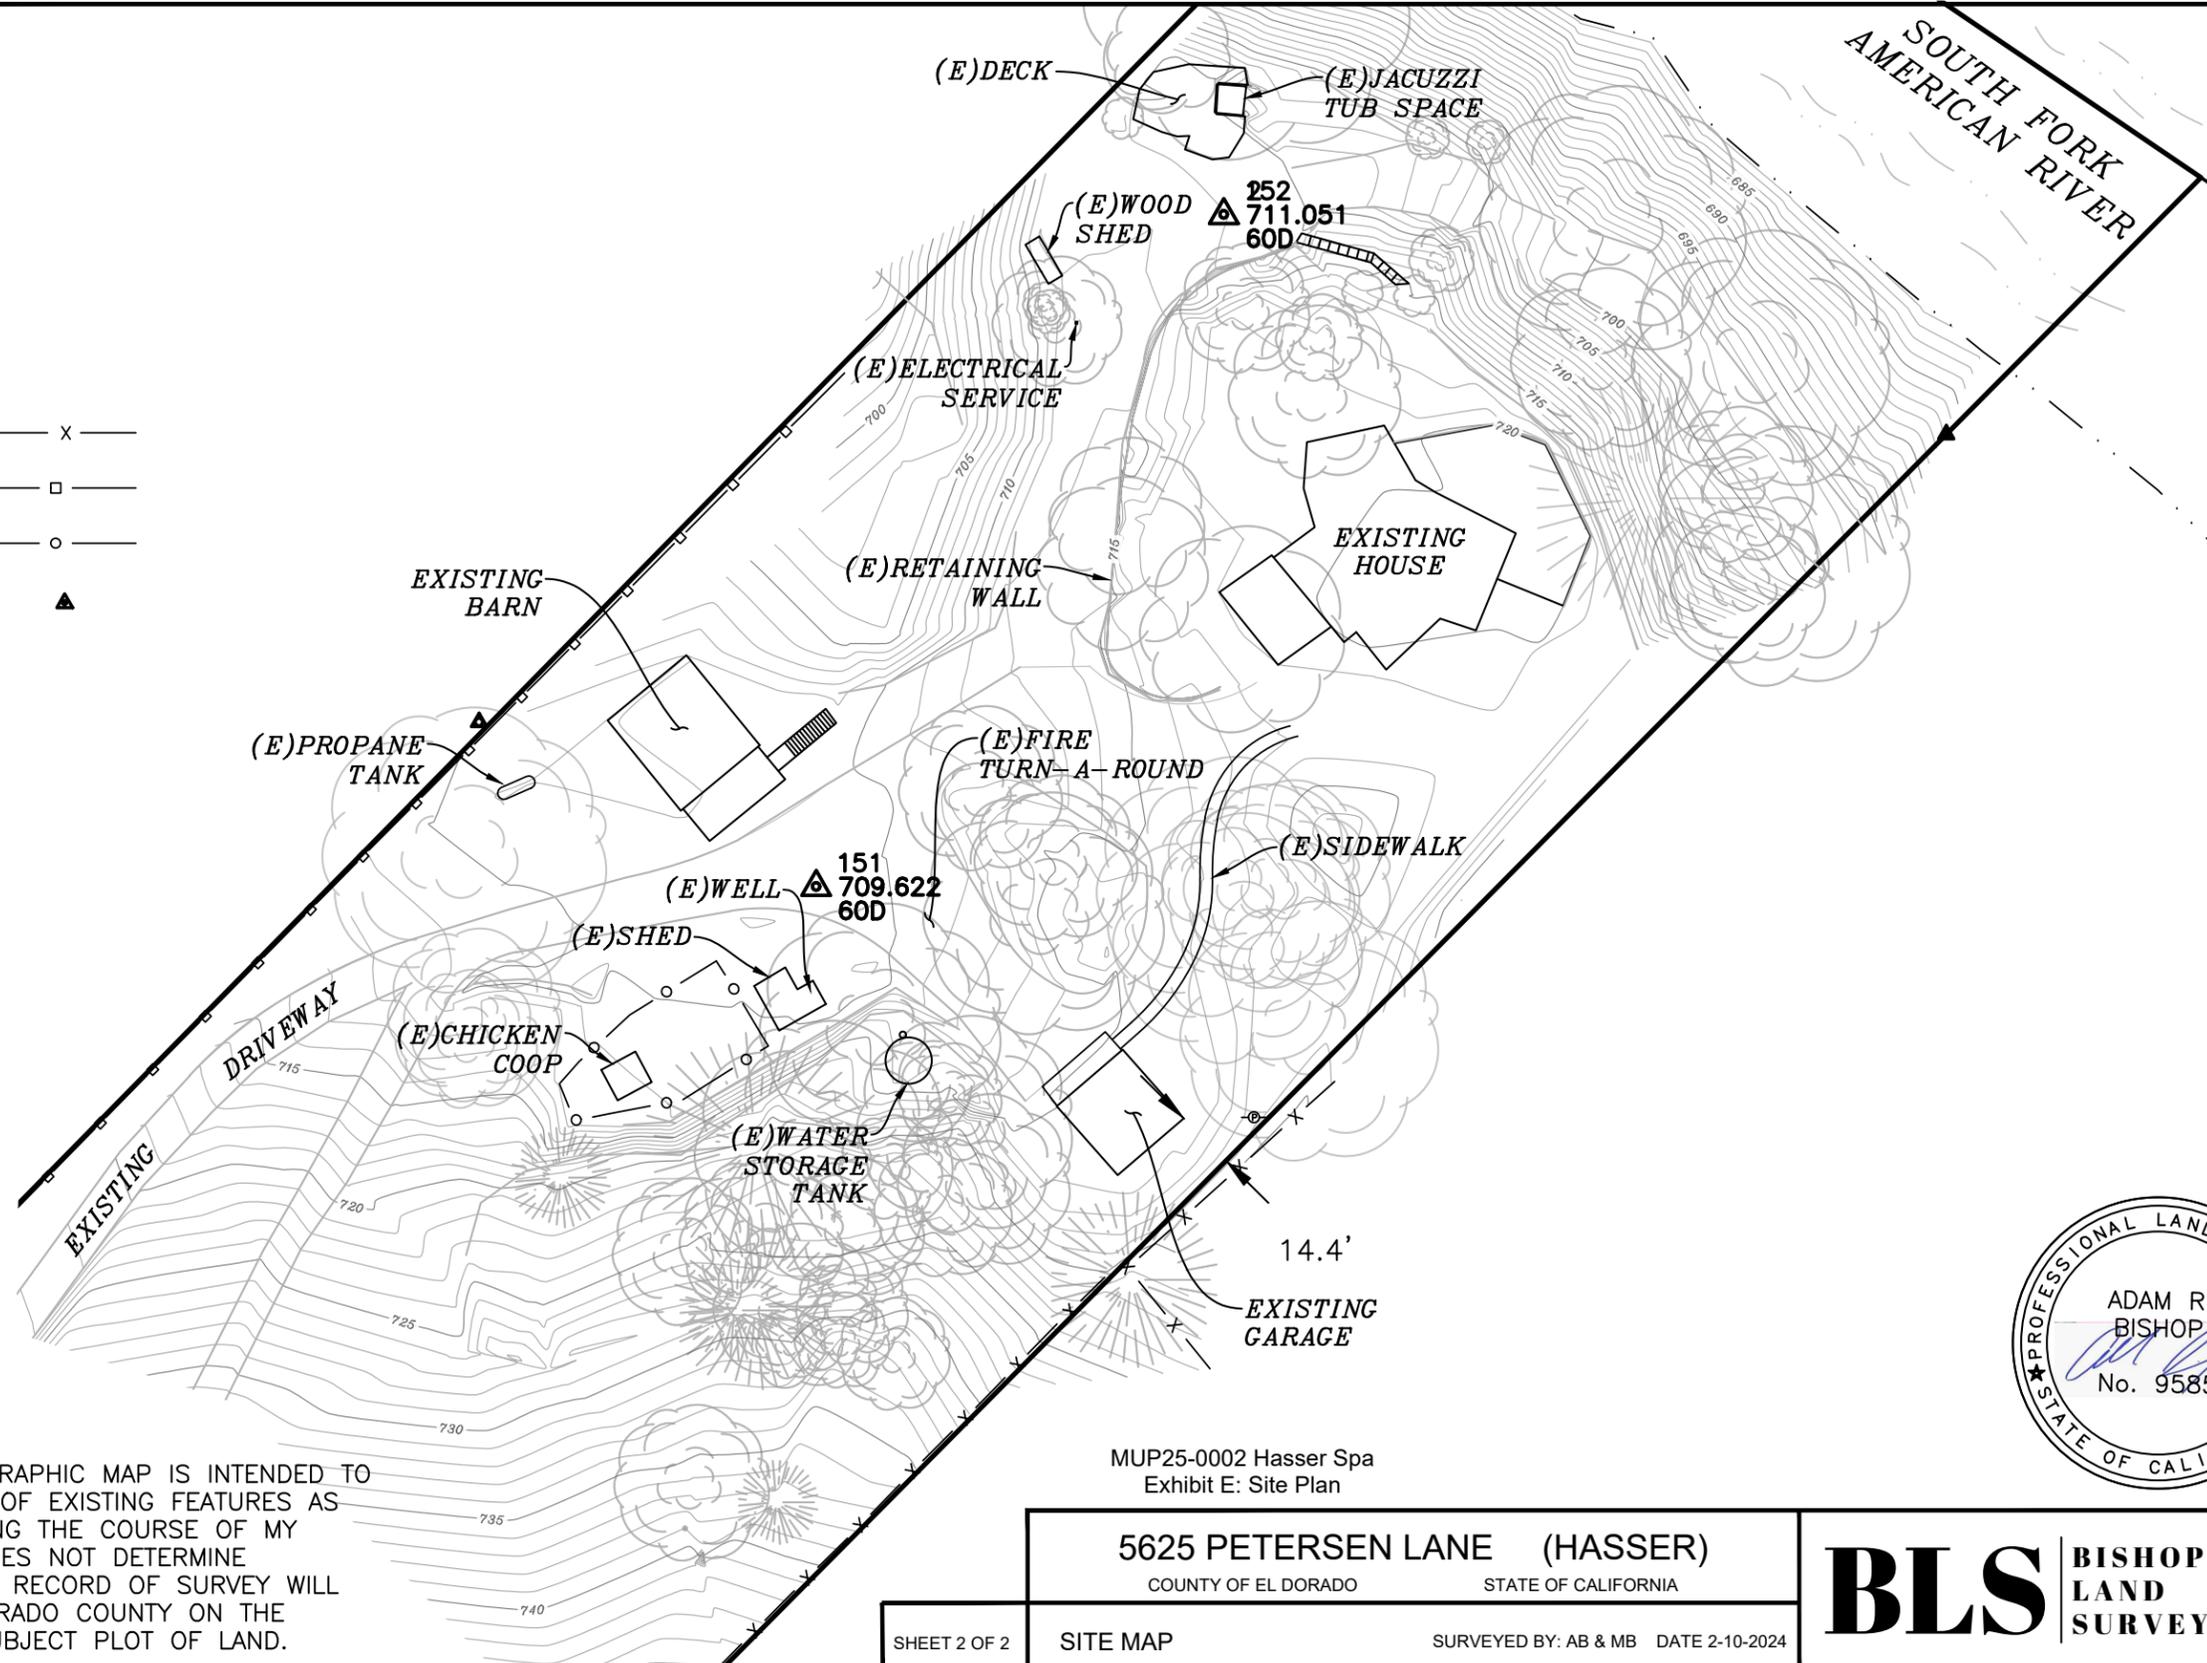
NOTE: THIS TOPOGRAPHIC MAP IS INTENDED TO PROVIDE THE LAYOUT OF EXISTING FEATURES AS FOUND ON SITE DURING THE COURSE OF MY SURVEY. THIS MAP DOES NOT DETERMINE OWNERSHIP RIGHTS. A RECORD OF SURVEY WILL BE FILED WITH EL DORADO COUNTY ON THE BOUNDARY OF THE SUBJECT PLOT OF LAND.

SITE MAP

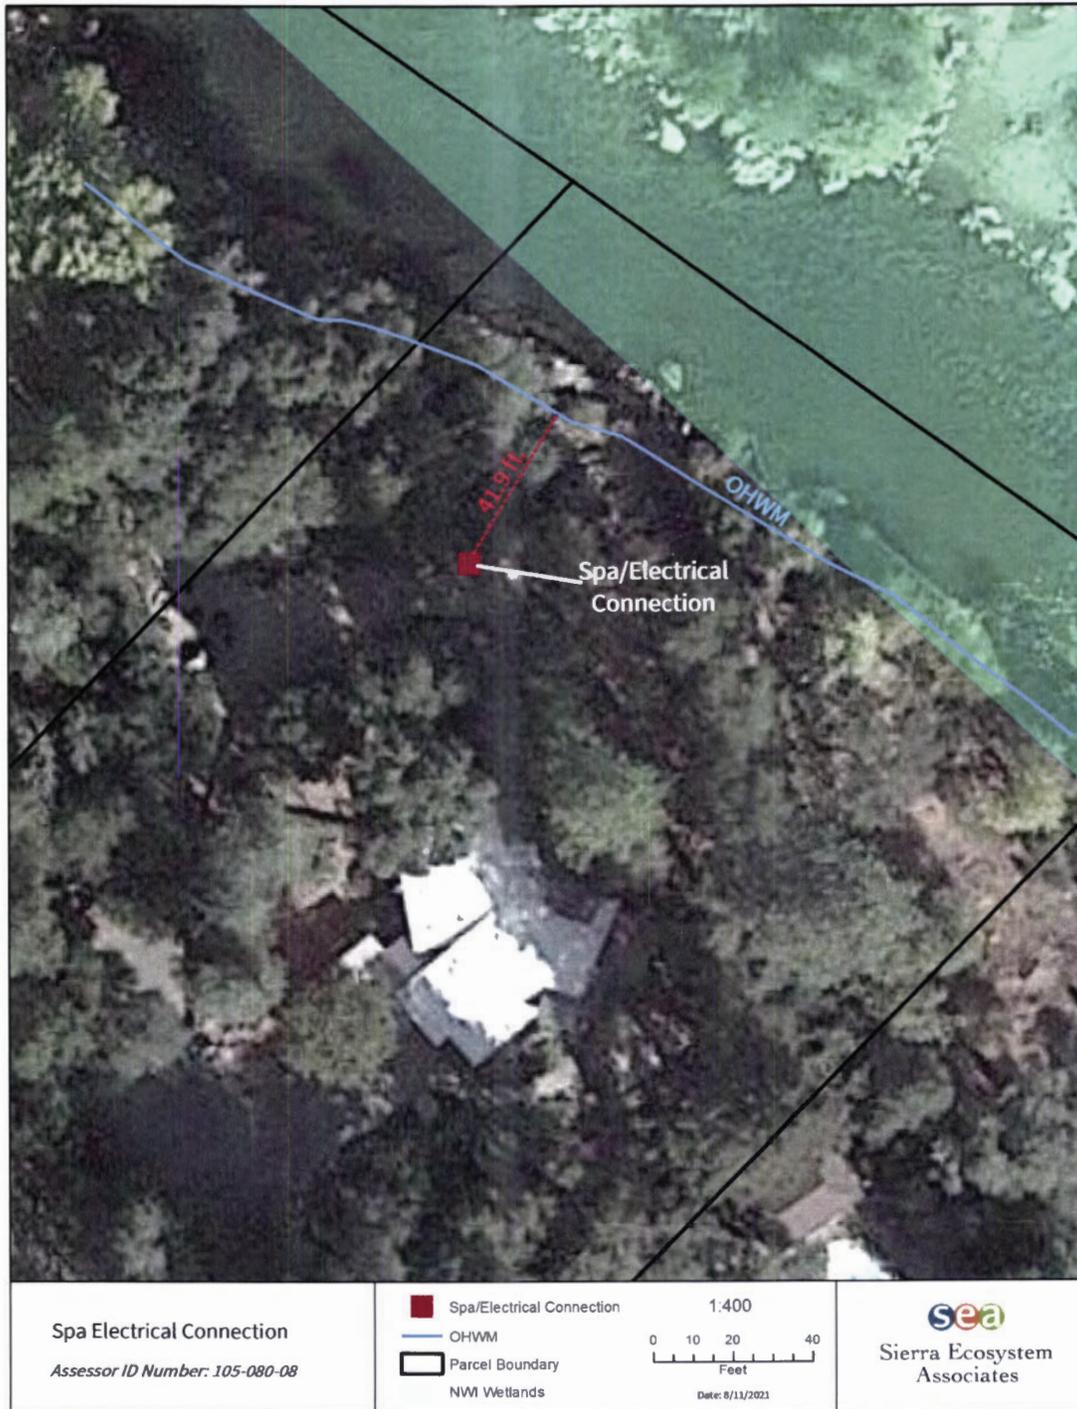
Figure 1. Site Map

Prior to the field survey, SEA staff conducted an aerial imagery analysis of the parcel and review of General Plan Policy 130.30.30.050 G, Protection of Wetlands and Sensitive Riparian Habitat; Wetlands and Perennial River Buffer. The policy requires a 50-foot buffer from a perennial stream and 100-foot buffer from specific rivers including the South Fork American River. On July 30, 2021, SEA Senior Biologist, Jeremy Waites, conducted a field survey of the Project area. Points taken were with a sub-meter GPS unit at the spa and electrical receptacle and at 10-foot intervals along the OHWM within the Project parcel. In addition to the GPS points, horizontal distance between the determined OHWM and the Project was calculated using a tape measure for additional accuracy and to account for potential GPS errors. These points were uploaded and post-processed for accuracy using GIS software. The approximate position of the spa, County parcel data and National Wetland Inventory (NWI) shapefiles were added to create the map in Figure 1.

No jurisdictional determinations of wetland boundaries were made; although, OHWM was defined based on the topographical break in slope, changes in sediment characteristics, and changes in vegetation characteristics. No wetland vegetation exists above the OHWM. Vegetation above the OHWM consists of typical upland vegetation like black oak (*Quercus kelloggii*), buckeye (*Aesculus californica*), Interior live oak (*Quercus wislizenii*), and redbud (*Cercis occidentalis*). The NWI layer shown in Figure 1 is very coarse and inaccurate at this scale. The wetlands and riparian resources in this area are narrower through this incised portion of the river and exist solely below the labeled OHWM in Figure 1.

The Project would retain a spa and 220-volt receptacle in place. The spa and electrical connection are located 41.9 feet away from the OHWM on a rocky flat area above a steep slope greater than 45 degrees (100%). The location is an area previously disturbed by a water diversion pipe installed by a previous owner, but which has since been removed. The OHWM is delineated with riparian vegetation, including willow (*Salix ssp.*), Oregon ash (*Fraxinus latifolia*), and alder (*Alnus rhombifolia*). The riparian zone along this side of the river is relatively narrow due to the steep slope near the river. It is open, with few large trees to create a canopy. A mixture of alder and willow species (*Salix ssp.*) make up the riparian overstory. Shrubby willows and Himalayan blackberry (*Rubus armeniacus*) are the dominant shrubs. The herbaceous component includes sedges, willowherb (*Epilobium ssp.*) and various native and nonnative grasses.

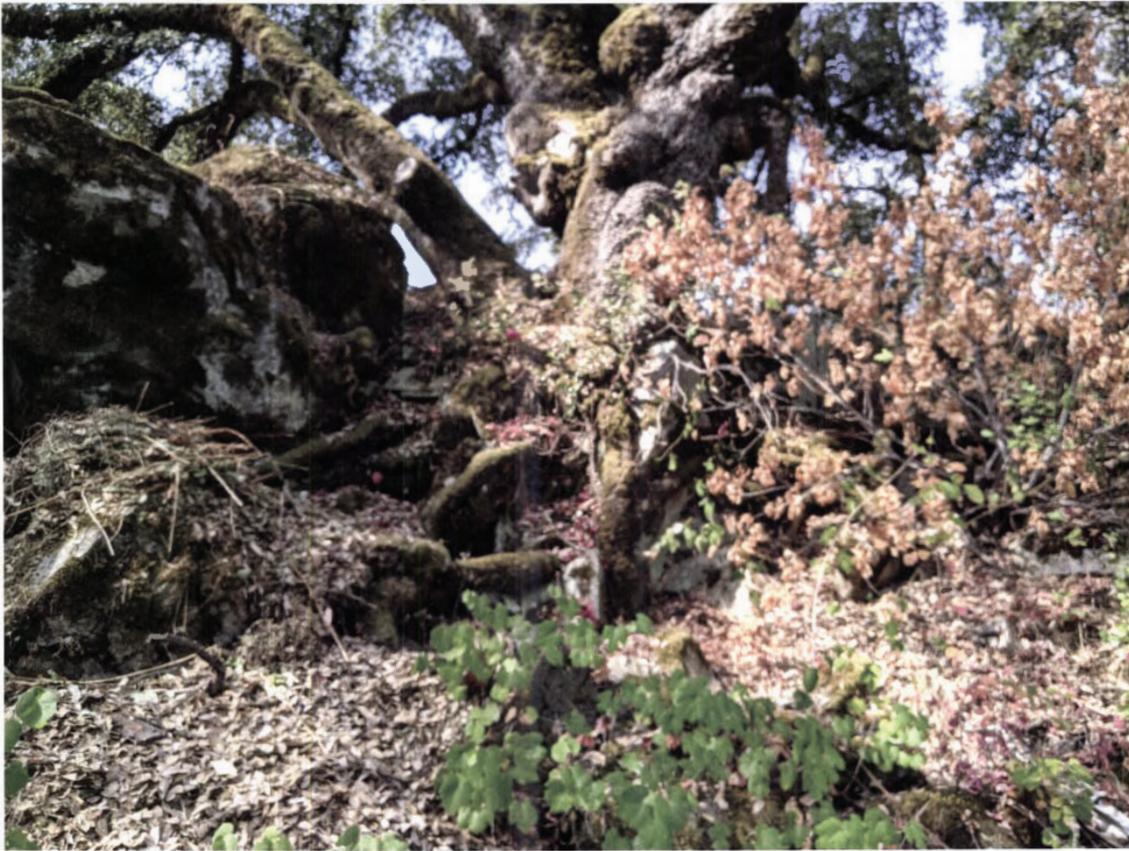
Photo 1. Looking up slope from edge of OHWM directly towards spa.

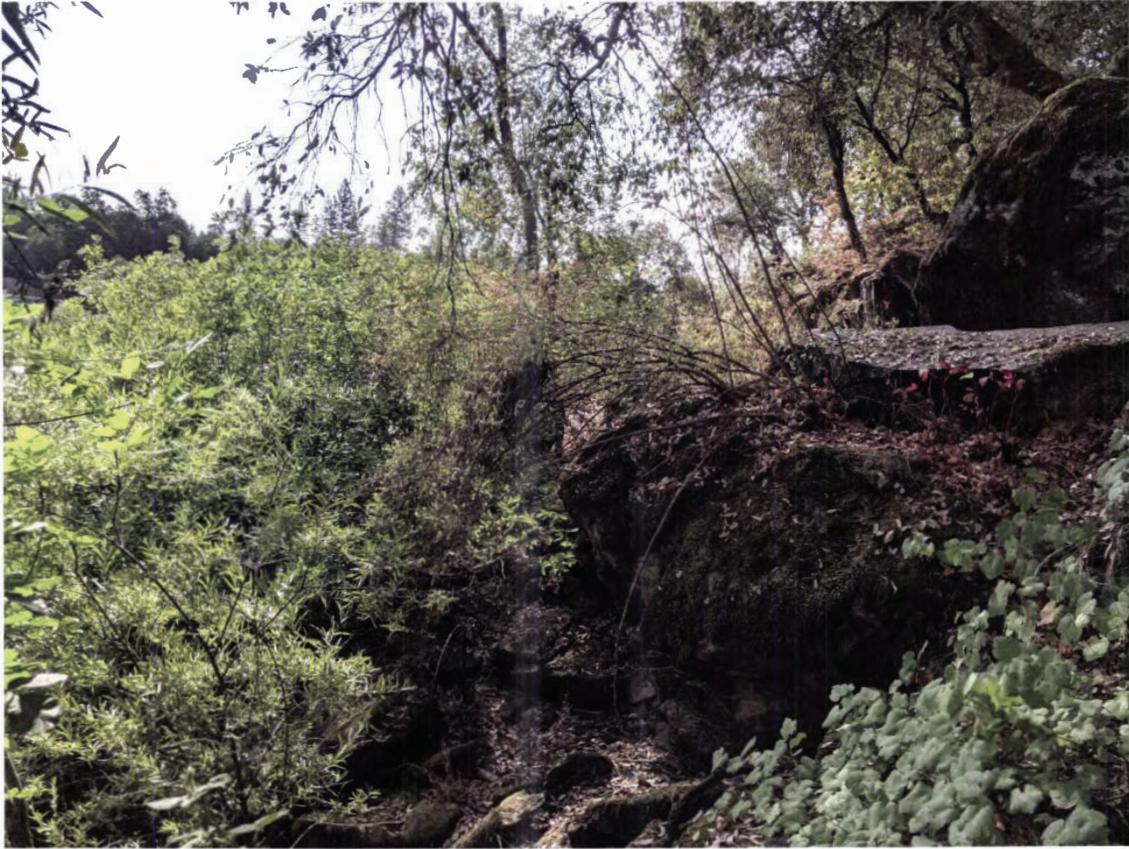
Photo 2. Downhill of spa showing typical characteristics of an OHWM.

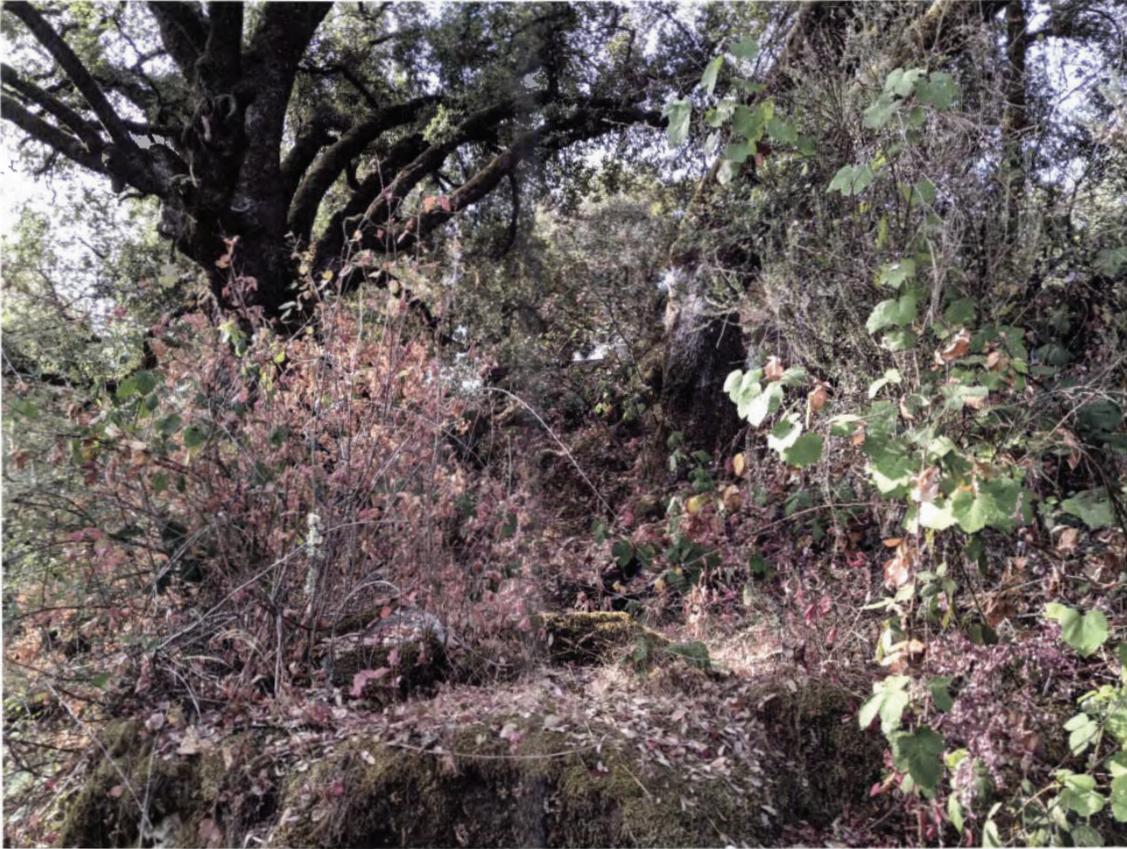
Photo 3. Looking up slope from edge of OHHM directly towards spa.

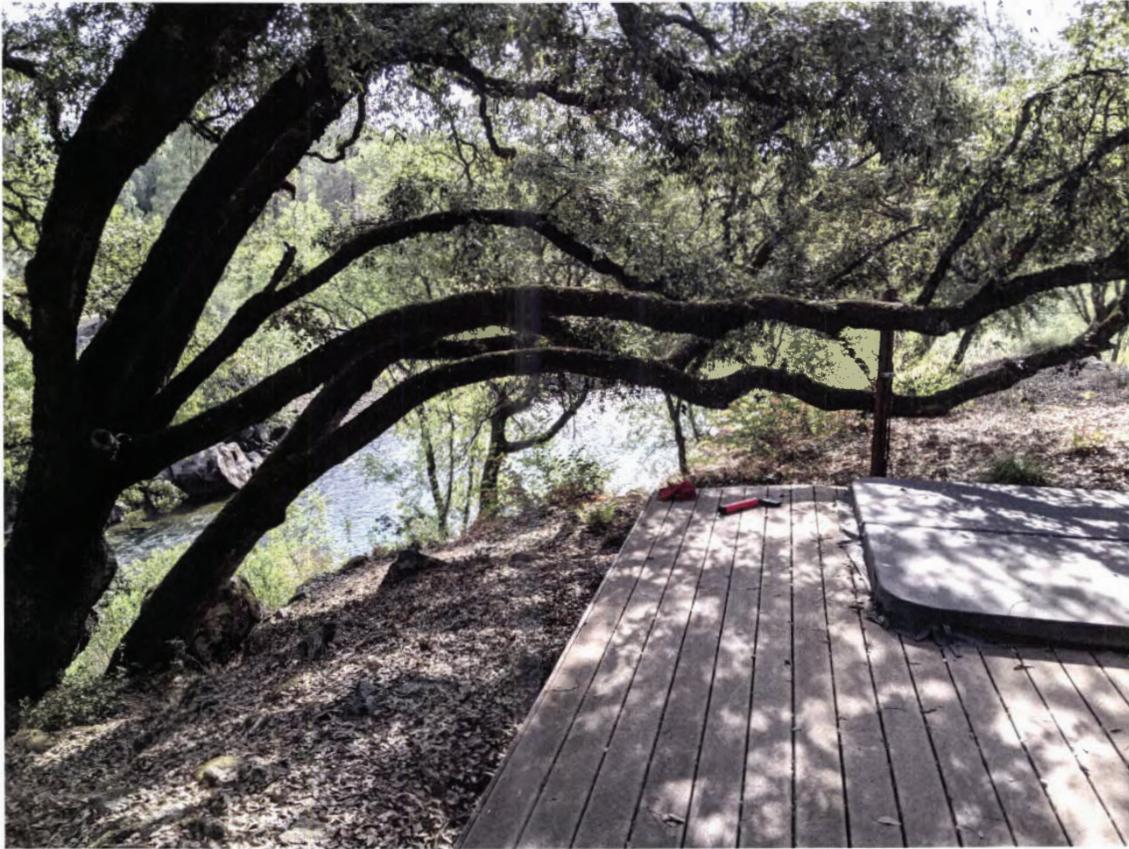
Photo 4. Spa location within a zone of upland vegetation.

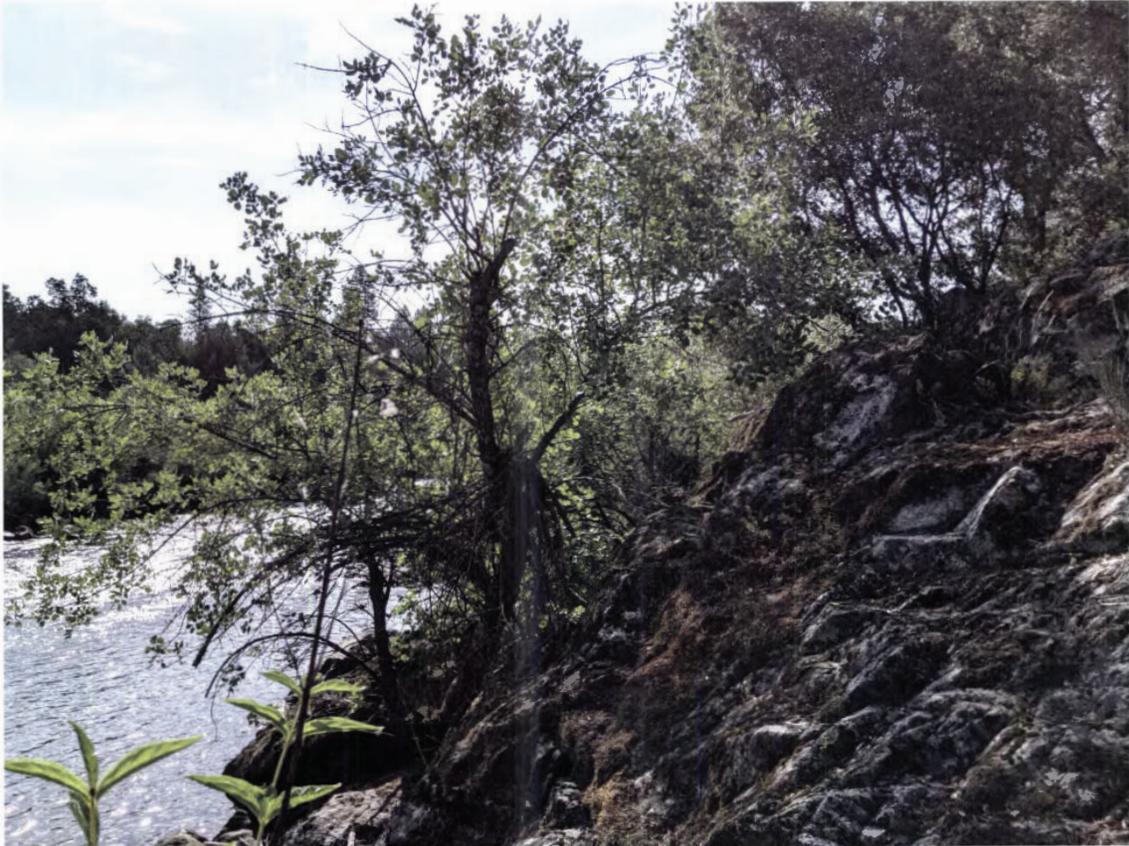
Photo 5. Downslope and downstream of Project. Debris that has collected during a high-water event.

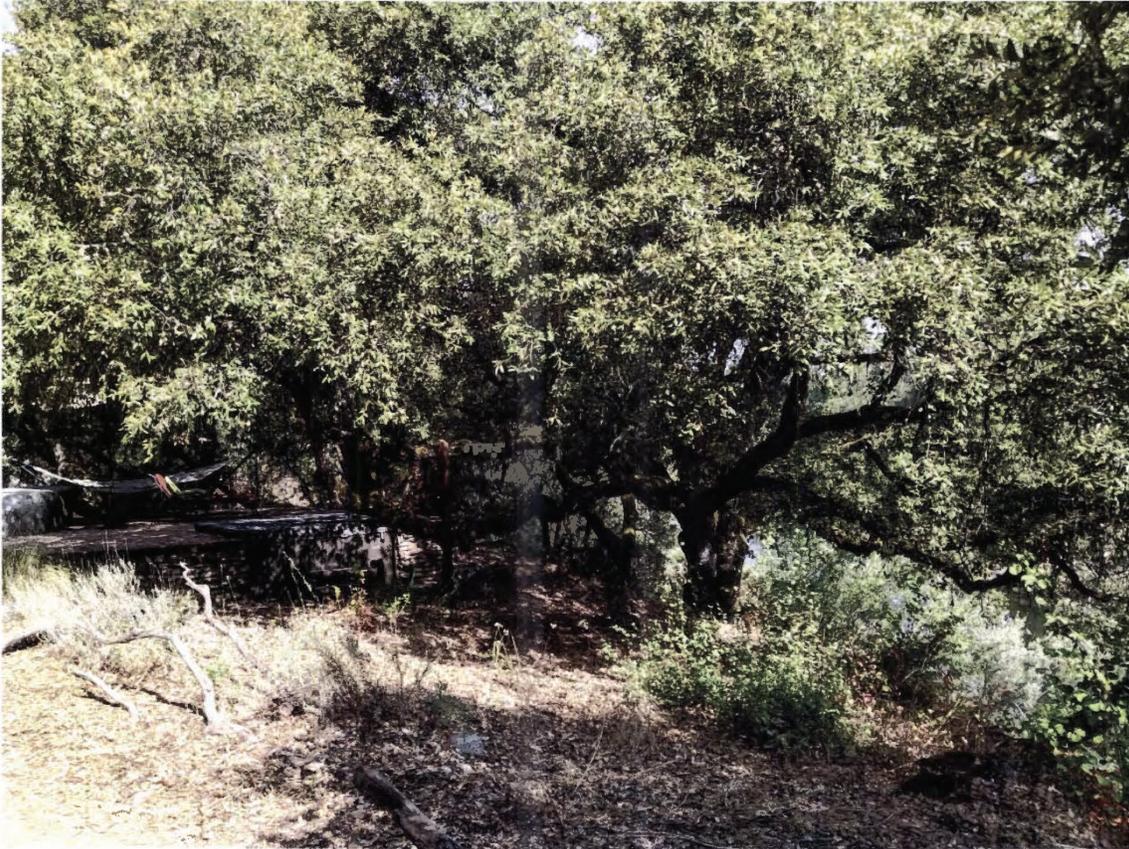
Photo 6. Spa location within a zone of upland vegetation.
