# City of South Lake Tahoe

Subject: APN 026-050-05-100, Facilities Assessment – El Dorado County Owned Buildings

The objective of this memorandum is to provide a summary of the facility condition assessments related to the buildings owned by El Dorado County situated on Parcel # 026-050-05-100. The Buildings are formally known as:

Per a request by City Manager Kerry, Public Works staff inspected the facilities and updated the facility condition index as well as the Facility needs assessment attached hereto.

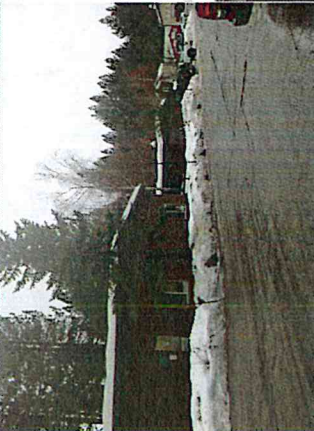
| | | | | Facility Exterior - East | Soffit damage from roof failure | Soffit damage from roof failure | Poor Interior Lighting |

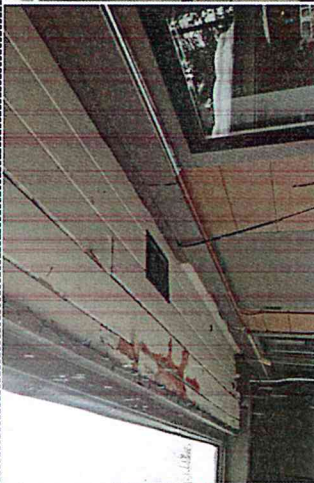
| LEVEL 1 ELEMENT | | LEVEL 2 ELEMENT | LEVEL 3 ELEMENT | LEVEL 4 SUB-ELEMENT | | EMERGENCY<br>\$ | URGENT<br>\$ | REGULAR<br>MAINTENANCE<br>\$ | DEFERRED | Notes |
|---|--|---|---|---|---|---|---|---|---|---|
| | | | | B2016 - Exterior Soffits | \$1,000 | | | | | Notable damage from leaking roof system |

| Notable Issues: | | | | 1. Roof System is at end of life. Repairs are no longer holding. Roof replacement is mandatory. May need to address water damage to roof substructure<br>2. Building hall ways are under lit.<br>3. Building is showing heavy wear at mechanical and plumbing systems. Electrical wiring is concerning. | | | |

| LEVEL 1 ELEMENT | | LEVEL 2 ELEMENT | LEVEL 3 ELEMENT | LEVEL 4 SUB-ELEMENT | | EMERGENCY<br>\$ | URGENT<br>\$ | REGULAR<br>MAINTENANCE<br>\$ | DEFERRED | Notes |
|---|--|---|---|---|---|---|---|---|---|---|
| | | | | B1022 - Pitched Roof Construction | | | | | X | Roof needs to be replaced. At end of lifespan, may have structure damage due to moisture |
| | | | | B3011- Roof Finishes | | | \$25,000 | | | Roof needs to be replaced |

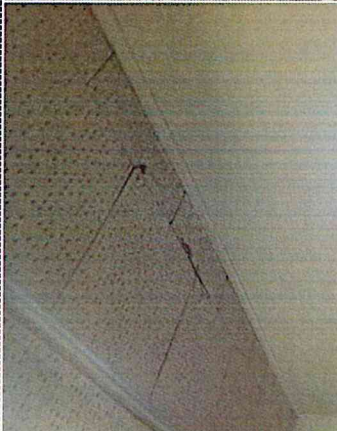
| | | | | Interior damage from roof failure | Interior carpet damage through out | Fire Safety Concerns | Electrical Concerns |
