Biological Resources Assessment

El Dorado Springs ±23-Acre Site
El Dorado County, California

Prepared for: Standard Pacific Homes

**GEOTECHNICAL ENGINEERING STUDY
FOR
EL DORADO SPRINGS 23
El Dorado Hills, California**

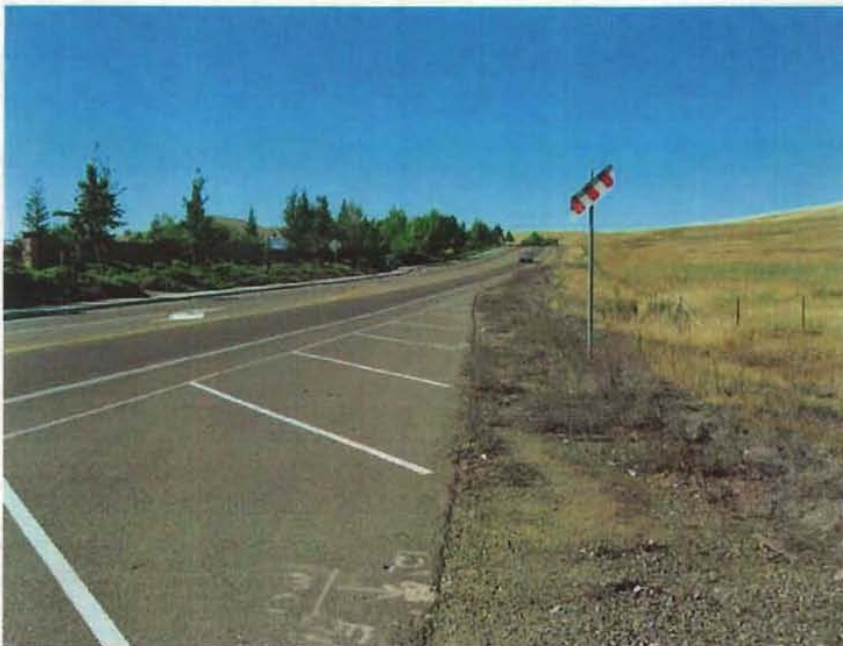
The current roadway is paved in asphalt that capped the old White Rock Road/Lincoln Highway's concrete roadway. As part of the previous White Rock Road Widening Project, the hill within a part of the 1,772-foot segment reported here was cut down 10 feet below the existing road. Therefore that particular segment of the old concrete road was removed. The remainder of 1,772 foot long road segment paved over the old concrete roadway.

The photo, below, shows the 1,772 foot long road segment as it appears today looking southwest towards the county line and in the background, White Rock Hill as seen from the intersection with Stonebriar and 4-Seasons Drives.

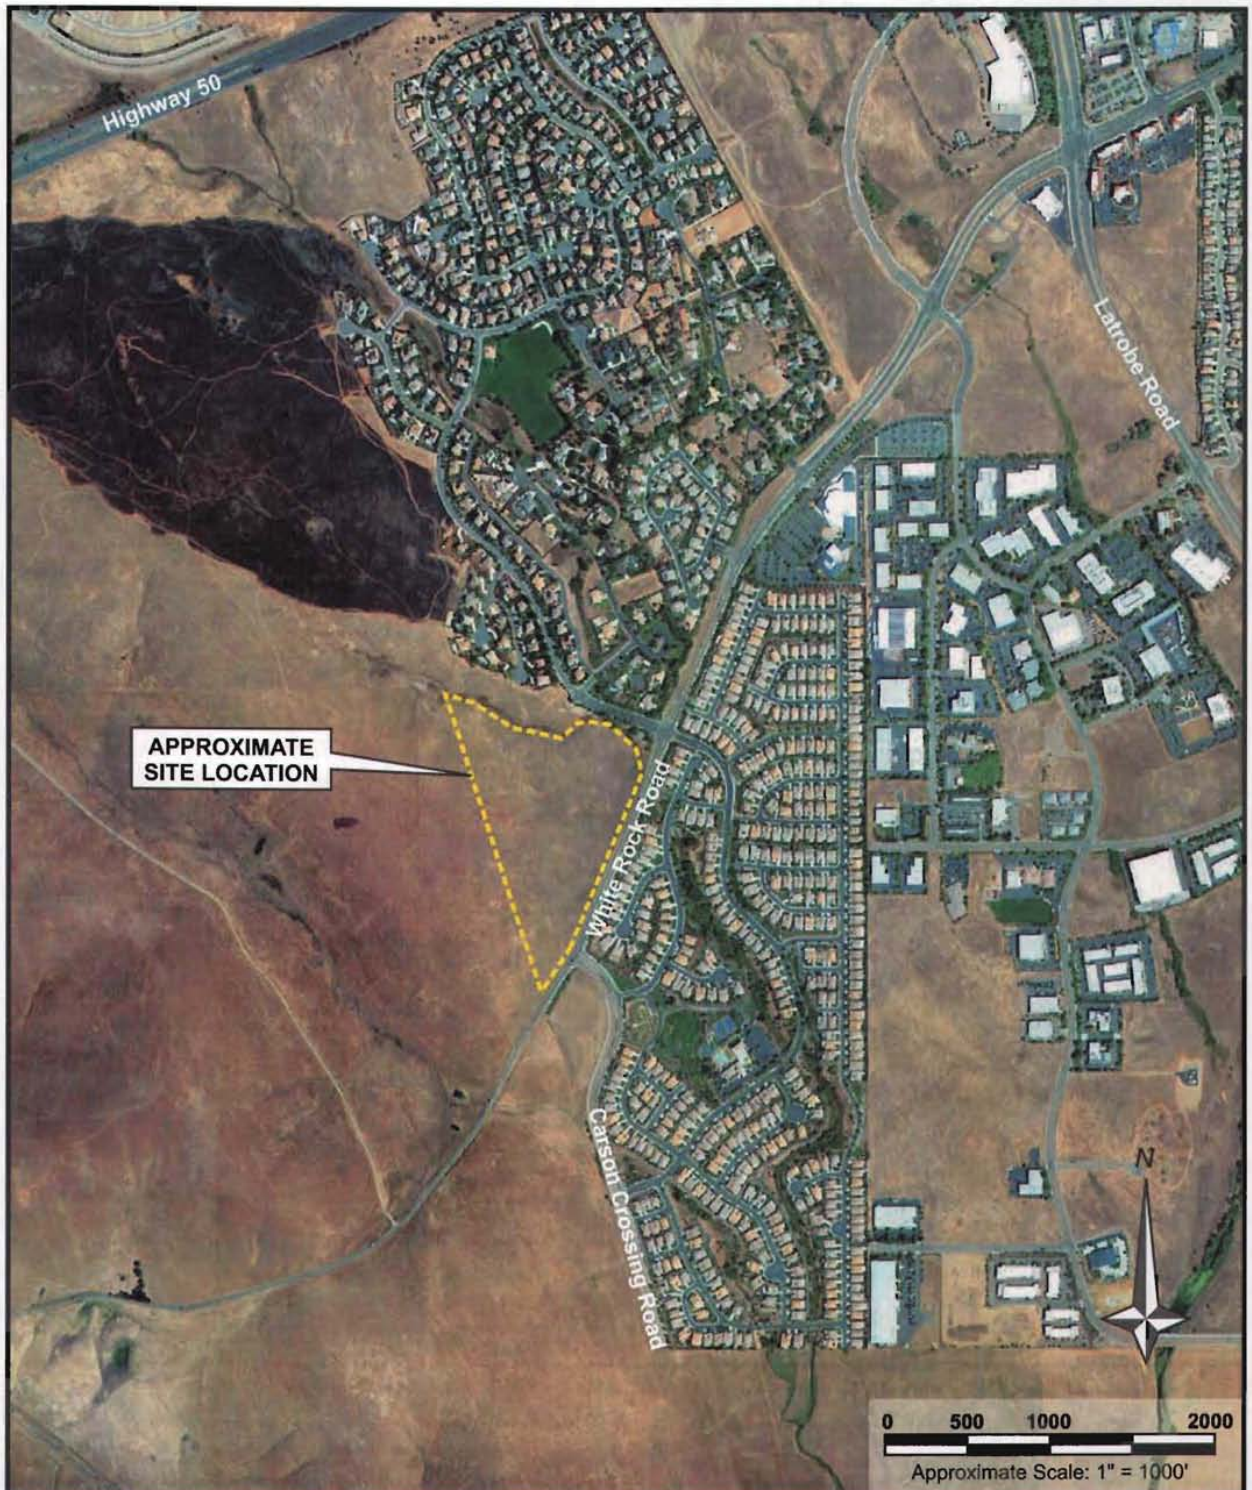
BASE MAP REFERENCE: Google Earth, Aerial Data 8/13/2013

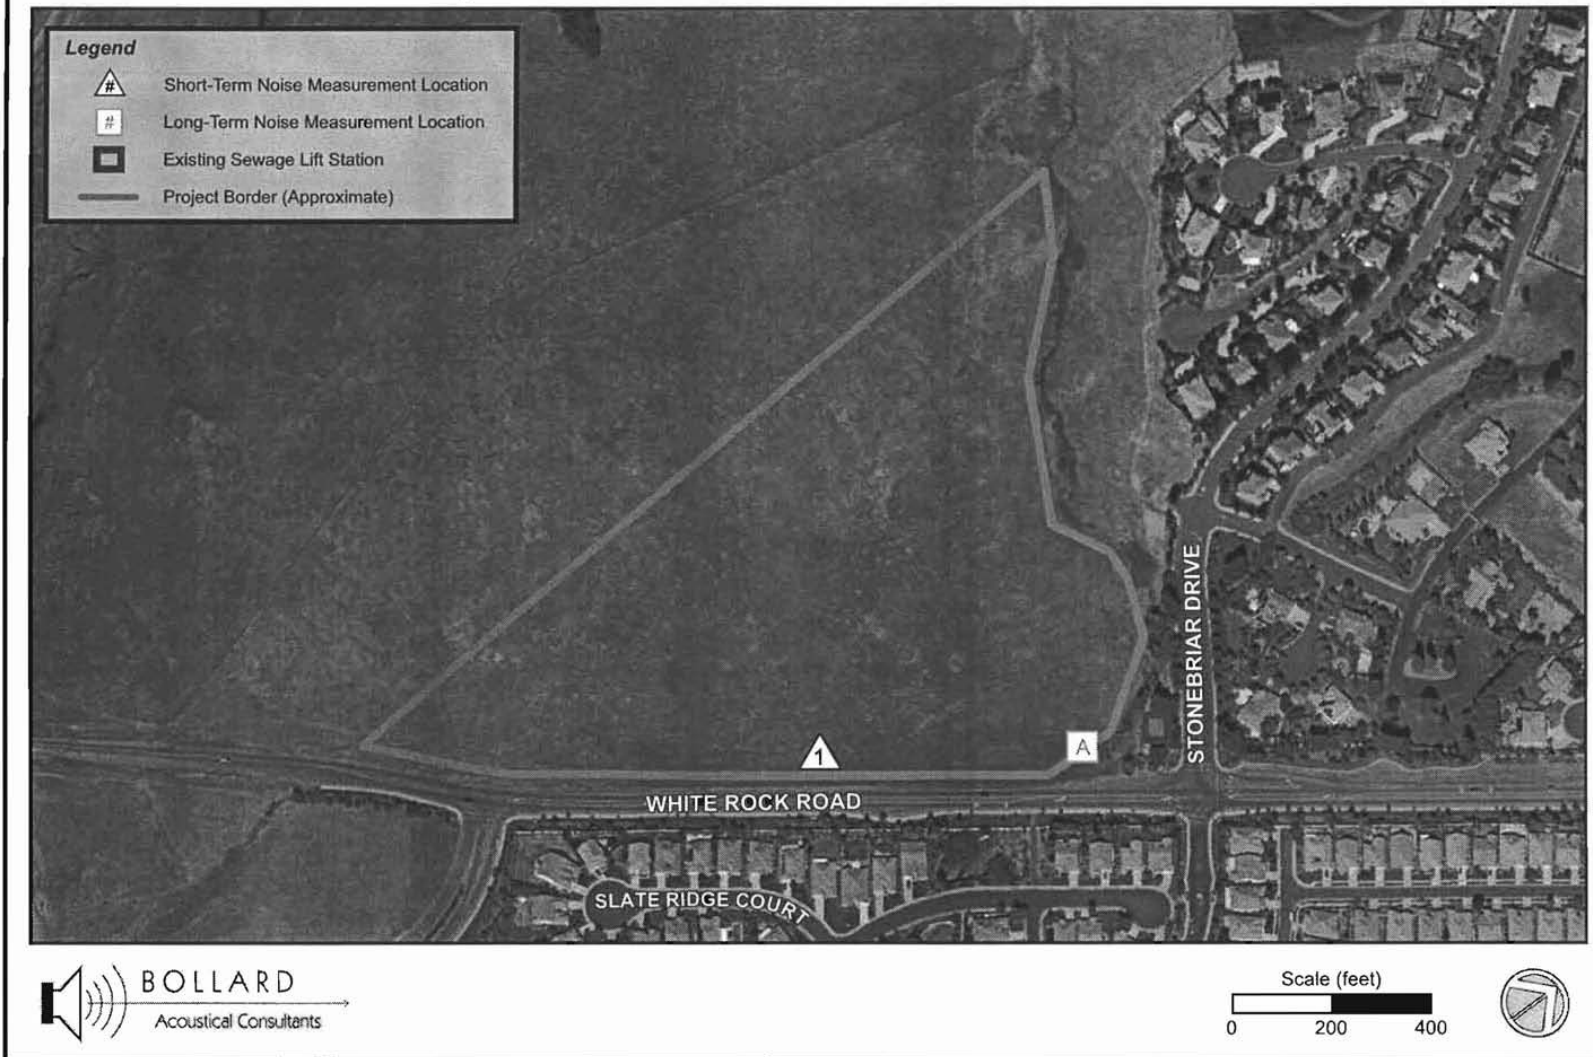
Figure 1
El Dorado Springs Subdivision - El Dorado County, California
Project Area and Ambient Noise Measurement Locations

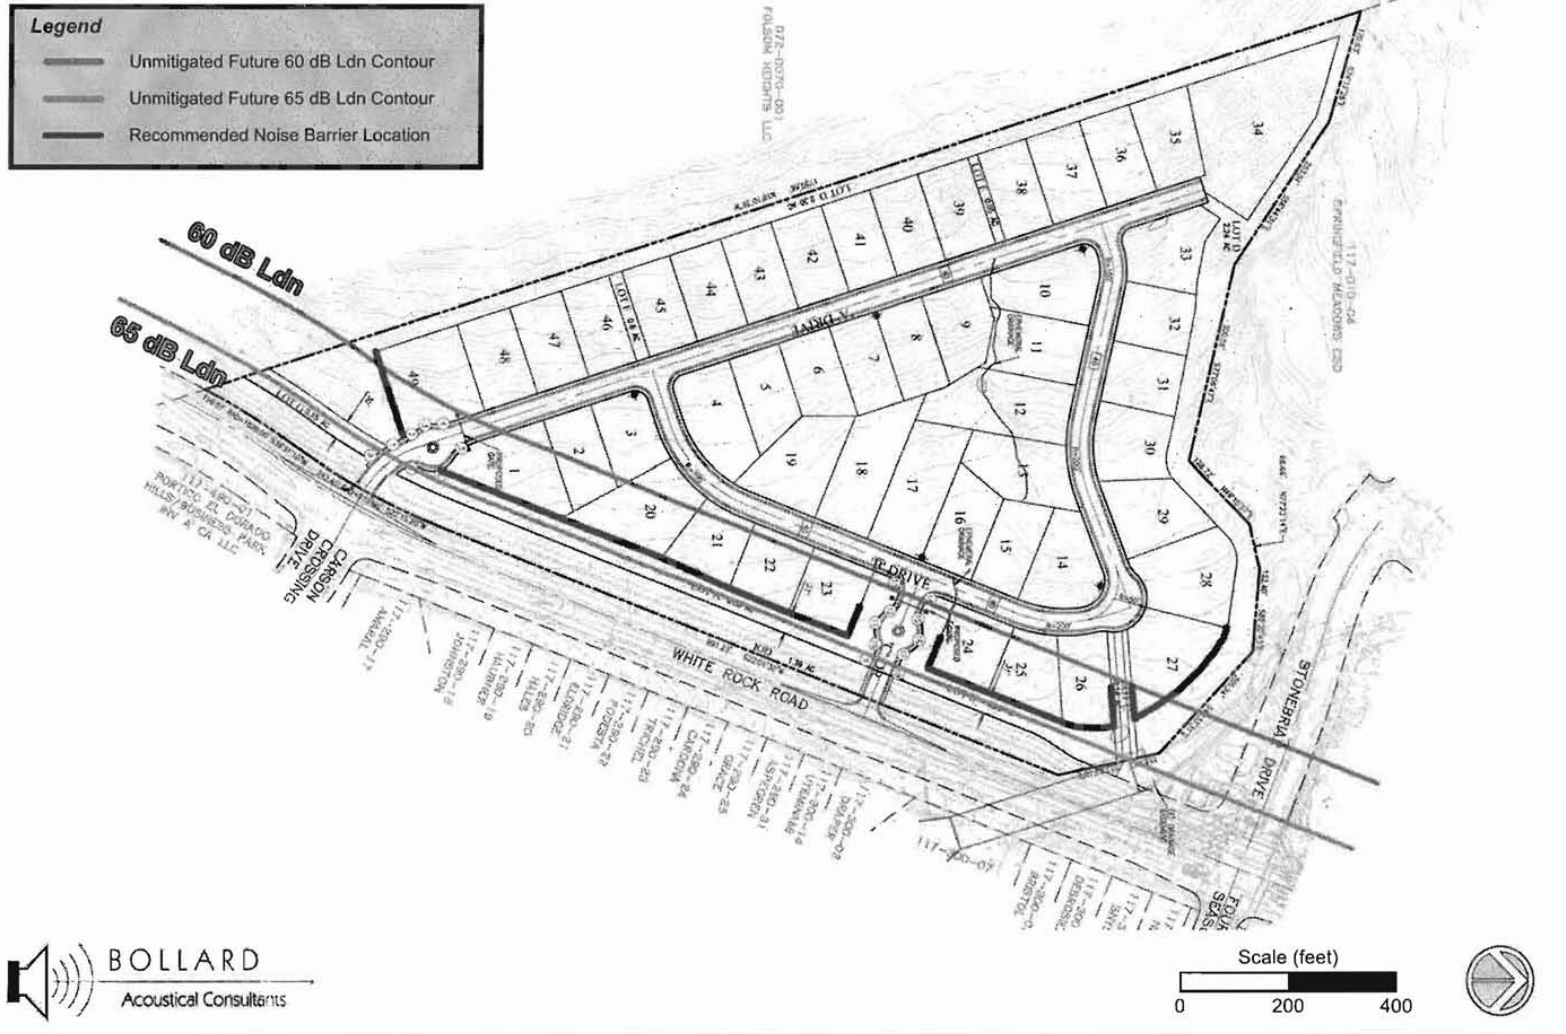
Figure 2
 El Dorado Springs Subdivision - El Dorado County, California
 Proposed Project Site Plan
