DIXON RANCH RESIDENTIAL PROJECT ENVIRONMENTAL IMPACT REPORT

TECHNICAL APPENDICES-VOLUME TWO:

APPENDICES C - G

STATE CLEARINGHOUSE # 2012062023

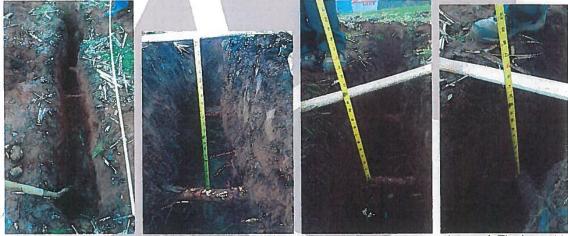
Ten foot long, two-foot deep trench excavated 16 feet from trunk. Two roots were observed. The impact to tree from root pruning of these two roots at this point from the trunk is considered low.

Other testing or examination: A trench to examine the root system of tree number 8025 was excavated on March 4, 2014 to look for roots in the area proposed for excavation approximately 16 feet from the trunk and within the dripline. The proposed dripline encroachment is less than 20%. The trench was ten feet long, wide enough for a shovel to carefully remove soil, and two feet deep. Two roots were found in the trench. A 0.9 inch diameter root was found at 11 inches below grade, and a 2.1 inch diameter root was found at 14 inches below grade. No other roots were observed.

This excavation confirmed the expectation that few roots will be found in the shallow soil as the distance moves outward towards the dripline farther from the trunk. During the summer months, there is little moisture, and roots will not easily survive in the shallow soil away from the trunk. This supports the ability to cut soil grades at the edge or near the dripline with rare root conflicts.

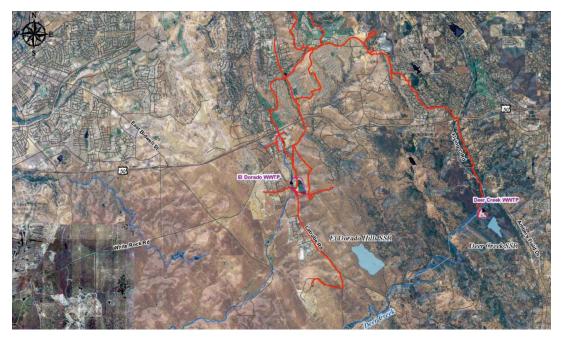
Figure 3-2 Existing Recycled Water Distribution Mains (in red) and Location of the DCWWTP and EDHWWTP

In general, the optimal location for a seasonal storage reservoir is within the existing or future service areas. The current recycled water distribution mains are shown in a red line on Figure 3-2. Locations outside of the service area may be advantageous if they offer benefits such as land use compatibility, efficient topography, readily available material for embankment construction, and limited environmental impacts. However, these must be weighed against the additional piping and pumping costs.

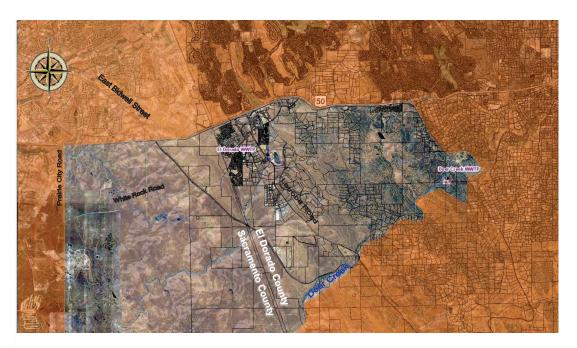
Figure 3-3 Study Boundary (not shaded)

The study area, shown in Figure 3-3, is bounded on the east by Flying C Road and Amber Field Road due to residential development and elevation gain further east; on the north by Highway 50, due to residential development; to the south by Deer Creek because of the cost of creek crossing and distance away from the service area; and on the west by Prairie City Road due to distance from the service area. This study area provides significant opportunity to identify potential locations for reservoir sites.

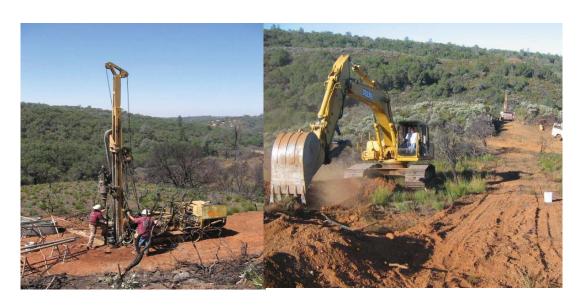
Figure 4-2. Drilling Rig

Figure 4-3. Test Pit Excavation

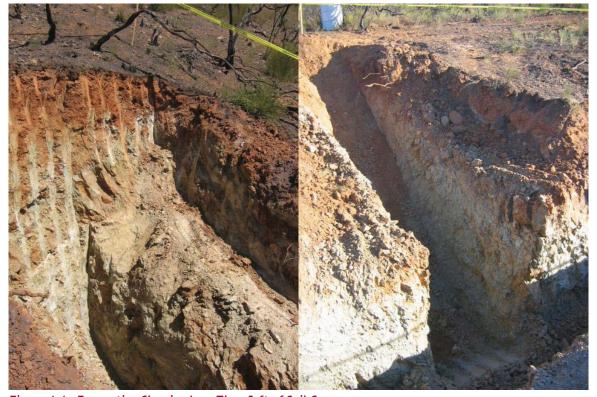
Figure 4-4. Excavation Showing Less Than 3-ft of Soil Cover

significant portion of sand- and silt-sized material. In general, the depth of weathering was greater toward the middle and upper portion of the slopes of the drainage, and relatively shallow, closer to the bottom of the drainage channel. The bedrock contains significant amounts of talc schist and serpentinite (containing naturally occurring asbestos) (Figure 4-5). The rock size and hardness is not suitable for a rock fill embankment (Figure 4-6); instead, the material is more similar to a soil than a rock and is suitable for an earthen embankment.

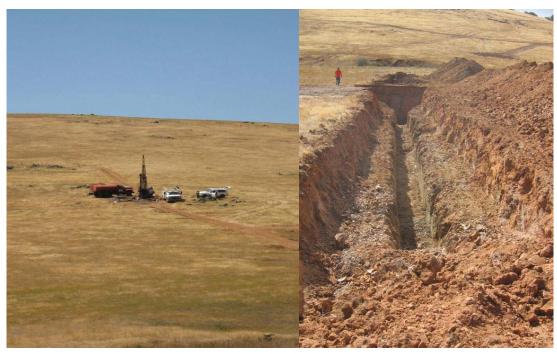
Figure 4-15. Drilling Rig

Figure 4-16. Fault Trench

Figure 4-15 shows the drill rig at boring location B3 looking west-south-west. Figure 4-16 shows a fault trench excavation at T3 looking west.

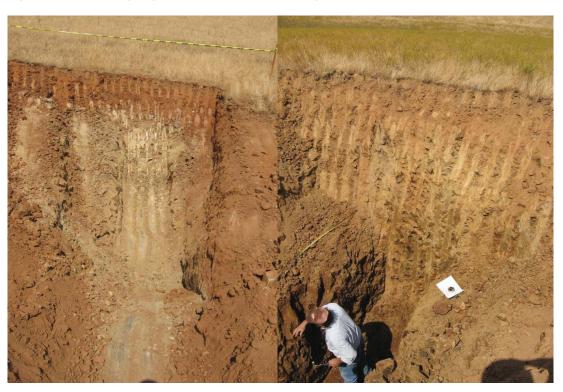
Figure 4-17. Shallow Bedrock with less than 3-Ft of soil cover

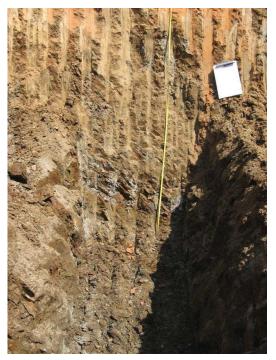
Figure 4-18. Bedrock Deeply Weathered and Sheared, Highly Fractured

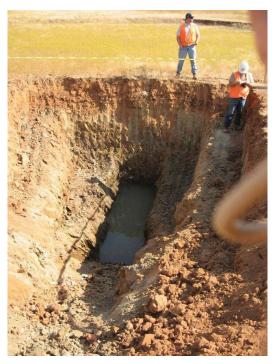
Figure 4-19. Groundwater Found at 6 to 8 Feet in Western Half of Site

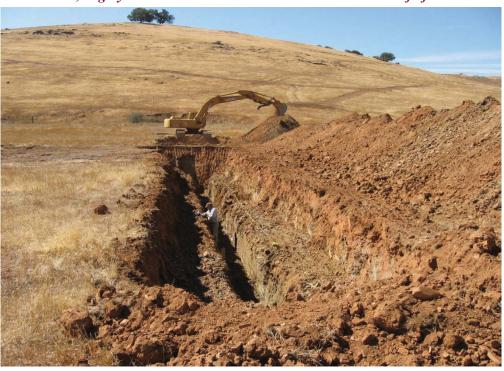
Figure 4-20. Rock not Suitable for Rockfill Embankment, Soil-like in Upper Several feet Across Western two-thirds of Site.

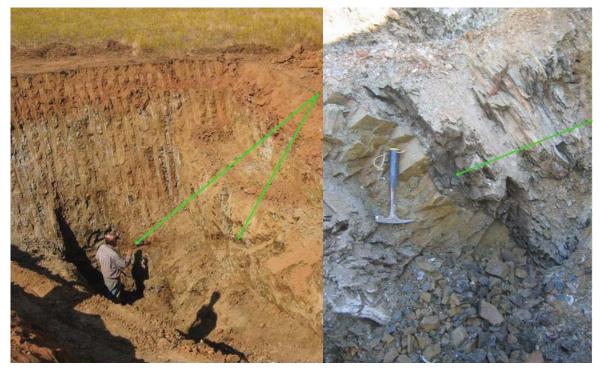
Figure 4-23. Cross-Structure Shear in Trench T3 and Sheared Rock and Contact in Trench T1

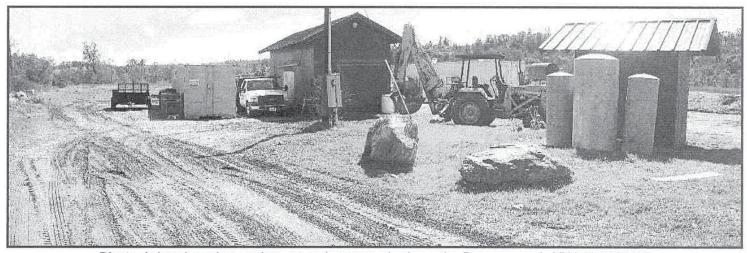
Photo 4: Landscaping equipment and storage sheds on the Peters parcel, APN 115-080-04.

onsite. The Peters parcel 115-080-04 is south of the Norris parcel. The Peters parcel includes strawberry fields on the northern portion (Photo 3) and landscaping equipment and storage sheds on the southern portion (Photo 4). Paint cans, gas containers, and other containers were observed on the southern portion of the Peters parcel (Photo 5). An aboveground diesel fuel storage tank (AST) was present on the Peters parcel (Photo 6). Soil and rock piles were also noted on the southern and western slopes of the Peters parcel (Photo 7). The northern and western portions of the Vanderburg parcel 126-150-13 include the residence's mailbox and driveway and undeveloped areas (Photo 8).

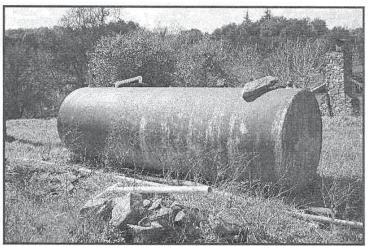
Photo 10: Former fuel storage tanks reportedly used as water irrigation tanks for the strawberry field in the northernmost portion of the Louie parcel, APN 126-150-23.

The Louie property includes three parcels 126-150-23, 126-020-02, and 126-020-03. Strawberry fields are located in the northernmost portion of parcel 126-150-23 (Photo 9). Two fuel storage tanks, reportedly used as water irrigation tanks for the strawberry field, were observed on surface soil in the northernmost portion of parcel 126-150-23 (Photo 10). A shed with chemicals and fertilizers for the strawberry field was observed in the central portion of parcel 126-150-23 (Photo 11). A landscaping storage yard was also noted in the central portion of parcel 126-150-23 (Photo 12). The historic Dixon Ranch residence and animal sheds (Photo 13) and barn with stored materials (batteries, vehicles, lawnmower, etc.) (Photo 14) are located in the central portion of parcel 126-150-23. East of the historic Dixon Ranch area are two ponds and Green Springs Creek (Photo 15). The southern portion of this parcel is grazing land (Photo 16).

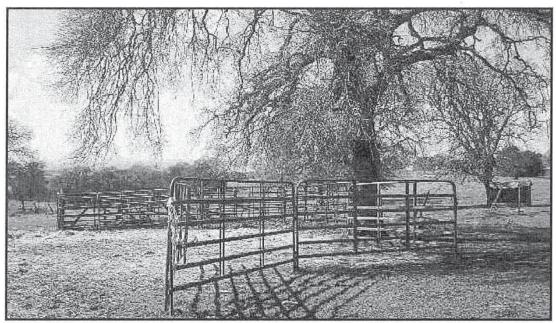
Photo 19: Cattle corral at the boundary btw the southeast Louie parcel, APN 126-020-03, and southwest Louie parcel, APN 126-020-02.

An overhead power line and tower are located at the southern boundary of parcel 126-020-03 (Photo 17). Parcel 126-020-03 is grazing land (Photo 18). A cattle corral is located at the boundary between parcel 126-020-03 and parcel 126-020-02 (Photo 19). Cattle were observed grazing on parcel 126-020-02 (Photo 20). All of parcel 126-020-02 was observed to be cattle grazing land (Photo 21). A rock wall was observed on parcel 126-020-02 (Photo 22). Bisecting parcels 126-020-02 and 126-020-03 is the contemporary Dixon family residential property (Photo 23).
