**RE: Work Order: Senior Center Facility Assessment, Recommendations and Estimate;
El Dorado County, 937 Spring Street, Placerville, CA 95667**

Spring Street Senior Center Facility Description

Exhibit A
Recommendations and Cost Estimate
El Dorado County Senior Center
937 Spring Street, Placerville CA

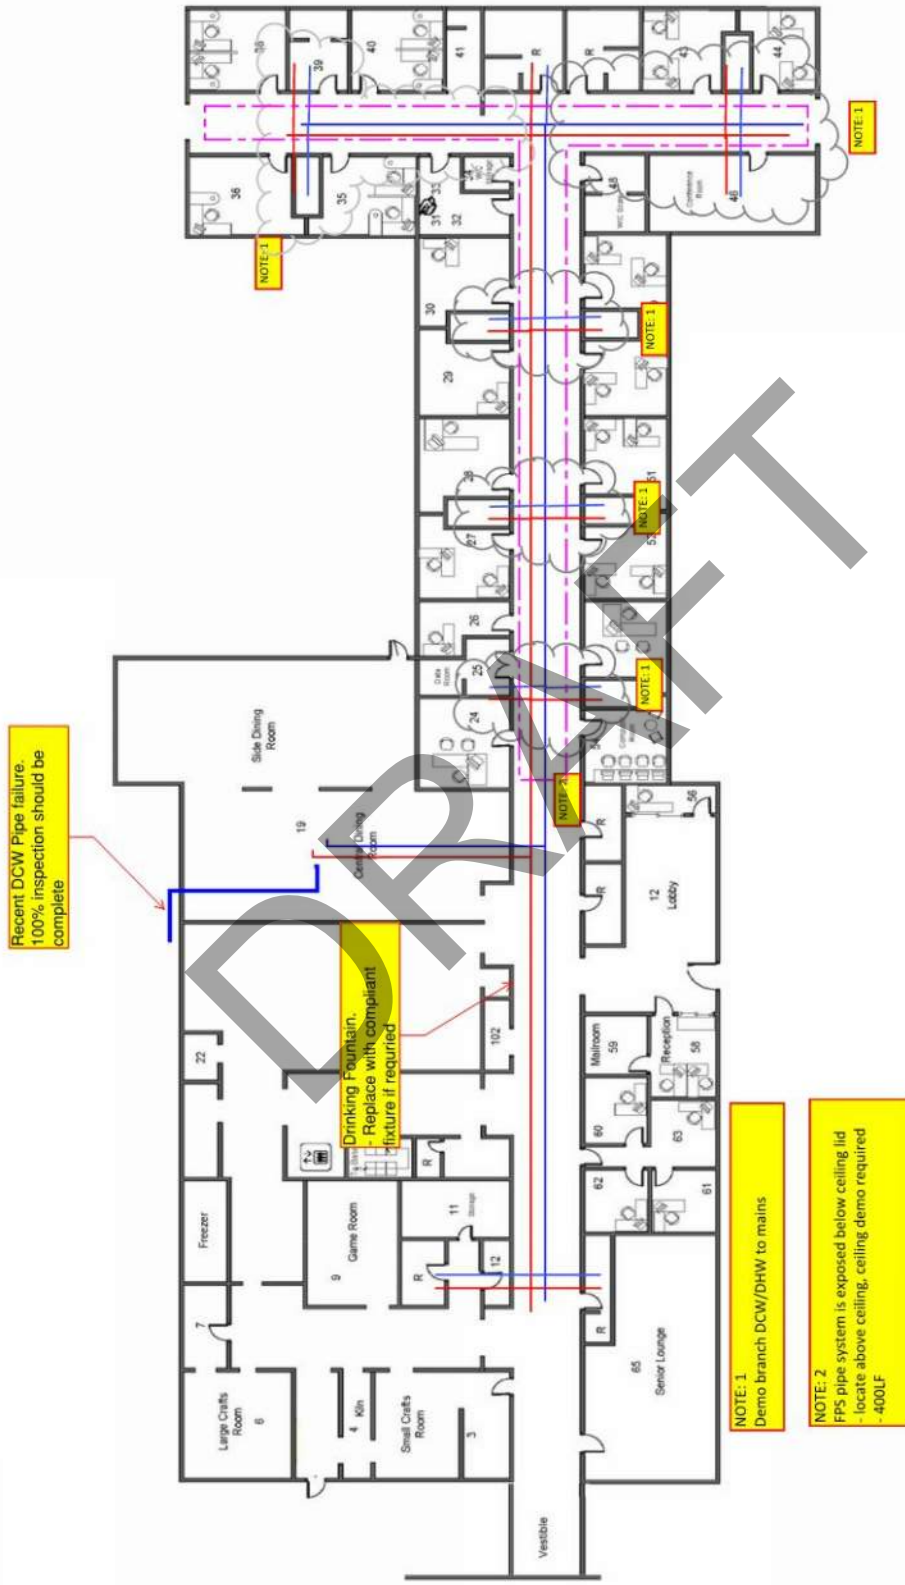
Plumbing Plan - 1st Floor
 937 Spring St. Placerville, CA 95667

NOTE: 4
 Kitchen SS pipe has had recent repair for failure (leaks)
 - Replace 4IN SS (60-100LF) and min Beach floor sinks

NOTE: 2
 Remove and Demo shower with RR reconfig
 - Seal waste pipes and Vents
 - Demo DCW / DHW branch to main pipes
 - Replace Exh Fan - see mech

NOTE: 3
 Inspect condition of Cast Iron Pipe, replace interior space section if condition shows corrosion or potential leaking

NOTE: 5
 Inspect condition of Cast Iron Pipe, If condition is leaky / faulty:
 1. Seal Off and Abandon in place
 2. Route new SS pipe at exterior 225LF
