Caples Ecological Restoration Project

Amador and Placerville Ranger Districts
Eldorado National Forest

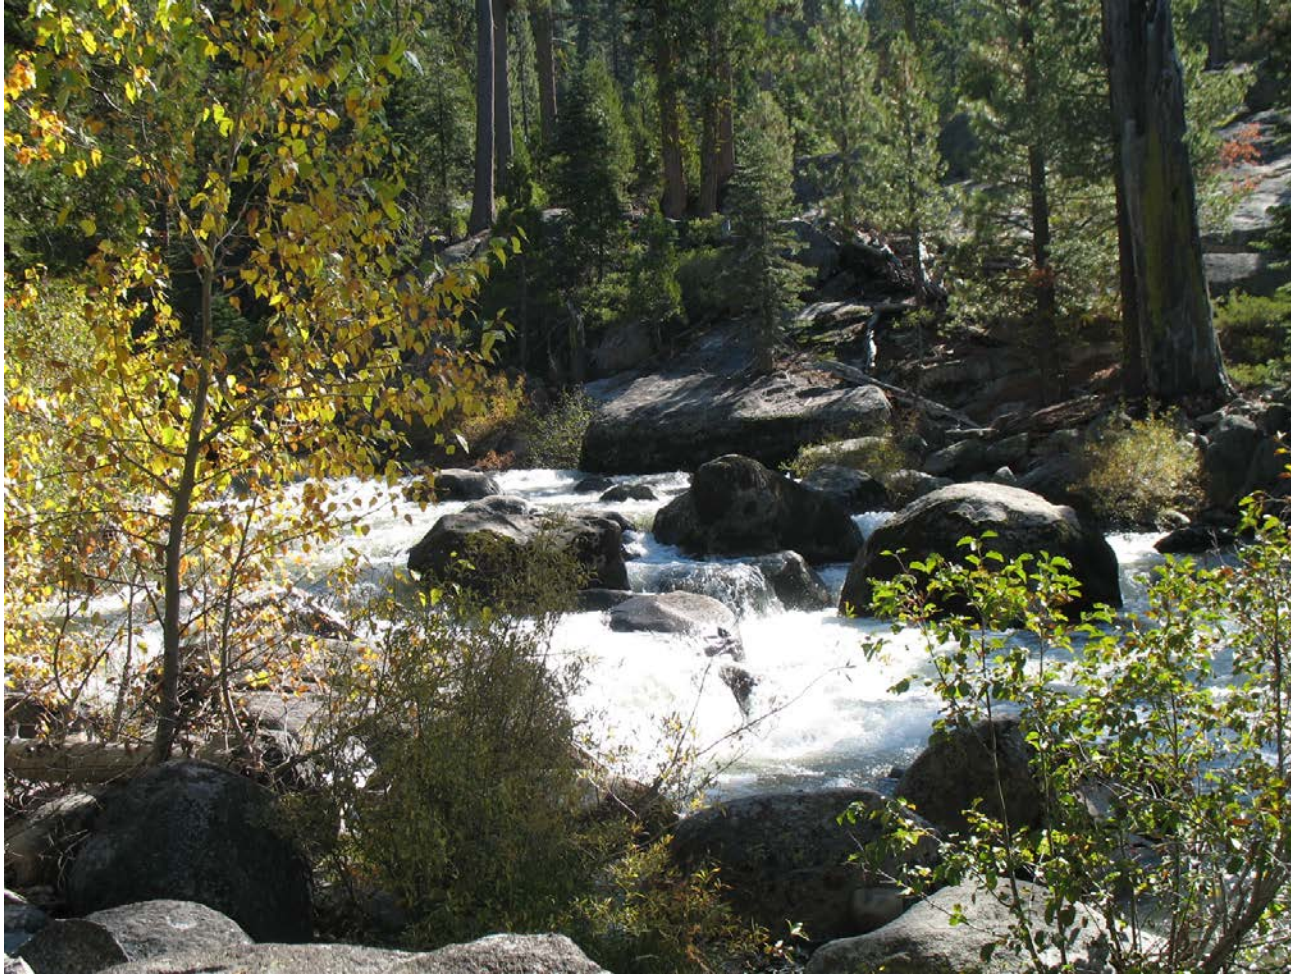
8. Silver Fork American River: The confluence of Caples Creek with the Silver Fork American River defines the lower boundary of the Caples Creek Watershed. Both the Silver Fork American River and Caples Creek are Class I productive streams with brown trout and rainbow trout. Pictured above is a segment of the Silver Fork American River, downstream of the project area.

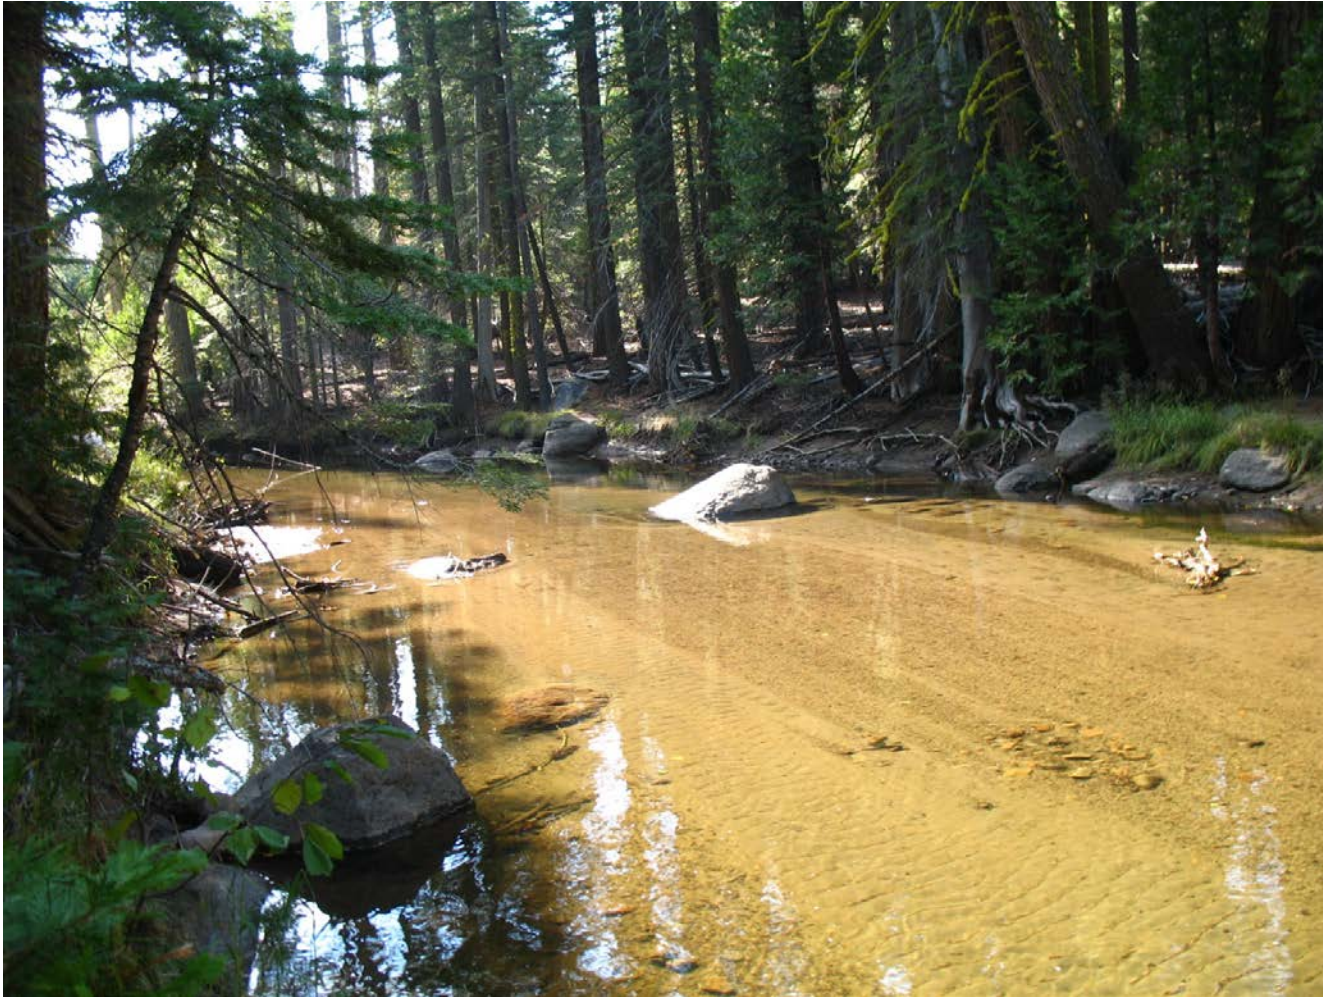
10. Caples Creek: The entire length of Caples Creek (pictured above) within the boundary of the proposed fuels project is Wild and Scenic River Status eligible. To be eligible for Wild and Scenic River designation, a river must be free-flowing and contain at least one "outstandingly remarkable value." The outstandingly remarkable values for Caples Creek are recreation and fisheries. Rivers in the National Wild and Scenic Rivers System are further classified as Wild, Scenic, or Recreational, dependent upon on the extent of development and accessibility along each section. Caples Creek is considered to be a Wild river, meaning that it is "...free of impoundments, generally inaccessible except by trail (no roads), with watersheds or shorelines essentially primitive, and having unpolluted waters. (<http://www.rivers.gov/information.html>)"
