2009 SMARA MINE INSPECTION Somerset Sand Mine CA Mine ID No. 91-09-0009

El Dorado County, California October 22, 2009

2009 SMARA Mine Inspection Somerset Sand Mine CA Mine ID No. 91-09-0009 El Dorado County, California

Subject: 2009 SMARA Mine Inspection

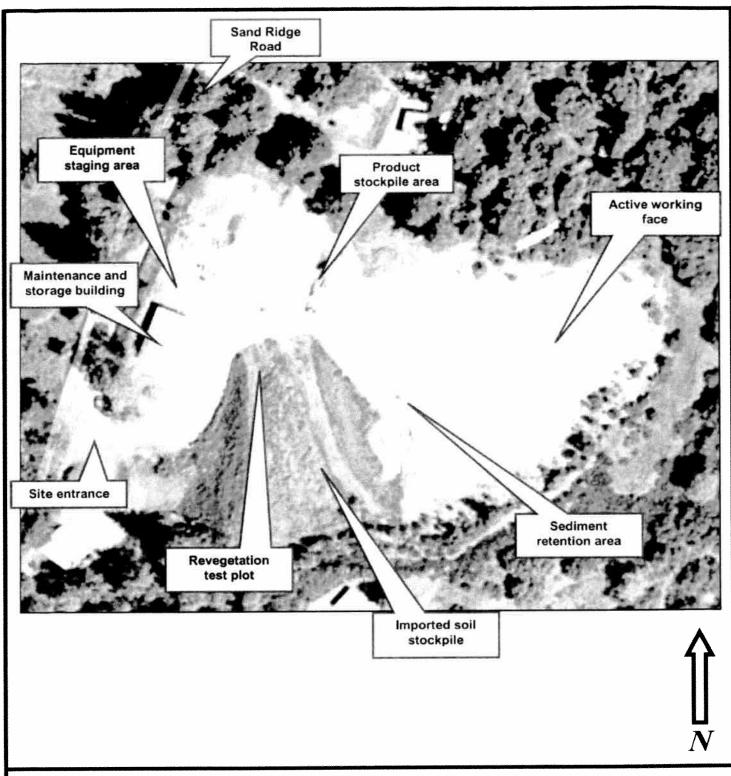
FIGURE 2 SITE LAYOUT MAP

The working face includes south, west, and northwest-facing cut slopes situated in the central portion of the property (Photograph Nos. 3 and 7 through 10). A site location map and site layout map are presented in Figures 1 and 2, respectively.
