**GEOTECHNICAL ENGINEERING STUDY  
FOR  
DIAMOND SPRINGS COMMUNITY PARK**  
Oak Dell Road  
Diamond Springs, California

Project No. E23142.000  
July 2023

Subject: **DIAMOND SPRINGS COMMUNITY PARK**  
Oak Dell Road, Diamond Springs, California  
*GEOTECHNICAL ENGINEERING STUDY*

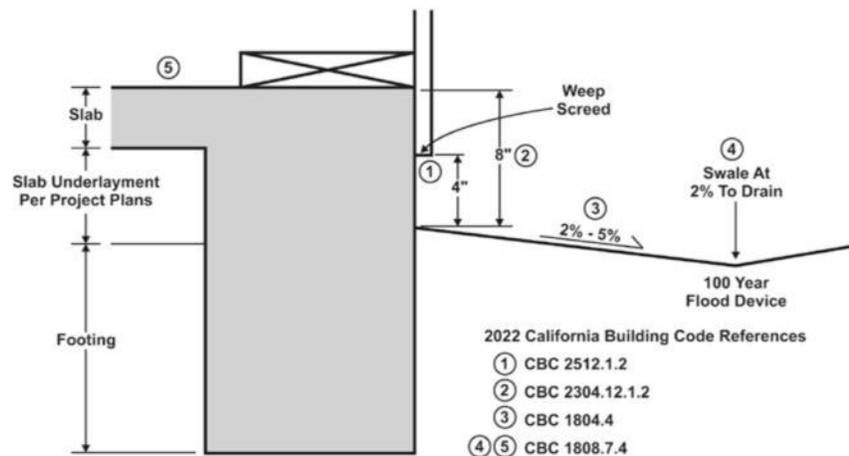
All grades should provide rapid removal of surface water runoff; ponding water should not be allowed on building pads or adjacent to foundations or other structural improvements (during and following construction). All soils placed against foundations during finish grading should be compacted to minimize water infiltration. Finish and landscape grading should include positive drainage away from all foundations. Section 1808.7.4 of the 2022 California Building Code (CBC) states that for graded soil sites, the top of any exterior foundation shall extend above the elevation of the street gutter at the point of discharge or the inlet of an approved drainage device a minimum of 12 inches plus 2 percent. If overland flow is not achieved adjacent to buildings, the drainage device should be designed to accept flows from a 100-year event. Grades directly adjacent to foundations should be no closer than 8 inches from the top of the slab (CBC 2304.12.1.2), and weep screeds are to be placed a minimum of 4 inches clear of soil grades and 2 inches clear of concrete or other hard surfacing (CBC 2512.1.2). From this point, surface grades should slope a minimum of 2 percent away from all foundations for at least 5 feet but preferably 10 feet, and then 2 percent along a drainage swale to the outlet (CBC 1804.4). Downspouts should be tight piped via an area drain network and discharged to an appropriate non-erosive outlet away from all foundations.

**Typical 2022 California Building Code  
 Drainage Requirements**

The above referenced elements pertaining to drainage of the proposed structures is provided as general acknowledgement of the California Building Code requirements, restated and graphically illustrated for ease of understanding. Surface drainage design is the purview of the Project Architect/Civil Engineer. Review of drainage design and implementation adjacent to the building envelopes is recommended as performance of these improvements is crucial to the performance of the foundation and construction of rigid improvements.

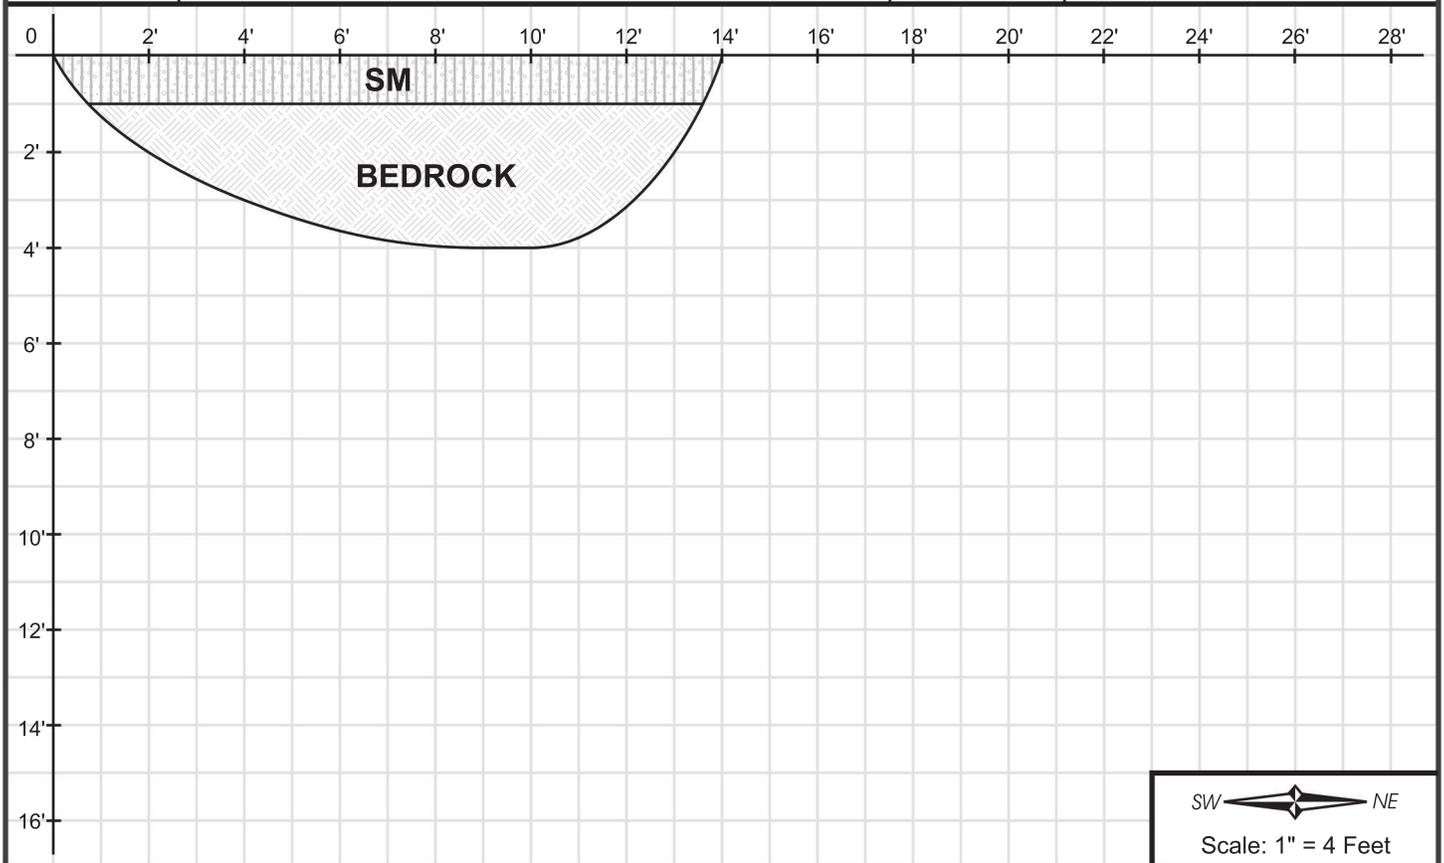
<b>TP-1</b> @ 1'		
@ 1' - 4'	Light brown <b>BEDROCK</b> , highly weathered, hard			
@ 4'	<i>Grades moderately weathered</i>			
	Test pit terminated at 4' (practical refusal) No free groundwater encountered No caving noted

The soils encountered were logged during excavation and provide the basis for the "Logs of Test Pits", Figures A-3 through A-11, this Appendix. These logs show a graphic representation of the soil profile, the location, and depths at which samples were collected.

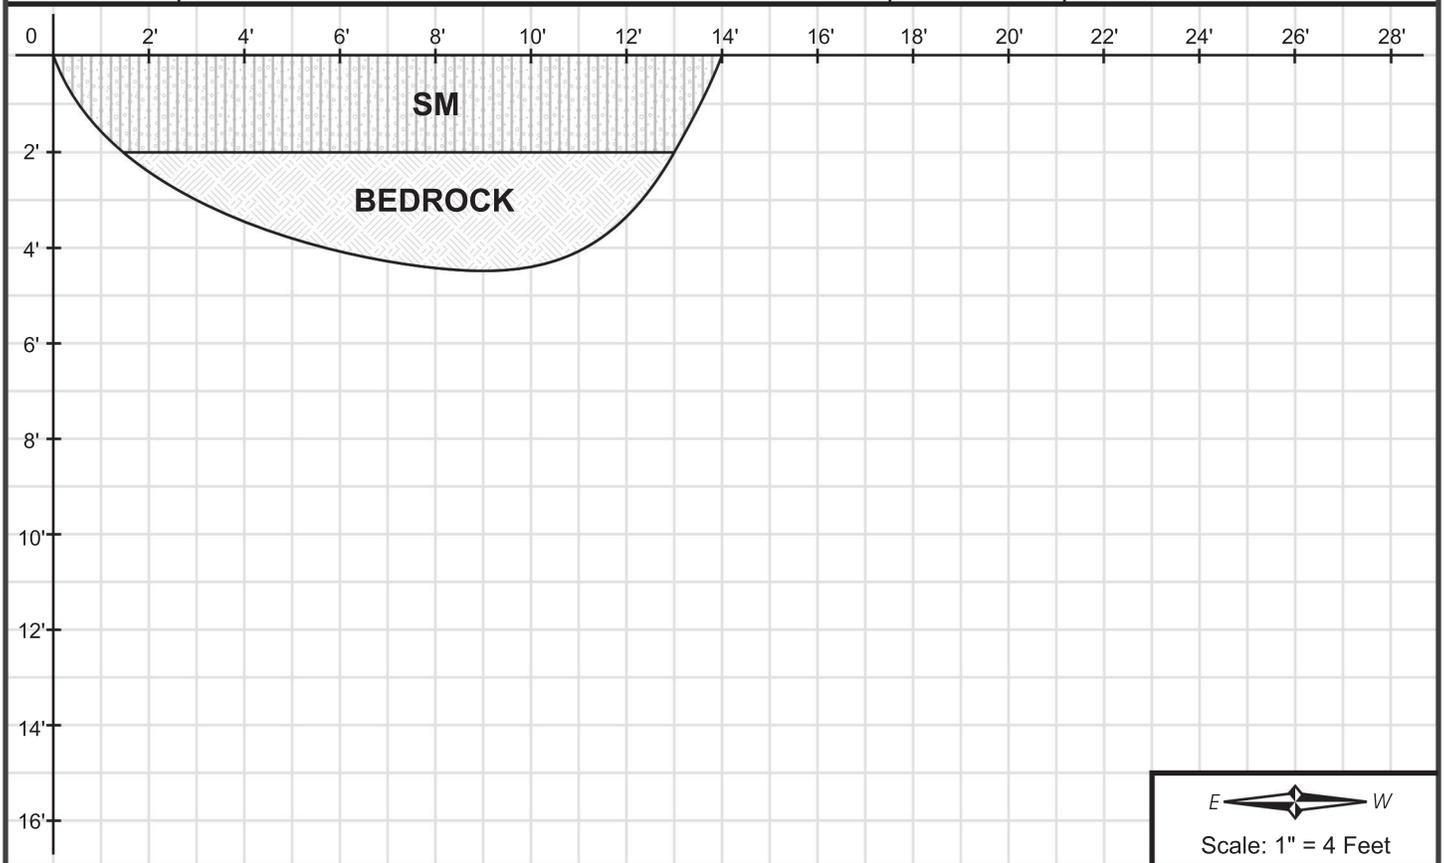
<b>YOUNGDAHL</b> CONSULTING GROUP, INC. <small>ESTABLISHED 1984</small>	Project No.: E23142.000	<b>EXPLORATORY TEST PIT LOG</b> Diamond Springs Community Park Diamond Springs, California	<b>FIGURE</b> <b>A-4</b>
	July 2023

<b>TP-2</b> @ 3'		
@ 2' - 4.5'	Dark brown <b>BEDROCK</b> , highly weathered, hard			
@ 4.5'	<i>Grades moderately weathered</i>			
	Test pit terminated at 4.5' (practical refusal) No free groundwater encountered No caving noted

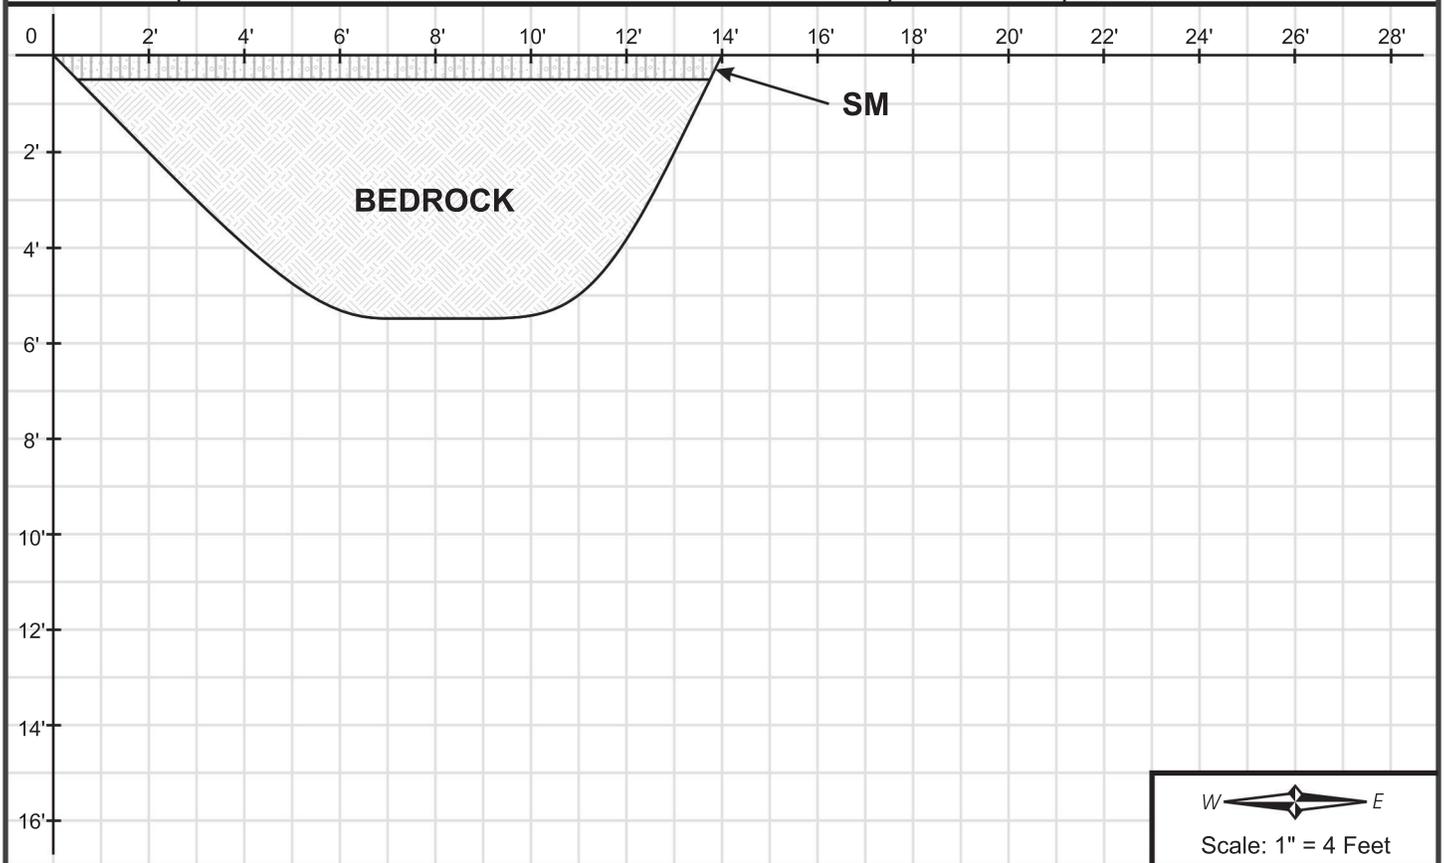
Logged By: <b>ARD</b>		Date: <b>27 June 2023</b>	Lat / Lon: <b>N 38.678725° / W 120.833967°</b>		Pit No. <b>TP-3</b>
Equipment: <b>John Deere 410G with 24" Bucket</b>			Pit Orientation: <b>250°</b>	Elevation: ~	
Depth (Feet)	Geotechnical Description & Unified Soil Classification	Sample	Tests & Comments		
@ 0' - 0.5'	Light brown silty <b>SAND (SM)</b> , medium dense, dry				
@ 0.5' - 4'	Red brown to blue grey <b>BEDROCK</b> , highly weathered, moderately hard to hard				
@ 4' - 5.5'	<i>Grades dark red brown to blue grey, hard</i>				
@ 5.5'	<i>Grades moderately weathered</i>				
	Test pit terminated at 5.5' (practical refusal) No free groundwater encountered No caving noted

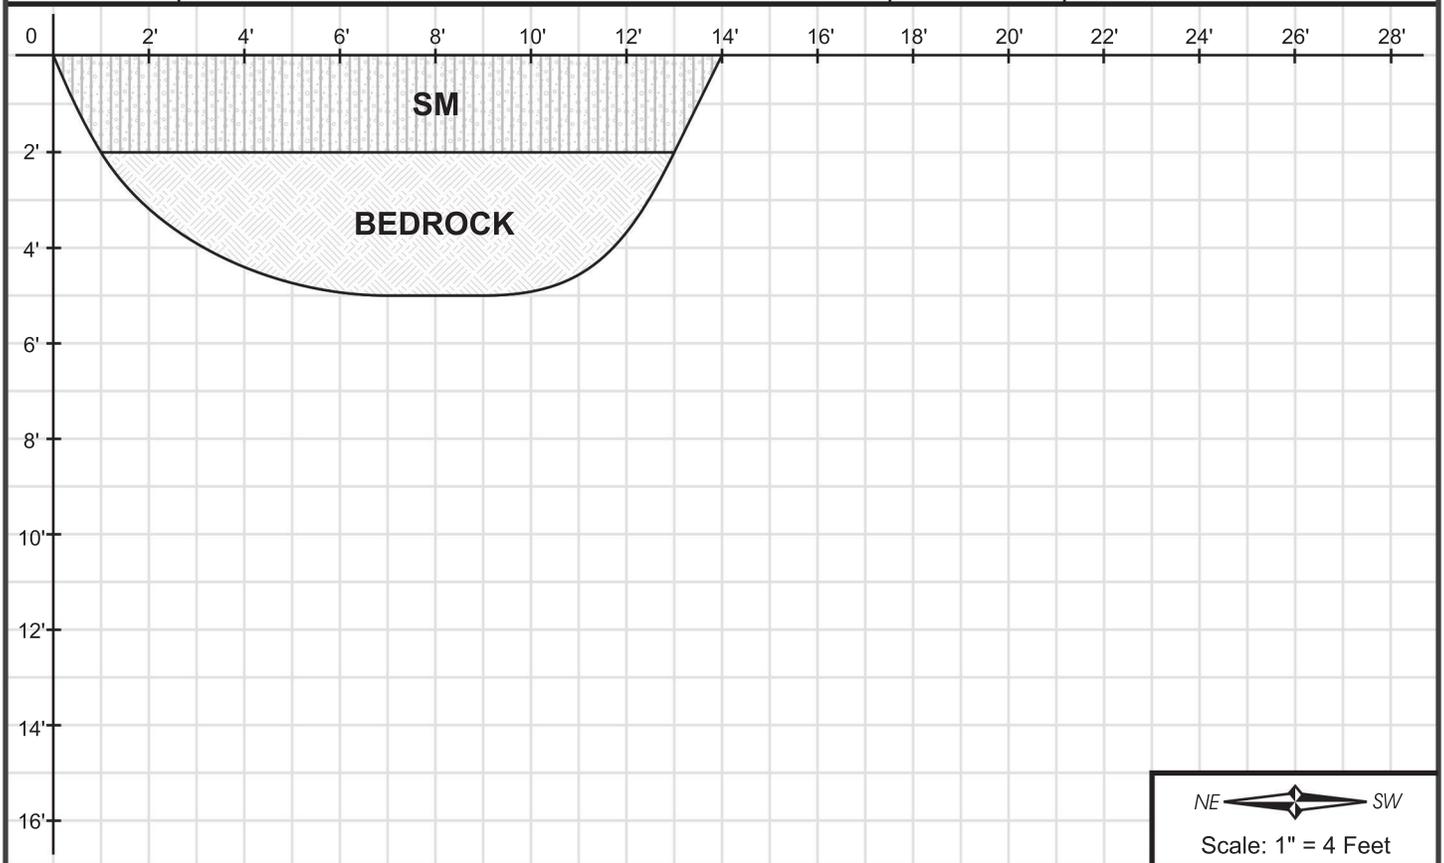
<b>YOUNGDAHL</b> CONSULTING GROUP, INC. <small>ESTABLISHED 1984</small>	Project No.: E23142.000	<b>EXPLORATORY TEST PIT LOG</b> <b>Diamond Springs Community Park</b> Diamond Springs, California	<b>FIGURE</b> <b>A-6</b>
	July 2023

<b>TP-4</b> @ 4'		
@ 2' - 5'	White <b>BEDROCK</b> , highly weathered, moderately soft to moderately hard			
@ 5'	<i>Grades moderately weathered, hard</i>			
	Test pit terminated at 5' (practical refusal) No free groundwater encountered No caving noted

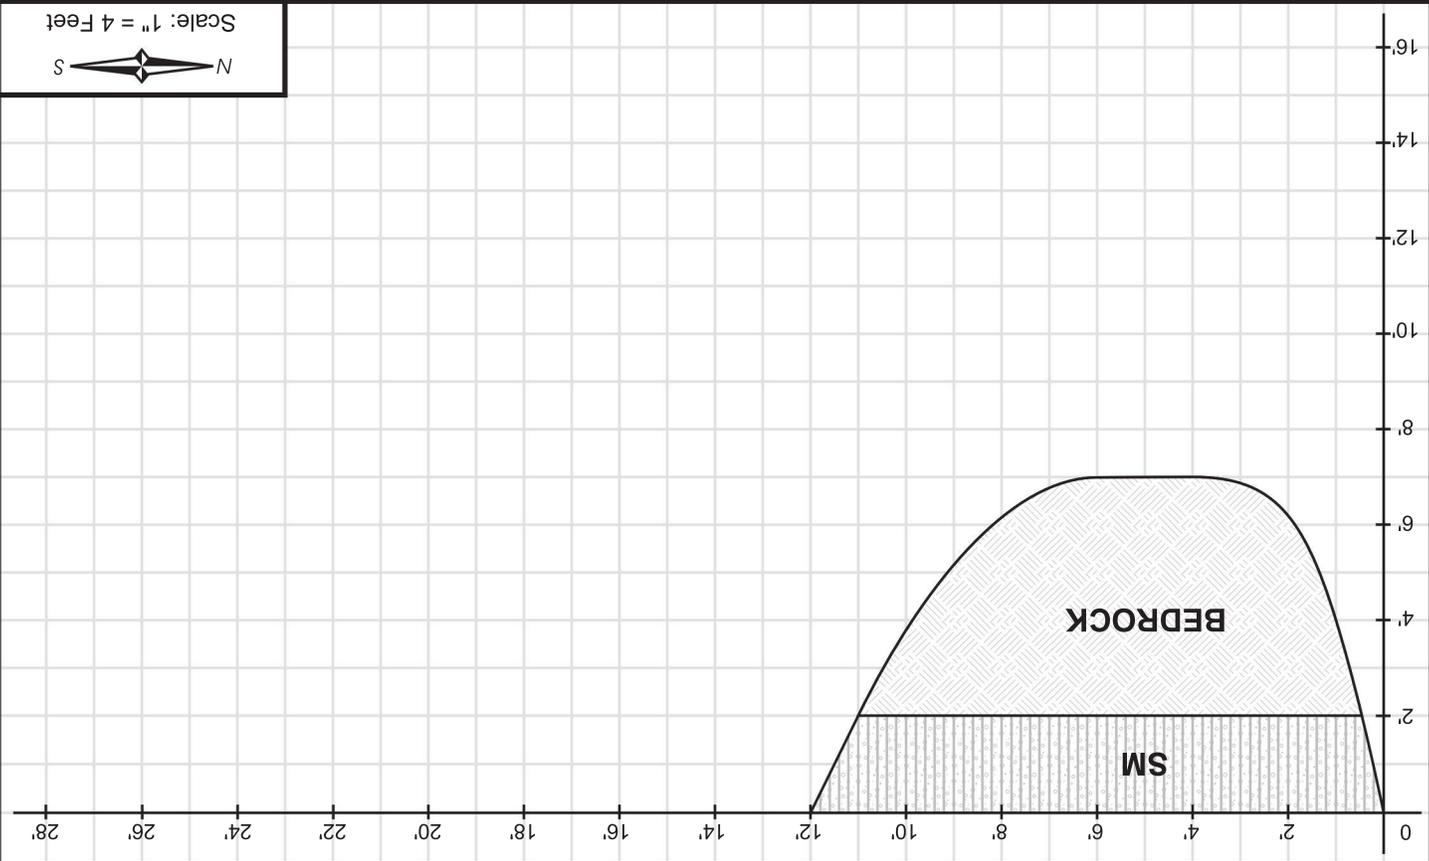
<b>TP-5</b> Pit No.		Logged By: <b>ARD</b> Date: <b>27 June 2023</b>		Lat / Lon: <b>N 38.680150° / W 120.833704°</b> Elevation: ~		Equipment: <b>John Deere 410G with 24" Bucket</b> Pit Orientation: <b>5°</b>		Tests & Comments	
Depth (Feet)		Geotechnical Description & Unified Soil Classification		Sample		Tests & Comments		Tests & Comments	
@ 0' - 2' Light brown silty <b>SAND (SM)</b> , medium dense, dry		@ 2' - 4' Yellow brown <b>BEDROCK</b> , completely weathered, very soft to soft		@ 4' - 7' Grades white to tan, highly weathered		@ 7' Grades moderately weathered, moderately hard		Test pit terminated at 7' (practical refusal) No free groundwater encountered No caving noted

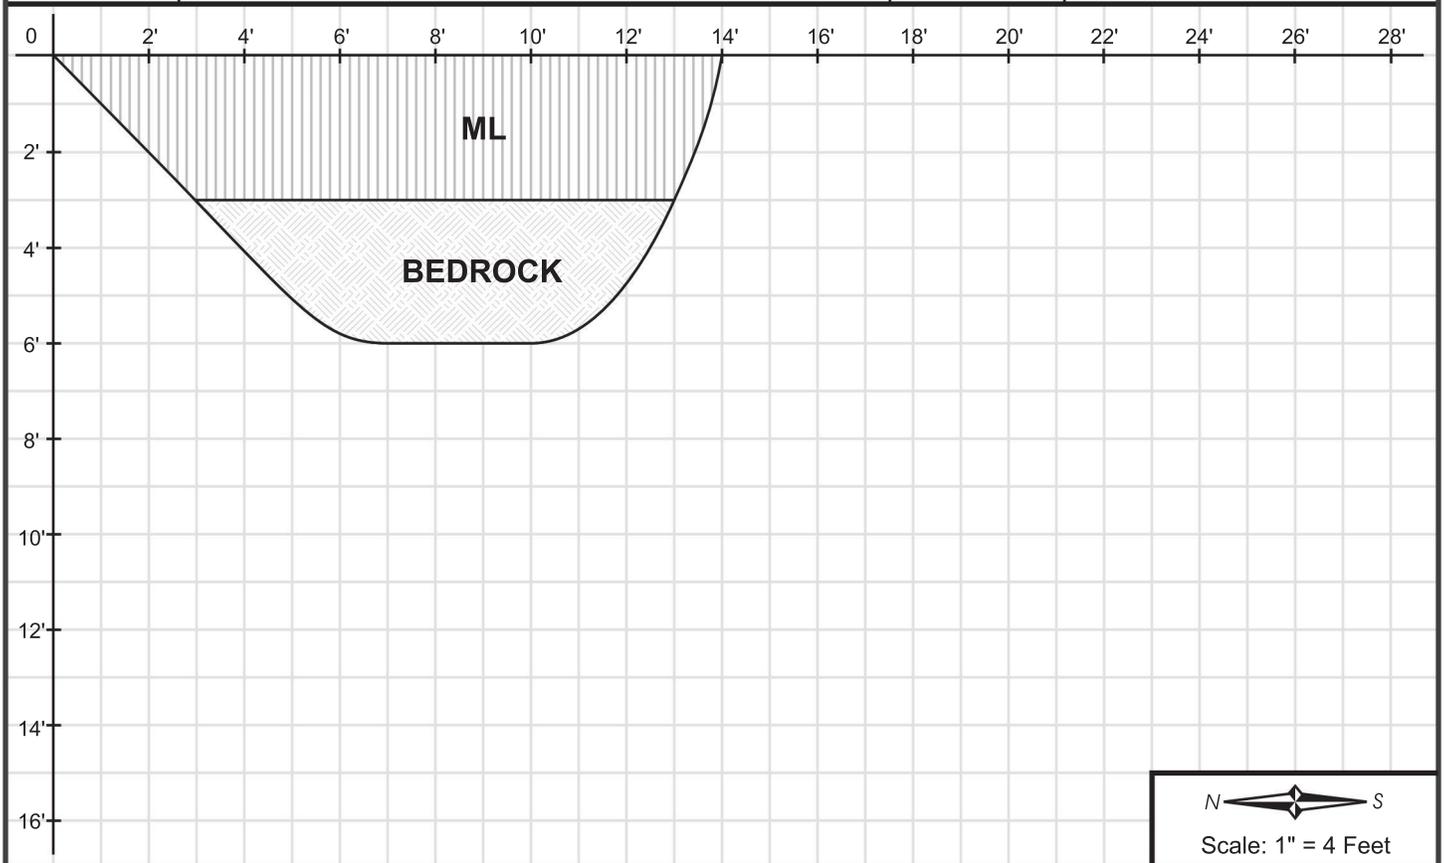
Logged By: <b>ARD</b>		Date: <b>27 June 2023</b>	Lat / Lon: <b>N 38.681374° / W 120.834216°</b>	Pit No. <b>TP-6</b>
Equipment: <b>John Deere 410G with 24" Bucket</b>		Pit Orientation: <b>19°</b>	Elevation: ~	
Depth (Feet)	Geotechnical Description & Unified Soil Classification	Sample	Tests & Comments	
@ 0' - 3'	Olive brown <b>SILT (ML)</b> with sand and gravel, soft to medium stiff, dry

<b>TP-6</b> @ 1'		
@ 3' - 6'	White to tan <b>BEDROCK</b> , highly weathered, moderately soft			
@ 6'	<i>Grades moderately weathered, moderately hard</i>			
	Test pit terminated at 6' (practical refusal) No free groundwater encountered No caving noted

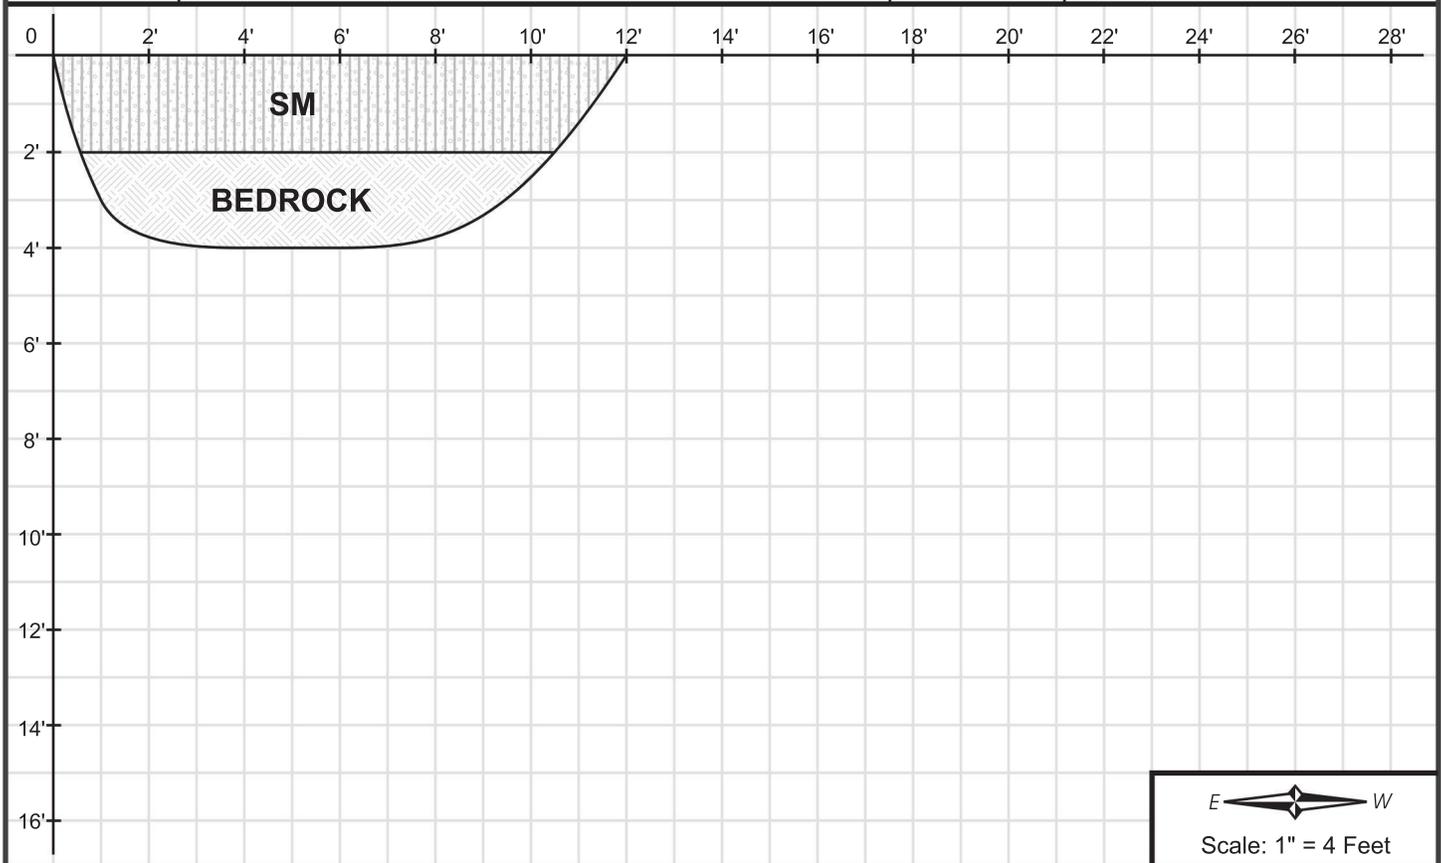
<b>TP-7</b> @ 3'		
@ 2' - 4'	White to tan <b>BEDROCK</b> , highly weathered, soft to moderately soft			
@ 4'	<i>Grades moderately weathered, moderately hard</i>			
	Test pit terminated at 6' (practical refusal) No free groundwater encountered No caving noted

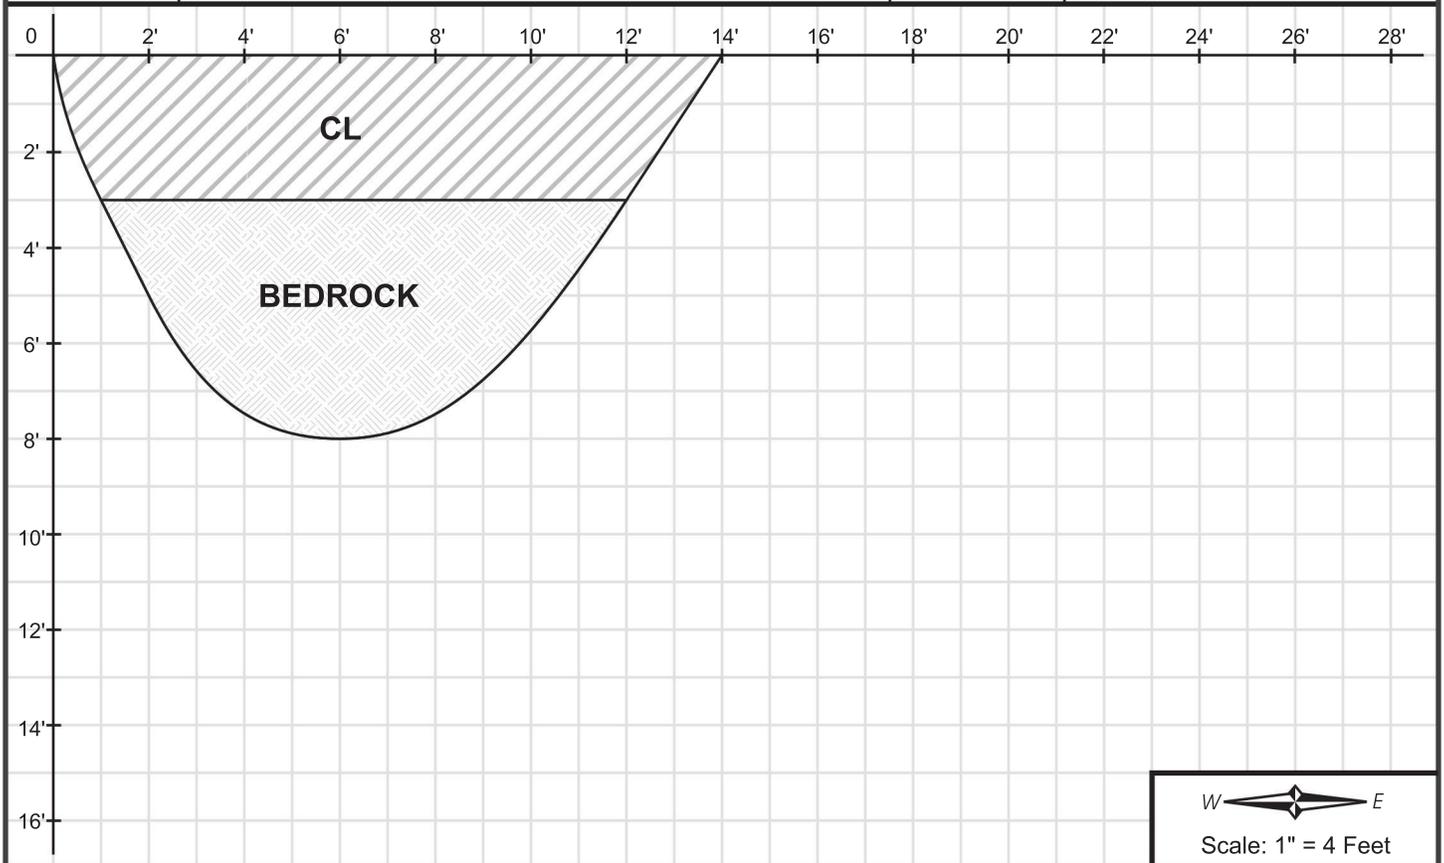
<b>YOUNGDAHL</b> CONSULTING GROUP, INC. <small>ESTABLISHED 1984</small>	Project No.: E23142.000	<b>EXPLORATORY TEST PIT LOG</b> <b>Diamond Springs Community Park</b> Diamond Springs, California	<b>FIGURE</b> <b>A-10</b>
	July 2023

<b>TP-8 @ 2'</b>		
@ 3' - 6'	Brown to grey <b>BEDROCK</b> , completely weathered, very soft to soft			
@ 6' - 8'	<i>Grades red yellow, highly weathered, moderately hard</i>			
@ 8'	<i>Grades moderately weathered, moderately hard</i>			
	Test pit terminated at 8' (practical refusal) No free groundwater encountered No caving noted

The materials encountered in our explorations included plastic materials in the form of a lean clay in Test Pit TP-8, near the proposed gym. Expansion index testing was performed on a sample of the material and resulted in a value of 74, which is considered to be a medium expansion potential. Expansive soils could cause damage to foundations and other rigid improvement if left in place. Depending on the proposed grading plans and cuts or fills in the areas where clay is encountered some focused excavations of the clay may be required if sufficient separation from planned improvements is not achieved. In addition, if during the site preparations operations, the clay soils are determined to be soft and/or unstable under the weight of the construction equipment, they will require overexcavation as discussed in the recommendations section below. If necessary, recommendations can be made based on our observations at the time of construction should greater quantities of expansive soils be encountered at the project site which were not encountered during this study.

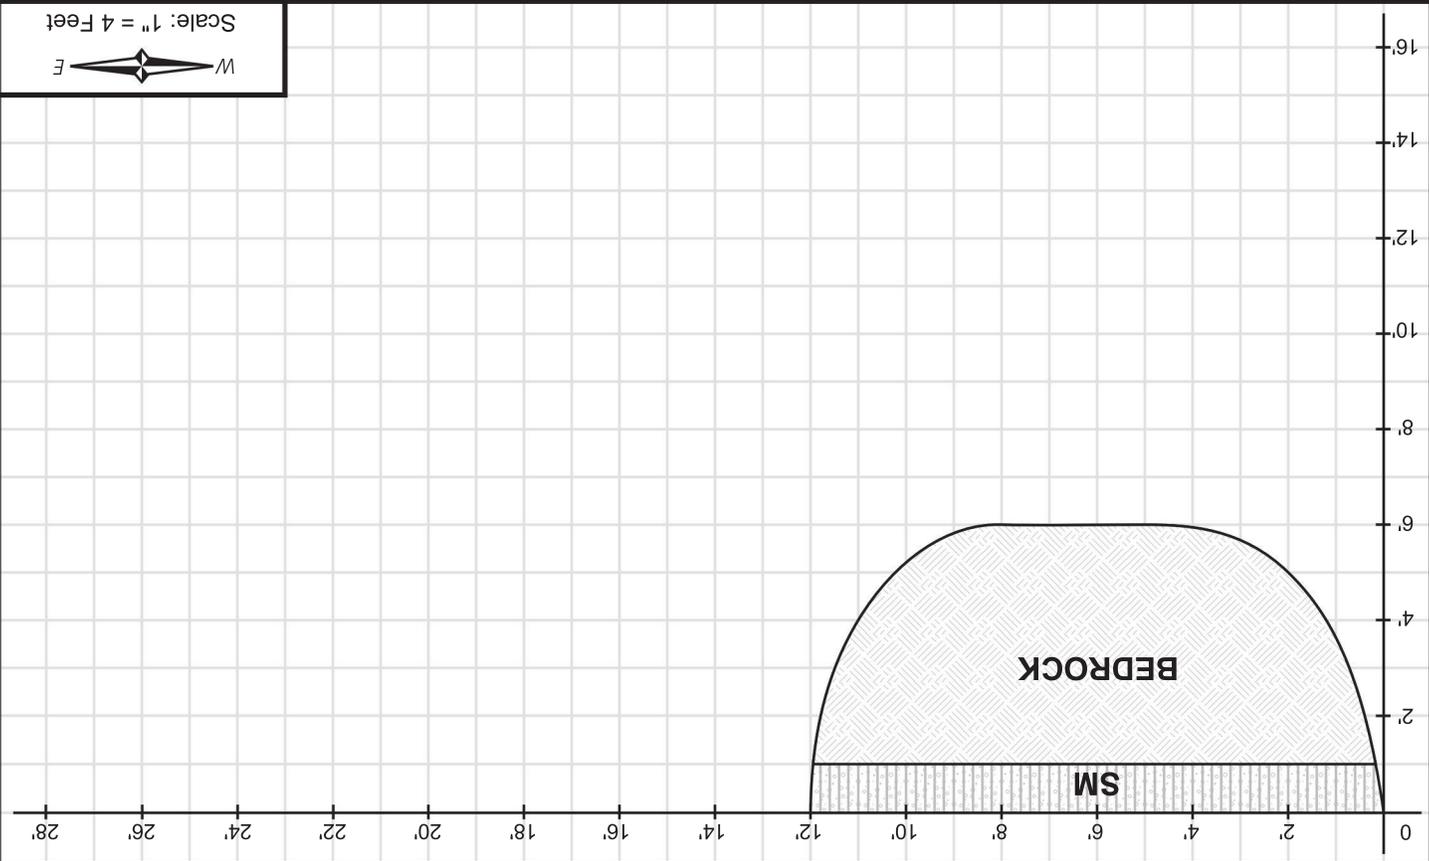
<b>TP-9</b> Pit No.		Logged By: <b>ARD</b> Date: <b>27 June 2023</b>		Lat / Lon: <b>N 38.680916° / W 120.832879°</b>		Equipment: <b>John Deere 410G with 24" Bucket</b>		Pit Orientation: <b>272°</b> Elevation: ~	
Tests & Comments		Sample		Geotechnical Description & Unified Soil Classification		Depth (Feet)		Geotechnical Description & Unified Soil Classification	
				Brown silty <b>SAND (SM)</b> with clay, medium dense, dry to slightly moist		@ 0' - 1'		White to tan <b>BEDROCK</b> , completely weathered, very soft to soft	
				Grades light brown, highly weathered, moderately hard		@ 4' - 6'		Grades moderately weathered, moderately hard	
				Test pit terminated at 6' (practical refusal) No free groundwater encountered No caving noted

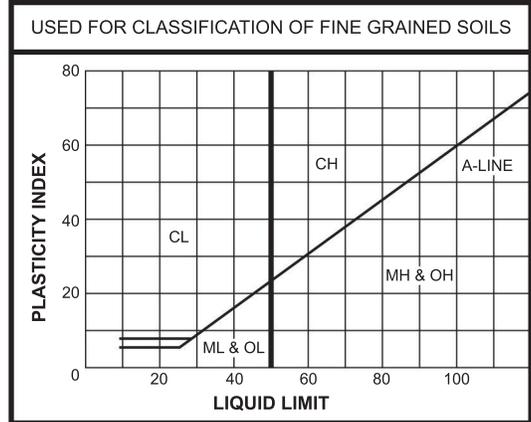
## PLASTICITY CHART

CL Inorganic <b>CLAYS</b> of low to medium plasticity, gravelly, sandy, or silty <b>CLAYS</b> , lean <b>CLAYS</b>	
		OL Organic <b>CLAYS</b> and organic silty <b>CLAYS</b> of low plasticity	
	<b>SILTS &amp; CLAYS</b> Liquid Limit > 50	MH Inorganic <b>SILTS</b> , micaceous or diamaceous fine sandy or silty soils, elastic <b>SILTS</b>	
		CH Inorganic <b>CLAYS</b> of high plasticity, fat <b>CLAYS</b>	
		OH Organic <b>CLAYS</b> of medium to high plasticity, organic <b>SILTS</b>	
	<b>HIGHLY ORGANIC CLAYS</b>	PT PEAT & other highly organic soils

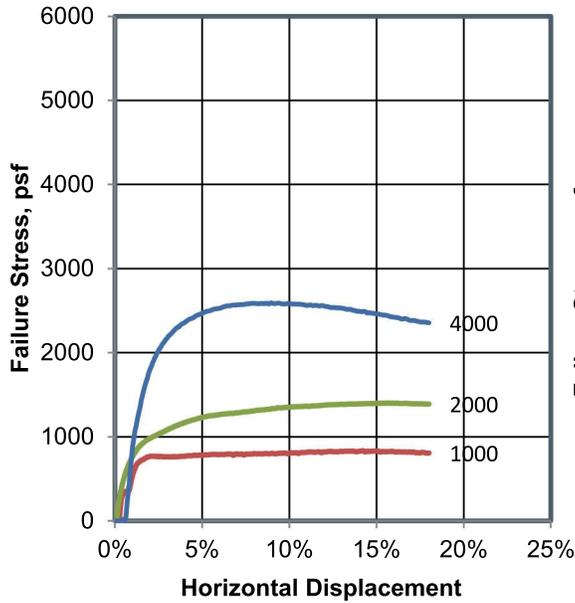
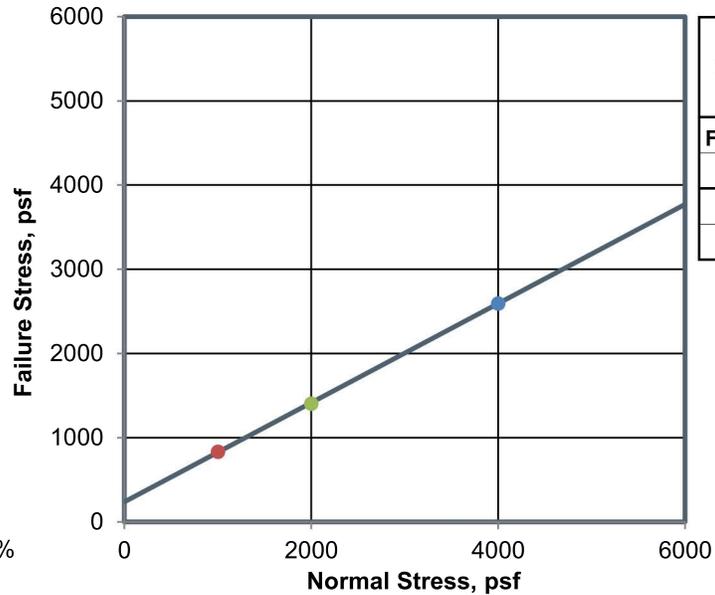
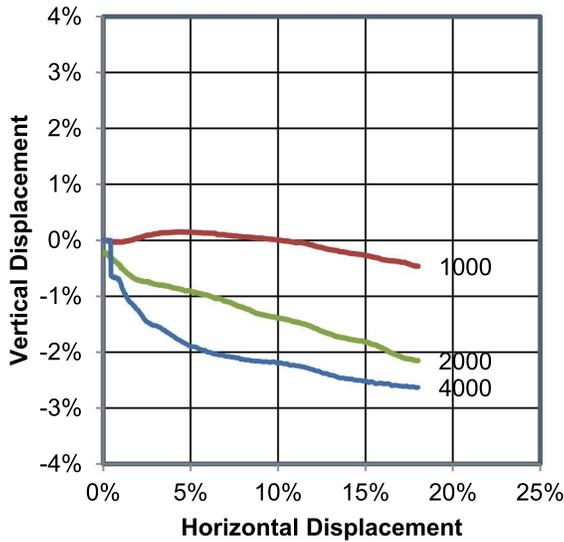
## Direct Shear Test of Soils Under Consolidated Drained Conditions, ASTM D3080

<b>Direct Shearbox Results</b>
Friction Angle 30.5°
Cohesion 237 psf

Test No.		1	2	3
Initial	Wet Density, pcf	104.6	104.6	104.6
	Dry Density, pcf	89.1	89.1	89.1
	Moisture Content, %	17.4	17.4	17.4
	Diameter, in	2.50	2.50	2.50
	Height, in	1.00	1.00	1.00
Pre Shear	Wet Density, pcf	124.3	126.5	128.4
	Dry Density, pcf	91.2	92.3	93.5
	Moisture Content, %*	36.3	37.0	37.4
	Diameter, in	2.50	2.50	2.50
	Height, in	0.98	0.97	0.95
Normal Stress, psf		1000	2000	4000
Failure Stress, psf		832	1401	2592
Failure Strain, %		14.24	15.68	8.95
Rate, in/min		0.002

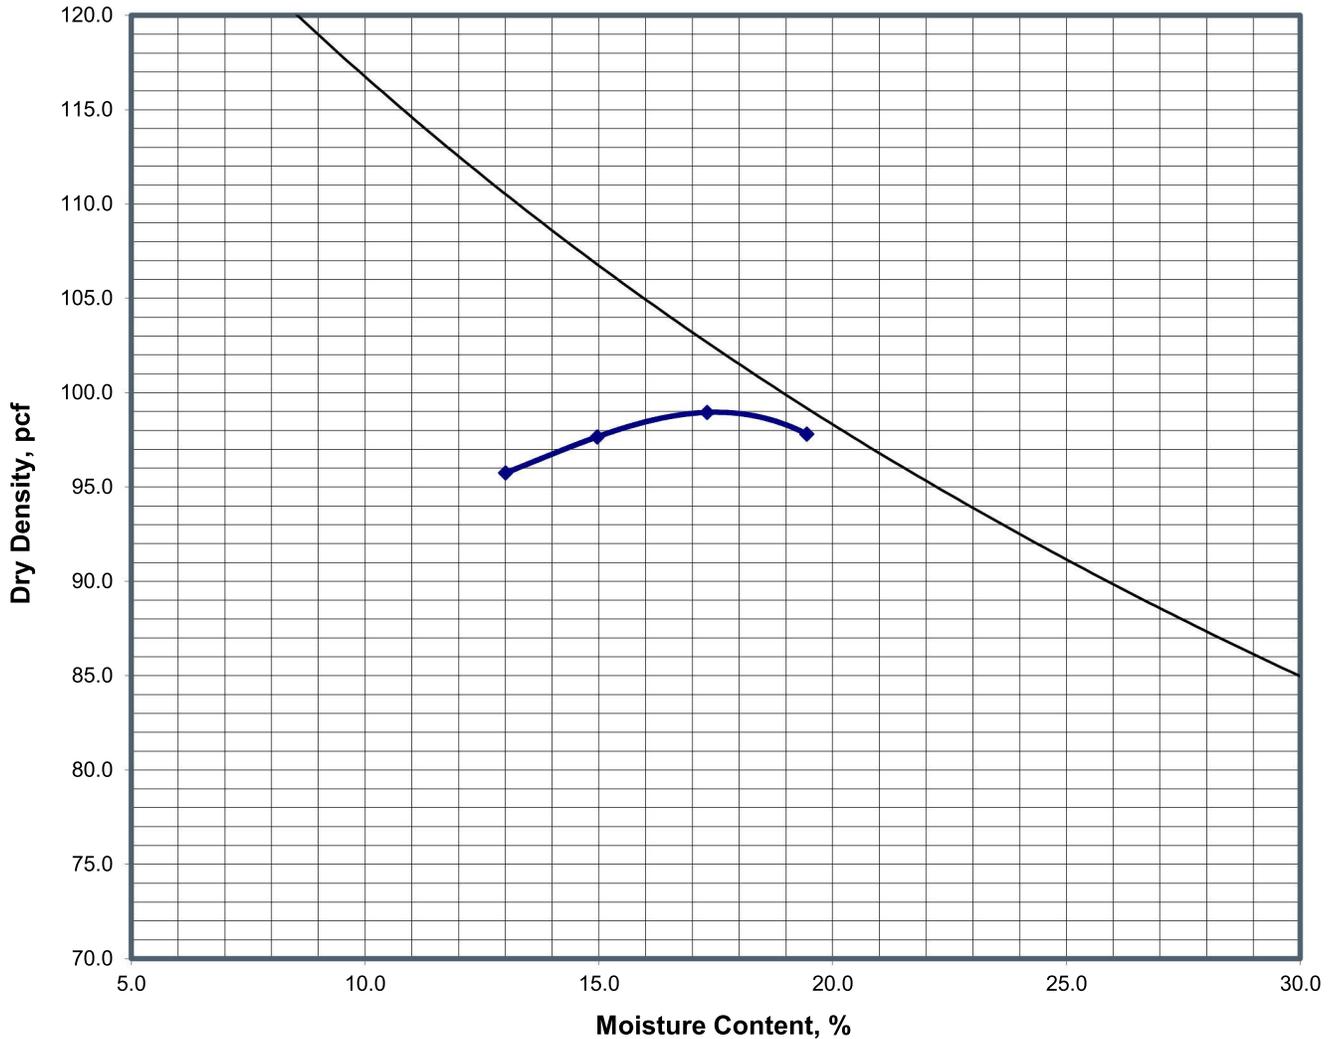
**Laboratory Compaction Characteristics of Soil  
Using Modified Effort (56,000 lbf-ft<sup>3</sup>), ASTM D1557, Method A**

— Zero Air Voids Curve at 100% Saturation;  
Specific Gravity Estimated at: 2.30

Maximum Dry Density, pcf: <b>99.0</b>	Optimum Moisture Content, %: <b>17.5</b>
---------------------------------------	--

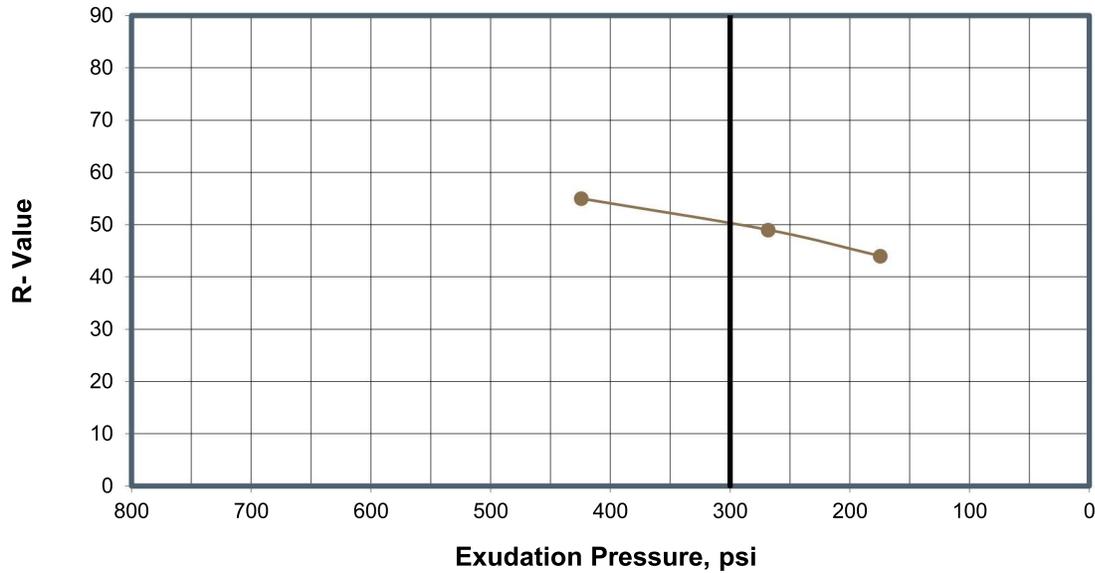
### R- Value Chart

## Resistance "R" Value of Soil and Soil-Aggregate Mixtures, CTM 301

Test Specimen No.:	1	2	3
Moisture Content at Test, %	19.6	20.2	21.5
Dry Density at Test, pcf	101.8	101.1	100.6
Expansion Pressure, psf	398	364	333
Exudation Pressure, psi	424	268	175
Resistance "R" Value	55	49	44
"R" Value at 300 psi Exudation Pressure	<b>50</b>

Material Description: **Olive Brown SILT with Sand**

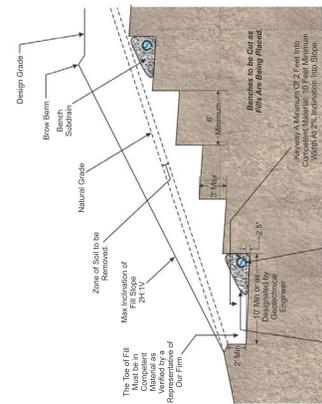
**PLACEMENT OF FILL ON NATURAL SLOPE**  
(Typical Cross Section)

All keyways should be observed and approved prior to placement of fill.  
Any keyway is required by YCC for fill on natural slopes of 2:1 or steeper.

Fill Color: Fill as Required as Determined by a Representative of Our Firm at time of Construction.

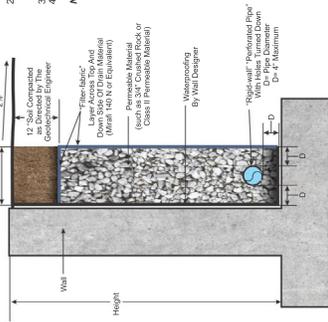
**Retaining Wall With Perforated Pipe Backrain**  
(Typical Cross Section)

- Notes: 1. Slope trench and "rigid-wall" pipes at least 1% gradient to drain to an appropriate outfall.
- 2. Use "sweeps" for directional flow in pipe flow (do not use 90° elbows).
- 3. Provide periodic "clean-outs".
- 4. Washed clean permeable material.

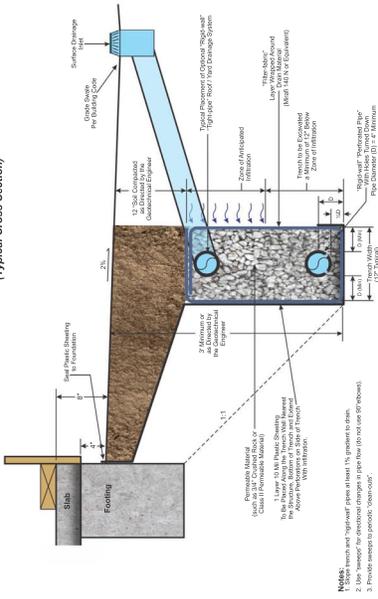
**"Two Pipe Slab-on-Grade Subrain" Installation**  
(Typical Cross Section)

- Notes: 1. Slope trench and "rigid-wall" pipes at least 1% gradient to drain.
- 2. Slope "sweeps" for directional changes in pipe flow (do not use 90° elbows).
- 3. Provide periodic "clean-outs".
- 4. Washed clean permeable material.

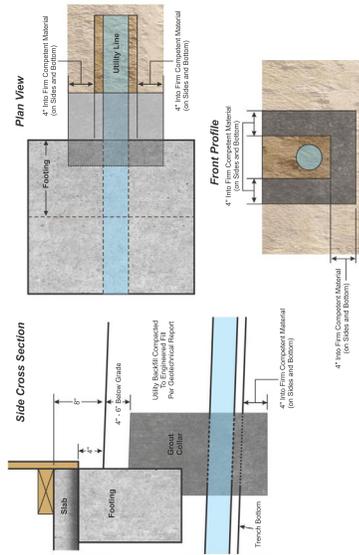
**FOUNDATION PENETRATION PLUG**  
(Typical Cross Section)
