# Facilities Capital Improve Plan

Fiscal Year 13/14

# El Dorado County

CAO Facilities

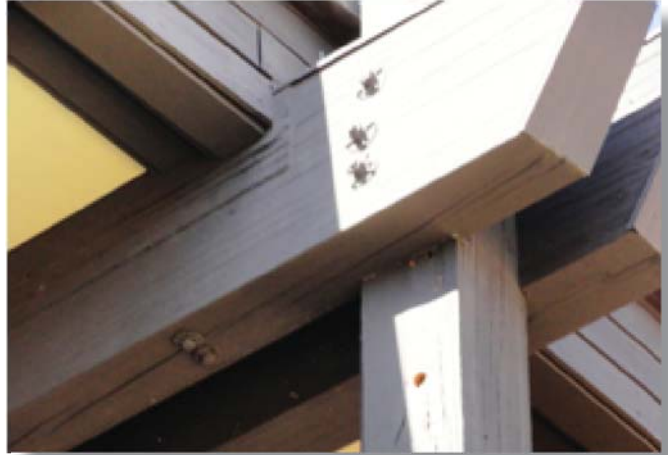
**BEAMS**

Beam repaired in 2005. The wood has vertical splitting.

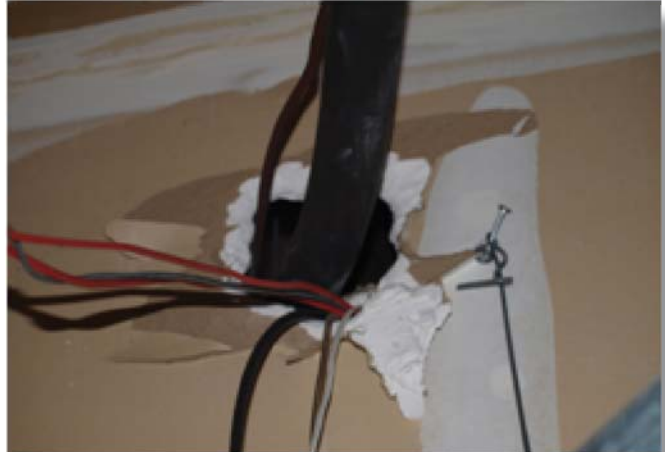
**CABLING**

Close-up of corridor wall penetration.

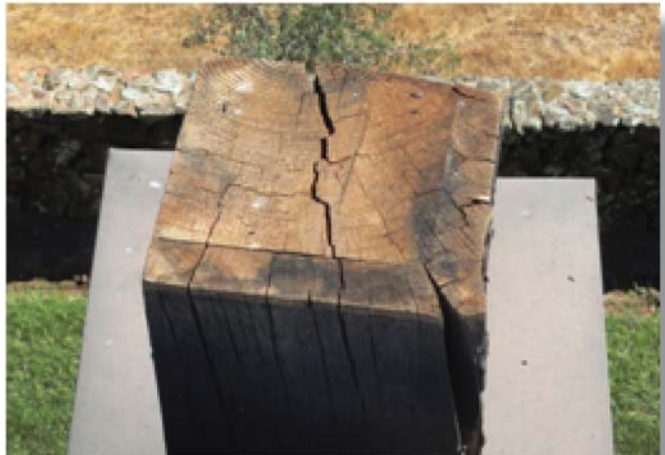
**COLUMN**

Sun damaged wood column. Wood is splitting and cracking.

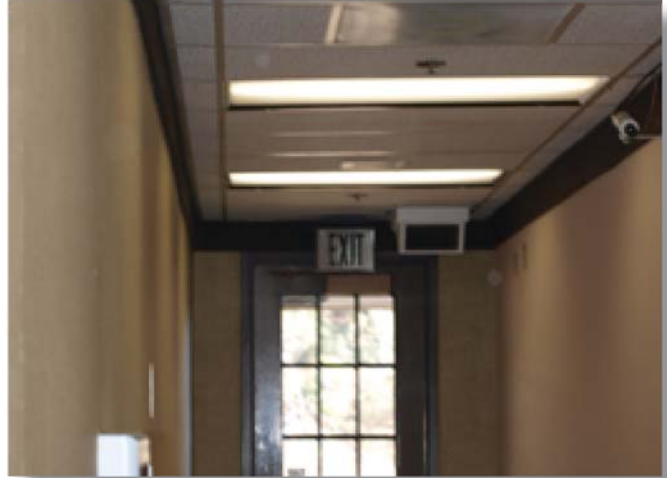
**EXIT LIGHT**

Non working exit light at 911 corridor.

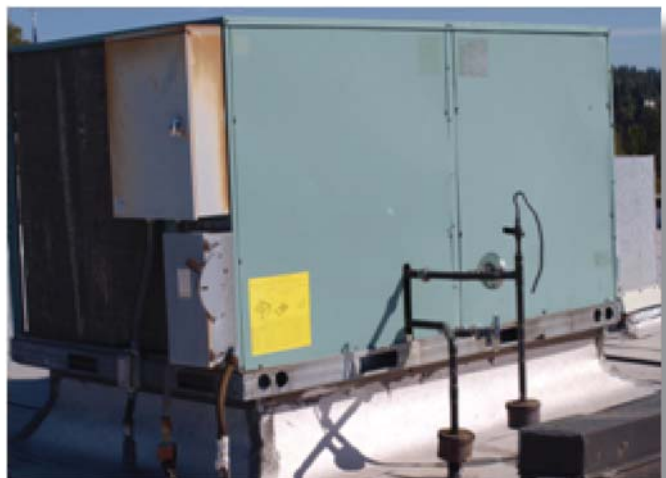
**HVAC**

20 year old roof top HVAC units.

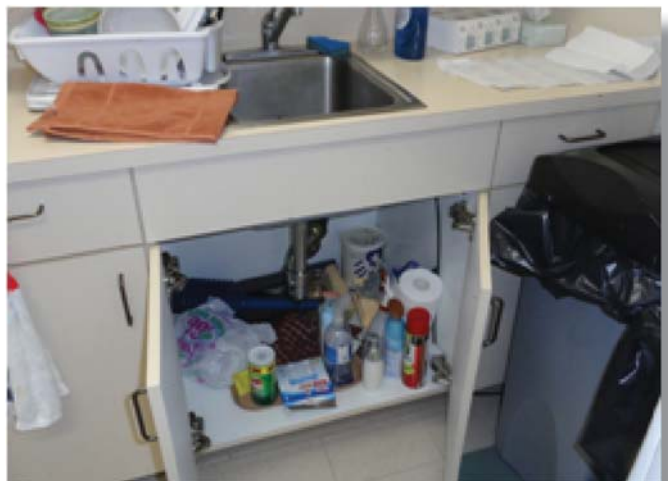
**SINK**

Non accessible sink in break room.

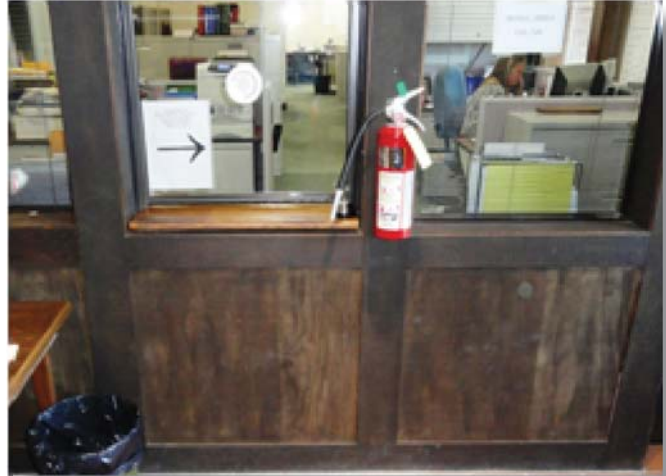
### TRANSACTION WINDOW

Counter does not provide wheelchair access and speaker hole is located too high on the window.

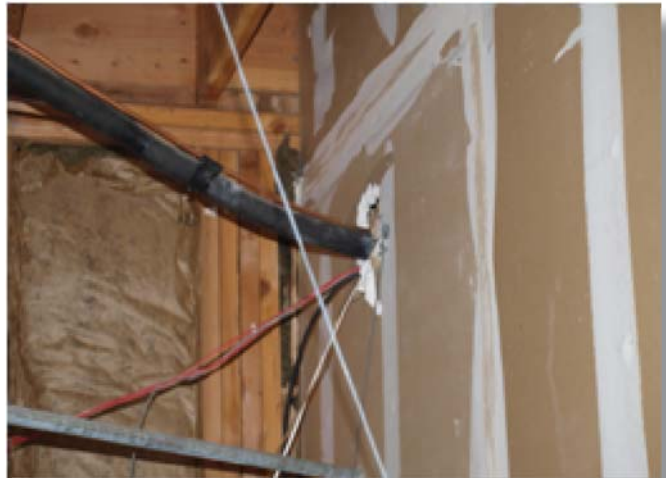
### WALL PENETRATION

Refrigerant line penetration through fire rated wall not sealed.

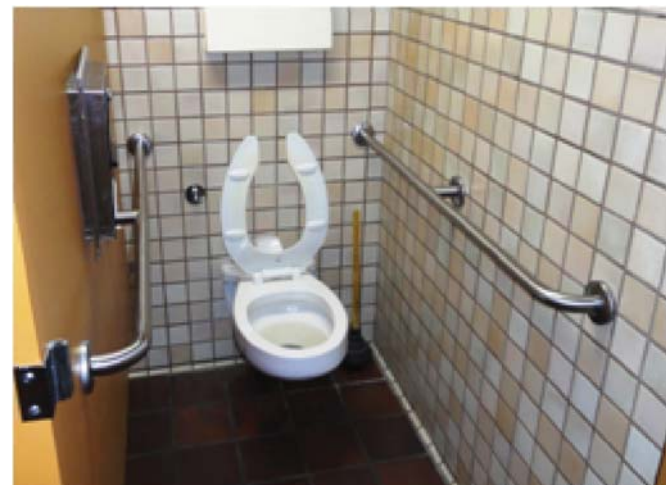
### WATERCLOSET

Grab bars have been added to sides of toilet, but compartment is not ADA accessible.

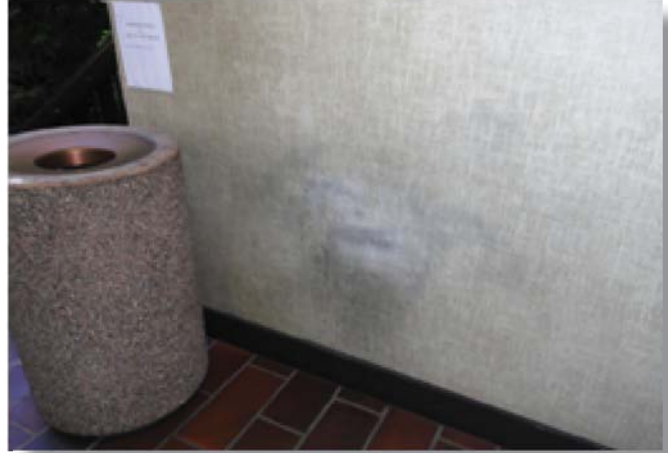
### WALL COVERING

Wall covering finish worn and stained.

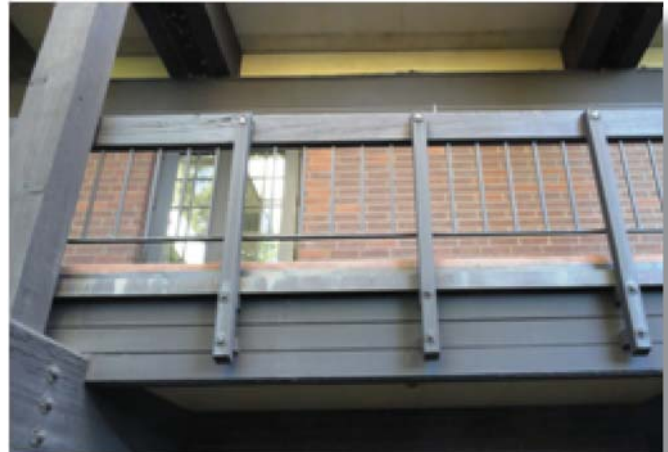
### BALCONY

Wood on balcony has dry-rot issues and splitting. The spacing on the vertical steel members requires alterations be made.

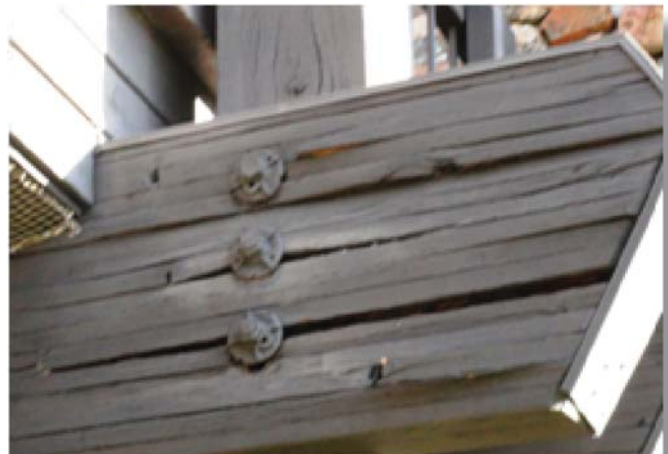
### BEAM

Damage to wood beam. Glu-lam beam is de-laminating, connection to column compromised.

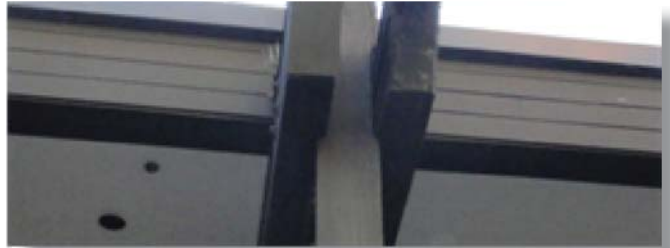
### **COLUMN**

The column has a vertical crack and the sheet metal cover is not securely attached to the beam.

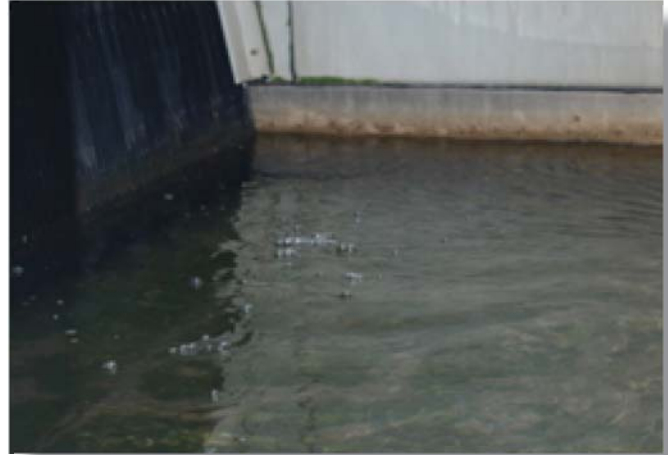
### COOLING TOWER

Cooling tower has visual sediment and debris in water.

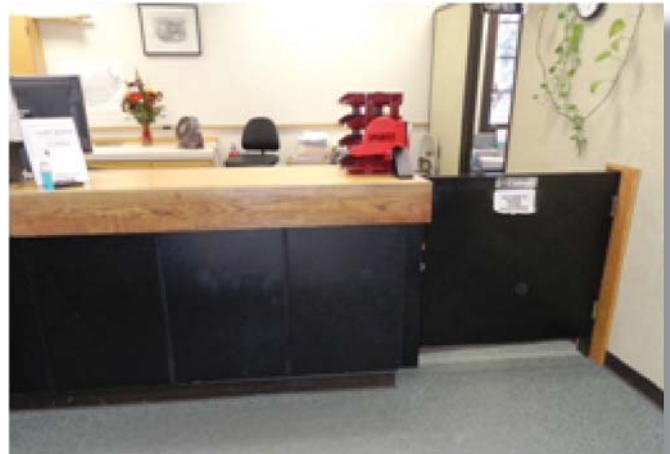
### COUNTER

Typical interior public counter in office. There is no ADA accessible station.

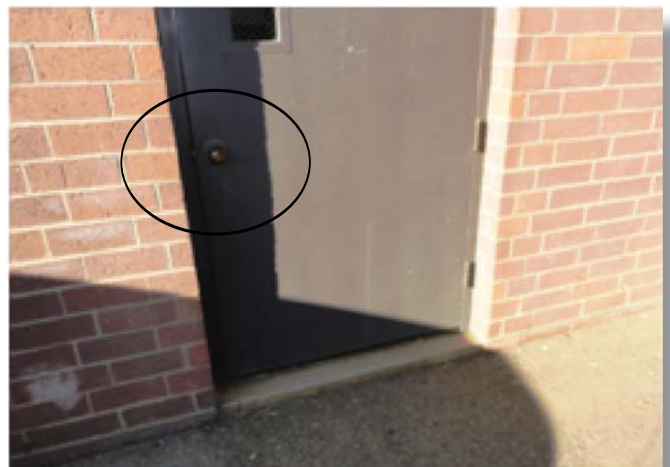
### EXTERIOR DOOR

Door does not have ADA lockset and threshold is not accessible.

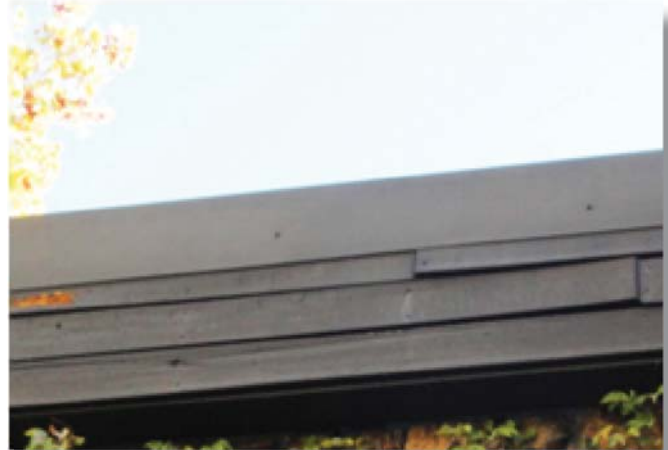
### FASCIA

Fascia boards are warped causing nails to pop.  
There is also wood splitting due to sun damage.

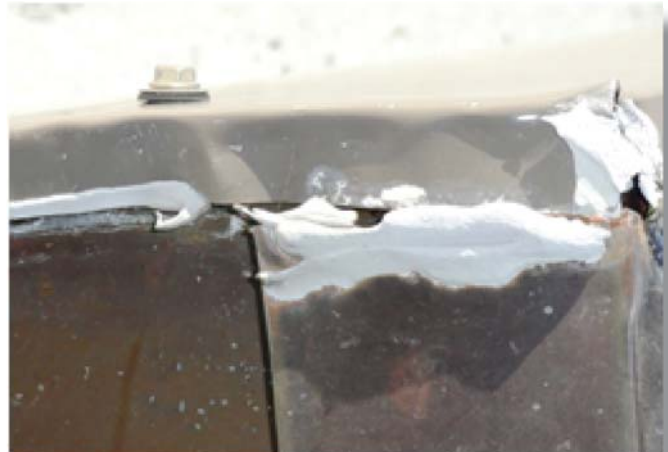
### FLASHING

Attempt made to seal roof flashing to prevent  
water infiltration.

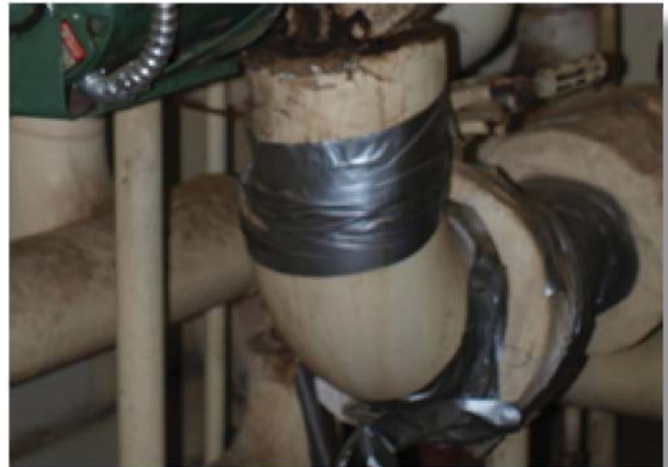
### PUMP

Original pump at air handler is past useful life. Insulation on piping kept together with duct tape.

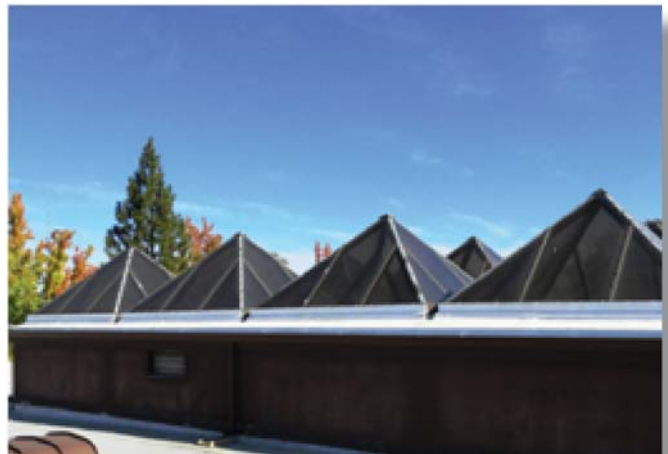
### SKYLIGHTS

Skylights leak due to deterioration of the sealants. The skylights rely on caulking rather than flashing to prevent moisture penetration which is a poor design.

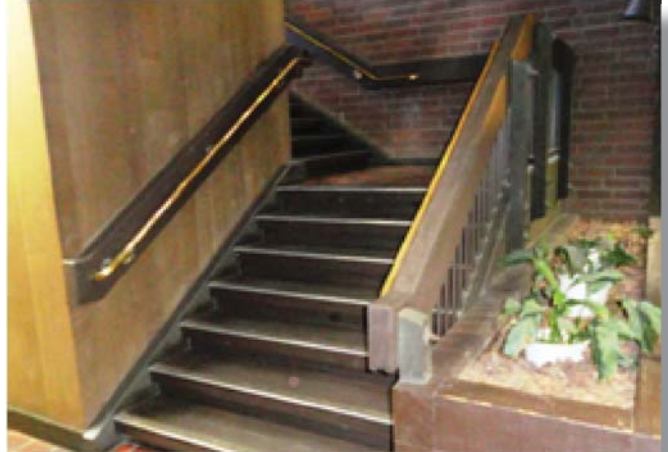
### STAIRS

Stairs do not have contrasting stripe and handrails do not extend 12" past last step.

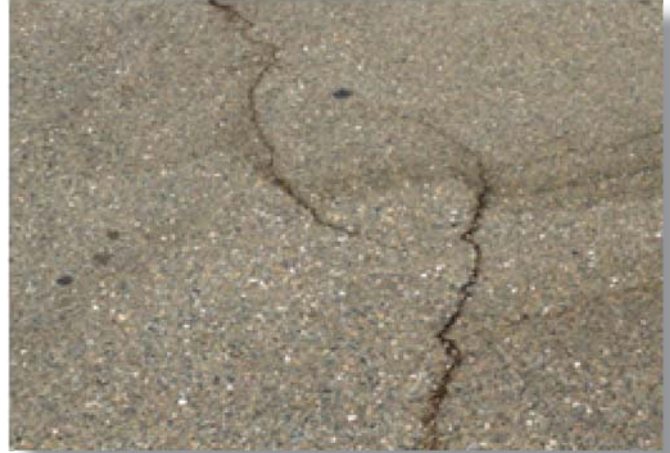
### ASPHALT

Cracking in asphalt pavement.

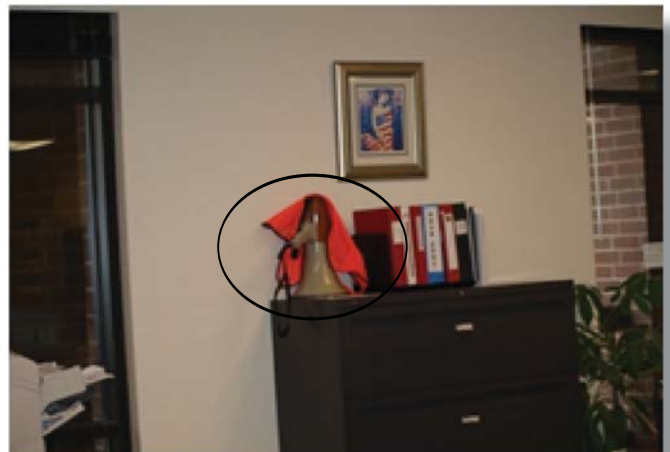
### BULL HORN

Lower level does not have operating PA system, so bull horn used for announcements.

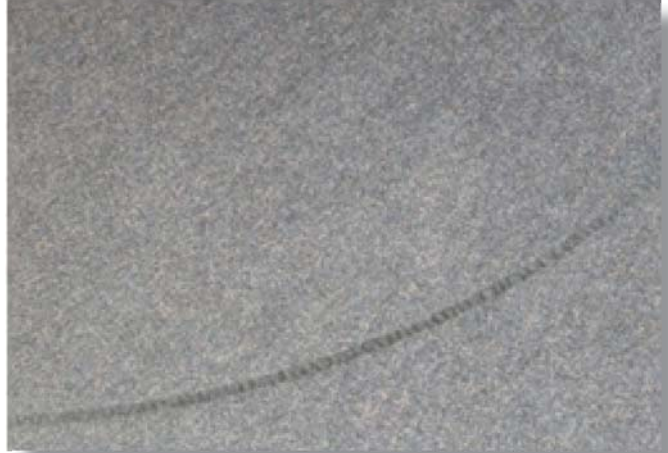
### **CARPET**

Carpet damaged by door rubbing on material.

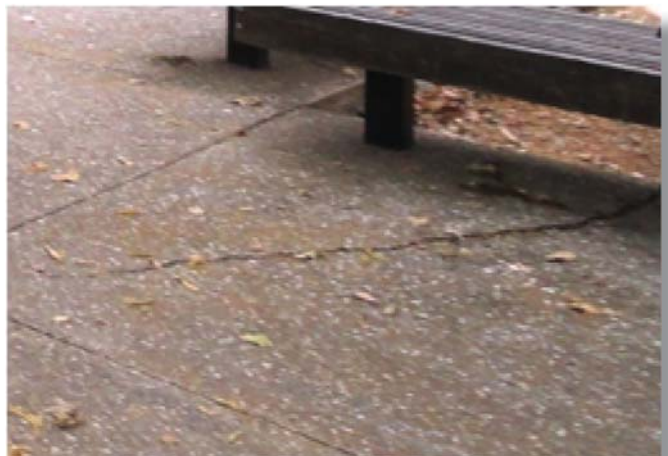
### **CONCRETE CRACKING**

Cracking in concrete walkway.

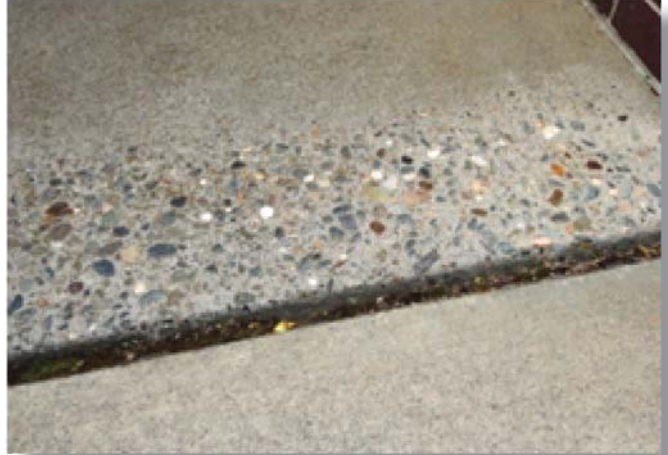
### CONCRETE GROUND

Uneven surface on concrete. Concrete was ground so adjacent sections are even, but movement has continued and surfaces are still not aligned.

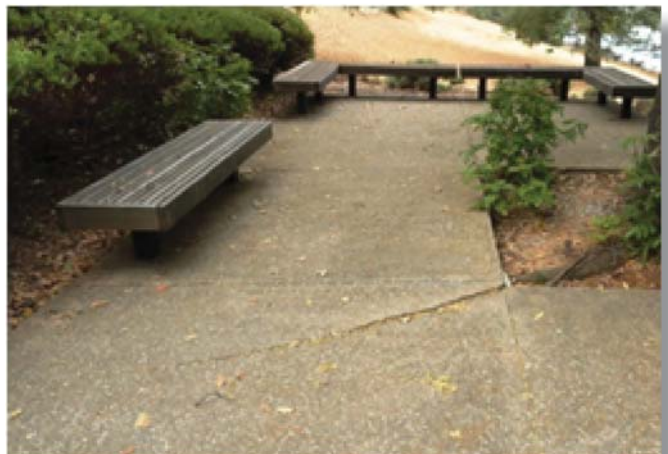
### CONCRETE TREE ROOT

Tree root has lifted up concrete pavement resulting in crack and uneven surface.

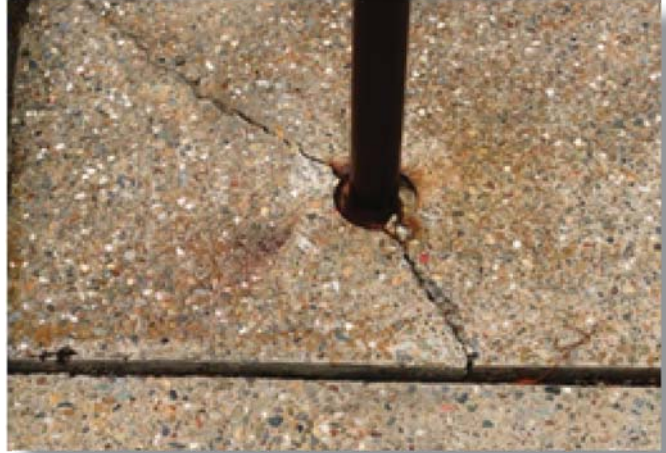
### CONCRETE

Coring for installation of handrail results in cracked concrete.

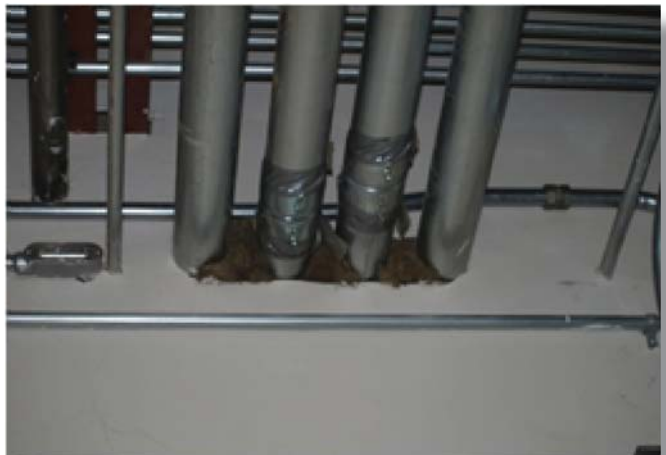
### CONDUIT

Conduit penetrations through wall not properly sealed.

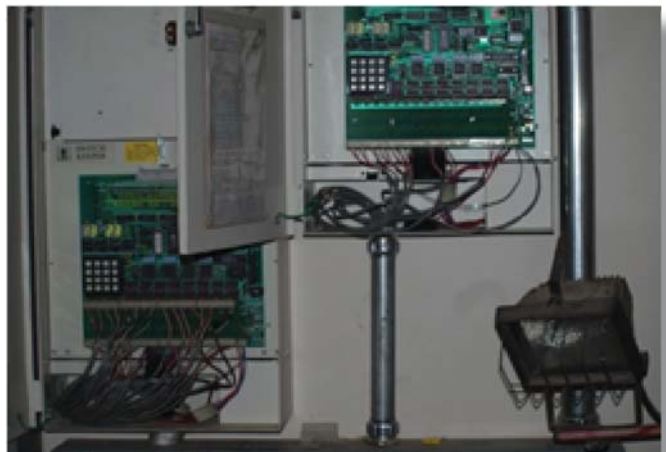
### CONTROLS

Controls for HVAC system are obsolete.

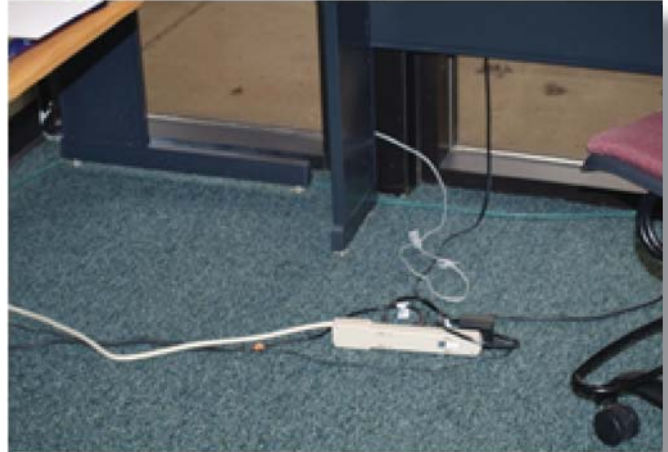
### WORKSTATION

Typical workstation. There are not enough power outlets. Extension cords present possible fire and tripping hazard.

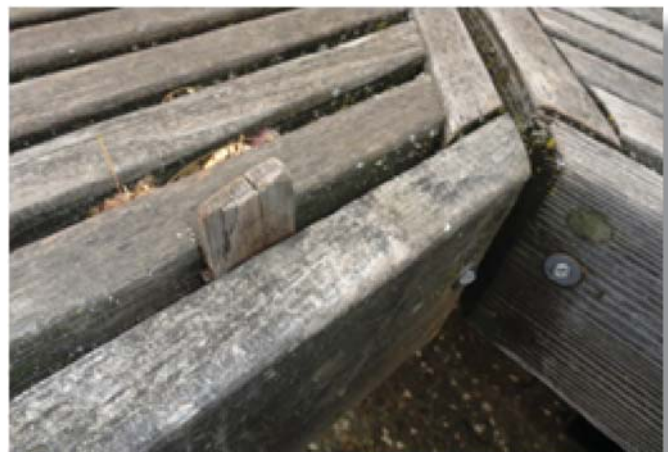
### EXTERIOR BENCH

Wood at exterior benches is deteriorating. Maintenance has added screws to keep bench from coming apart.

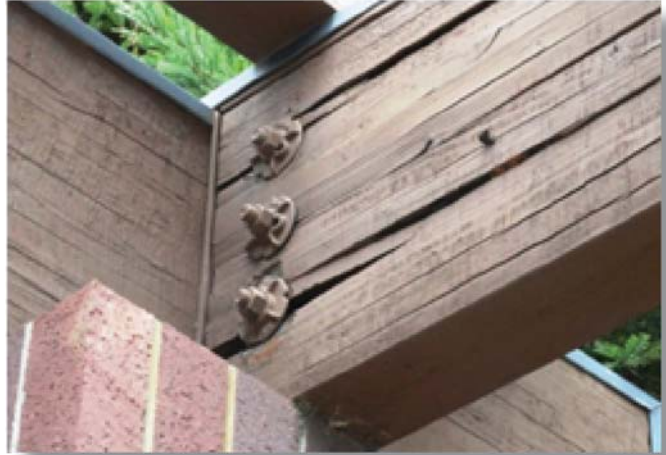
### FRAMING

Sun damaged wood beam at entrance pergola. The beam is split and the connection via the lowest bolt compromised.

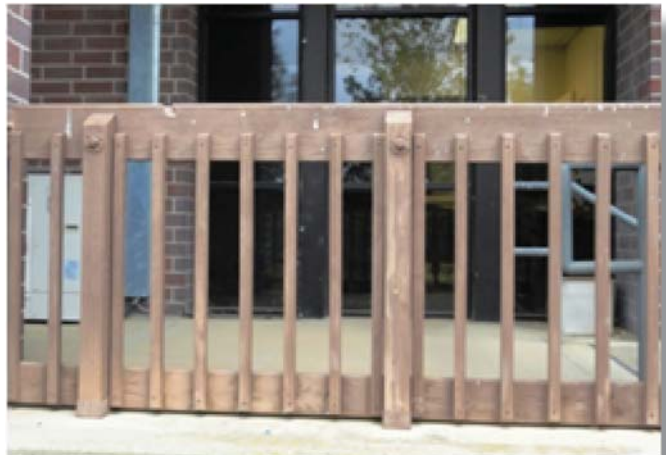
### RAILING -WEST

The sun damaged wood rail is split and rough.

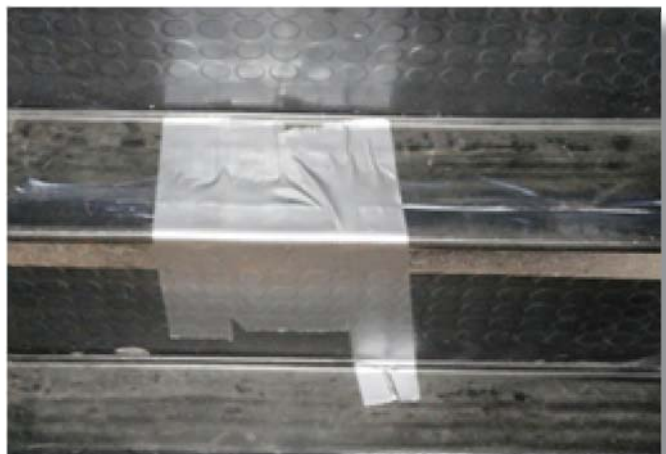
### STAIRS

Rubber at stair riser held substrate with duct tape.

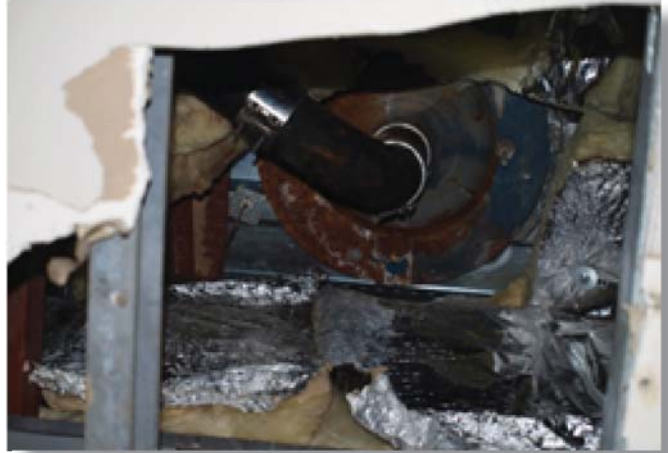
**ROOF DRAIN**

Water leak at roof drain.

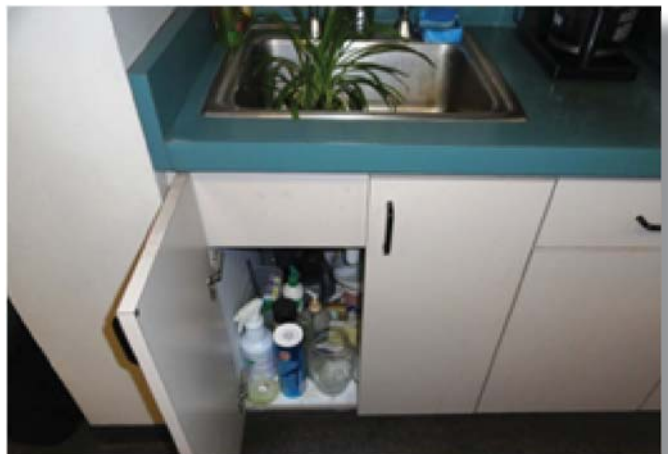
**SINK**

Non accessible sink in break room. Cabinet does not provide wheelchair access.

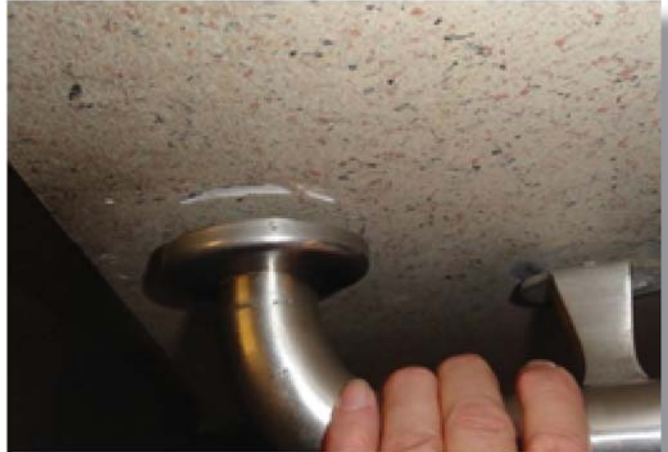
### STAIR HAND RIAL

The hand rail at stairs is not secure to wall.

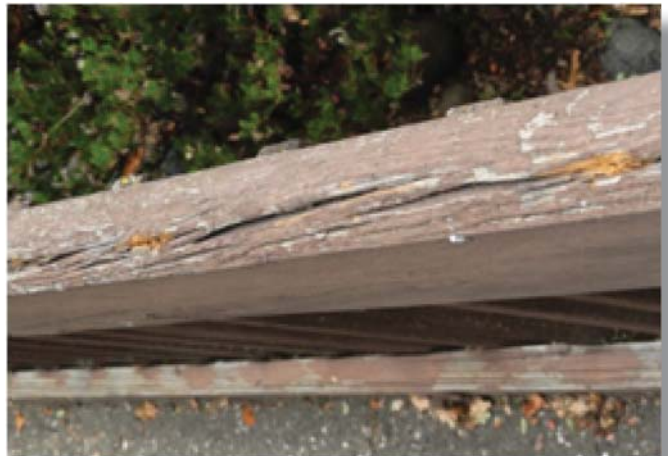
### RAILING

The sun damaged wood rail is split and rough.

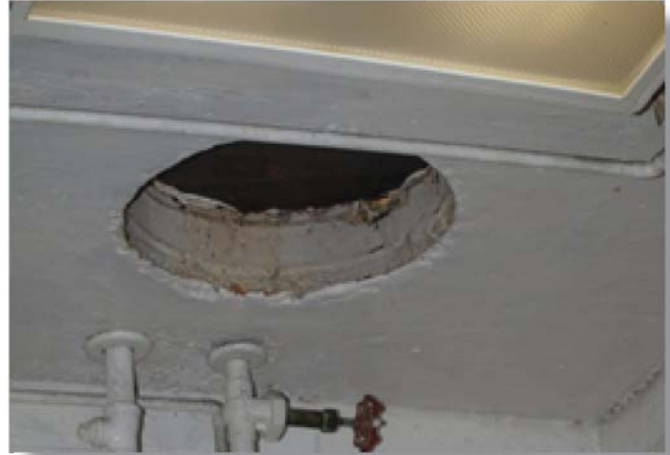
**ABANDONED**

Hole from abandoned piping was never in-filled.

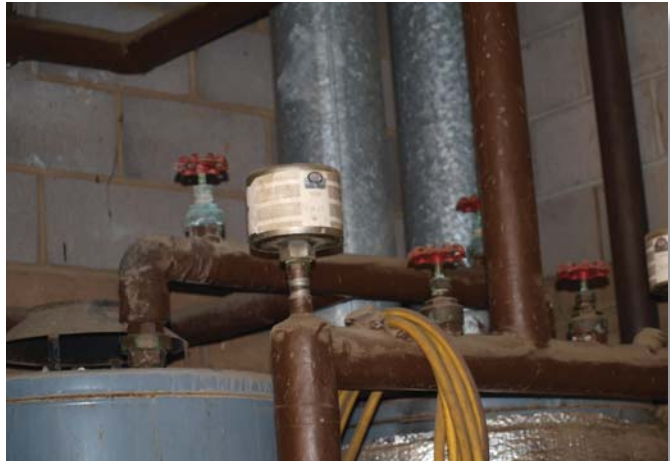
**ABANDONED**

Abandoned water heater was left in place.

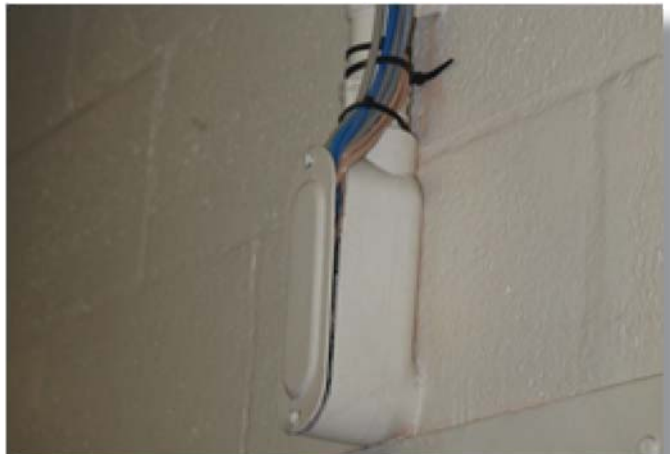
**ADAPTIVE**

Adaptive use for conduit and cabling not per code.

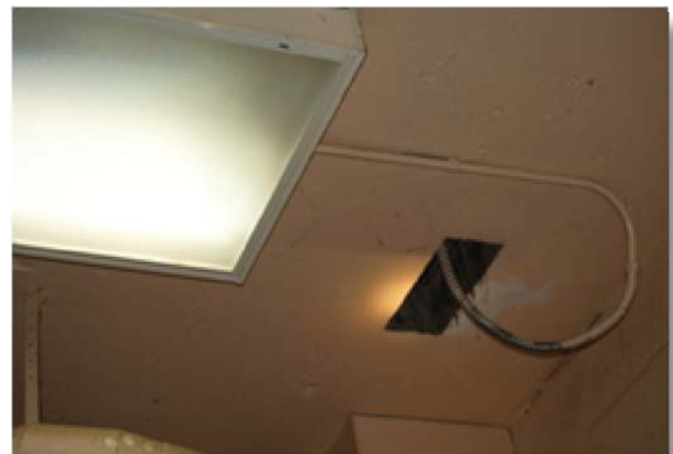
**DUCT**

Ductwork used for electrical conduit chase to power light fixture.

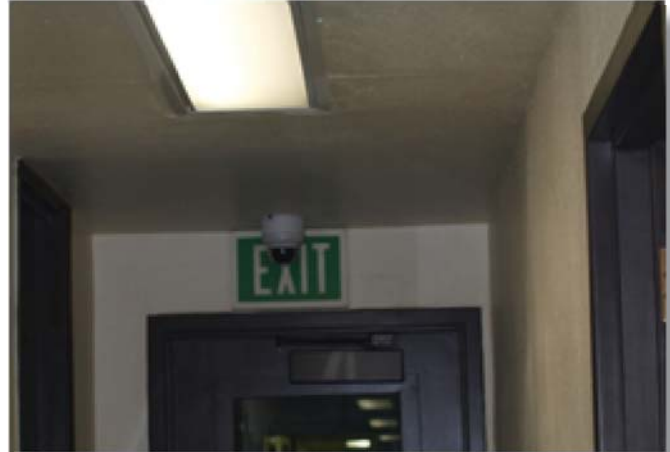
**EXIT**

Exit light does not work.

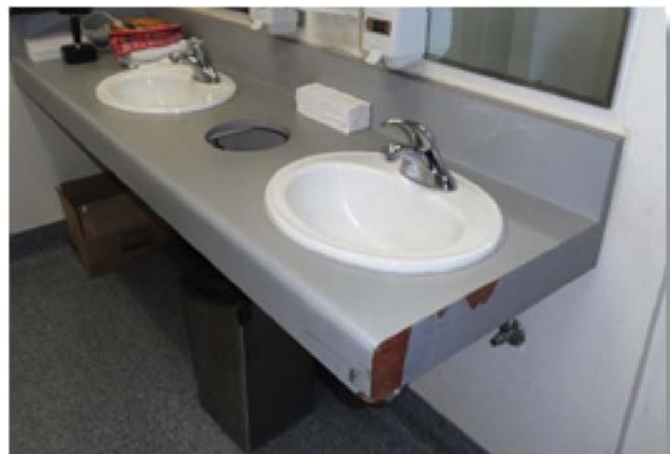
**COUNTER**

Damage to plastic laminate at restroom counter.

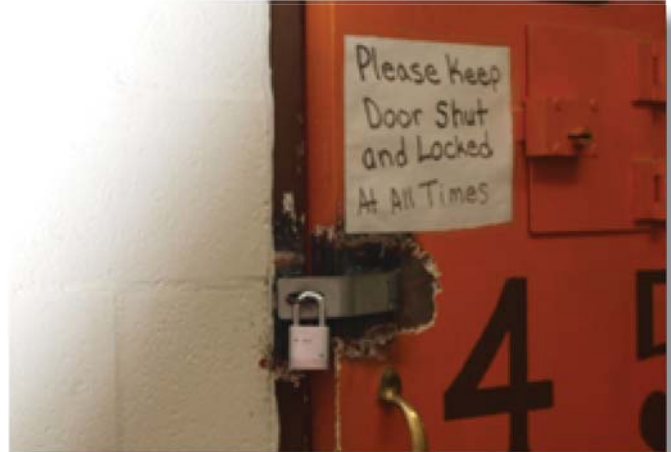
### DOOR

Door lock does not work. Padlock used to secure evidence.

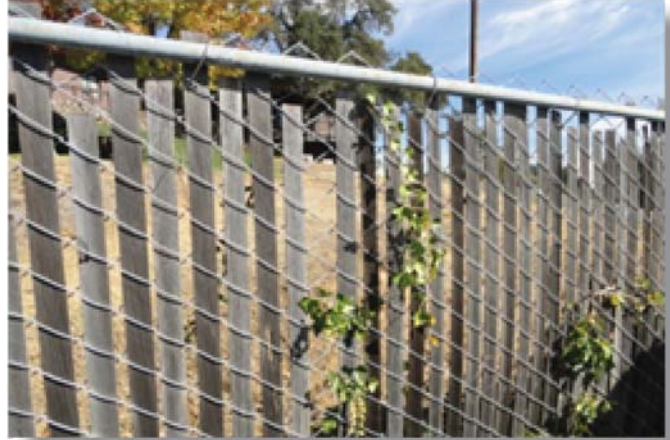
**FENCING**

Privacy slats in fencing damaged or missing.

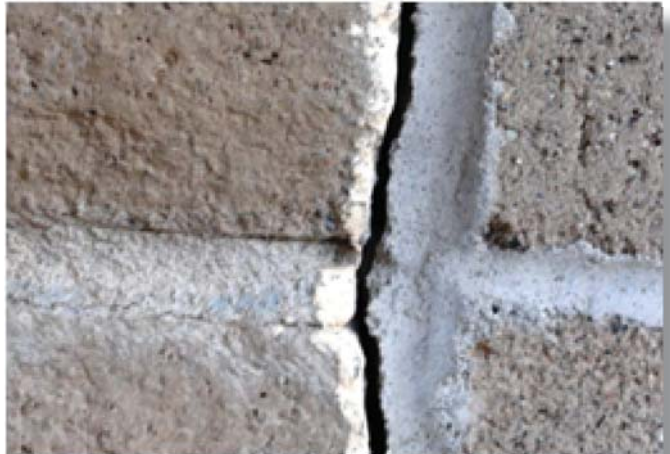
**GROUT SEPARATION**

Building settlement has created separation in the block.

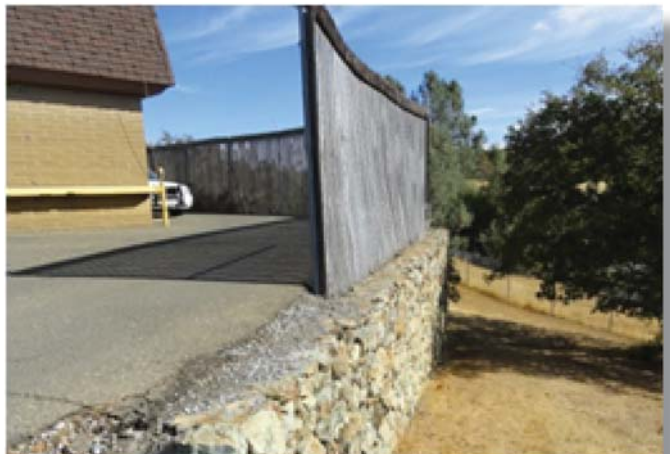
**FENCING**

Fencing ends before retaining wall. There is no fall protection which could lead to liability issues.

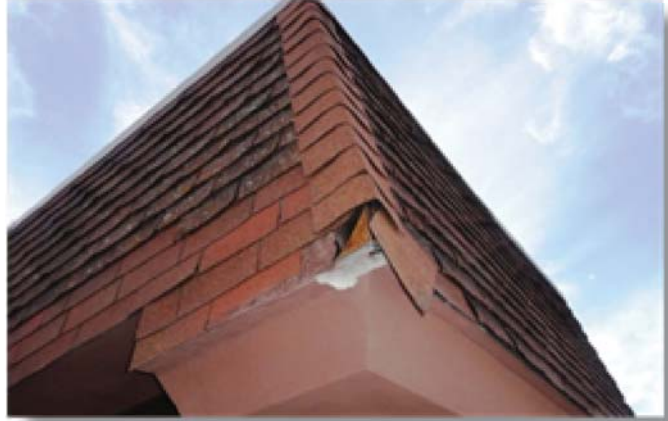
**MANSARD DAMAGE**

Corner of building appears to have been damaged by a delivery truck.

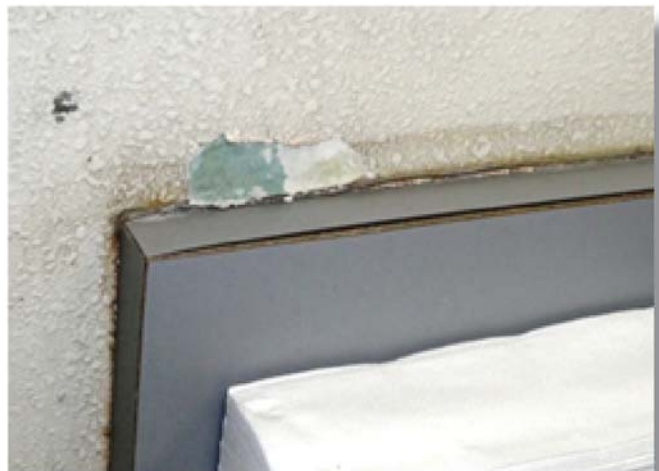
**RESTROOM COUNTER**

De-lamination in restroom counter. Mold growth occurring.

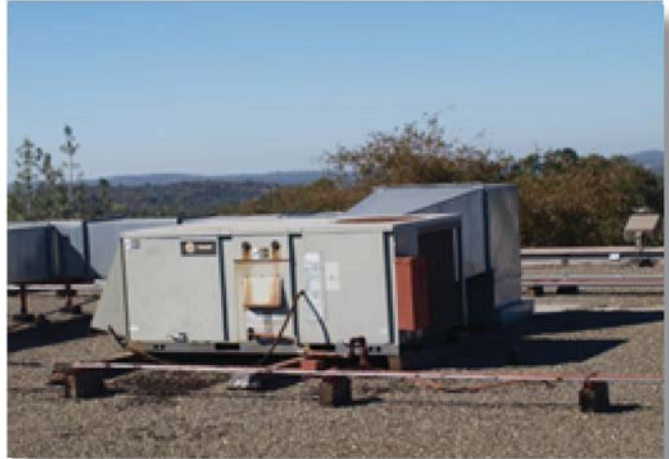
**PACKAGED UNIT**

Old package unit at end of useful life.

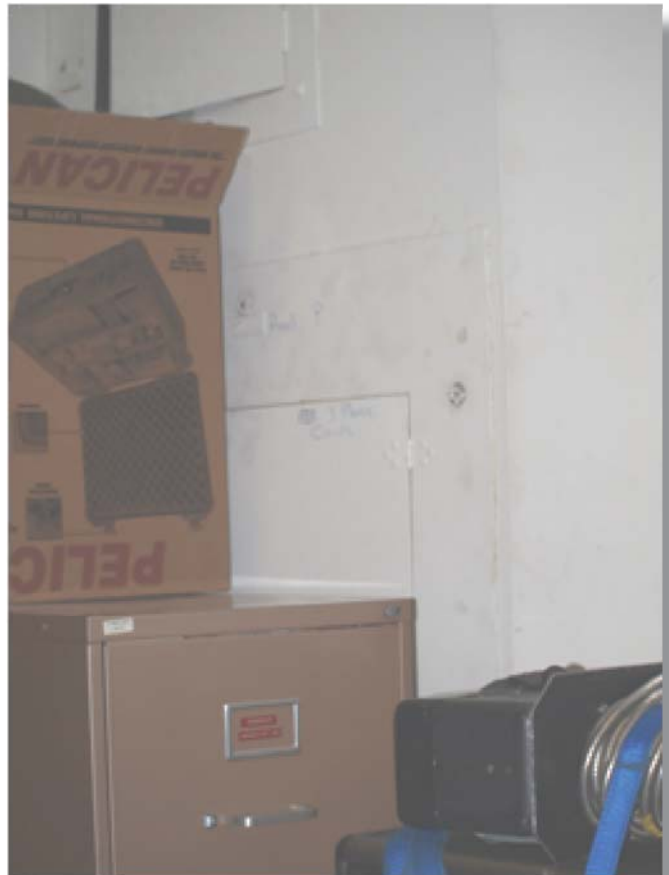
**PANEL**

Electrical panel is blocked by file cabinet and boxes.

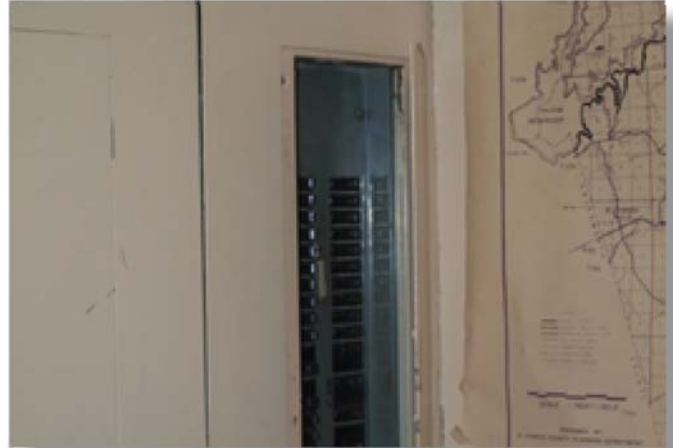
### PANEL

Electrical panel is blocked by added partition wall.

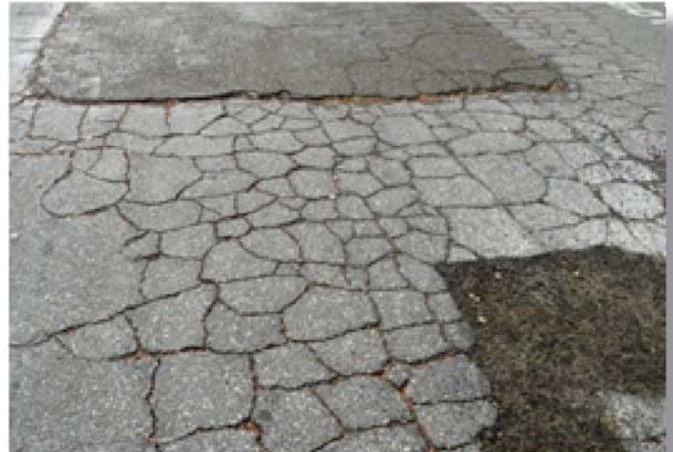
### PAVING

Paving in poor condition.

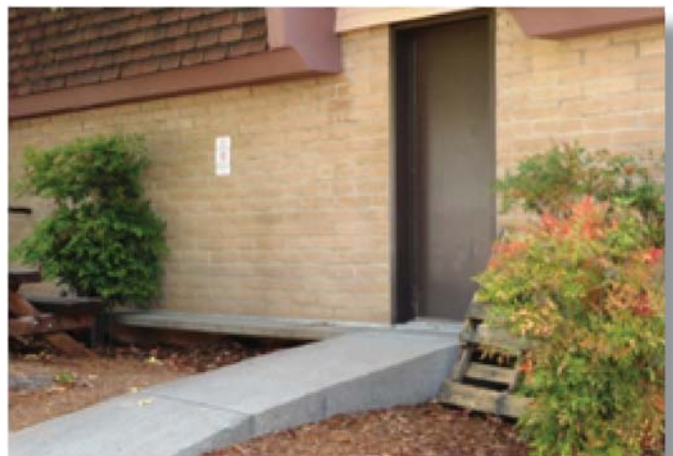
### RAMP

No handrail at ramp with slope of greater than 1:20 as per code.

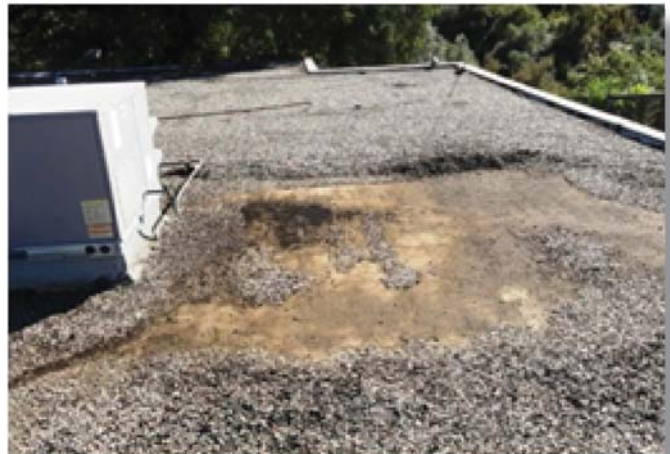
### ROOF

Gravel ballast does not cover roof membrane to protect from sun damage.

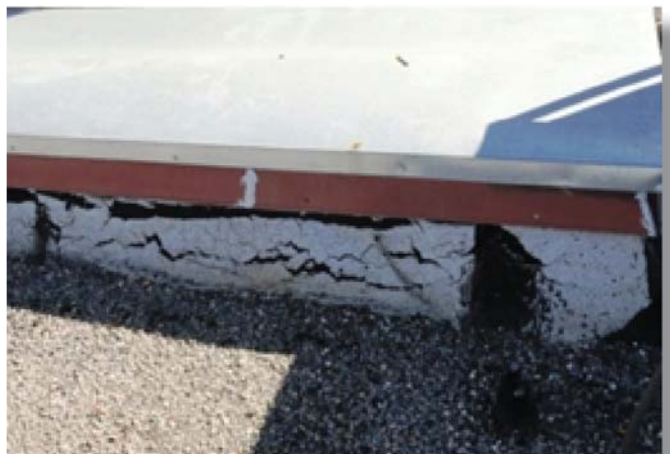
### ROOF

Cracking and repair work in membrane on parapet.

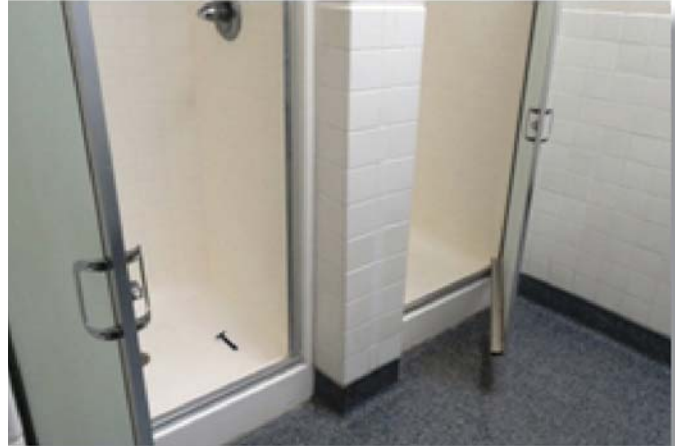
### **SHOWER**

There are no ADA showers in locker room.

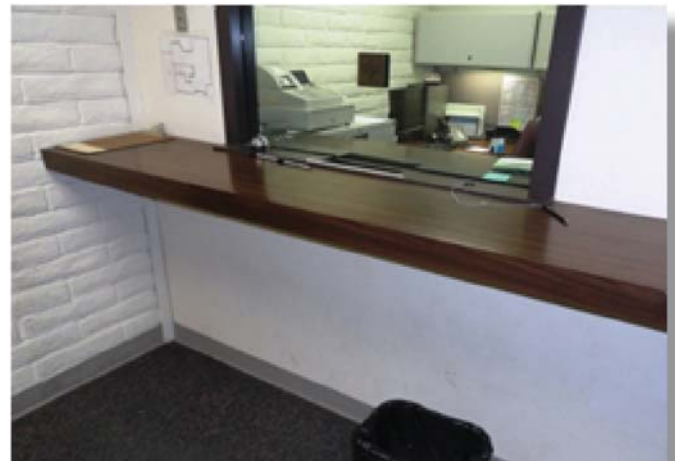
### **TRANSACTION**

Main transaction window is not ADA compliant.

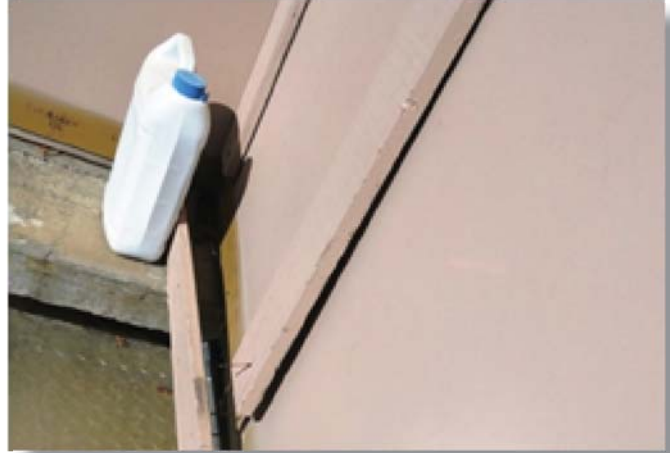
### TRIM BOARDS

Trim boards at plywood siding have sun damage and separating from the wall.

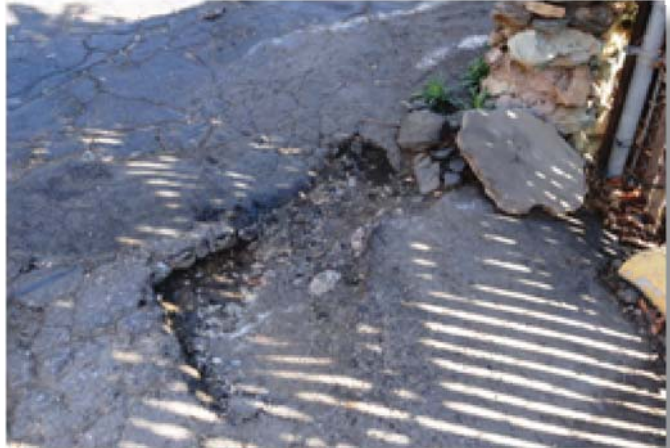
### PAVING

Complete paving failure has created tripping hazard.

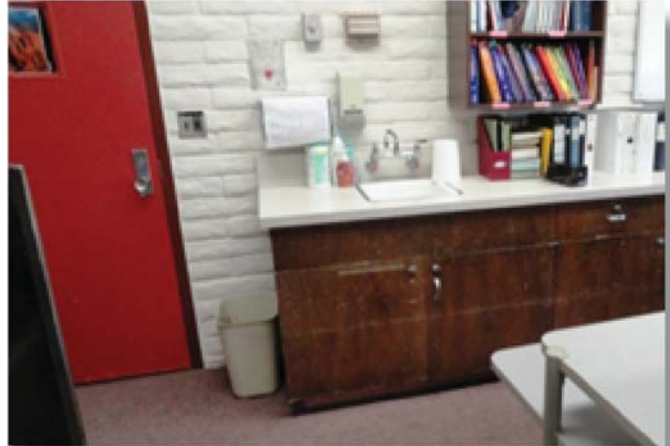
### **CABINET**

This door does not have an ADA lockset and cabinet is not ADA accessible.

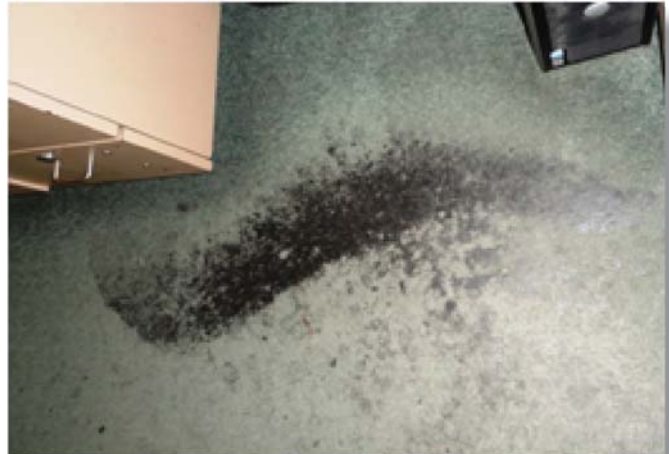
### **CARPET**

Control room carpet in very poor condition.

- Replace roofing and flashings. Consider adding tapered insulation to provide positive flow. Replace exterior doors and windows.
- Replace carpeting in control room and classrooms. Replace remote access locksets. Remove epoxy coating in cells and seal concrete floors.

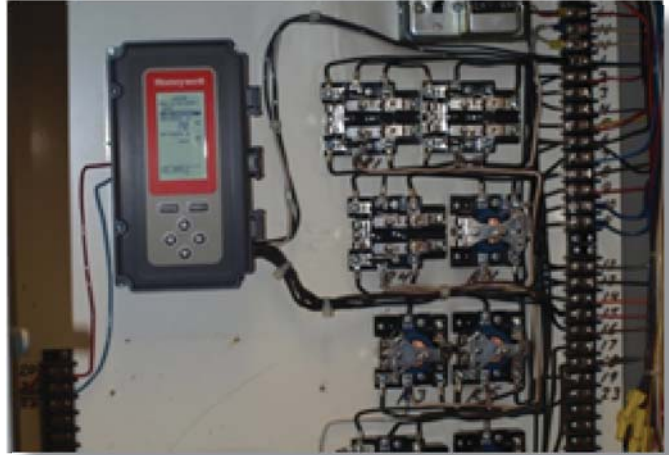
### CONTROLS

HVAC controls are obsolete.

- Replace deficient obsolete HVAC system equipment and components to improve energy efficiency and reduce maintenance costs. Replace original ductwork to improve air quality, occupant comfort and reduce energy costs. Install energy management system for optimal energy conservation with capability to monitor and control system off-site to reduce technician visits to building.

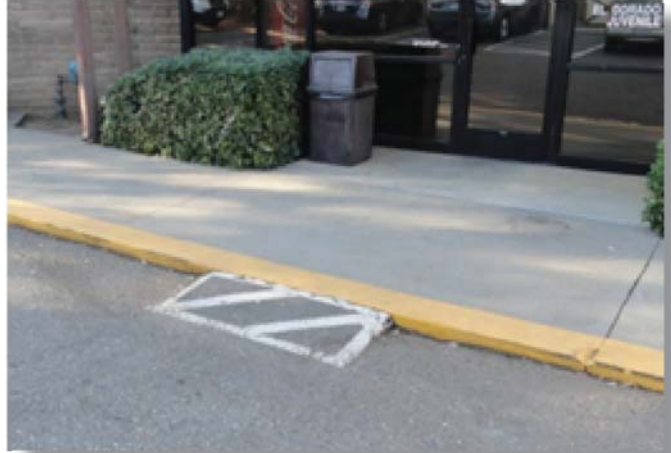
### **CURB RAMP**

Ramp at front is not ADA compliant.

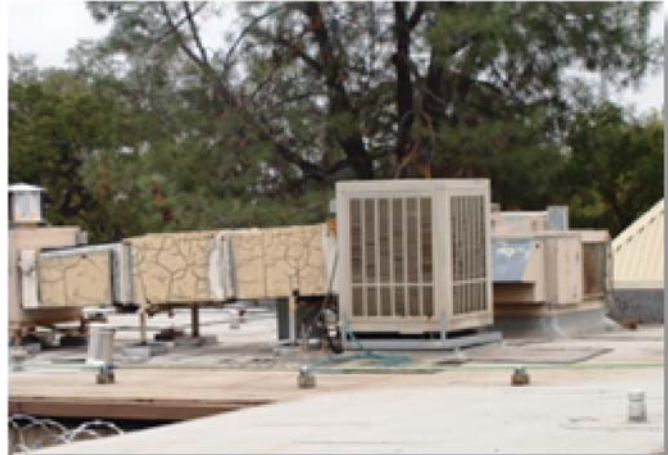
### **EVAPORATION COOLER**

Evaporative cooler for kitchen is 30+ years old.  
Ductwork is in poor condition.

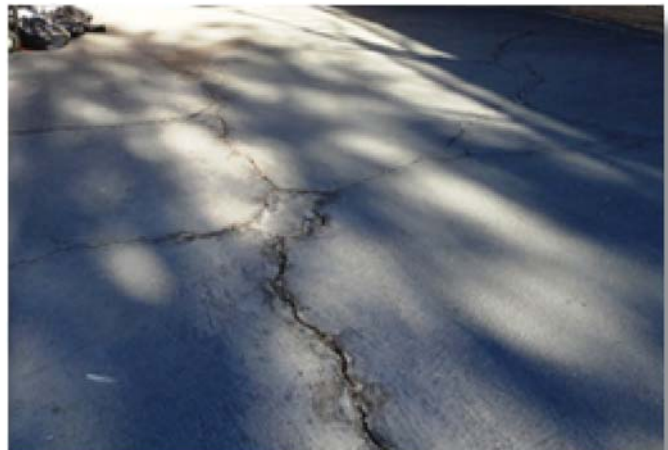
### **EXERCISE**

Asphalt paving in exercise yard is cracked, mainly  
along water flow line to catch basin.

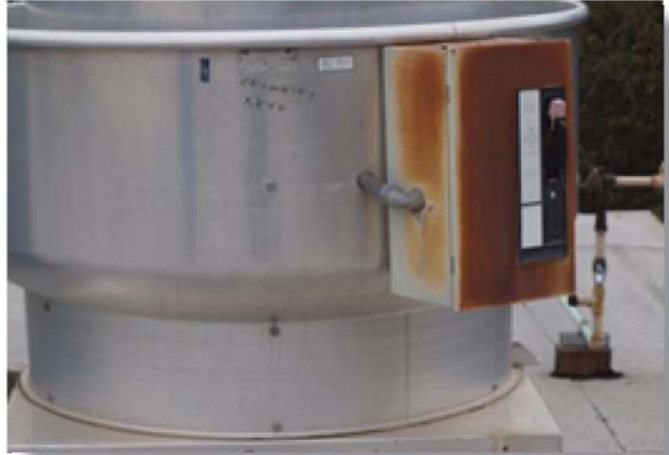
**EXHAUST**

Rusted 30 year old kitchen exhaust.

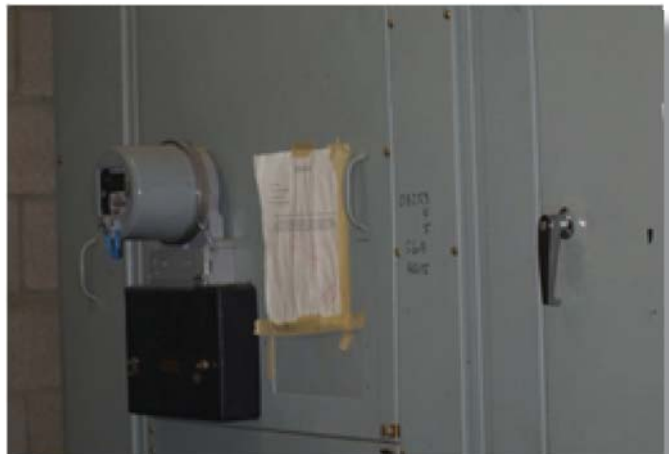
**MAIN**

40+ year old main electrical switchboard panel is obsolete.
