# Facilities Capital Improve Plan

Fiscal Year 13/14

# El Dorado County

CAO Facilities

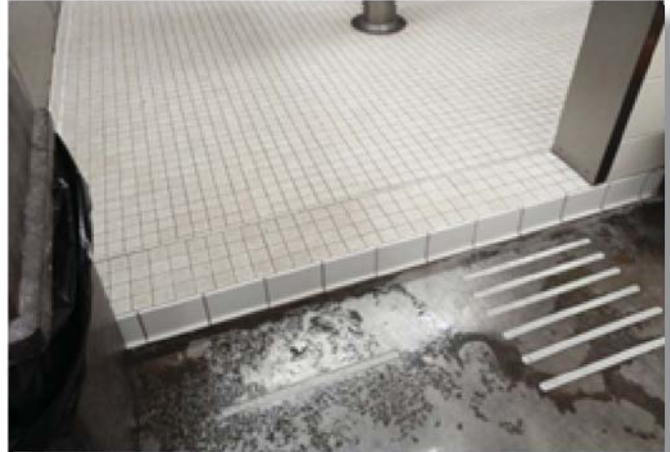
### SHOWER

Showers do not have ADA accessible threshold.

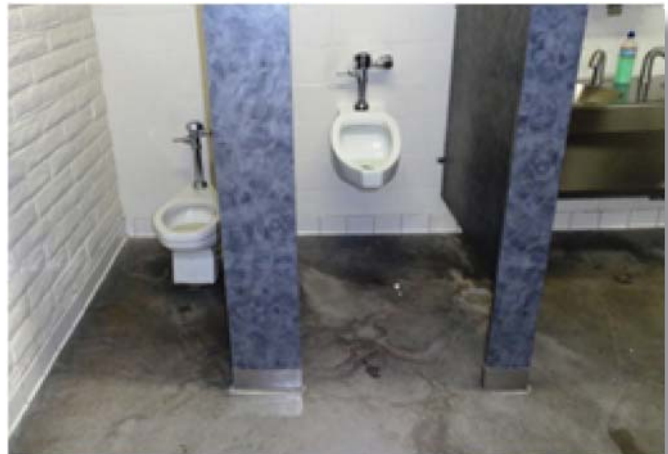
### TOILET

Inmate toilets are not ADA accessible.

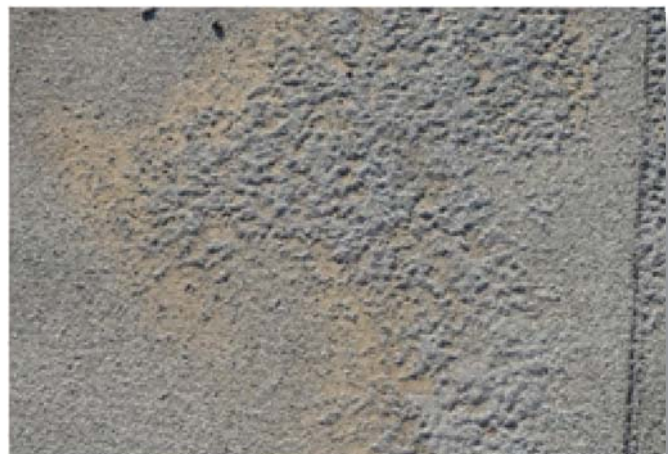
### ROOF

Gravel ballast does not cover roof membrane to protect from sun damage.

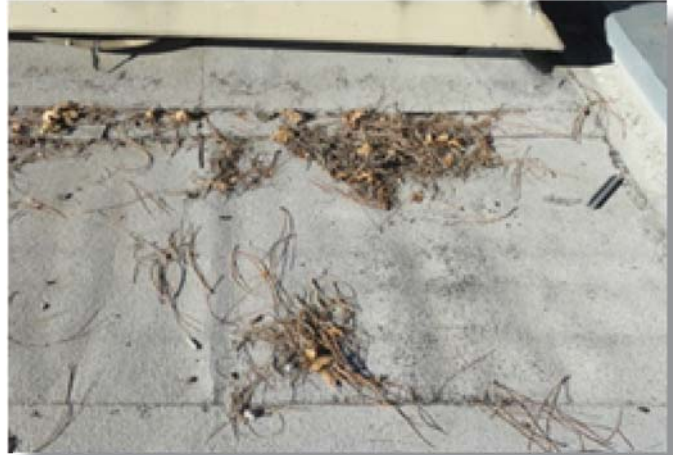
### ROOF

There are blisters in roof cap sheet.

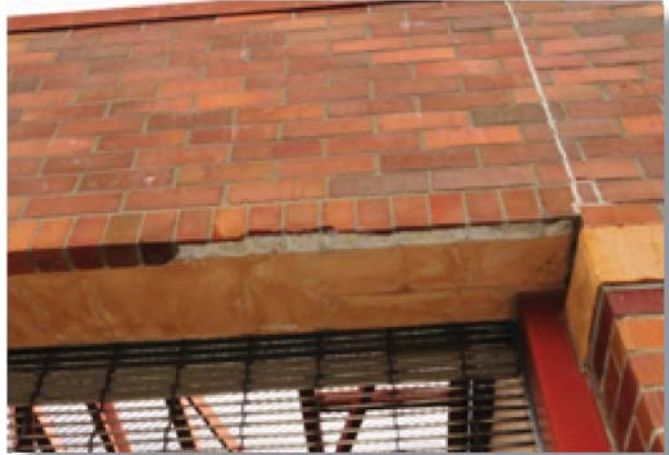
**BRICK**

Damaged brick veneer.

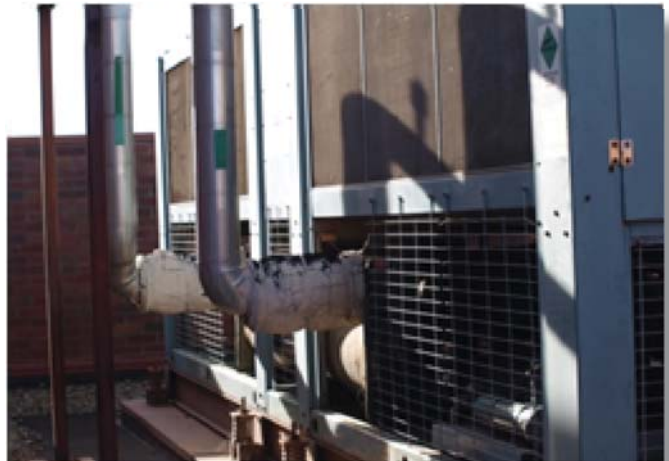
**CHILLER**

Original chiller and piping near end of useful life.

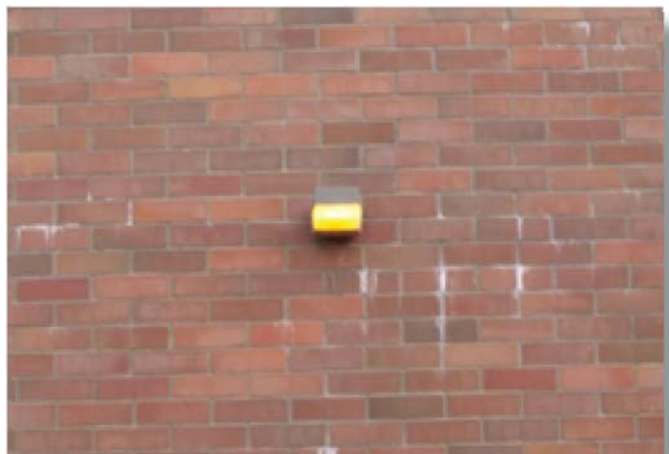
**EXTERIOR LIGHT**

Lens cover on light fixture yellowed from age.

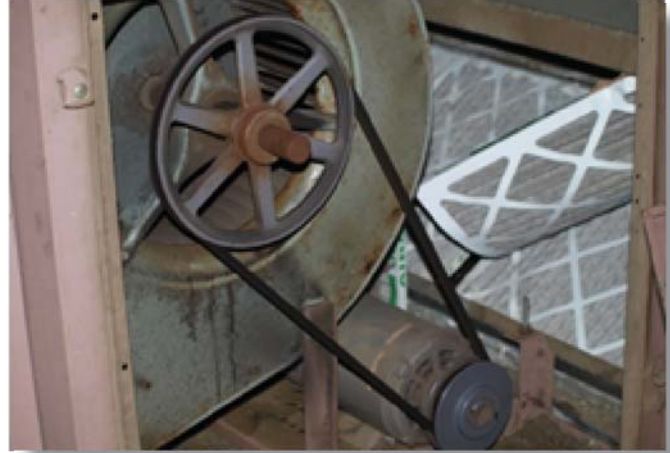
**FAN MOTOR**

MAU fan motor shows signs of rust.

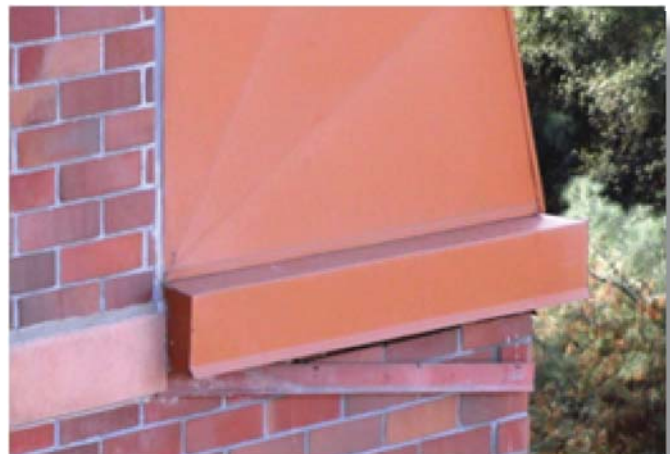
**FLASHING - LOOSE**

Flashing not secured to substrate.

- Replace roofing and flashings. Consider adding tapered insulation to provide positive flow. Replace joint sealants at exterior wall. Replace leaking windows.

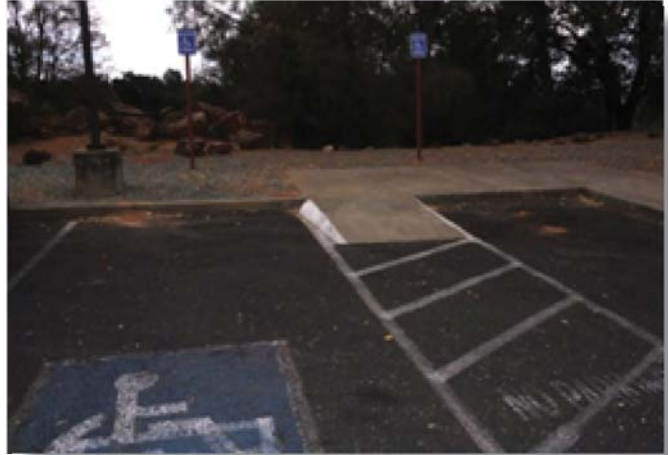
### HANDICAP PARKING

Curb ramp at handicap parking is not meet acceptable.

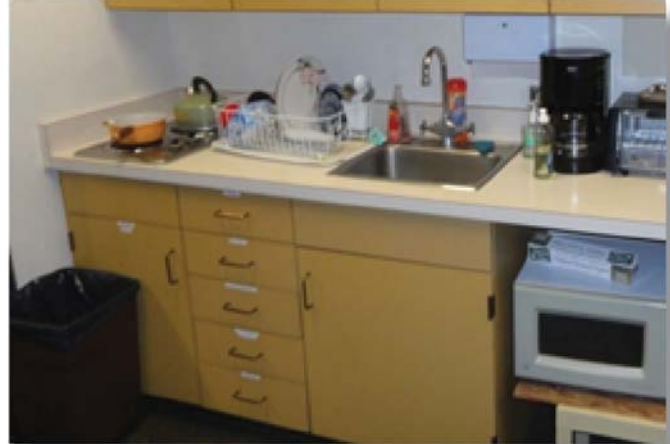
**BREAKROOM SINK**

The breakroom sink may require ADA modifications.

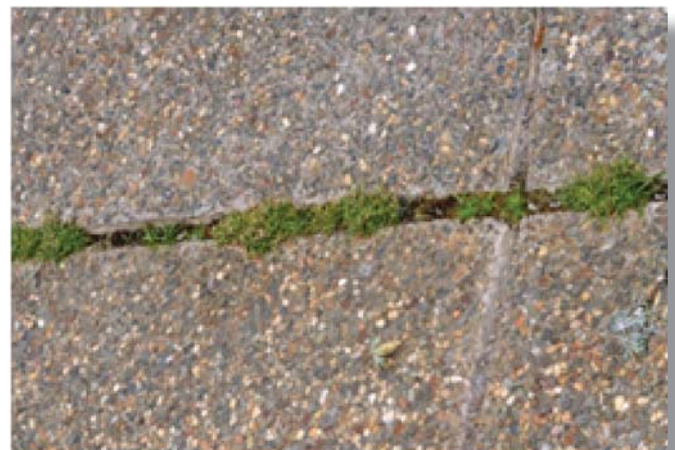
**CONCRETE**

Concrete walkway has excessive gap at joint that has vegetation growing.

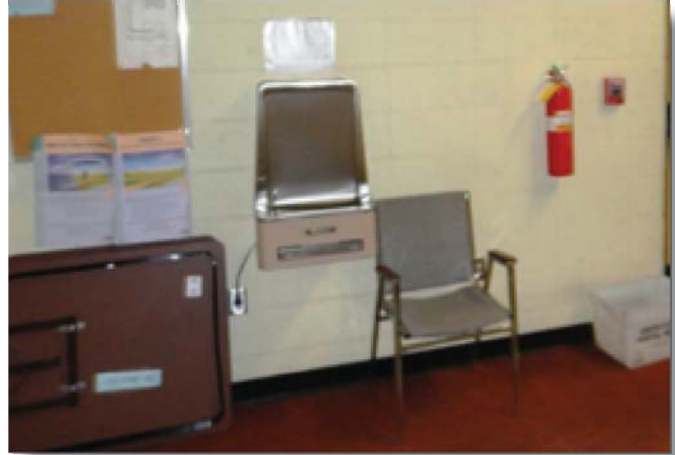
**DRINKING FOUNTAIN**

Non ADA drinking fountain.

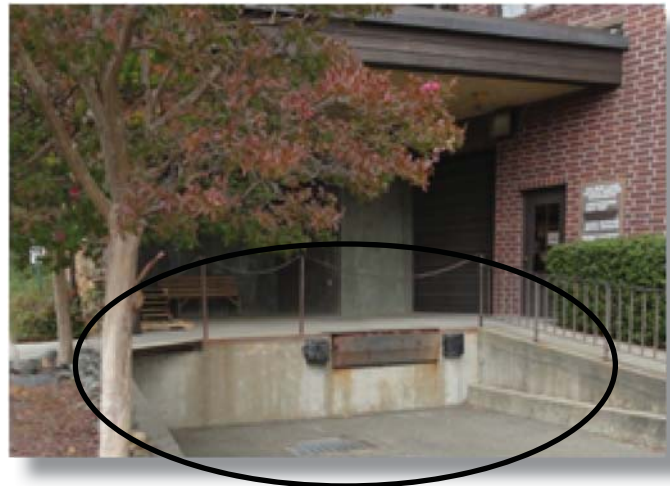
**DOCK**

Public enters basement level past the dock which does not have a code compliant guardrail.

- Fire and safety modifications issues should be addressed. Install new emergency and exit lighting. Install a removable railing at the loading dock. Add contrasting stripes at stairs and provide code compliant handrails. Have the fire sprinkler system tested to determine if and where corrosion has occurred in the piping from air pockets or MIC from the water quality. Replace piping and sprinkler heads that are determined to be sufficiently corroded to maintain the integrity of the system in place to reduce the cost for complete replacement of the system. Provide appropriate storage for historical documents and records to prevent damage from wet pipe fire sprinklers or provide appropriate fire protection system in areas which will not damage records. Provide combination fire/smoke dampers tied to the fire alarm system at all ducts passing through fire rated walls. Seal all openings through fire rated wall with fire rated materials.

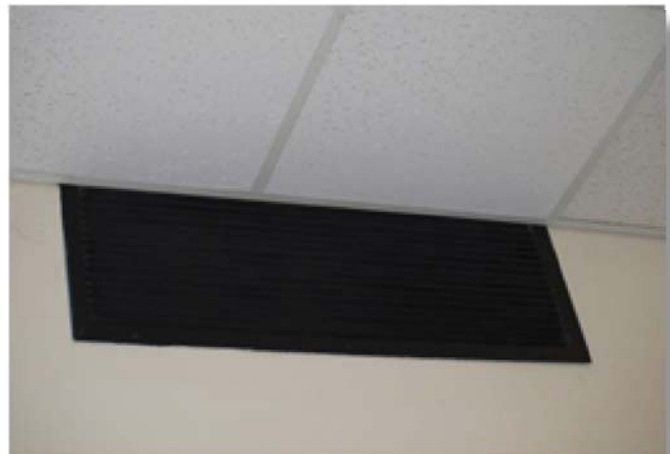
**GRILL**

Suspended ceiling partially blocks the return air grill.

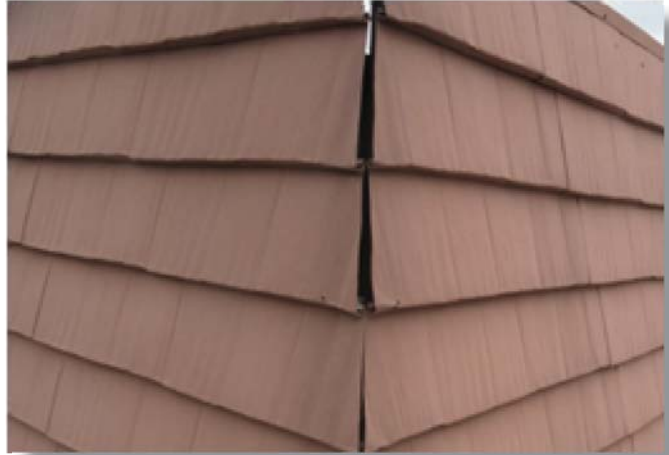
**MECHANICAL SCREEN**

Corner trim piece is missing from the roof top mechanical screen.

- Replace roofing and flashings. Consider adding tapered insulation to provide positive flow. Repair the minor damage to the mechanical screen and paint the exposed structural before the metal begins to rust. Replacing the windows will provide an energy savings. Suggest an energy audit to determine cost benefit. Seal all wall and floor penetrations to mitigate rodent intrusion.

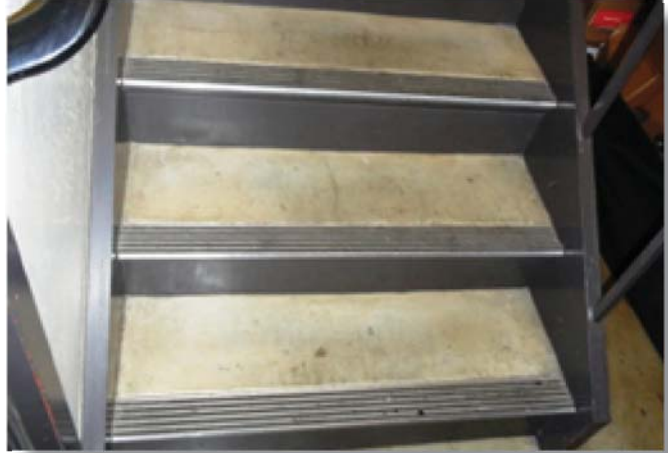
**STAIRS**

Stairs do not have contrasting stripe and vertical spacing on guardrail is greater than code maximum.

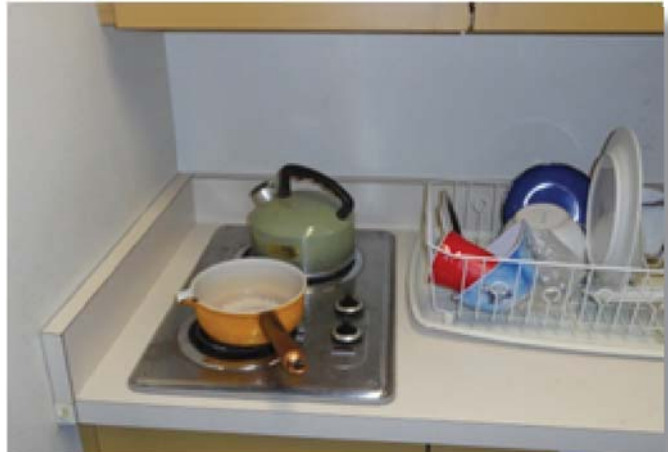
**STOVE**

The stove does not have a range hood or exhaust fan.

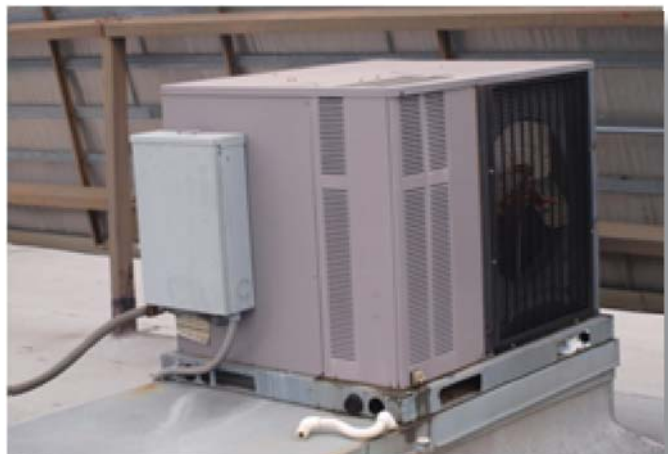
**AC UNIT**

10 year old unit with broken condensation drain line.

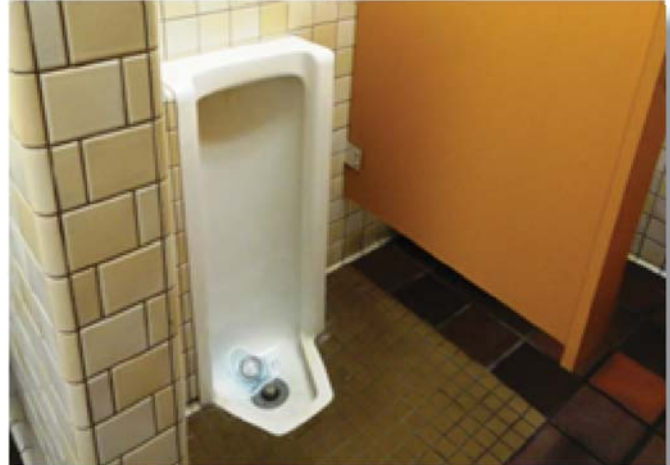
**URINAL**

Public restrooms require ADA updates. .

- Remodel restrooms on both the main level and in the basement to meet ADA standards. Replace the water and waste lines concurrently. Replace door hardware to meet access requirements.

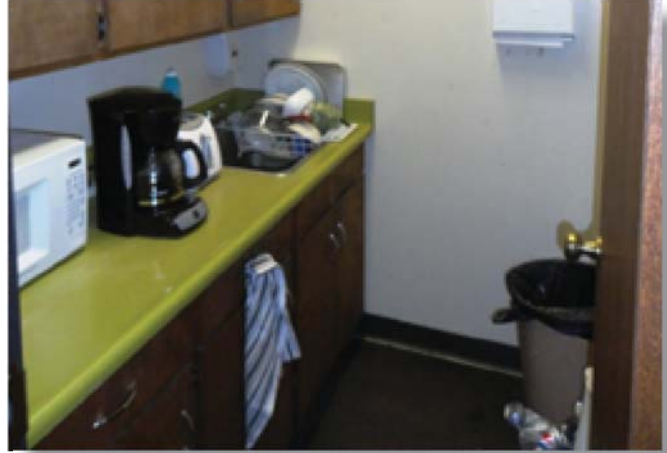
### **BREAKROOM**

Breakroom sink not ADA suitable. Door is lacking ADA lever lockset.

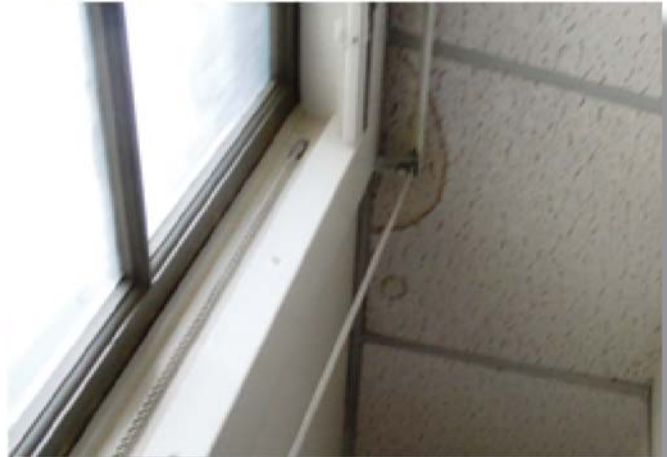
### **CEILING**

Stained ceiling tiles.

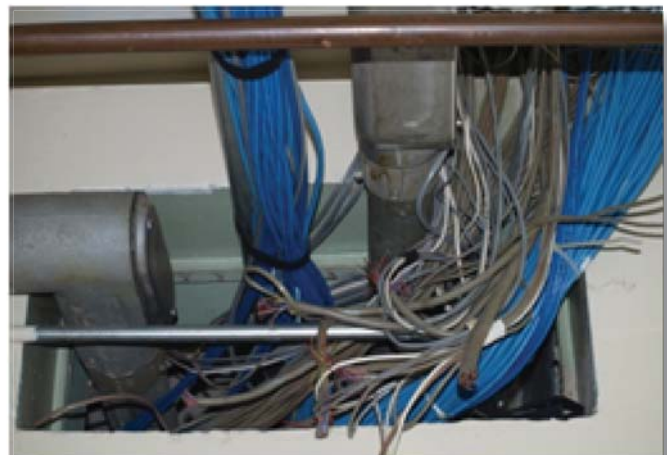
### **CONDUIT**

Conduit, cabling and abandoned cabling is run through an abandoned vent.

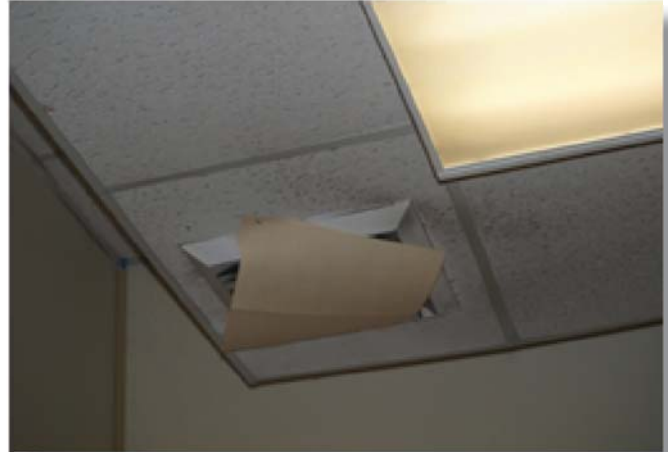
### **DEFLECTOR**

The HVAC system is not balanced. A deflector was added at the supply register to reduce the air flow.

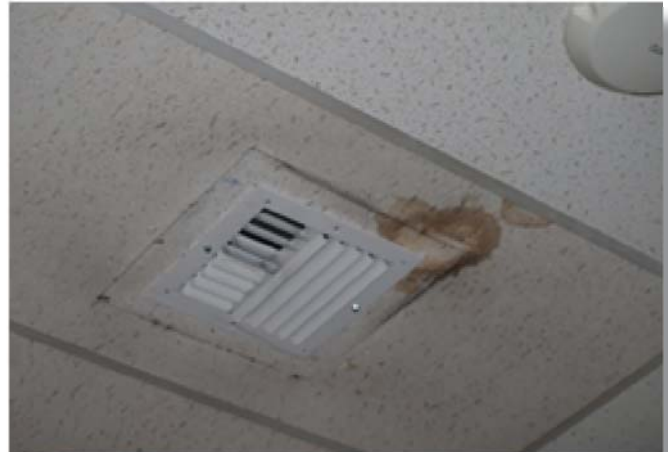
### **DIFFUSER**

Diffuser was cut into the acoustic ceiling. The fan coil unit above leaks and has stained the ceiling tile.

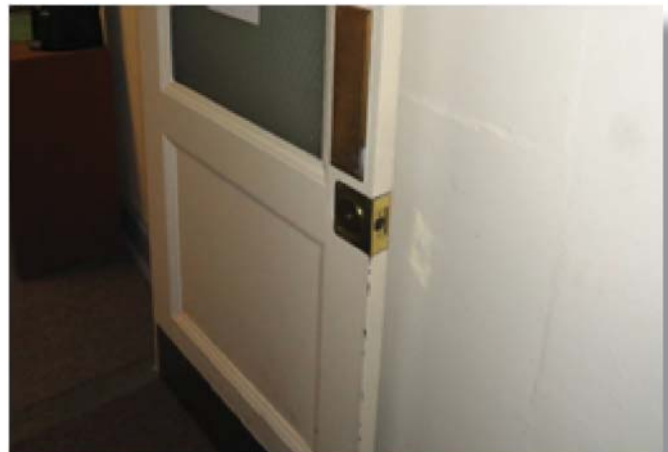
### **DOOR**

Door handle is missing.

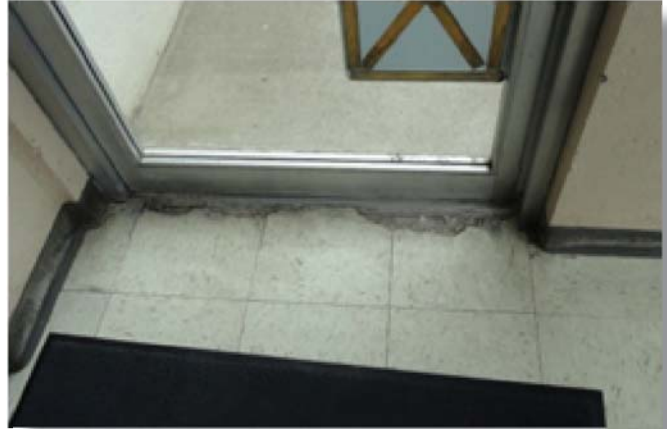
**FLOORING**

Vinyl Composition Tile is in poor condition.

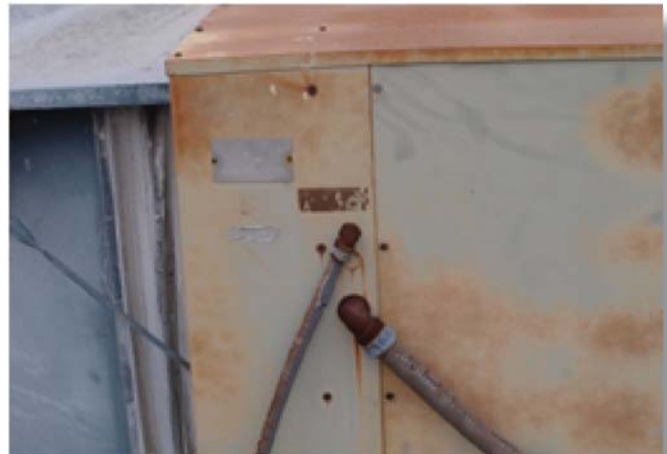
**HVAC**

Old roof top package unit with surface rust.

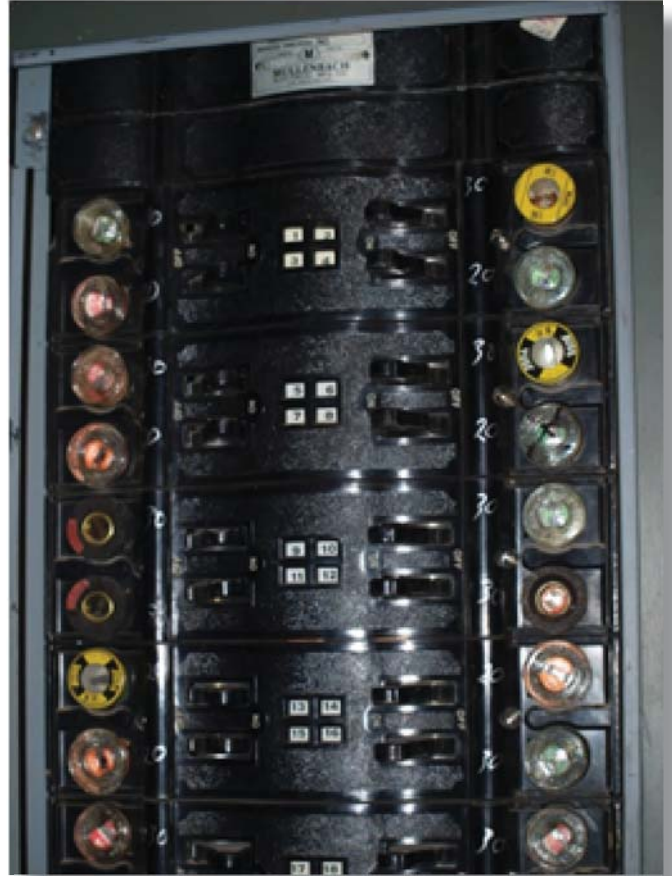
### PANEL

Original fused panel is obsolete.

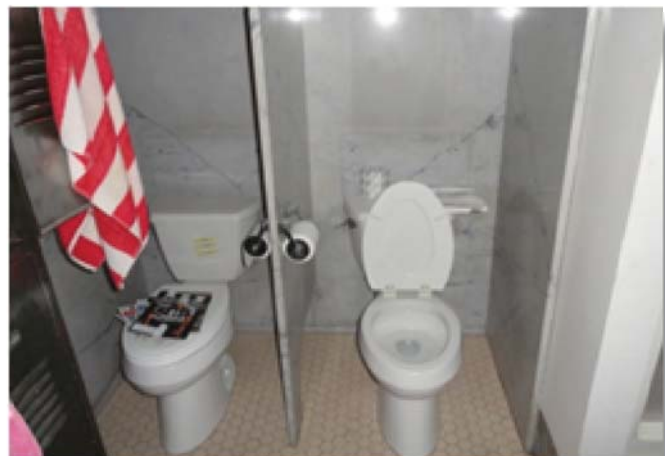
**RESTROOM**

Restroom is not ADA compliant. Stalls lack privacy.

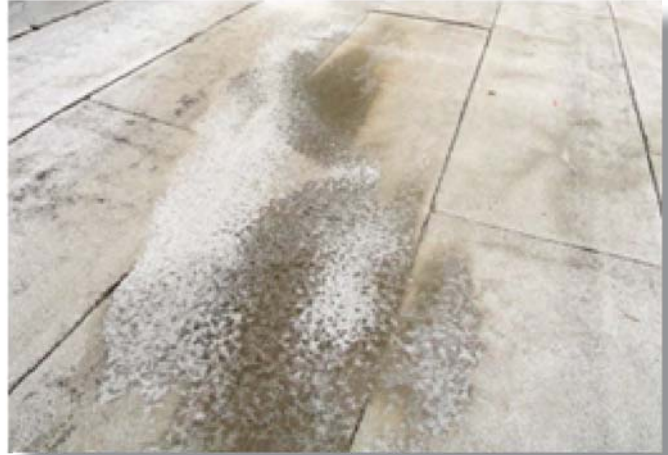
**ROOF**

Roof is in poor condition. There is a lack of slope which results in water ponding.

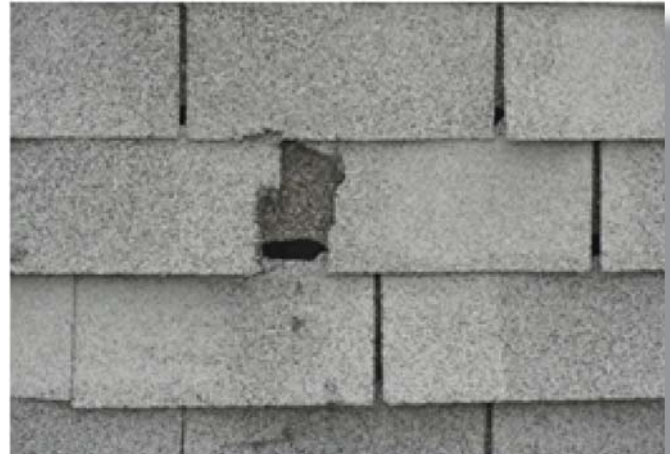
**ROOF**

Broken shingle.

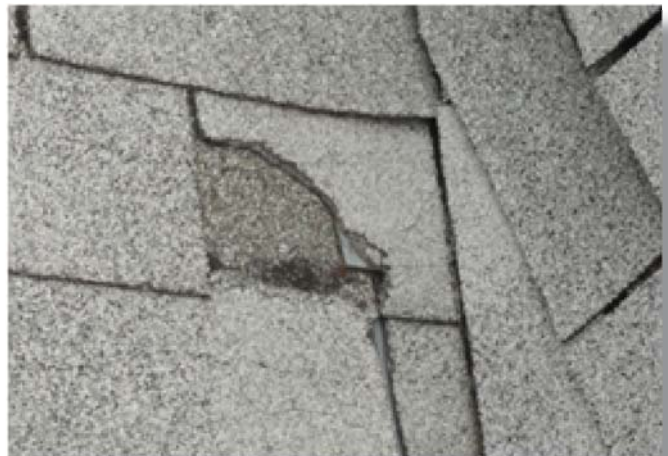
**ROOF**

Broken shingle.

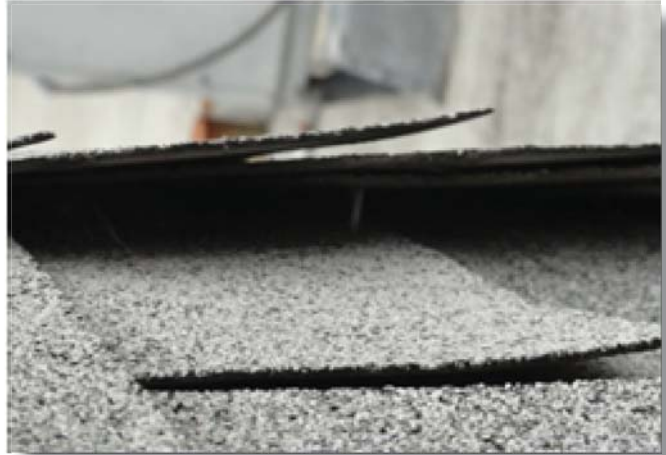
**ROOF**

Shingle is not secure and nail not secure to substrate.

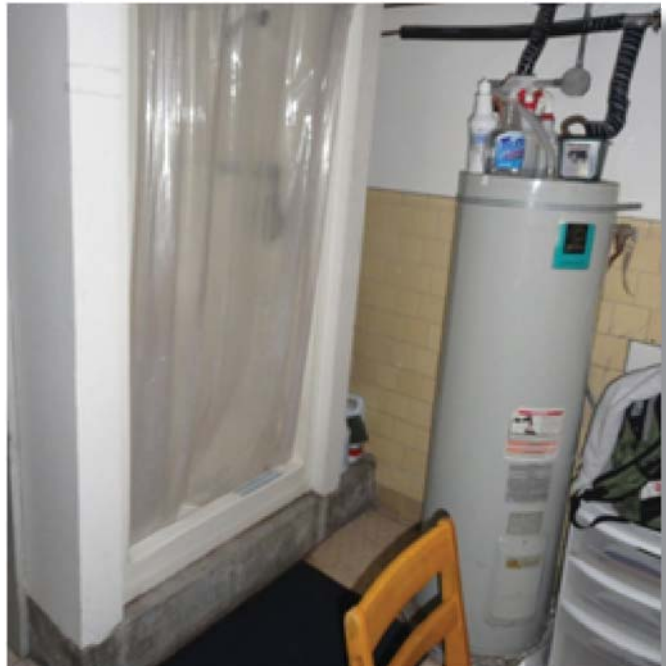
**SHOWER**

Non ADA shower.

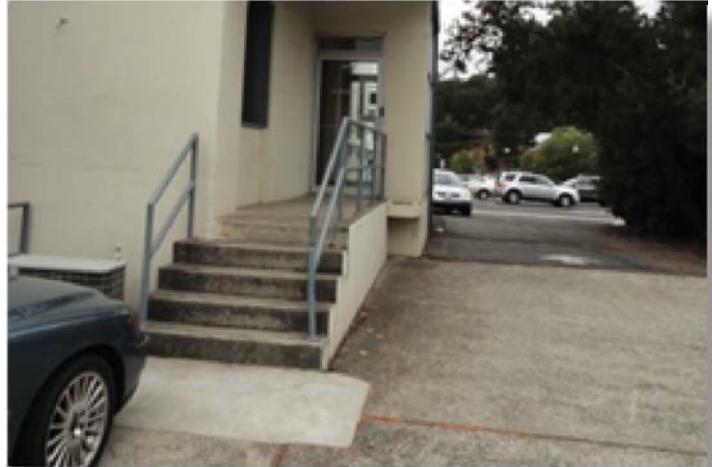
### STAIRS

Exterior stairs lack contrasting stripe and do not have code compliant railings.

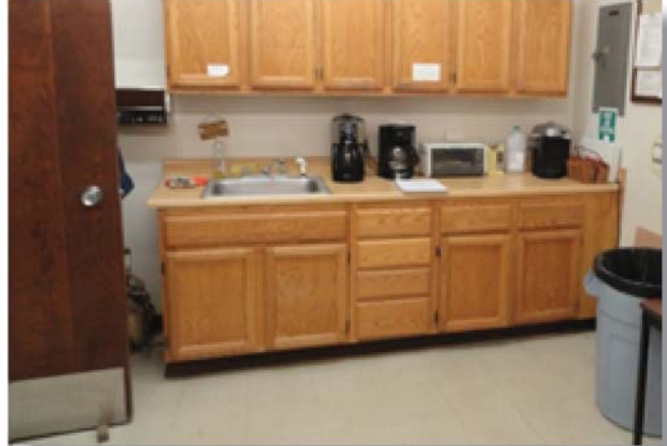
### **BREAKROOM**

Cabinets in good condition, however May require ADA updates. The door lacks an ADA lever lockset.

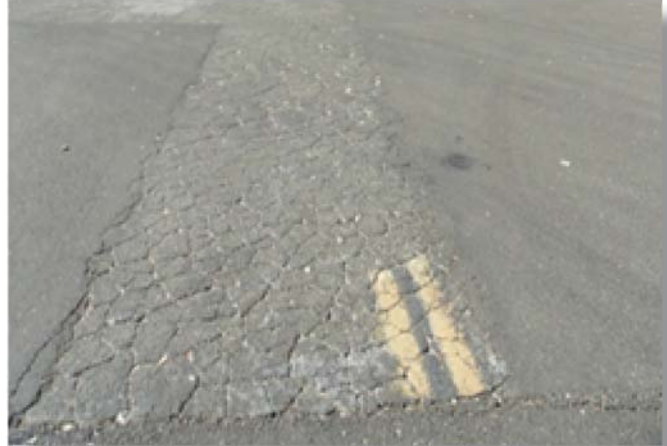
### PAVEMENT

Pavement has major cracking. It appears the base has settled.

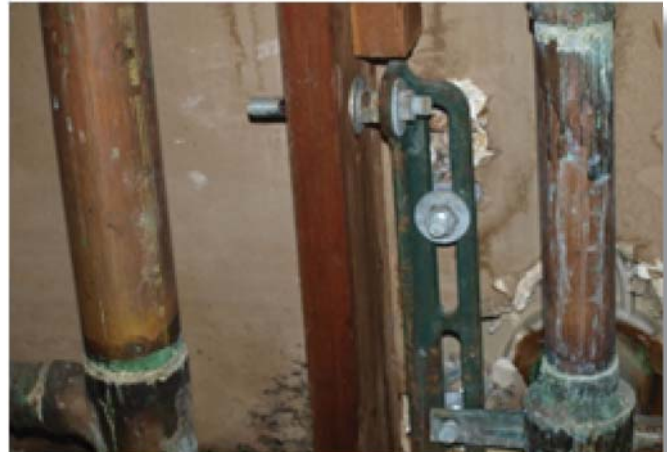
### PIPING

Electrolysis caused erosion on water piping.

- Remodel restrooms at upper level. Replace deteriorated water and waste lines concurrently. Repair damaged piping effected by electrolysis and provide preventative measures to mitigate future damage. Connect sewage system to city sewer system.

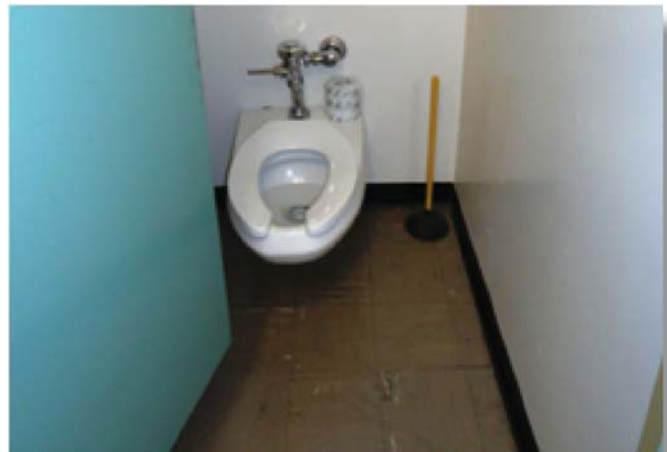
### RESTROOM

Non ADA restroom. Floor contains suspect floor tiles.

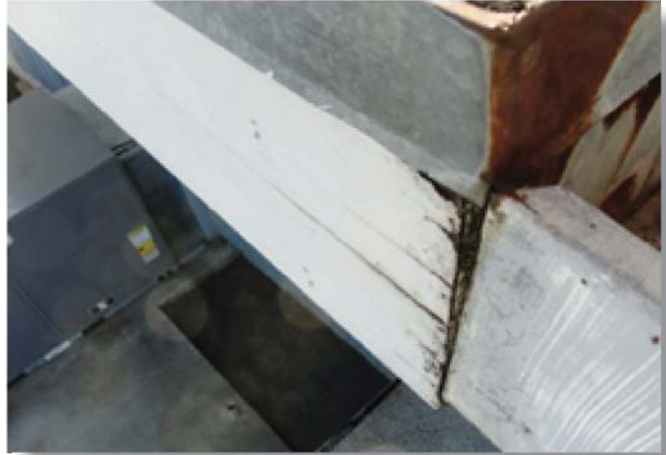
### FASCIA

Dry-rot damage to wood fascia boards.

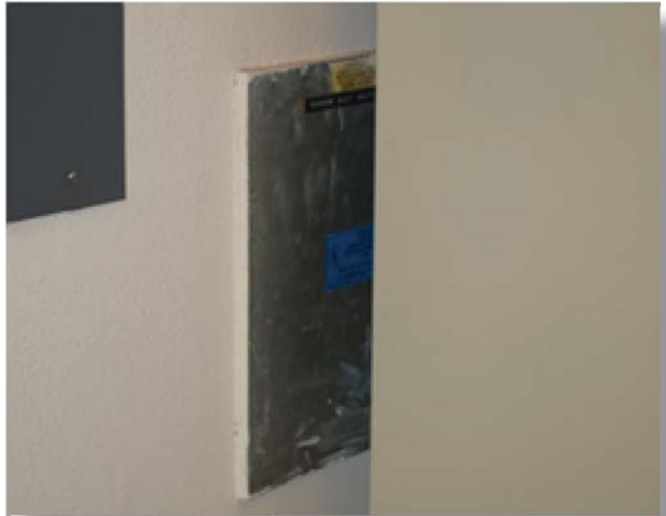
### PANEL

Electrical panel is blocked by added partition wall.

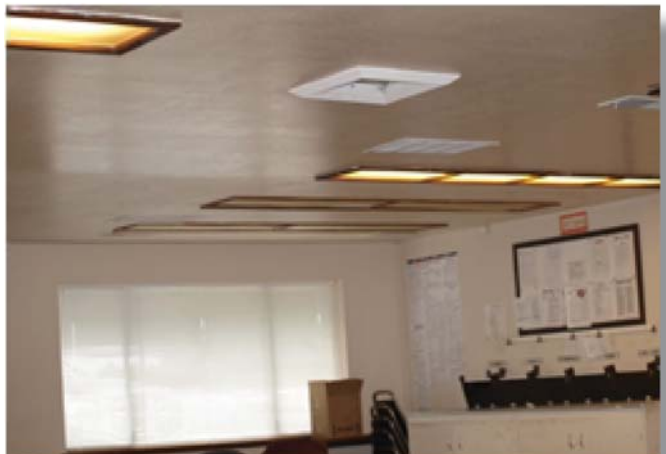
### LIGHTS

Light fixtures have old discolored lenses.

- Replace obsolete and undersized electrical panels and feeders to improve distribution to building loads. Replace existing lighting with energy efficient fixtures with improved optics. Replace local light switches with occupancy sensor light controls with a building lighting control panel to sweep off lighting in spaces unoccupied during off hours to reduce energy consumption. Install additional receptacles and signal outlets with concealed raceway or wiremold. Remove abandoned electrical equipment, conduit, low voltage cabling and power circuits.

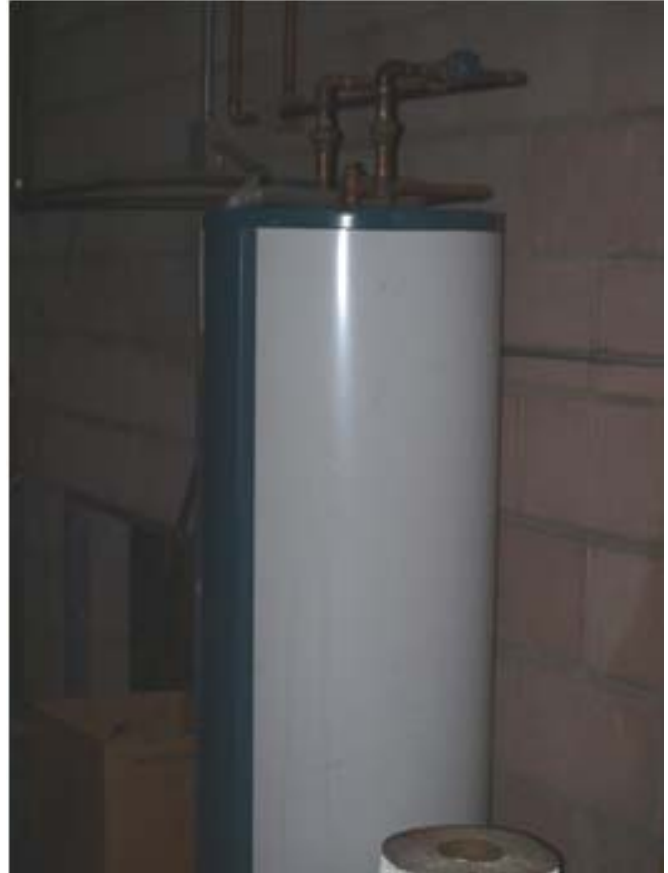
### **HOT WATER**

Hot water heater does not have earthquake strap installed.

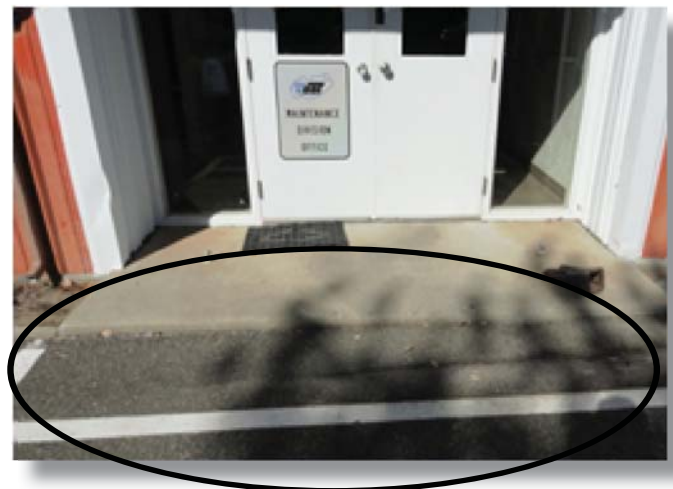
### **ENTRANCE**

Entrance has 2 to 3 inch lip which prevents wheelchair access.

- Revised entrance thresholds for wheel chair access. Provide ADA access to public counters and install lever handled locksets.
- Replace roofing, flashings, gutters and downspouts.

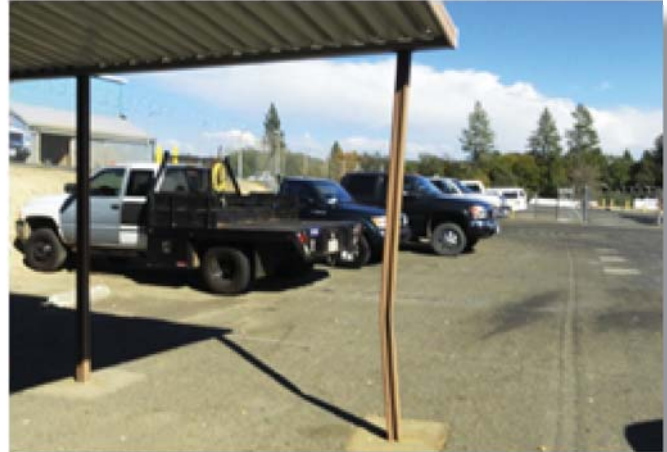
### **COLUMN**

Column appears to have been hit by a vehicle.

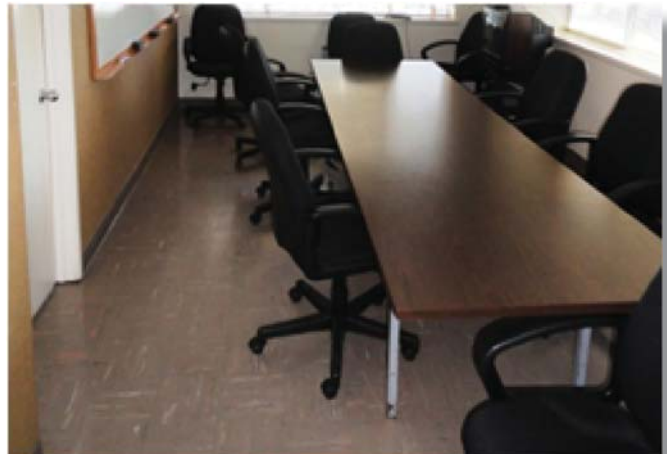
### **CONFERENCE**

Conference room door does not have ADA lever lockset.

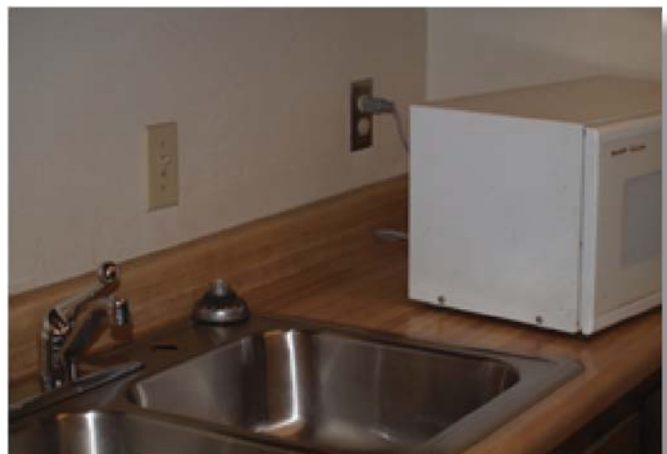
### **GFI**

No GFI power receptacle installed at sink.

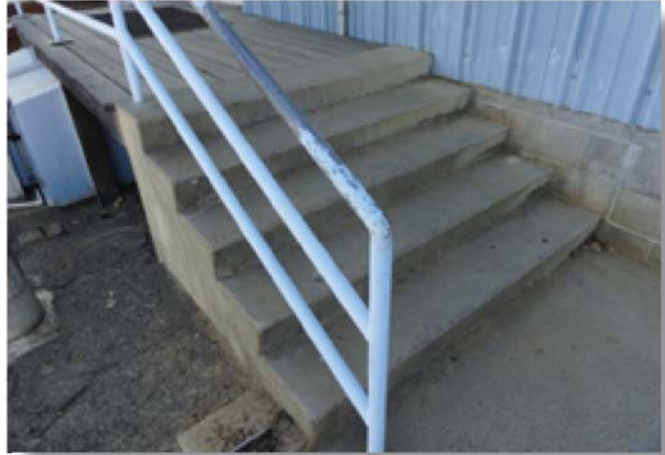
**STAIRS**

Exterior stair railing requires updating. Stairs also lack required contrasting stripes. Paint is worn out.

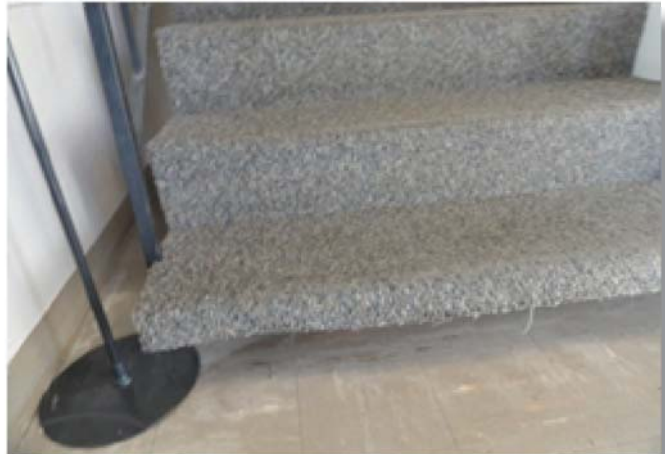
**STAIRS**

Carpeting at interior stairs is not secure. Stairs do not have contrasting stripe. Lobby flooring contains asbestos.

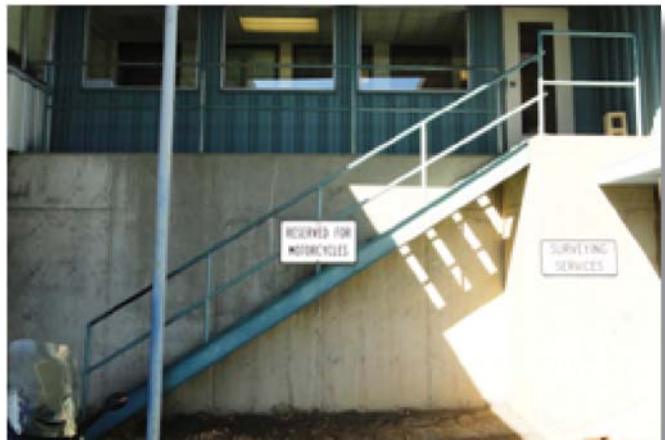
**STAIRS**

Second floor guardrail and stair railing requires updating.

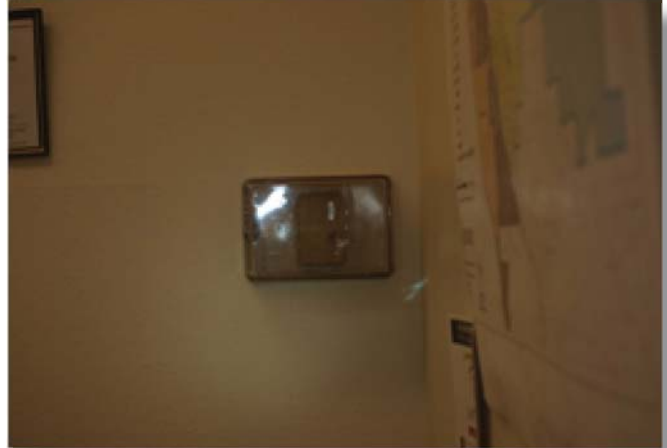
### **THERMOSTAT**

Old thermostat is too poorly located to be effective.

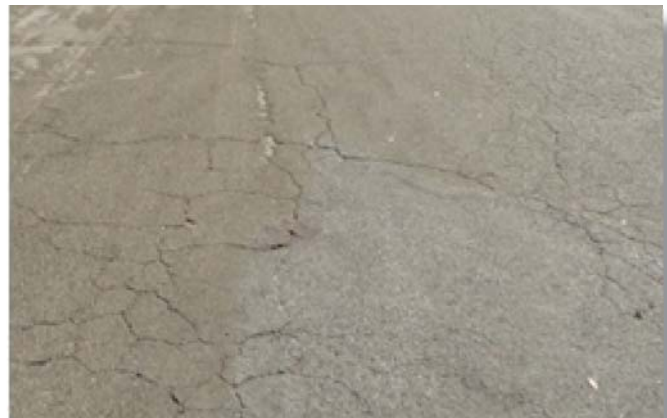
### **PAVEMENT**

Cracks in asphalt paving.

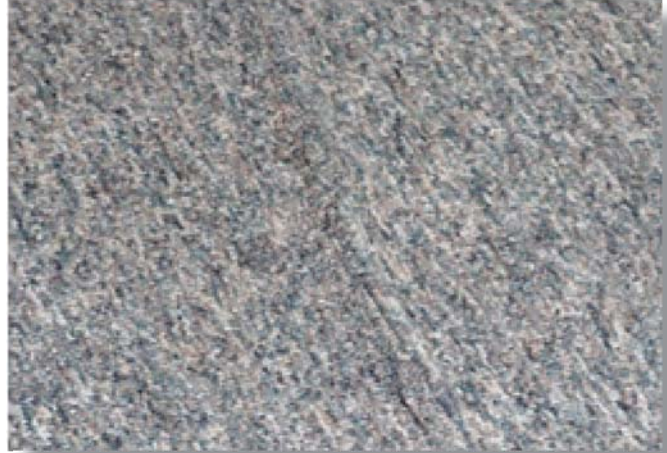
**CARPET**

Water damaged carpet.

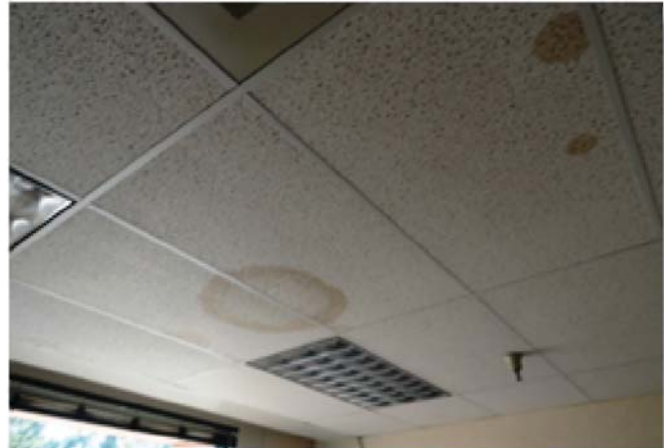
**CEILING**

Stained ceiling tiles.

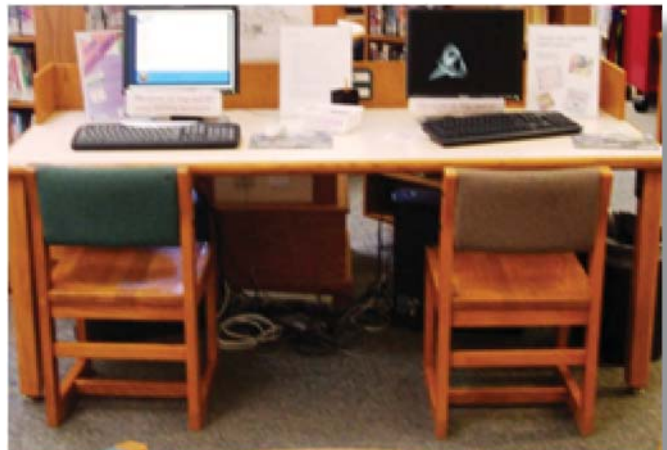
**COMPUTER**

Computers are all powered by one receptacle.  
Extension cords present possible fire hazard.

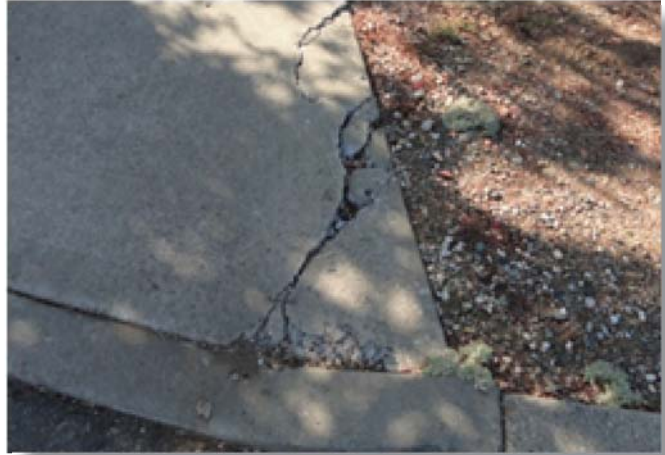
**CONCRETE**

Damaged concrete walkway.

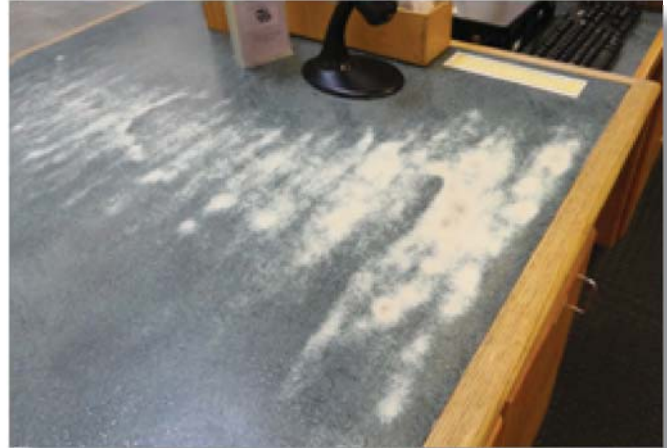
**COUNTER**

Finish on checkout counter is worn.

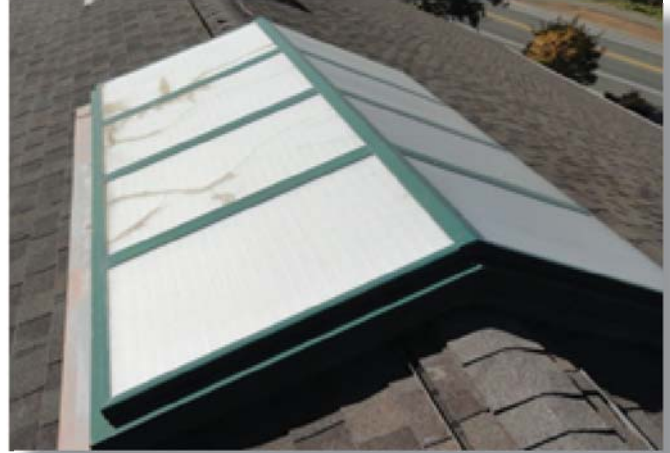
**SKYLIGHT**

Skylights have cracks in glazing.

- The theft detection system should be modified to provide ADA access. This work would be best done concurrent with carpet replacement.
- Asphalt shingle roof should be replaced along with the cracked skylights
- Replace HVAC system equipment that is at end of lifecycle. Install energy management system for optimal energy conservation with capability to monitor and control system off-site to reduce technician visits to building.
- Replace high wall and ceiling mounted remote ballast fixtures with energy efficient fixtures with improved optics. Install additional receptacles to reduce use of extension cords and wiremold raceway to conceal loose cabling.
- The parking lot paving has minor cracking. Suggest seal coating the lot. This should extend the time before replacement to 10 years.

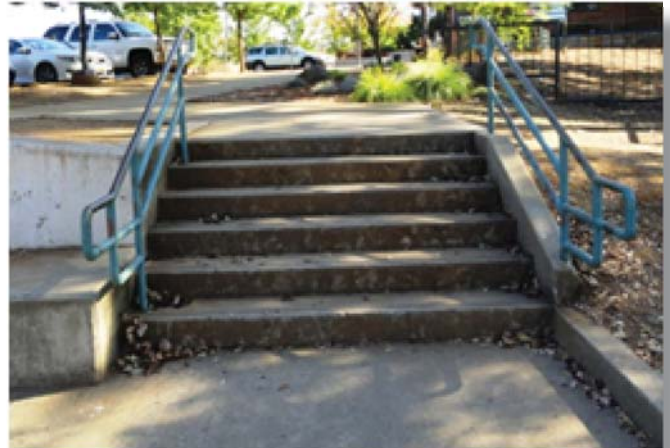
**STAIRS**

Exterior stairs do not have contrasting stripe.  
Finish on handrails is in poor condition.

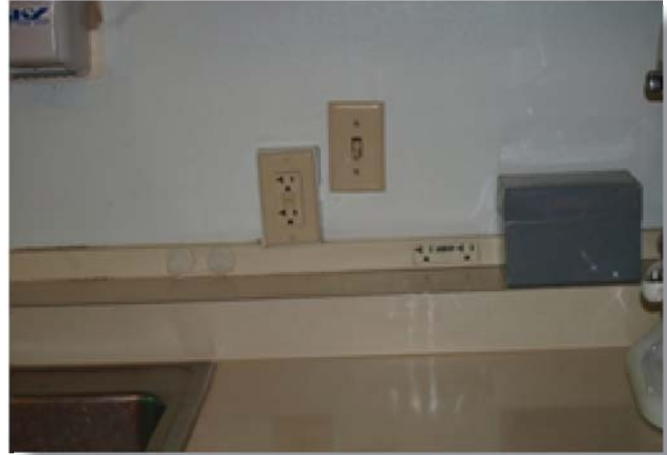
### **PLUG**

A plugstrip is installed below the GFI receptacle. Doesn't appear to have GFI protection.

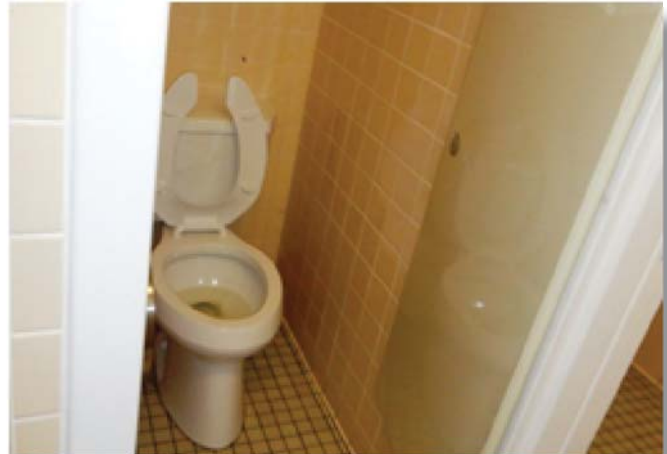
### **RESTROOM**

Resident restroom may require ADA updates.

- Remodel restrooms to comply with ADA. Replace deteriorated water and waste lines concurrently. Install ADA hardware at doors. Install new ADA compliant curb ramp at building entrance.

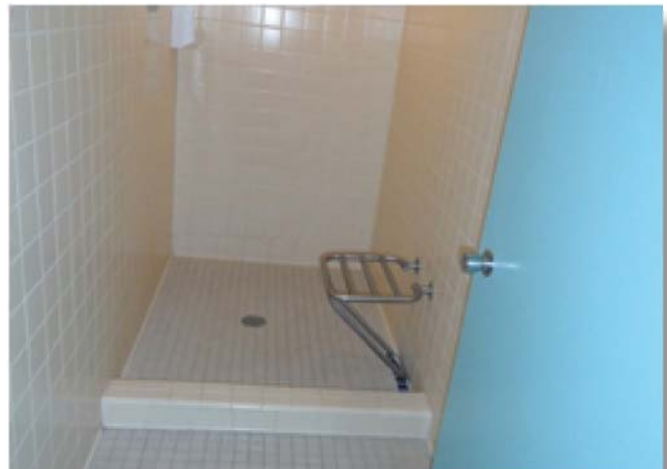
### **SHOWER**

Resident showers may require ADA updates.

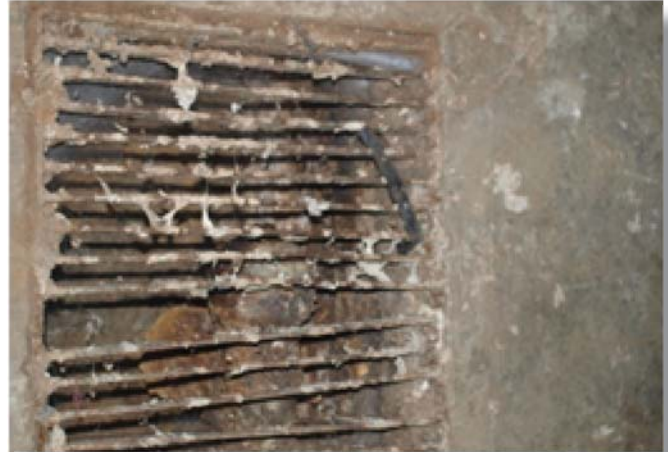
**VENT**

Vent on lower level appears to be abandoned.

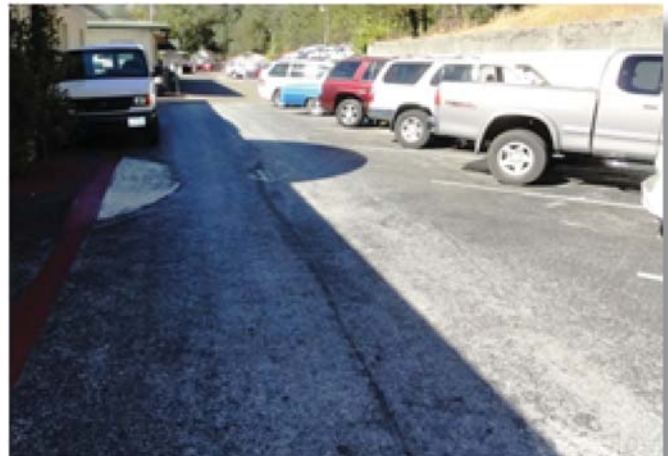
**PAVEMENT**

Cracking pavement appears to run along water flow line.

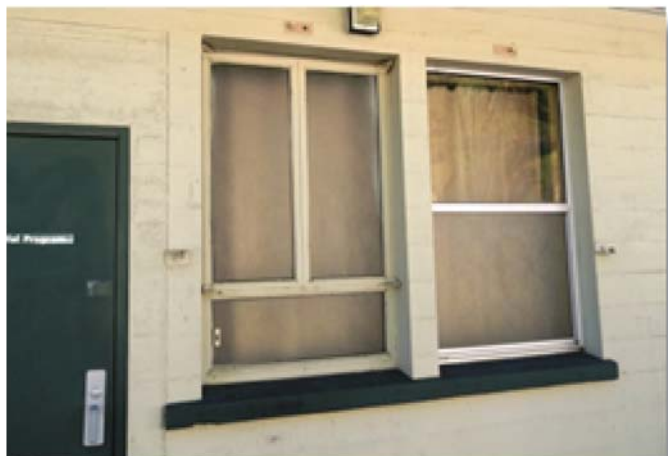
**WINDOWS**

Original windows are at end of life cycle and are not energy efficient.

- Replace roofing and flashings. Consider adding tapered insulation to provide positive flow. Suggest an energy audit to determine cost saving benefits to install EIFS system to exterior walls and replacing the windows. Seal all wall and floor penetrations to mitigate rodent intrusion.
