# Facilities Capital Improve Plan

Fiscal Year 13/14

# El Dorado County

CAO Facilities

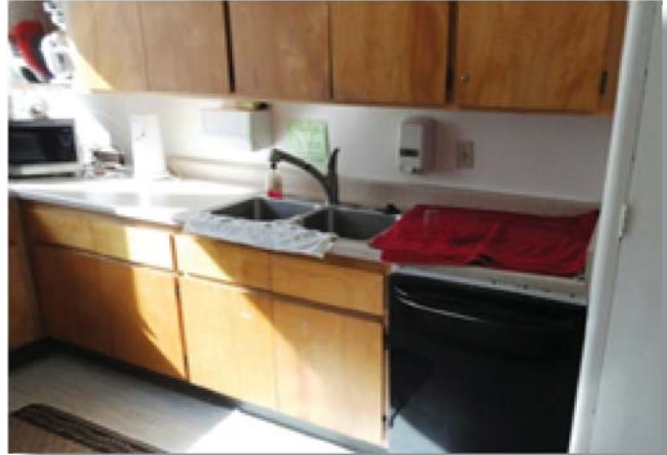
**KITCHEN**

Sink in kitchen may need ADA updates.

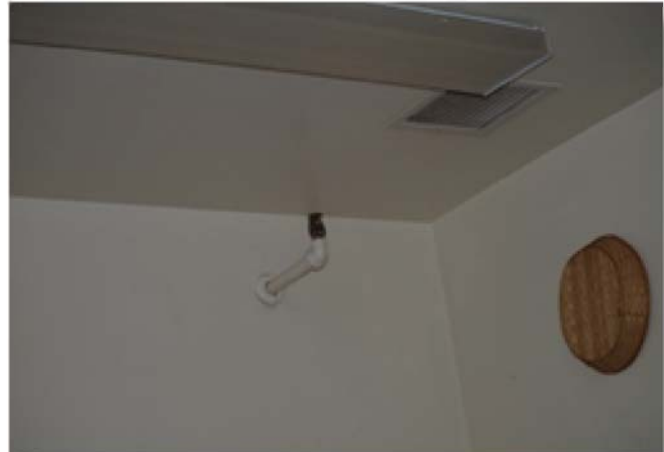
**KITCHEN**

Old light fixture in kitchen. Fire sprinkler head corroded.

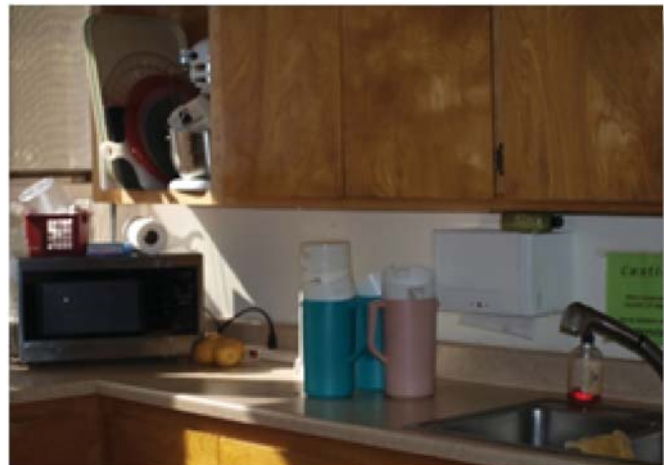
**KITCHEN**

Power strip on kitchen counter does not have GFI protection.

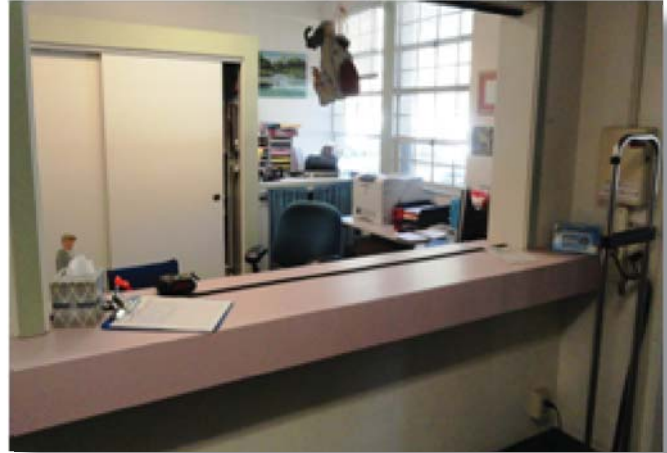
### RECEPTION

Reception counter is not ADA compliant.

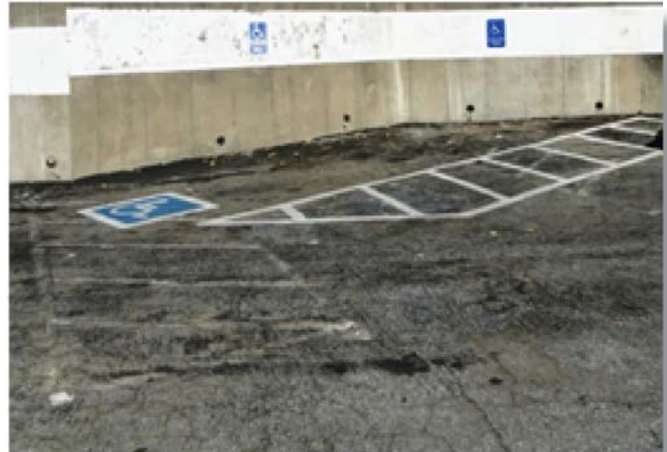
### PARKING

Pavement has cracking and deterioration.

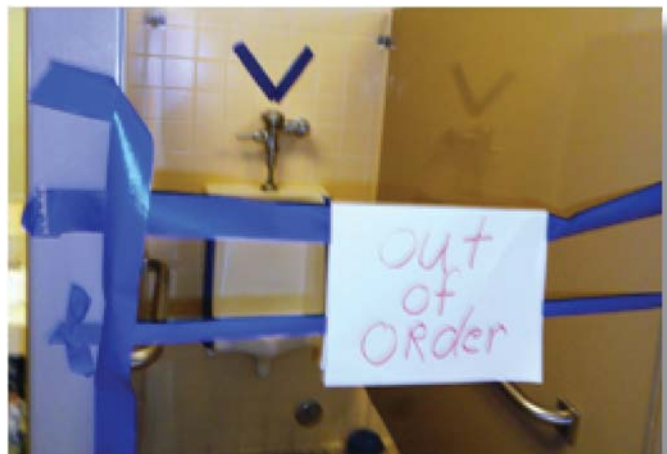
### RESTROOM

Urinal does not work.

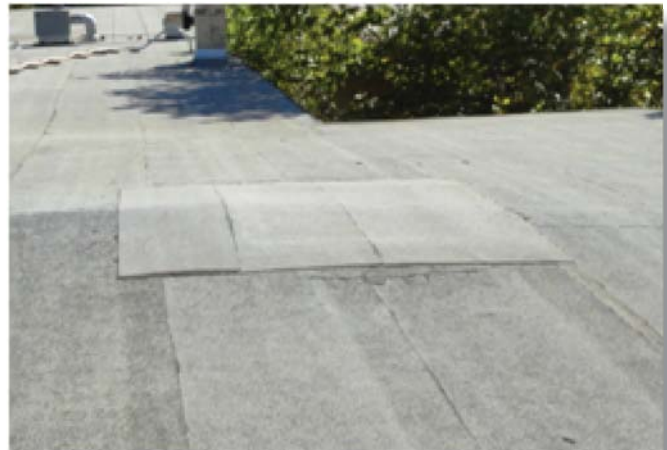
**ROOF PATCH**

Roof patch applied to stop leak.

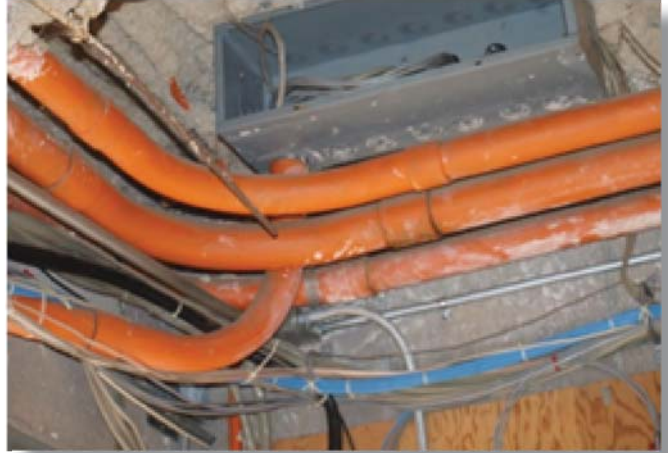
### **CABLING**

Disorganized cabling in mechanical room.

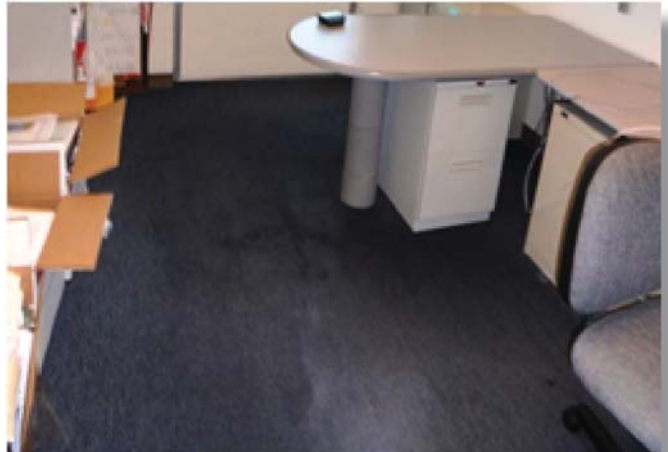
### **CARPET**

Stained and worn carpet.

- Replace carpeting and repair damaged wall coverings.
- Replace deficient antiquated HVAC system equipment and components to improve energy efficiency and reduce maintenance costs. Replace original ductwork to improve air quality, occupant comfort and reduce energy costs. Install energy management system for optimal energy conservation with capability to monitor and control system off-site to reduce technician visits to building. Replace plumbing fixtures and associated piping which has exceeded its useful life.

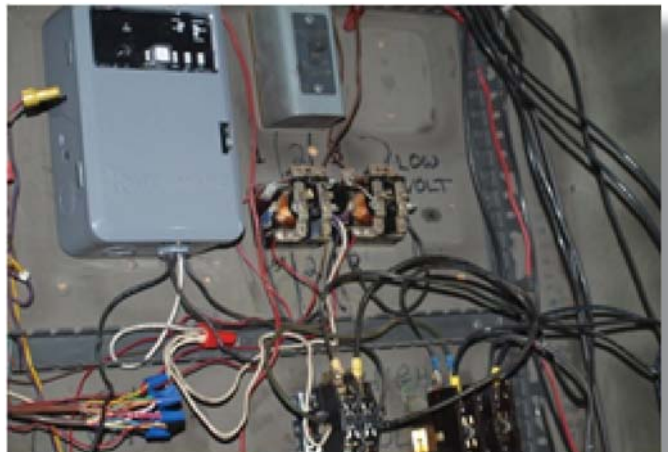
### **CONTROLS**

HVAC controls are obsolete.

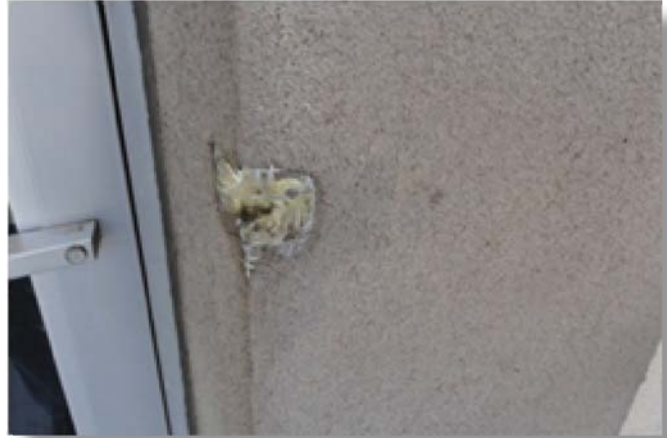
### DAMAGE

Hole in EIFS wall finish.

- Replace roofing and flashings. Consider adding tapered insulation to provide positive flow. Repair EIFS system on exterior walls and replace exterior doors and windows.

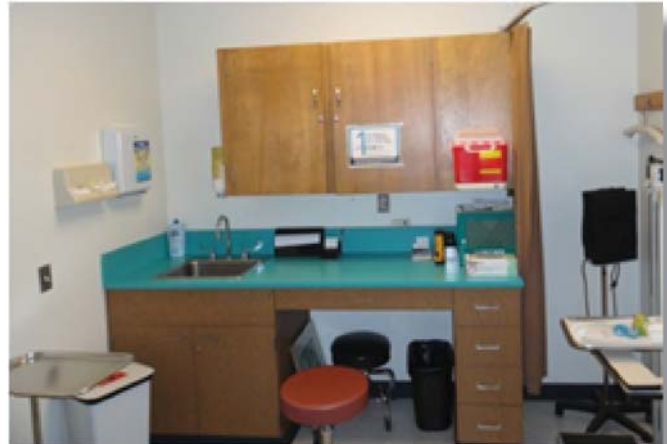
### EXAM

Typical exam room. There is no wheelchair access to sink.

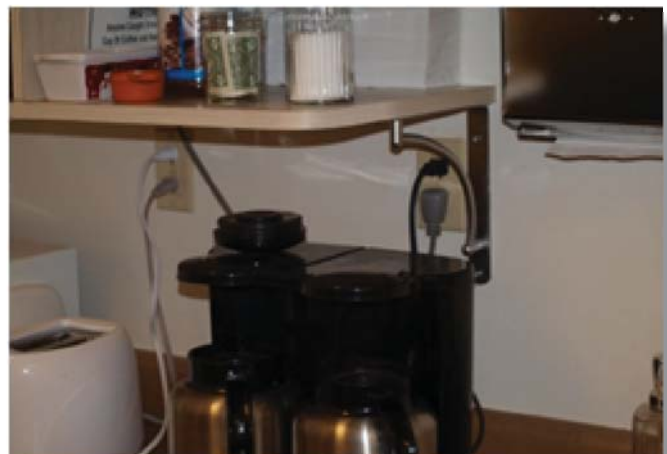
### GFI

No GFI receptacle installed at sink.

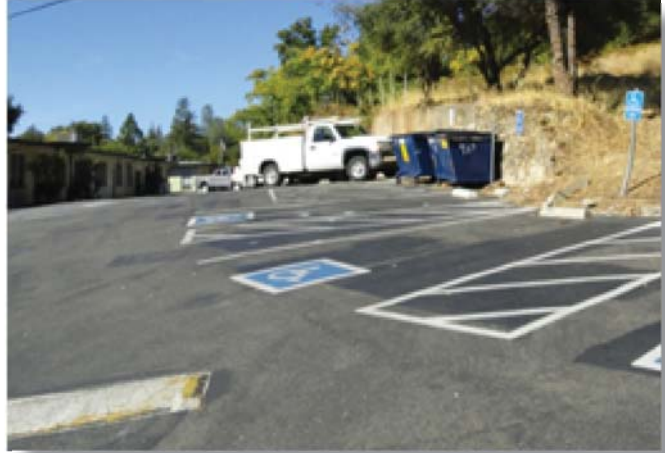
### **HANDICAP PARKING**

Handicap parking spaces require ADA updates.  
There is no ADA path of travel from parking spaces to building entrance.

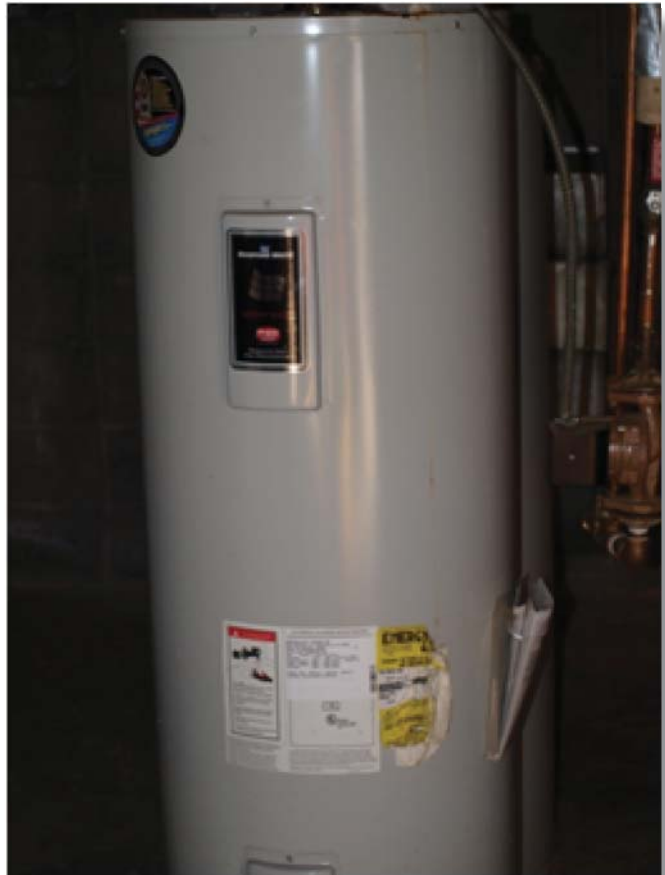
### **HOT WATER**

Hot water heater does not have earthquake strap installed.

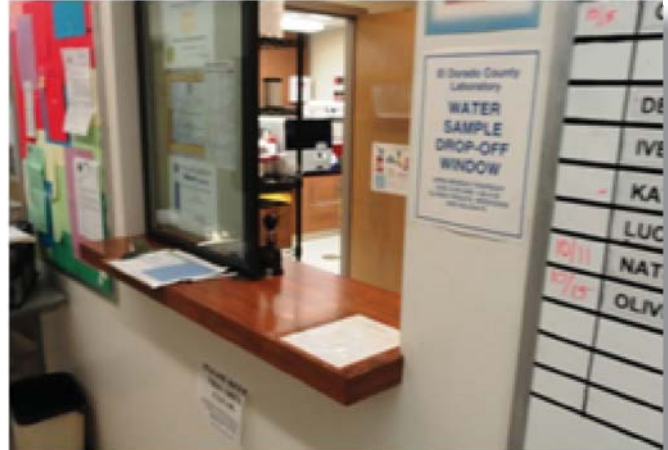
**LAB**

Counter at lab window is not wheelchair accessible.

- Seal all wall and floor penetrations to mitigate rodent intrusion.
- Remodel staff restrooms to comply with ADA. Replace deteriorated water and waste lines concurrently. Replace non-ADA drinking fountain. Install ADA lever handles at doors. Modify the Lab Station counter so it provides ADA access.

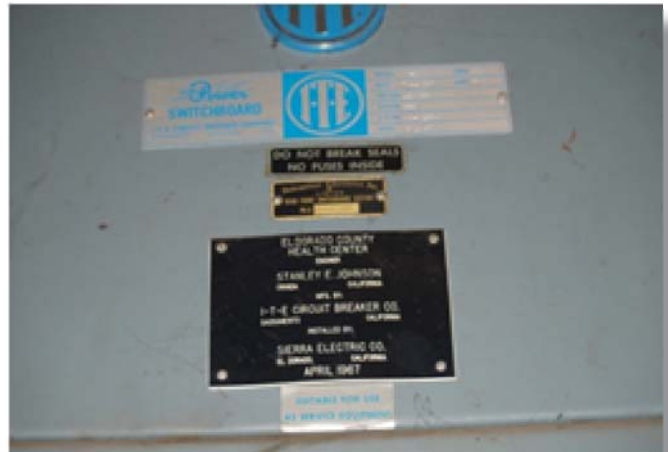
**MAIN**

1967 electrical is beyond its service.

- Replace obsolete and undersized electrical service, panels and feeders to improve distribution to building loads. Replace existing lighting with energy efficient fixtures with improved optics. Replace local light switches with occupancy sensor light controls with a building lighting control panel to sweep off lighting in spaces unoccupied during off hours to reduce energy consumption. Replace old electrical outlets and install additional receptacles and signal outlets with concealed raceway or wiremold. Remove abandoned electrical equipment, conduit, low voltage cabling and power circuits. Install parking lot lighting.

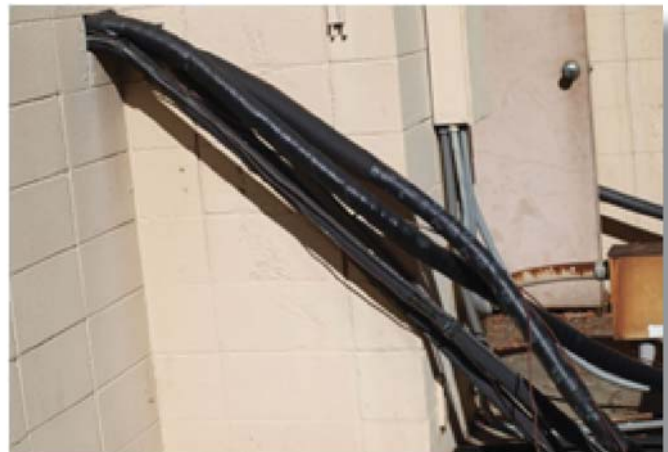
**REFRIGERANT**

Refrigerant piping is not supported and penetration through exterior wall not sealed.

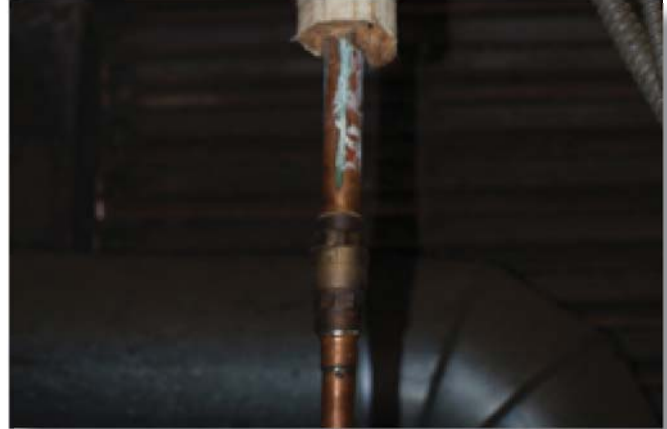
### INSULATION

Not all of the piping has insulation. Nearby tag indicates asbestos material.

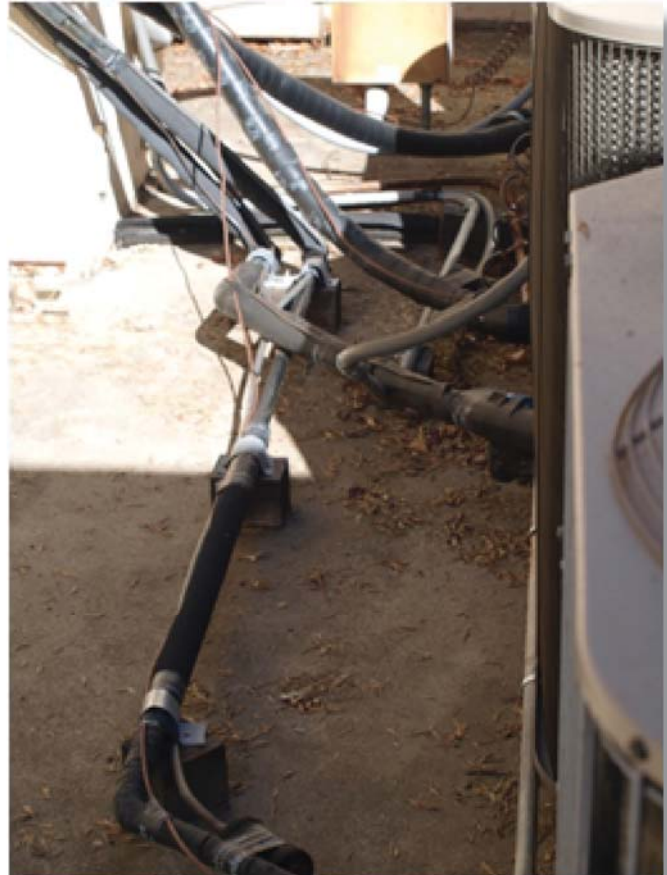
### PIPING

Refrigerant piping blocks access to unit for service.

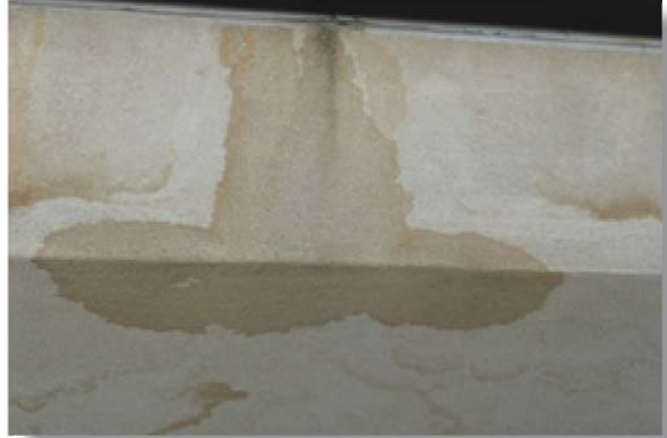
### **WATER STAINS**

Water stains on exterior wall and soffit.

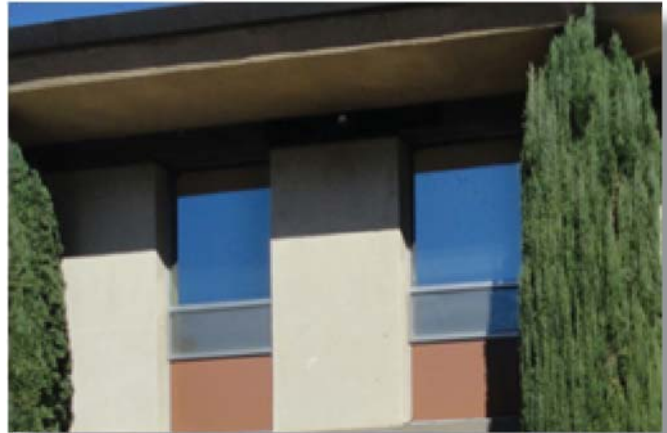
### **WINDOW**

Exterior windows are non energy efficient single glazed units. The lower panel is transite.

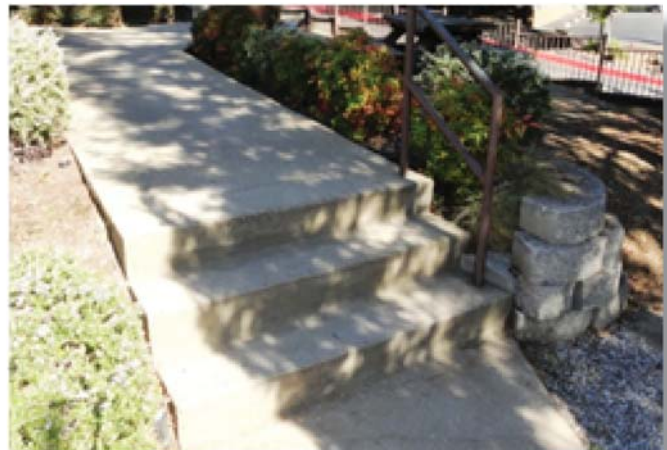
### **STAIRS**

Exterior stairs do not have contrasting stripe. There should be two handrails and the one present doesn't extend 12 inches past steps.

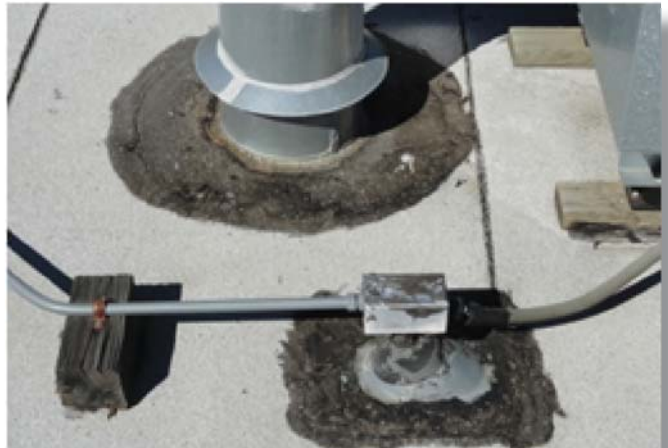
**ROOF**

Roof patches around mechanical and electrical penetrations to stop water leaks.

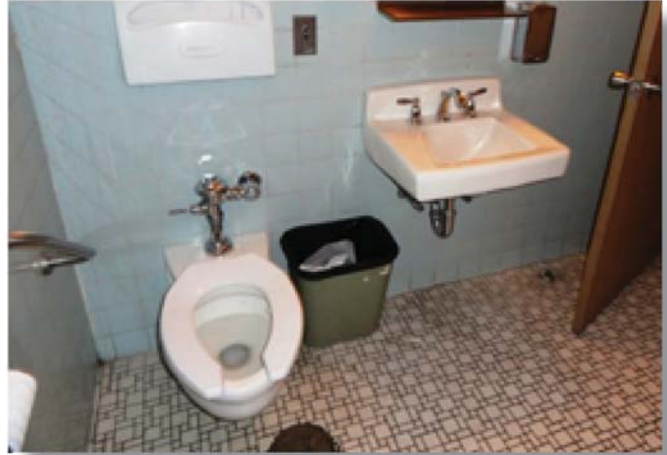
### BATHROOM

Bathroom may require ADA updates. Fixtures are not set at ADA heights. Grab bars not installed per ADA standards. The door does not have lever lockset.

- Remodel staff restrooms to comply with ADA. Replace deteriorated water and waste lines concurrently. Install ADA hardware at doors. Modify public counters for ADA access.

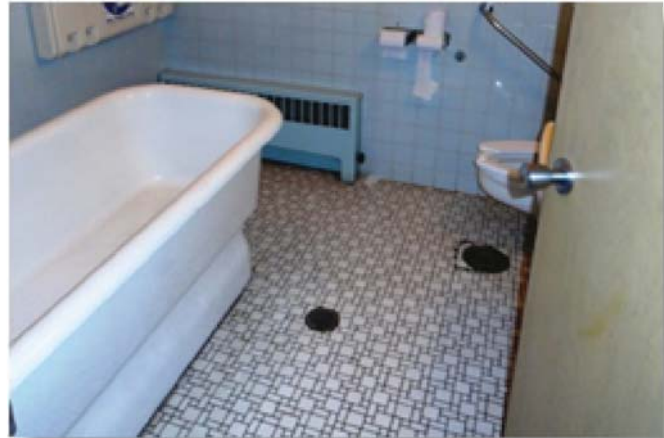
### BATHTUB

Original hospital bathtub is still present.

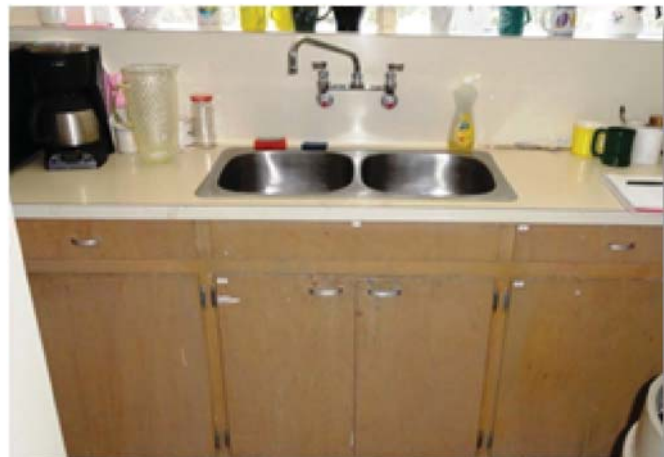
### BREAKROOM KITCHEN

Cabinets in good condition, however may require ADA updates.

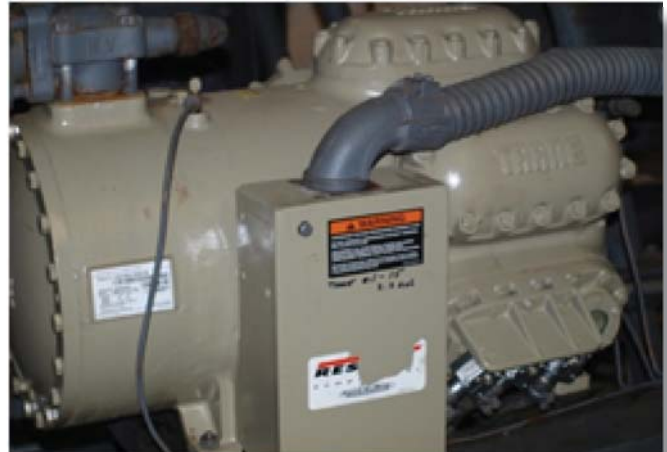
**CHILLER**

Original chiller is over 40 years old. One no longer used.

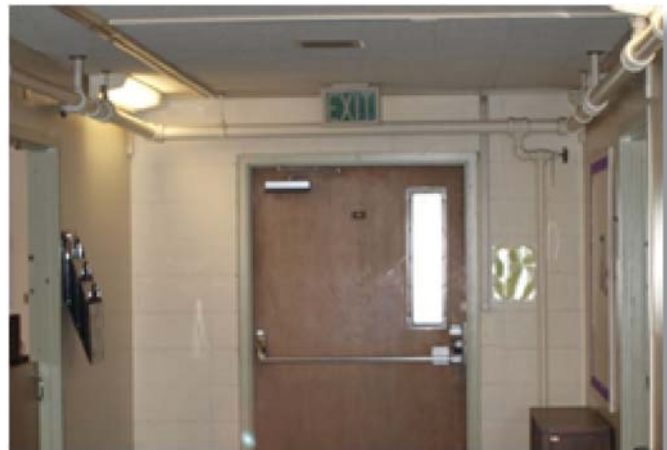
**EXIT**

Exit door. The exit light above door does not work and the panic bar is obsolete.

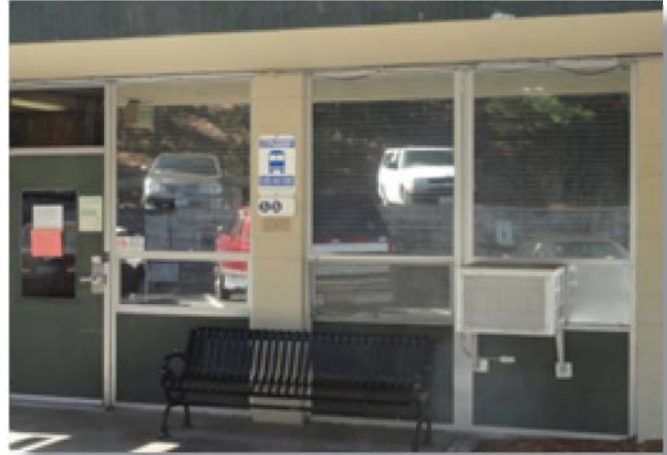
### EXTERIOR - EAST - Windows

Exterior windows are non energy efficient single glazed units. The lower transit panel is made out of asbestos.

- Replace roofing and flashings. Consider adding tapered insulation to provide positive flow. Suggest an energy audit to determine cost saving benefits to install EIFS system to exterior walls and replacing the windows. Seal all wall and floor penetrations to mitigate rodent intrusion.

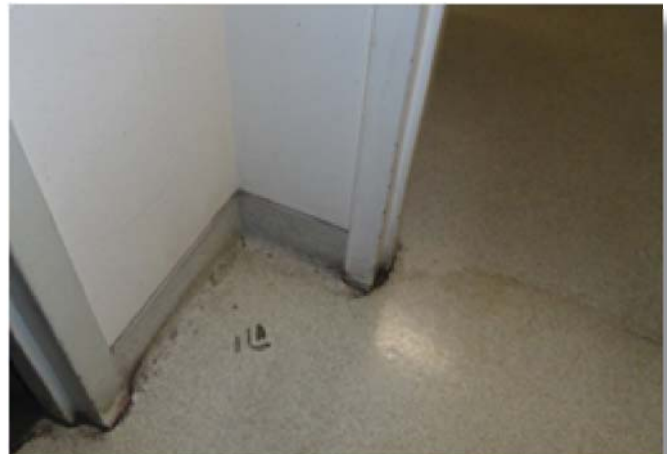
### FLOOR

Flooring in poor condition, particularly around door jambs.

- Replace chipped VCT flooring and VAT flooring.
- Replace deficient antiquated HVAC system equipment and components to improve energy efficiency and reduce maintenance costs. Replace original ductwork to improve air quality, occupant comfort and reduce energy costs. Install energy management system for optimal energy conservation with capability to monitor and control system off-site to reduce technician visits to building. Remove abandoned equipment and ductwork. Replace plumbing fixtures and associated piping which has exceeded its useful life.

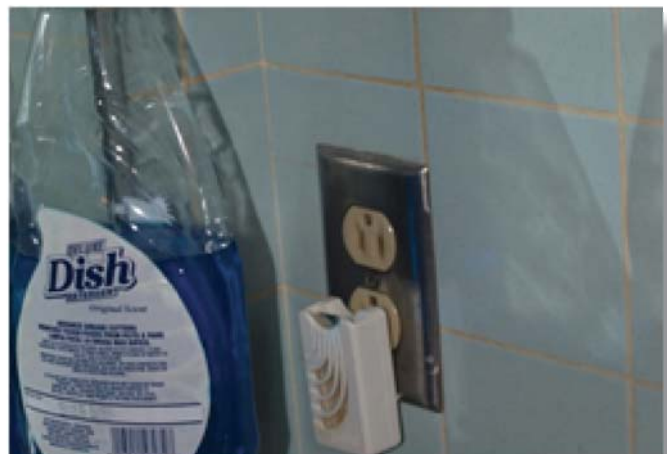
### GFI

Non GFI outlet old patient lavatory.

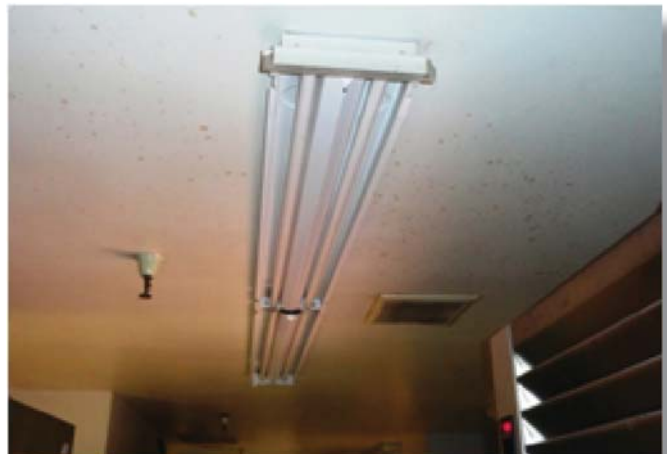
**LIGHT FIXTURE - NO COVER**

This light fixture is missing the lens cover.

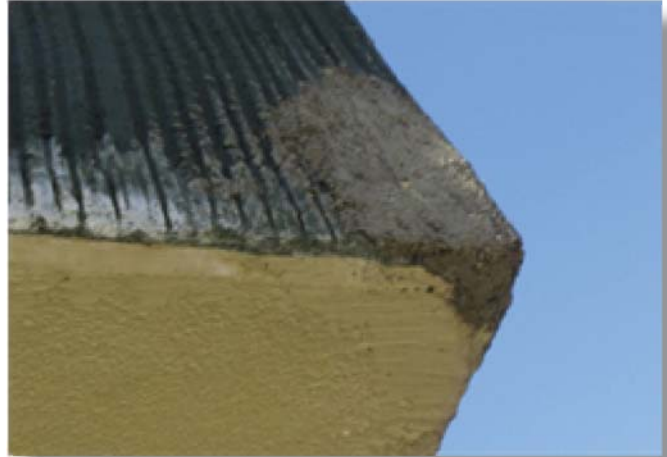
### PLASTER PATCH

The corner of the building was damaged and crude plaster patch installed.

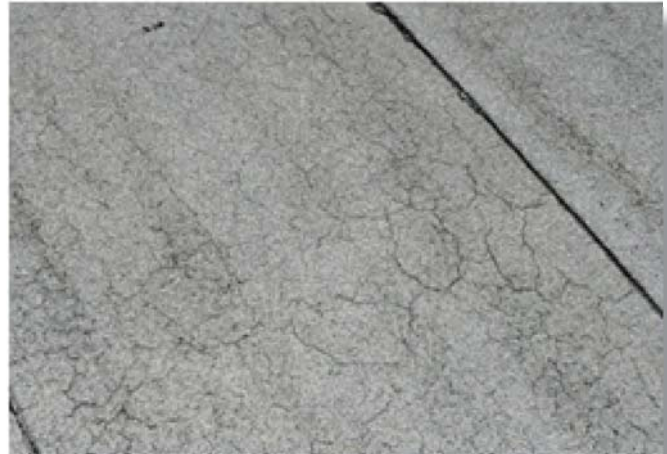
### ROOF

Alligator cracking in the built-up roofing cap sheet.

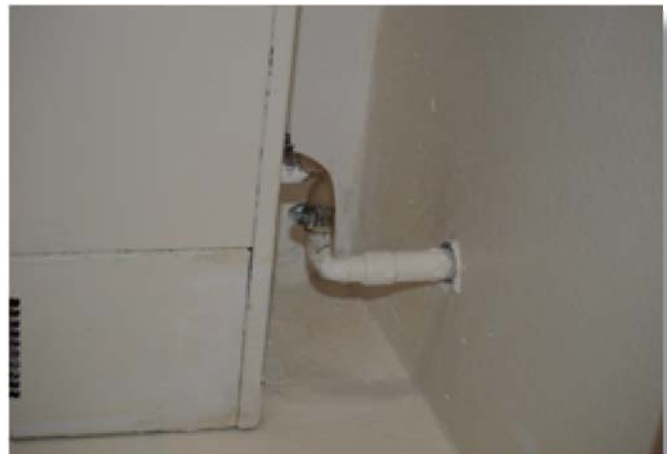
### PIPING REPAIR

Original ventilator piping is failing. Here it has been patched with flexible hose and two hose clamps.

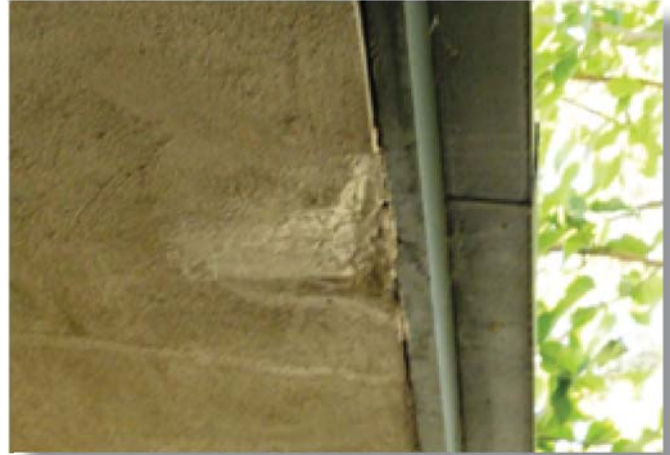
**PLASTER SOFFIT DAMAGE**

Crude patch where plaster soffit was damaged.

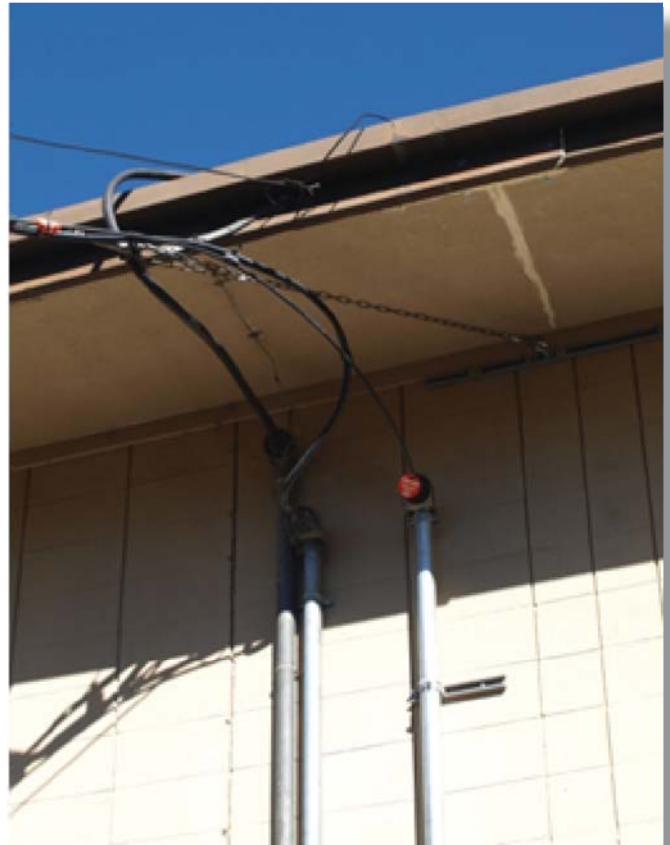
**SERVICE ENTRANCE**

Overhead electrical service to building. Should have weather head extending above roof.

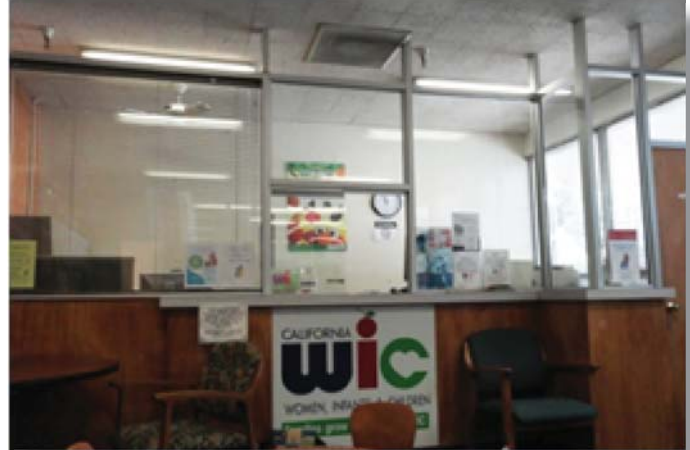
### WIC COUNTER

There is no wheelchair access at the reception counters.

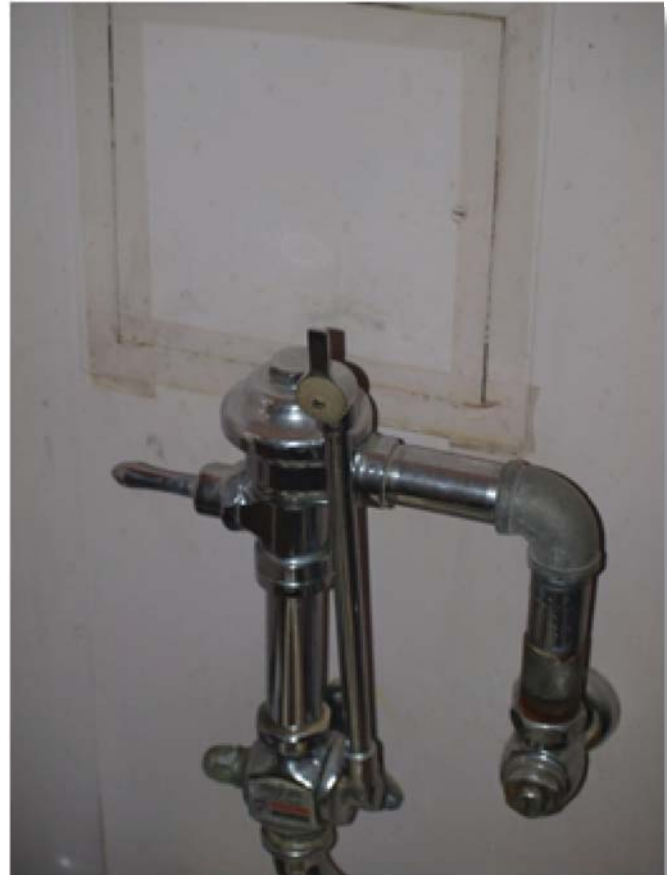
### FLUSH

Flush valves are very old & inefficient.

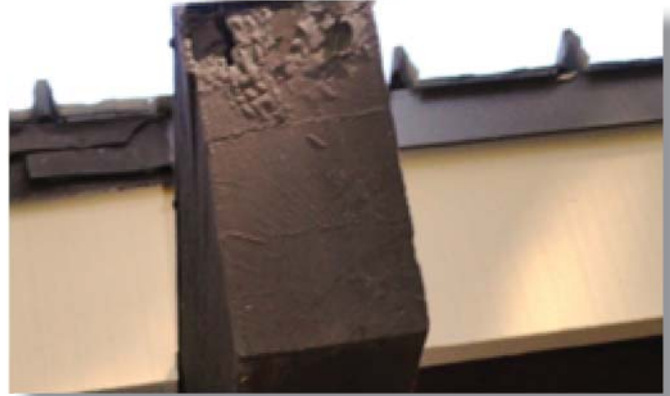
**BEAM**

Minor damage at end of outrigger beam.

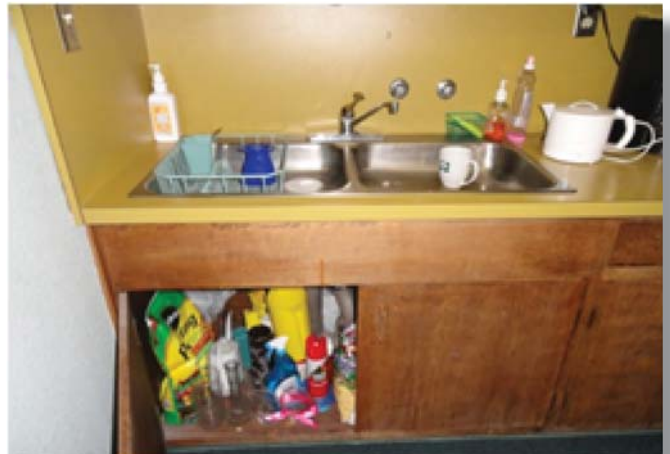
**BREAKROOM**

Breakroom sink not ADA suitable. Original plumbing was capped and left exposed.

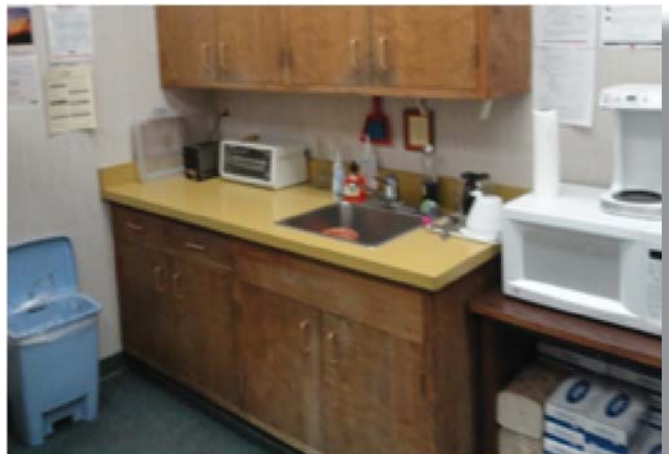
**BREAKROOM**

Breakroom sink not ADA suitable. Finish on cabinets is in poor condition.

- Remodel restrooms to comply with ADA. Replace deteriorated water and waste lines concurrently. Replace non-ADA drinking fountain. Install ADA lever handles at doors. Modify break room cabinets for ADA compliance.

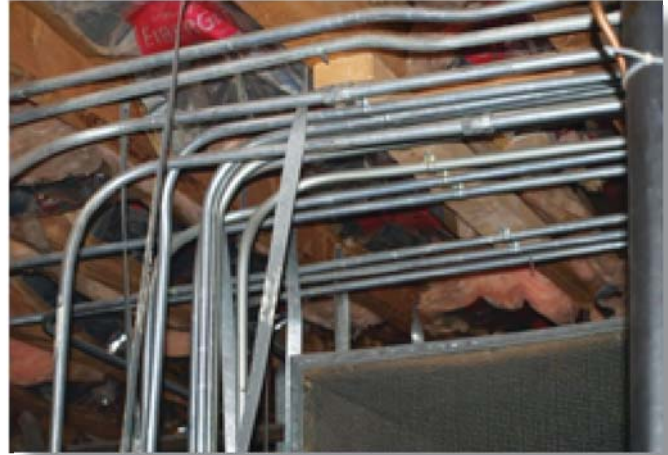
**CONDUIT**

Many of the conduits above the ceiling are not attached to structure for support.

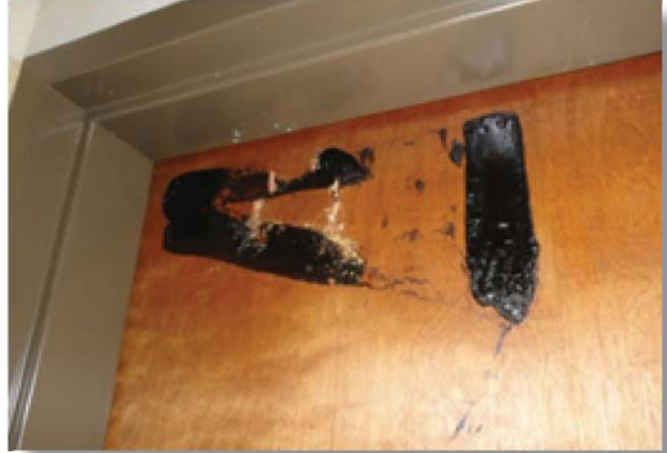
**DOOR**

Unightly patch where closer was removed from the door.

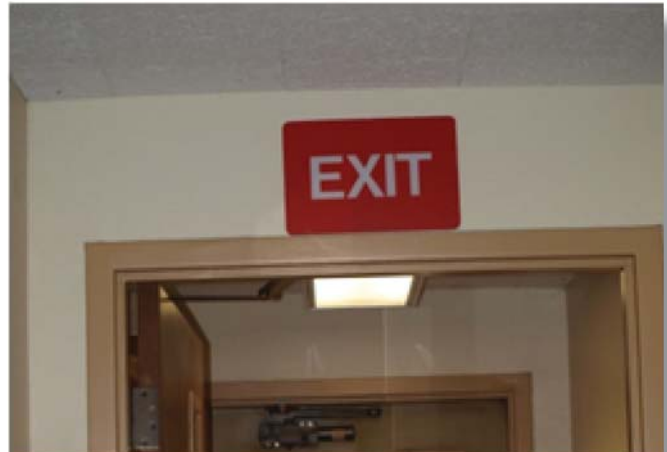
**EXIT**

Exit sign is not illuminated. Cover is missing from door closure.

- Fire and safety modernization should be addressed. Install new emergency and exit lighting. Have the fire sprinkler system tested to determine if and where corrosion has occurred in the piping from water ponding or (MIC) from the water quality on the dry pipe system. Replace piping and sprinkler heads that are determined to be sufficiently corroded to maintain the integrity of the system in place to reduce the cost for complete replacement of the system. Replace dirty heads, deficient valves and air compressor on fire sprinkler system. Provide combination fire/smoke dampers tied to the fire alarm system at all ducts passing through fire rated walls. Replace fire alarm system to meet current codes and to incorporate HVAC system for alarm and shutdown.

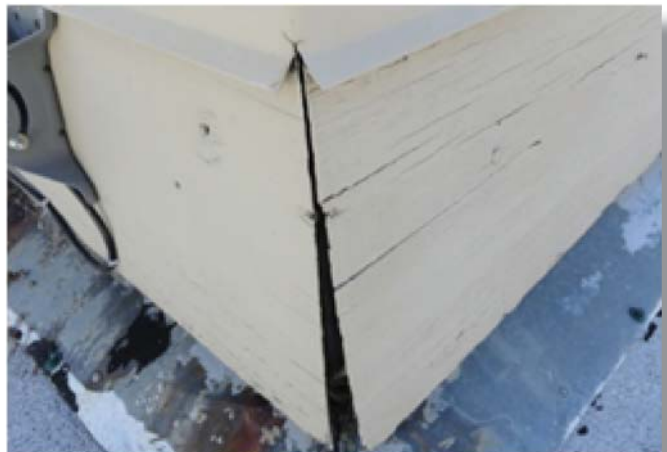
**FASCIA**

Sun damaged fascia boards are split and separating at joint.

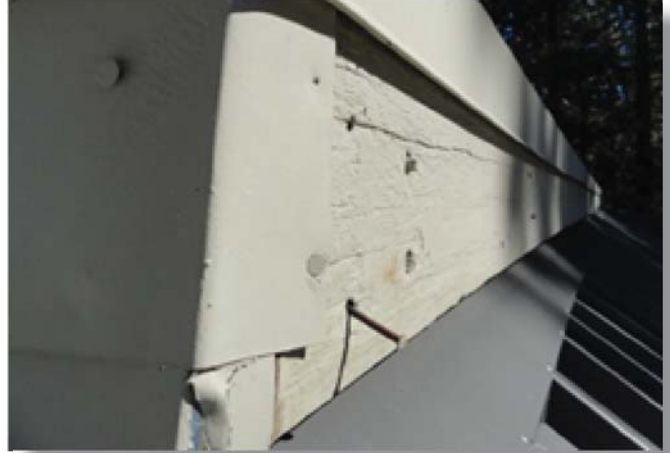
**FASCIA**

Nail popping at fascia.

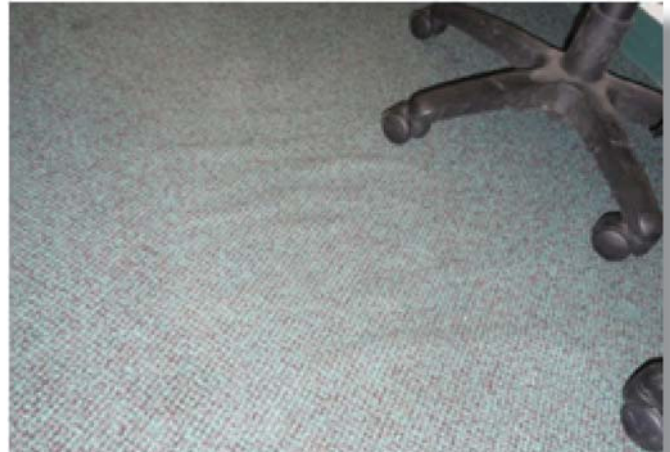
**FLOORING**

Carpet is not secure to substrate below and wrinkled.

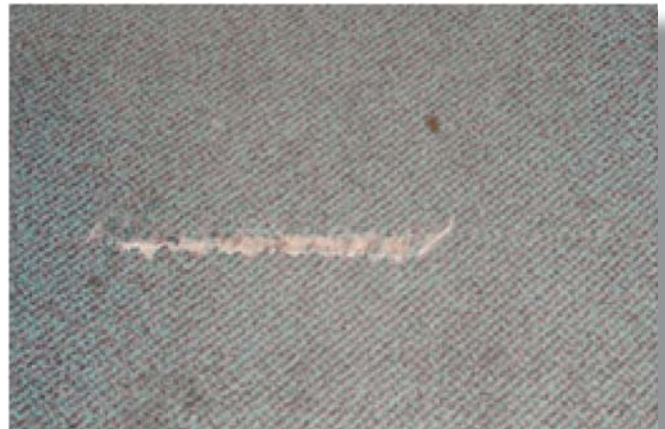
**FLOORING**

Tear in carpet at joint.

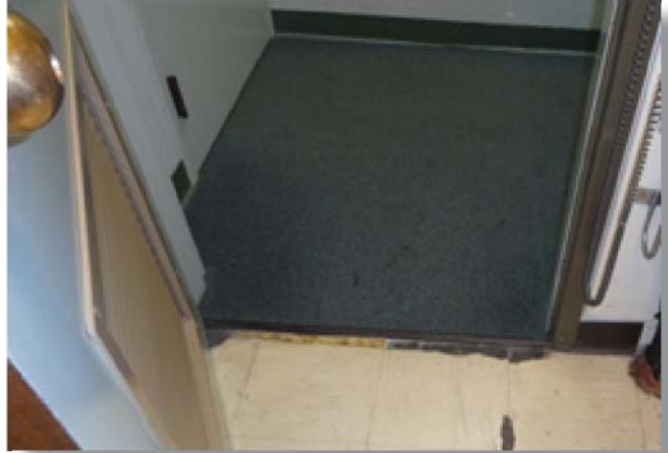
**FLOORING**

VCT flooring is chipped around door.

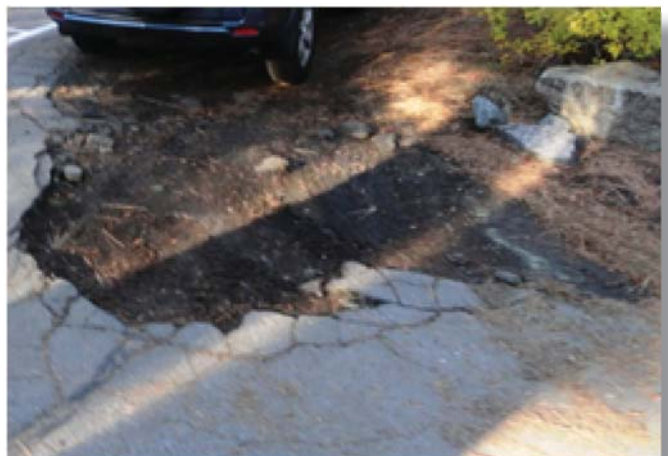
**PAVEMENT**

Complete failure in pavement.

- Replace asphalt walkways to provide suitable ADA access from parking lot.

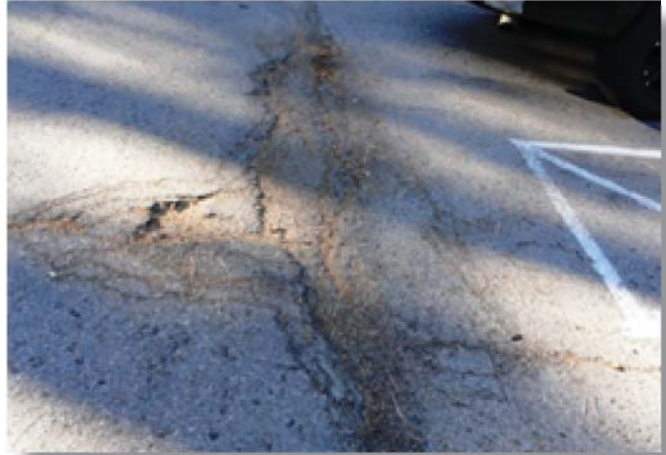
**PAVEMENT**

Parking lot pavement deterioration.

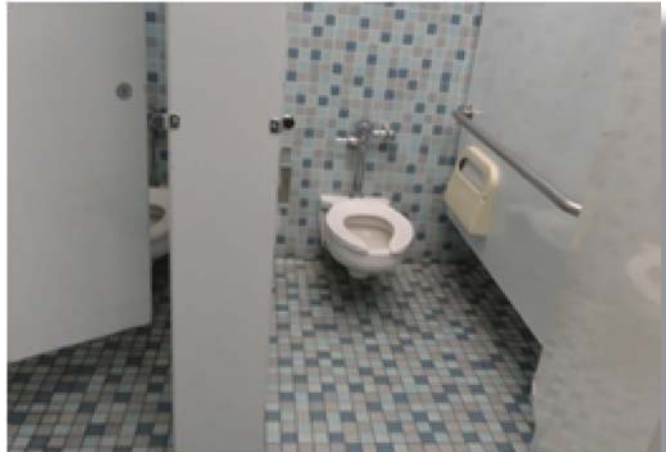
**RESTROOM**

Restroom has grab bar installed, but may require ADA upgrades.

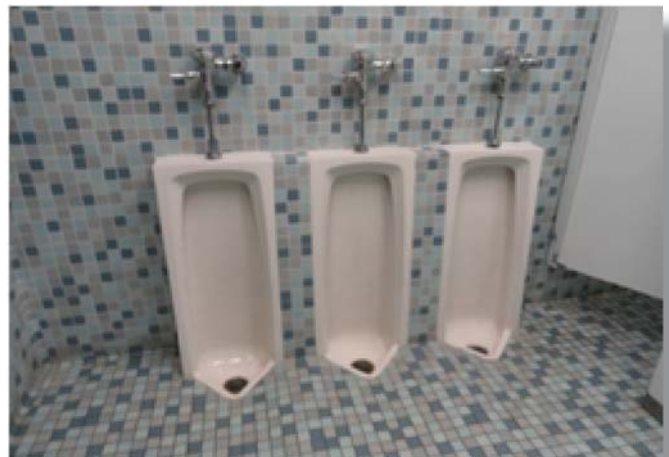
**RESTROOM**

Urinals are not ADA suitable.

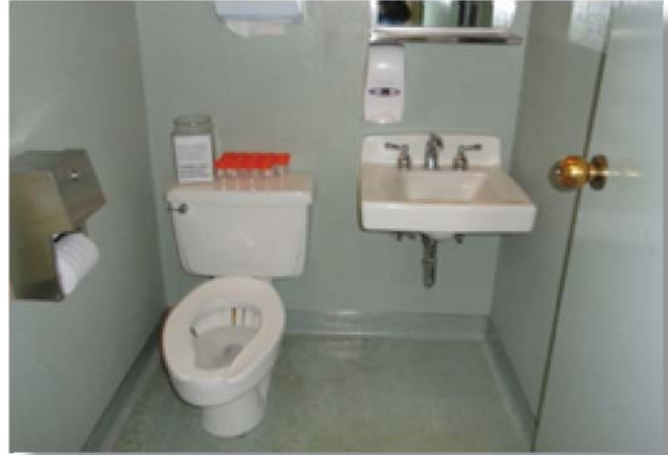
**RESTROOM**

Single occupant restroom is not ADA suitable.

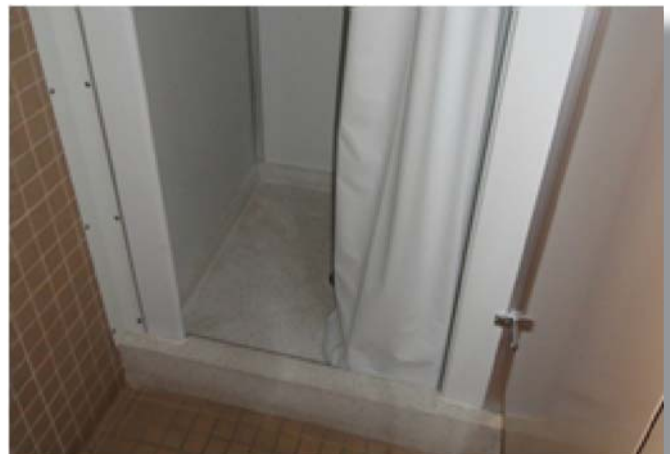
**SHOWER**

Shower may require ADA upgrades.

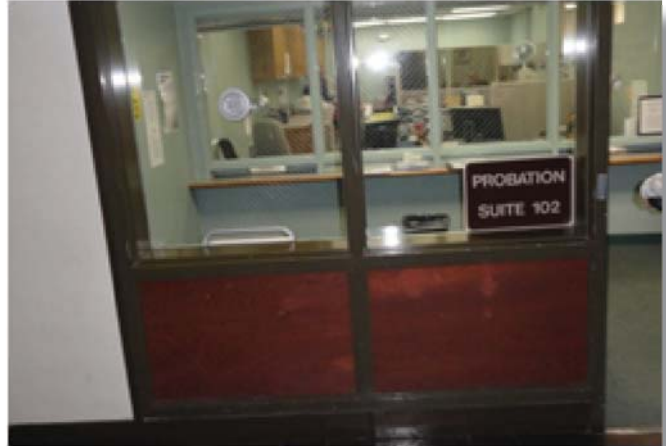
### TRANSACTION

Window is not wheelchair accessible and speaker is not ADA compliant.

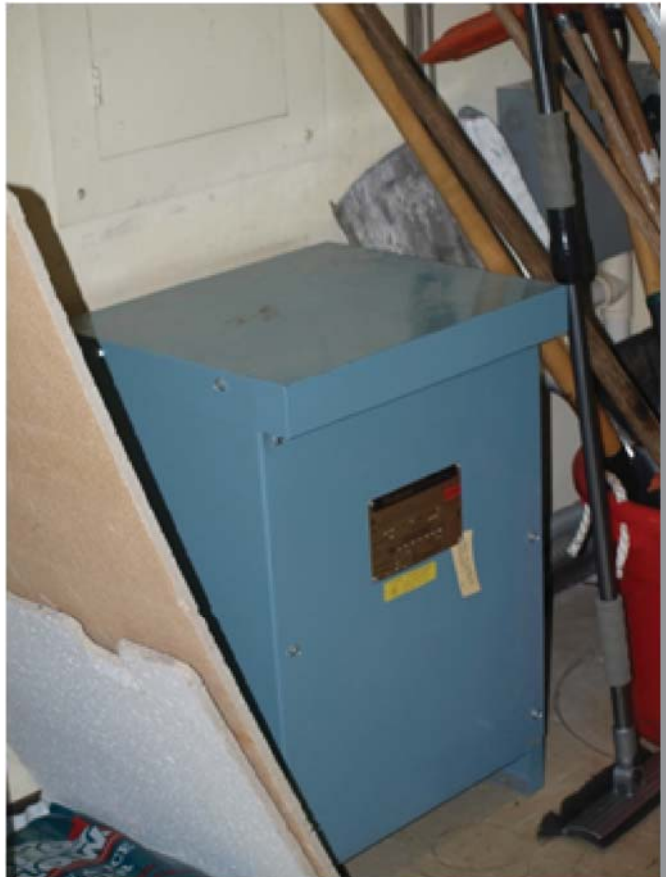
### TRANSFORMER

Transformer blocks full access to electrical panel above.

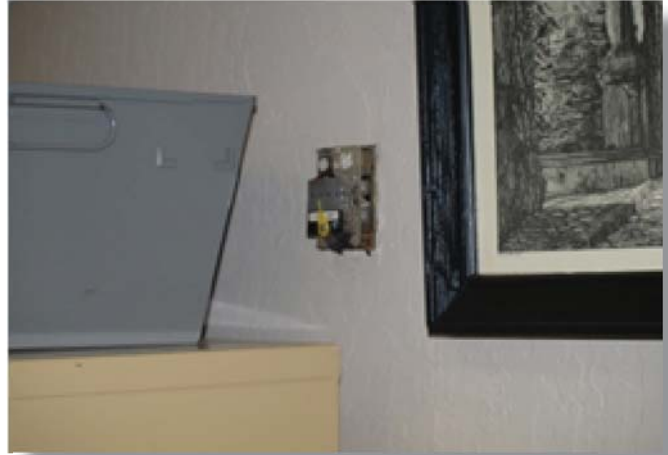
**THERMOSTAT**

There is no cover on the old thermostat.

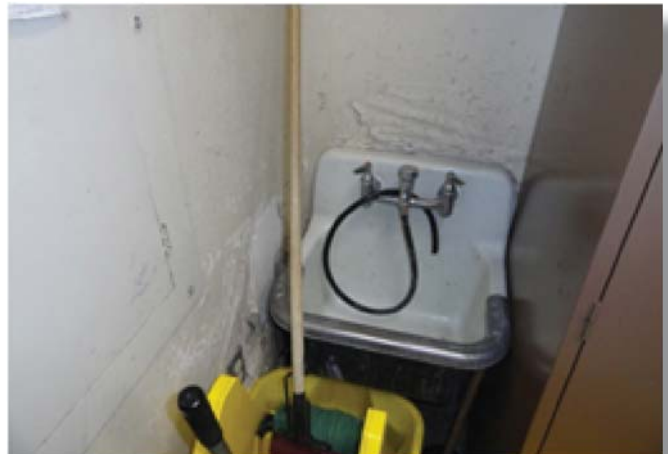
**WALL**

Wall has water damage around janitor's sink.

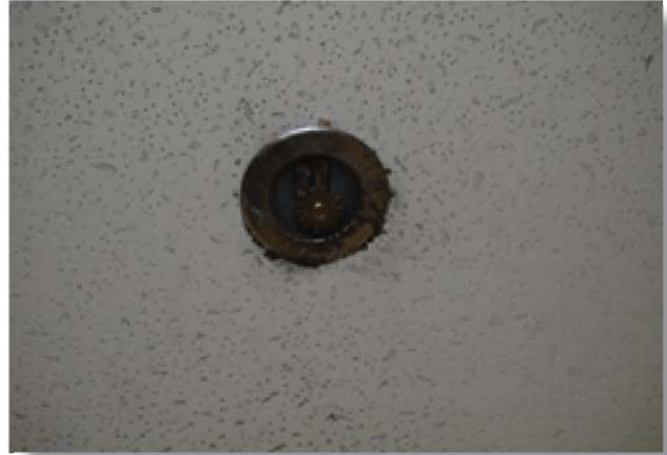
**SPRINKLER**

Typical fire sprinkler head. Heads are dirty with material buildup. System should be tested.

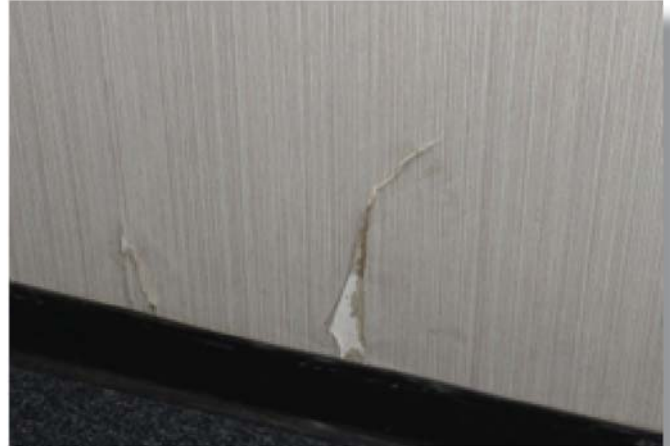
**WALL PAPER TEAR**

Tear in vinyl wall covering.

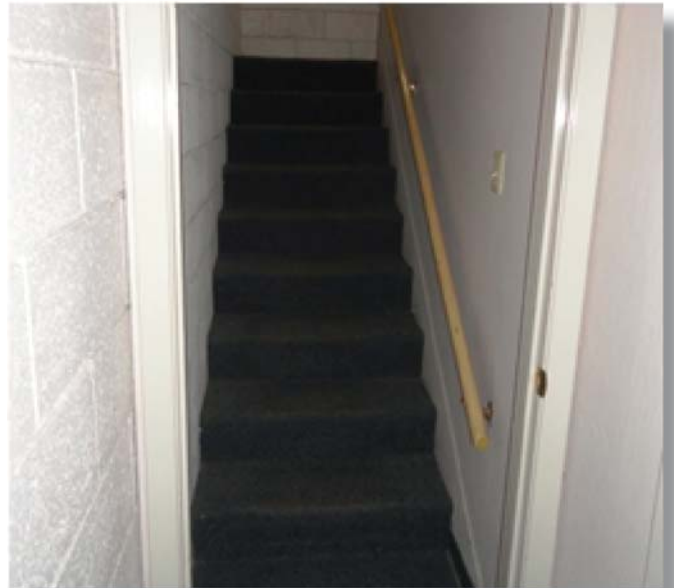
**STAIRWELL**

Stairs are very narrow and lack code compliant handrails and contrasting stripes.
