# Facilities Capital Improve Plan

Fiscal Year 13/14

# El Dorado County

CAO Facilities

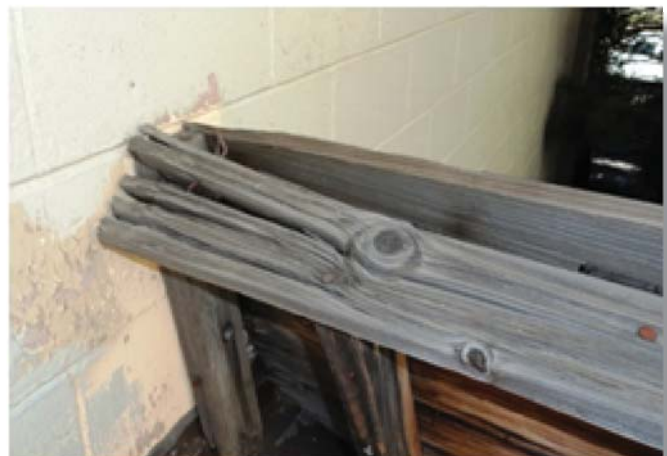
**MECHANICAL SCREEN MISSING**

The wood mechanical screen of north side of the roof is in very poor condition.

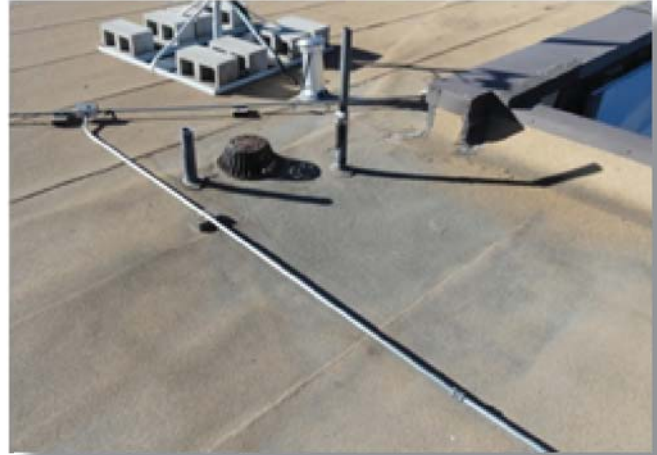
**ROOF**

Evidence of standing water at roof drain indicates either the drain is undersized or gets clogged.

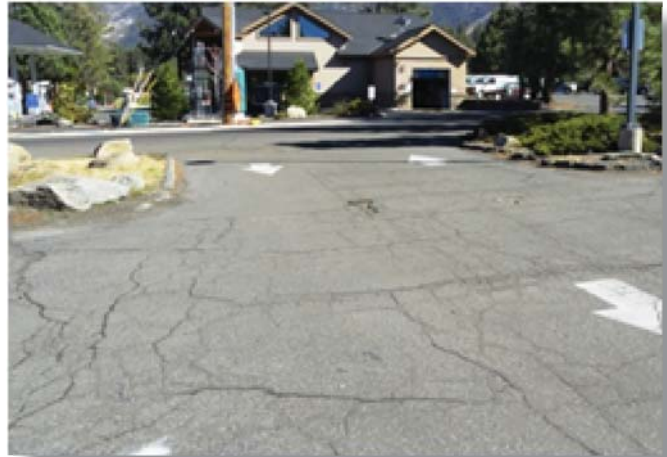
**PAVING**

Parking lot pavement is at end of life cycle.

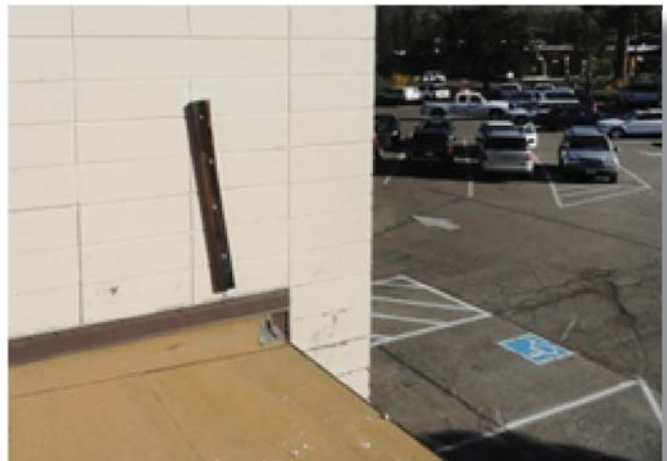
**MECHANICAL SCREEN**

The mechanical screen is completely gone on south side of roof. This level of roof is accessible through a door.

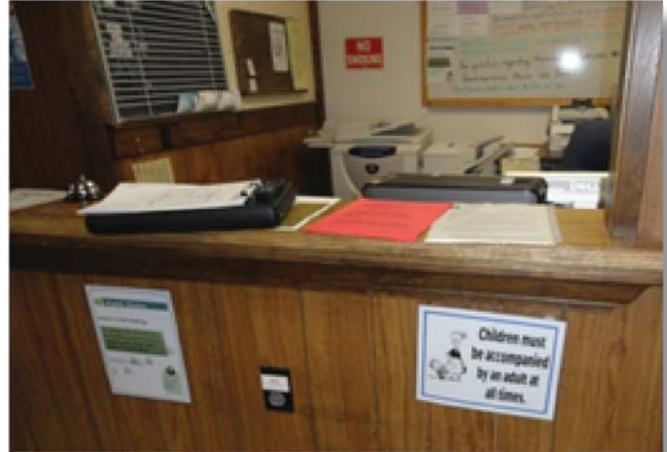
**NON ADA COUNTER**

Counter does not have wheelchair access.

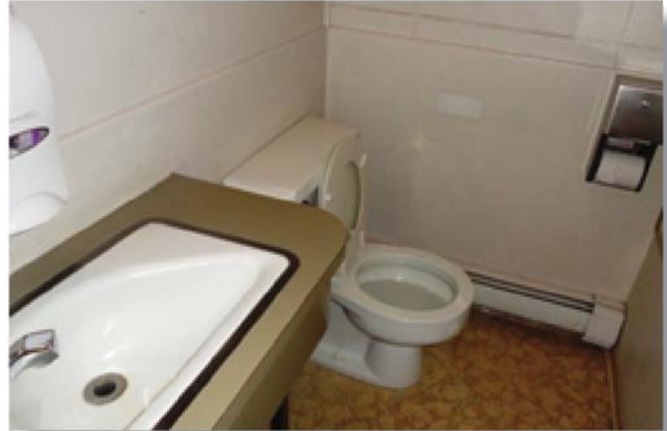
**NON ADA RESTROOM**

Restroom is non ADA compliant.

- Seal all wall and floor penetrations to mitigate rodent intrusion.
- Remodel public restrooms on all levels. Replace the water and waste lines concurrently.

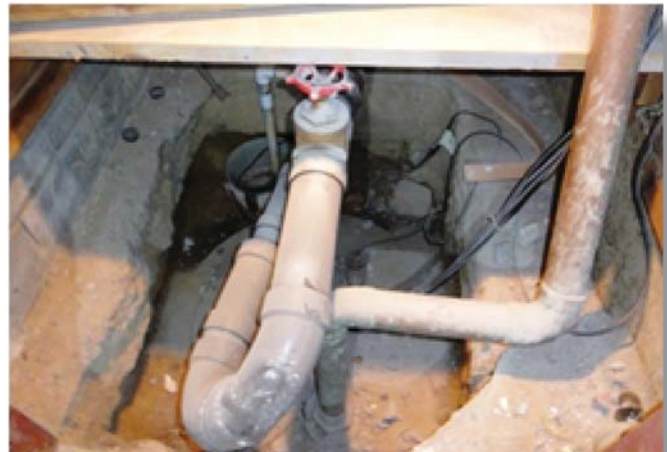
**WASTE PIT**

Unclosed waste pit in basement produces foul smell at lower level.

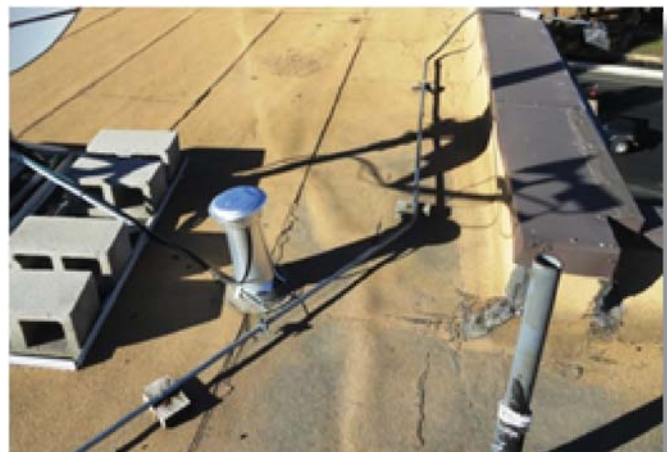
**ROOF BLISTER**

Roofing is in poor condition. Major blister in capsheet likely will cause problems soon.

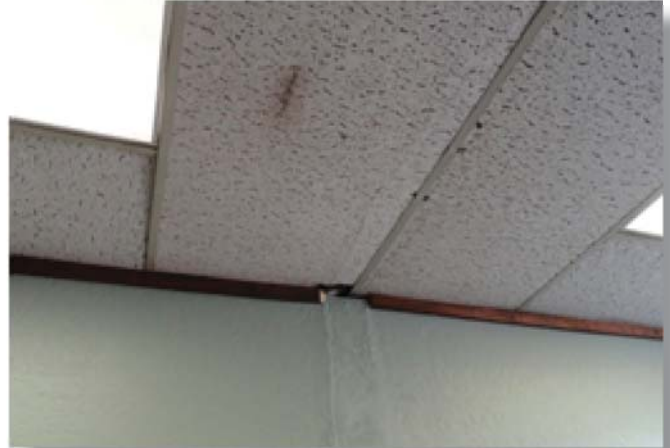
**MOULDING MISSING**

Finishes not patched when wall was removed during renovation.

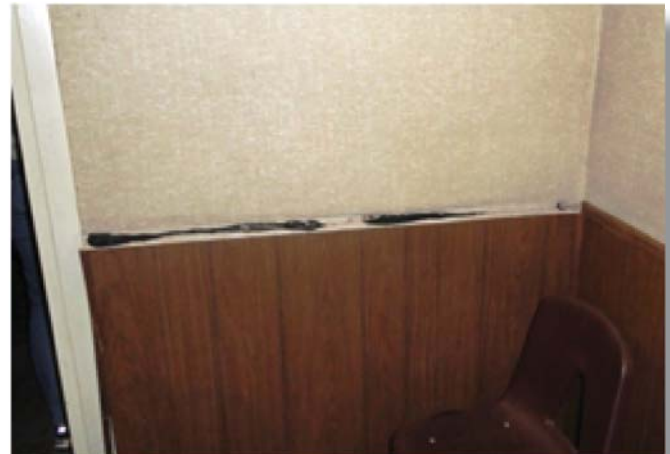
**CHAIR RAIL MISSING**

Chair rail at top of wainscot is missing.

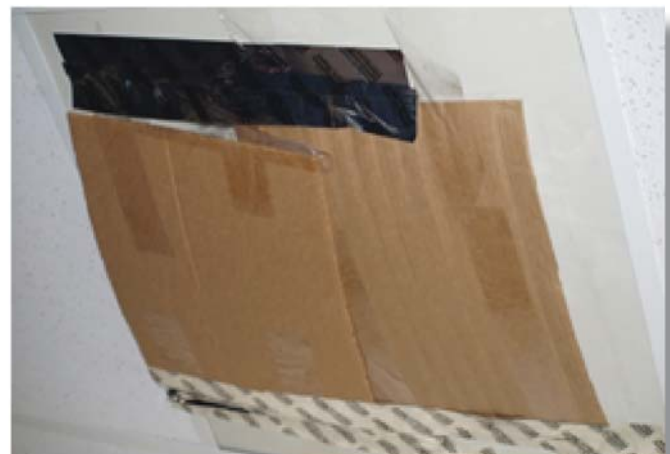
**DEFLECTOR**

The HVAC system is not balanced. A deflector was added at the supply register to reduce the air flow.

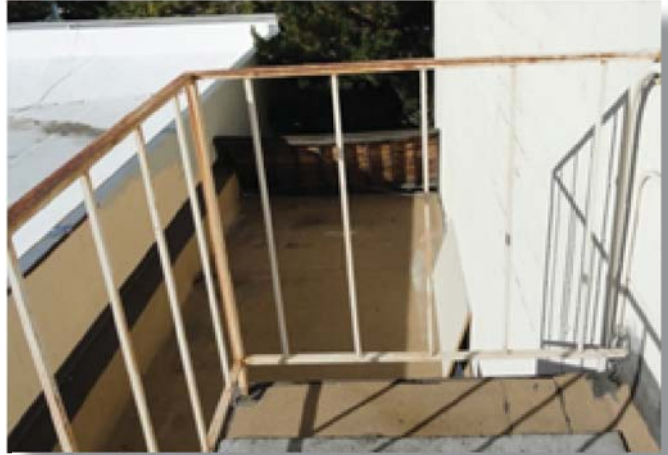
### **BALCONY RAILING**

Vertical spacing for pickets on balcony greater than per code. Steel members rusted.

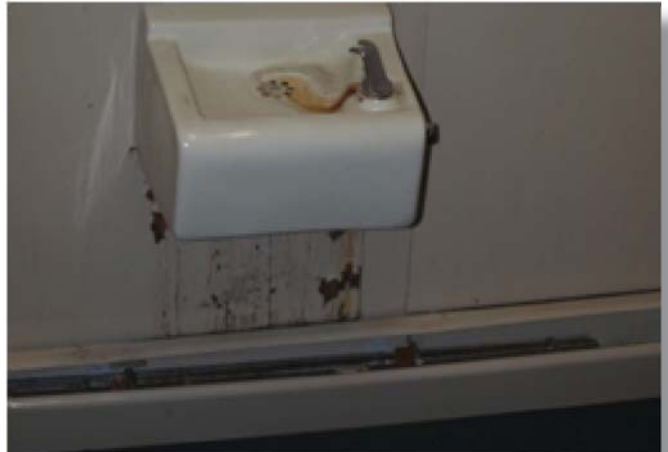
### **DRINKING FOUNTAIN**

Drinking fountain. This should not be used.

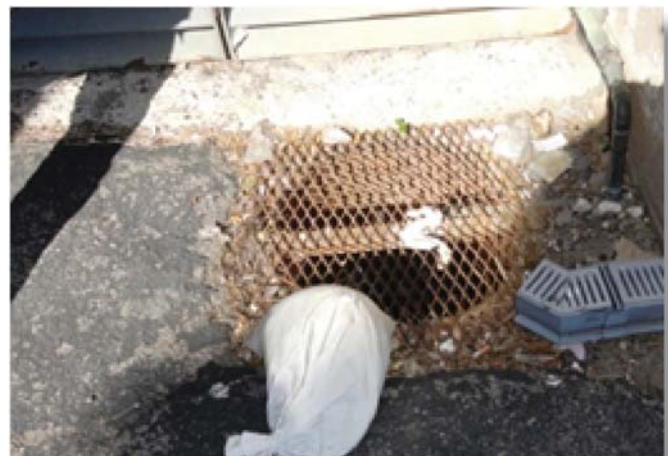
### **CATCH BASIN**

All water run-off from parking lot goes into this one drain where it is pumped through the building to the other side. If the drain clogs or pump malfunctions, then water gets into first floor.

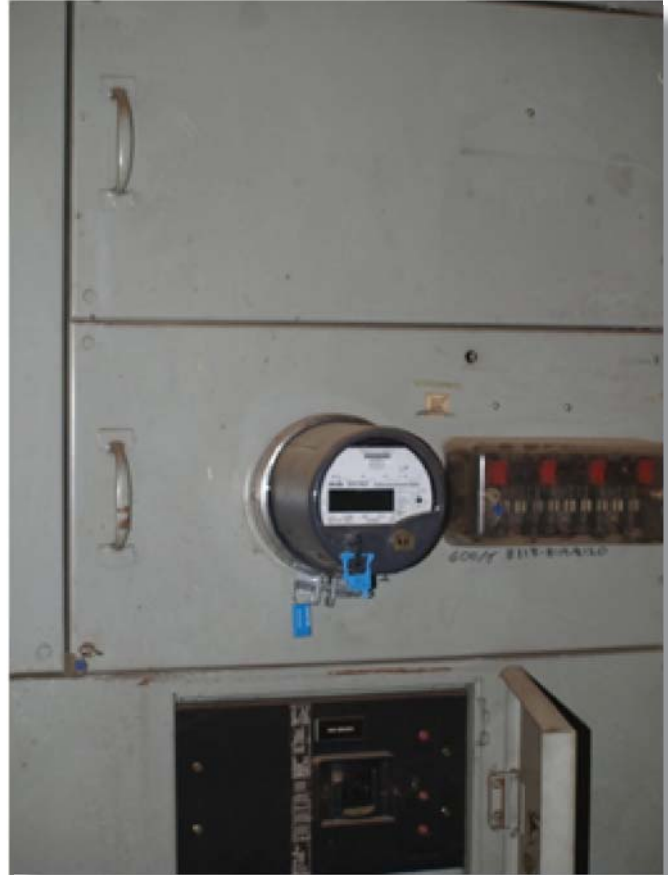
**MAIN**

400 amp main service is obsolete and undersized to handle a 20,000 sf office building.

- Replace obsolete and undersized electrical service along with downstream deficient panels and feeders. Replace existing lighting with energy efficient fixtures with improved optics. Replace local light switches with occupancy sensor light controls with a building lighting control panel to sweep off lighting in spaces unoccupied during off hours to reduce energy consumption. Replace parking lot and building mounted lighting. Install additional receptacles and signal outlets with concealed raceway or wiremold. Remove abandoned electrical equipment, conduit, low voltage cabling and power circuits.

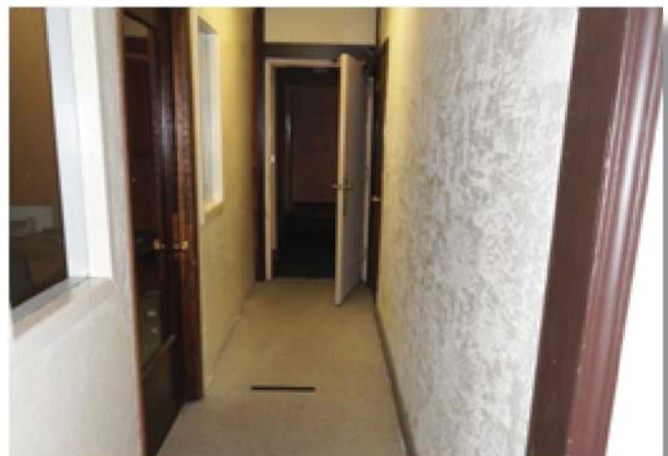
**BASEMENT HALLWAY**

Doors do not have ADA compliant lever locksets.

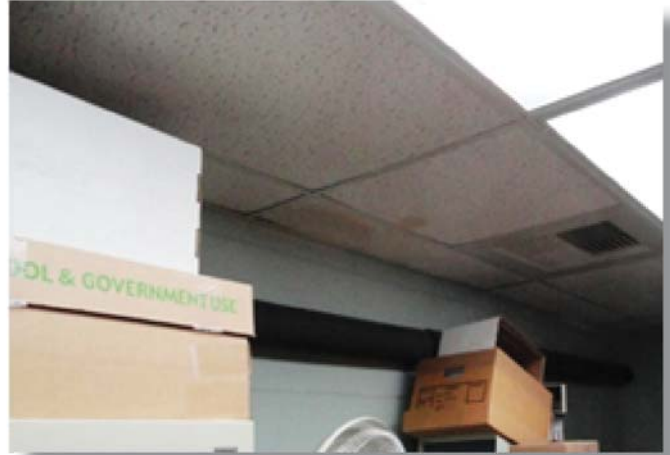
**CEILING**

Stained ceiling tiles.

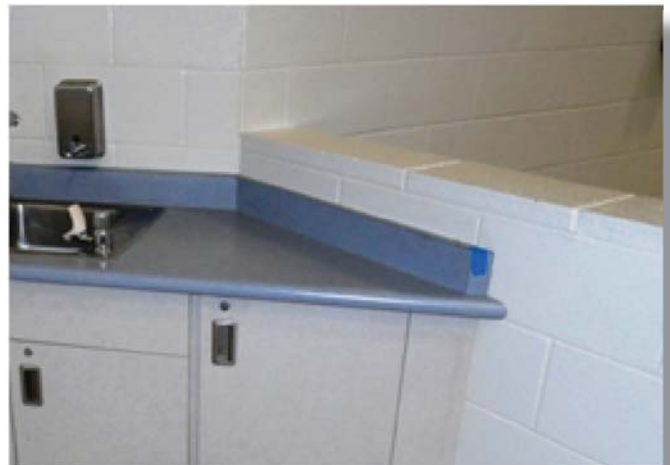
**DAYROOM COUNTERTOP**

Minor chip in countertop held in place by blue tape.

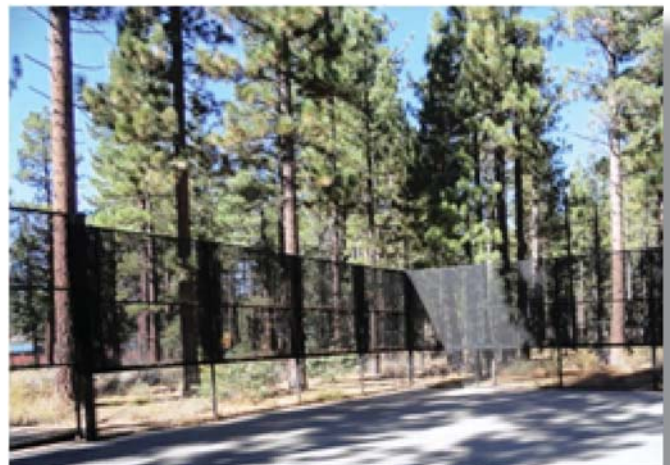
**OUTDOOR EXERCISE**

The outdoor exercise yard is rarely used because the fence is easily climbed.

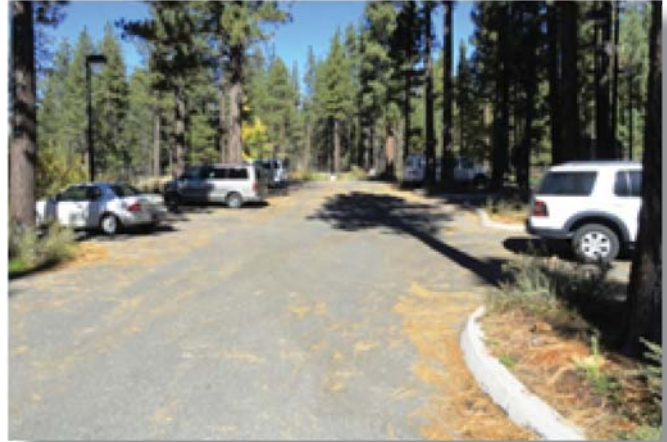
### **PARKING LOT**

Parking lot in good condition. Sealing and re-stripping parking lot will prolong pavement life.

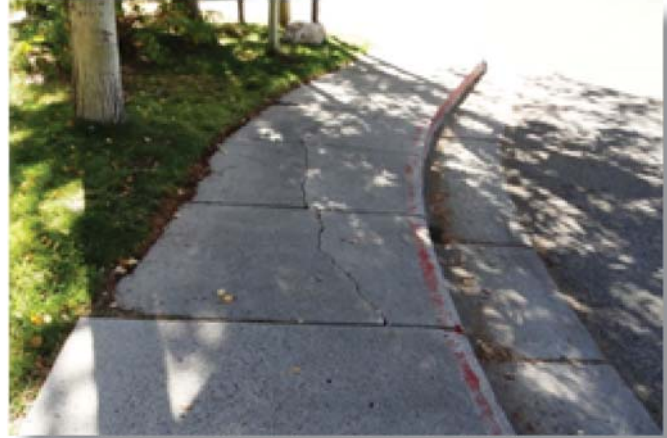
### **WALKWAY**

Cracks in concrete walkway appear to be due to roots from adjacent tree.

- Repair or replace damaged concrete paving. Repair damage asphalt paving and seal coat and re-stripe parking lot.

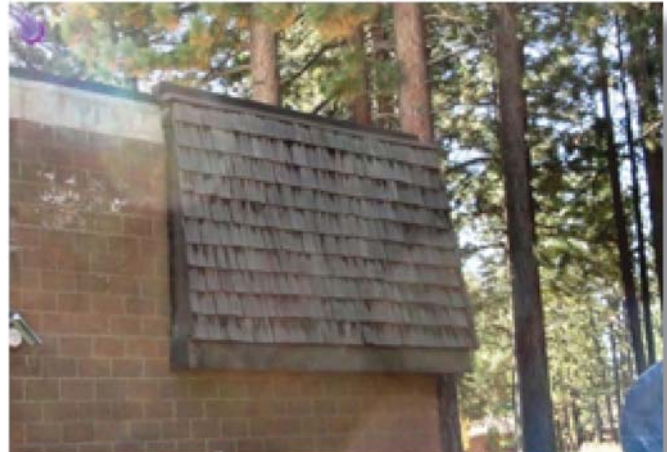
### **MANSARD**

Wood shingles on mansard ar brittle and have splits.

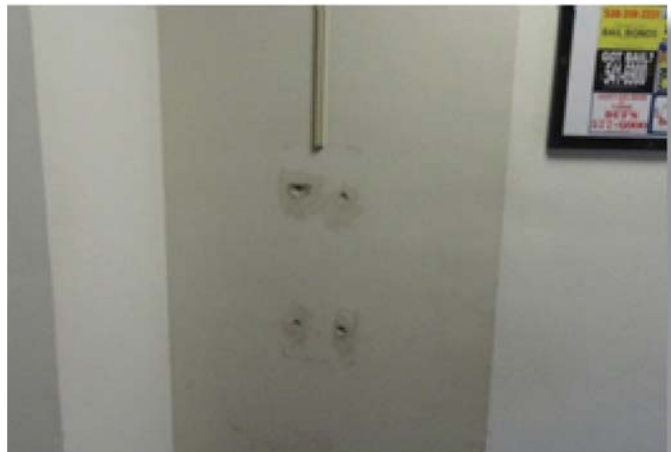
### **WALL REPAIR - TELEPHONE**

Telephone was removed and wall not patched.

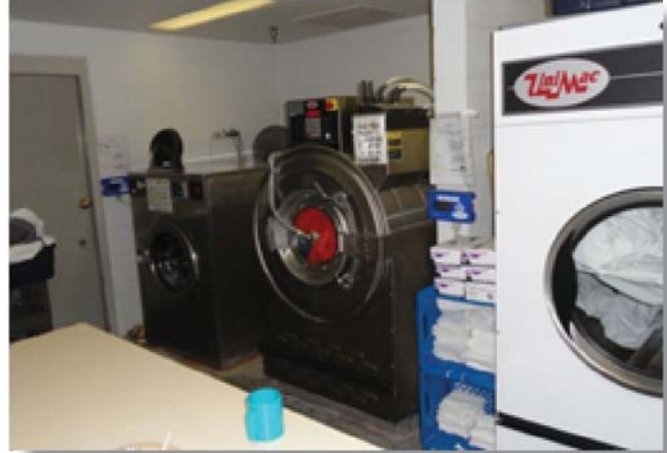
### LAUNDRY

Commercial equipment in laundry in good condition. Door does not have ADA lockset.

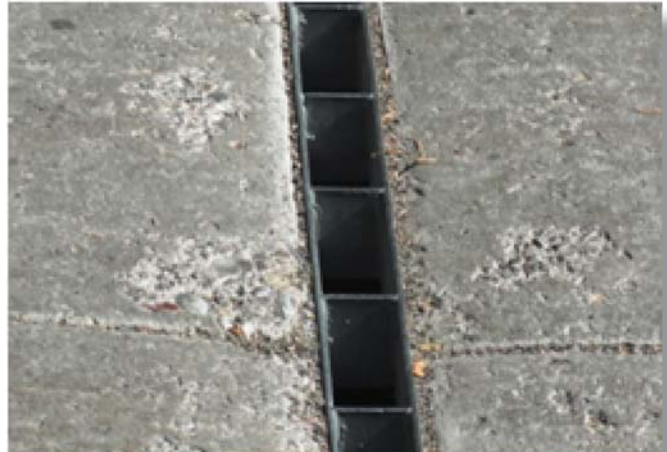
### TRENCH DRAIN

Trench drain does not have cover.

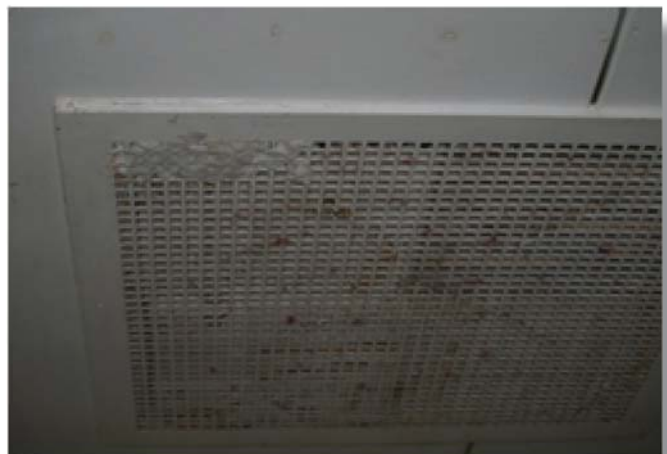
### DIFFUSER

Diffuser at original jail in poor condition. Reduced air flow due to blocked grate.

- Replace deficient obsolete HVAC system equipment and components at the older section of the jail to improve energy efficiency and reduce maintenance costs. Replace original ductwork at the older section to improve air quality, occupant comfort and reduce energy costs. Install energy management system for optimal energy conservation with capability to monitor and control system off-site to reduce technician visits to building. Replace cell plumbing fixtures and associated piping and valves in the older section that are at end of system lifecycle. Replace deficient costly plumbing valves.

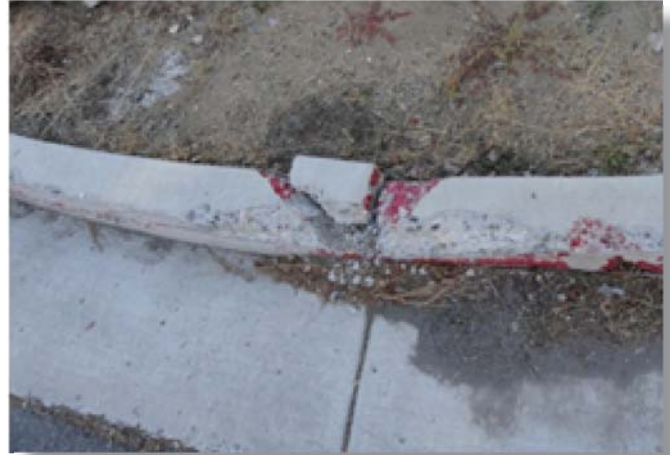
**CONCRETE CURB**

Concrete curb damage.

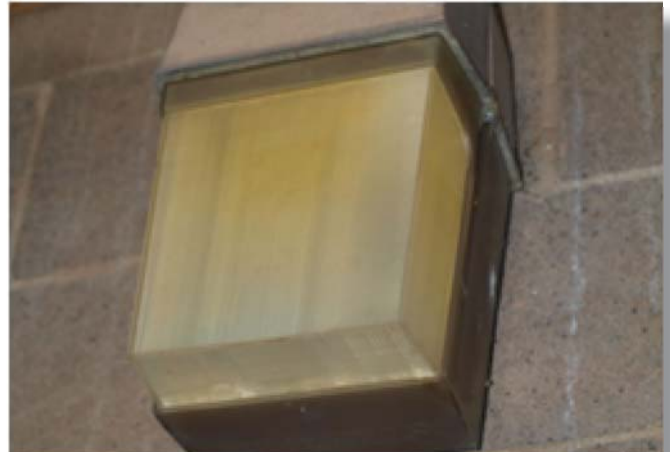
**EXIT LIGHT**

Lenses on exterior light fixture yellowed with age.

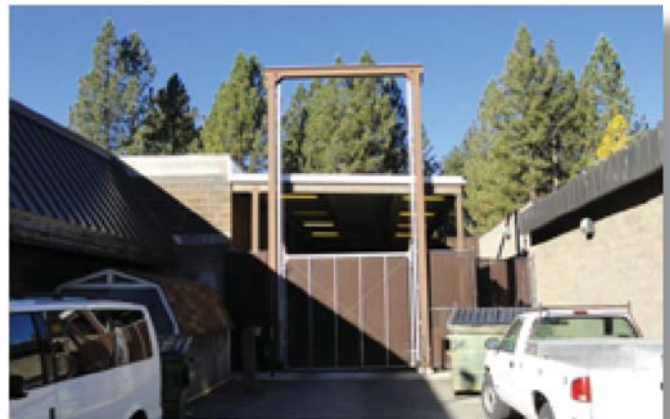
**SALLY PORT**

Lift mechanism occasionally sticks during winter weather.

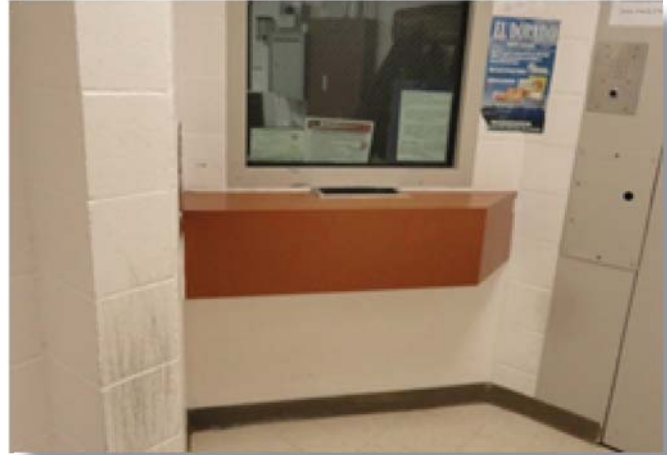
### **BAIL WINDOW**

Bail window may require ADA upgrades.

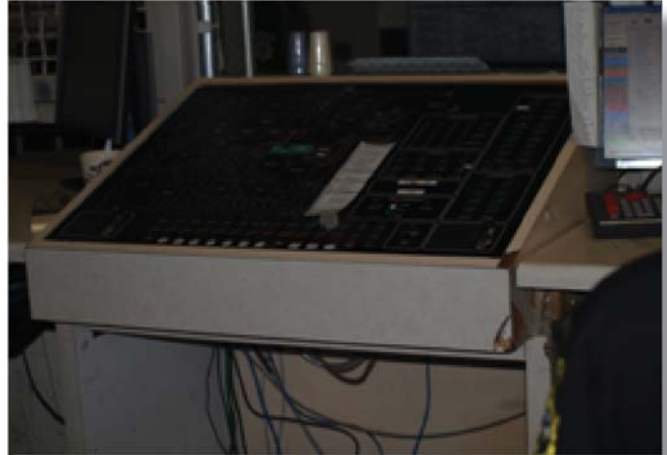
### **CONTROL PANEL**

Booking control panel in poor condition.

- Replace older panels, feeders and generator near or at end of lifecycle. Replace older existing lighting with energy efficient fixtures with appropriate security housings. Replace security access control, cameras, control station equipment and intercom system.

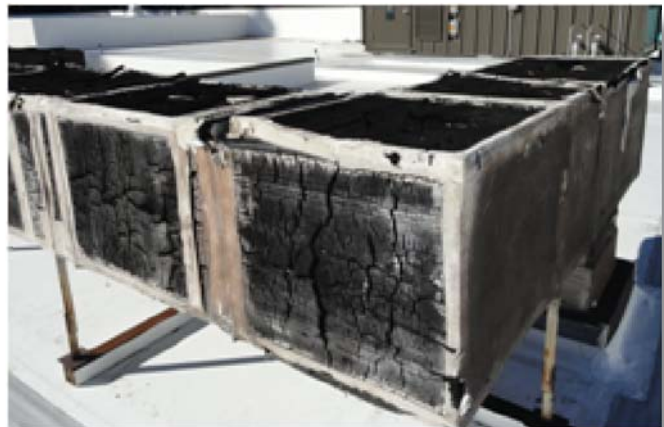
### **ROOF HVAC DUCTS**

Insulation of exposed duct is no longer functioning and needs to be replaced.

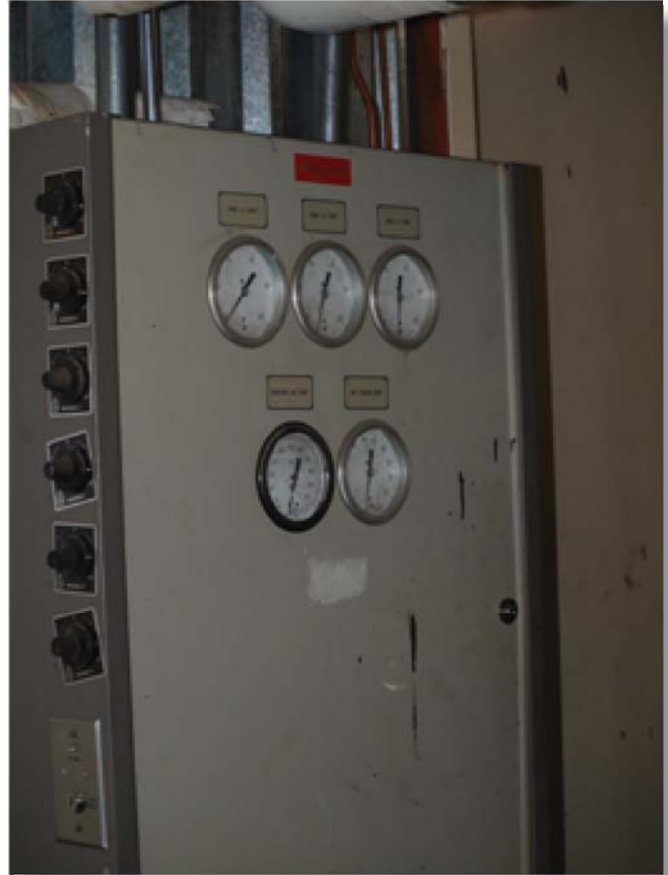
**CONTROLS**

Controls for the air handling units are obsolete.

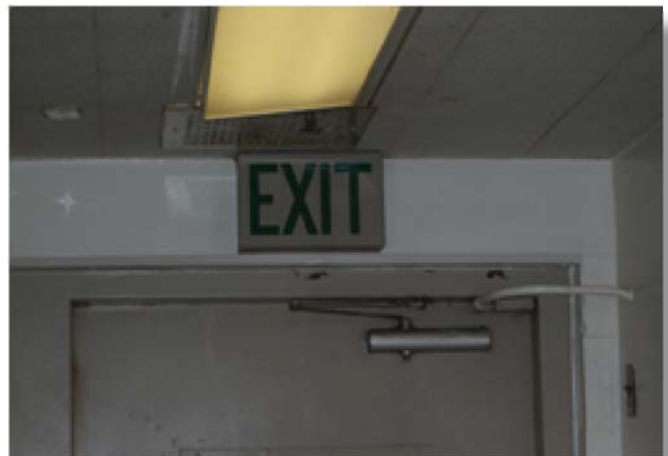
**EXIT**

The exit light above the door does not work.

- Fire and safety modernization should be addressed. Install new emergency and exit lighting. Have the fire sprinkler system tested to determine if and where corrosion has occurred in the piping from water ponding or MIC from the water quality on the dry pipe system. Replace piping and sprinkler heads that are determined to be sufficiently corroded to maintain the integrity of the system in place to reduce the cost for complete replacement of the system. Replace dirty heads, deficient valves and air compressor on fire sprinkler system. Provide combination fire/smoke dampers tied to the fire alarm system at all ducts passing through fire rated walls. Modify/replace fire alarm system to incorporate HVAC system and kitchen fire suppression system for alarm and shutdown.

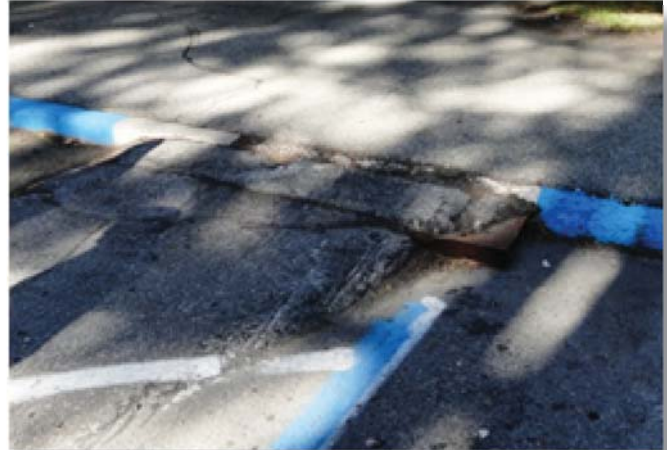
### ADA CURB

Curb ramp next to handicap parking is not ADA compliant.

- Replace asphalt walkways to provide suitable ADA access from parking lot.

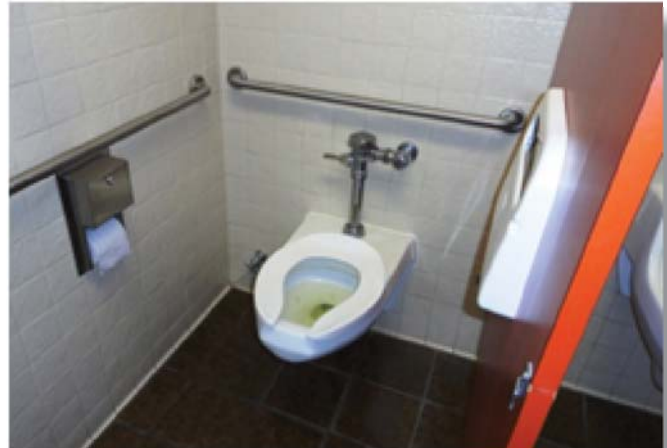
### ADA TOILET

Restroom is mostly ADA compliant. May require some enhancements.

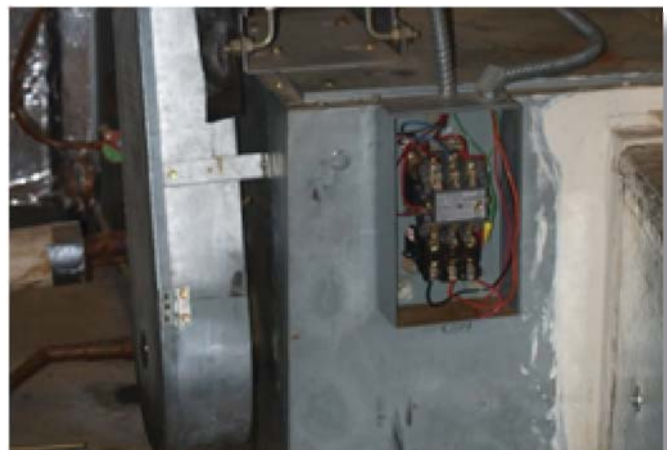
### AIR HANDLER ELECTRICAL BOX

Cover is missing from air handler electrical box. Moisture or dirt could cause problems with connections.

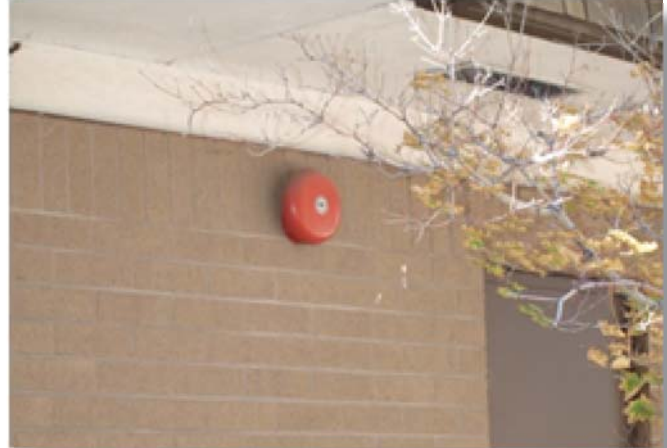
### **BELL**

Fire sprinkler bell provides only alarm to building.  
There are no visual alarms for hearing impaired.

- Fire and safety modernization should be addressed. Install new emergency and exit lighting. Have the fire sprinkler system tested to determine if and where corrosion has occurred in the piping from water ponding or microbiologically Influenced corrosion (MIC) from the water quality on the dry pipe system. Replace piping and sprinkler heads that are determined to be sufficiently corroded to maintain the integrity of the system in place to reduce the cost for complete replacement of the system. Replace dirty heads, deficient valves and air compressor on fire sprinkler system. Provide combination fire/smoke dampers tied to the fire alarm system at all ducts passing through fire rated walls. Replace fire alarm system to meet current codes and to incorporate HVAC system for alarm and shutdown.

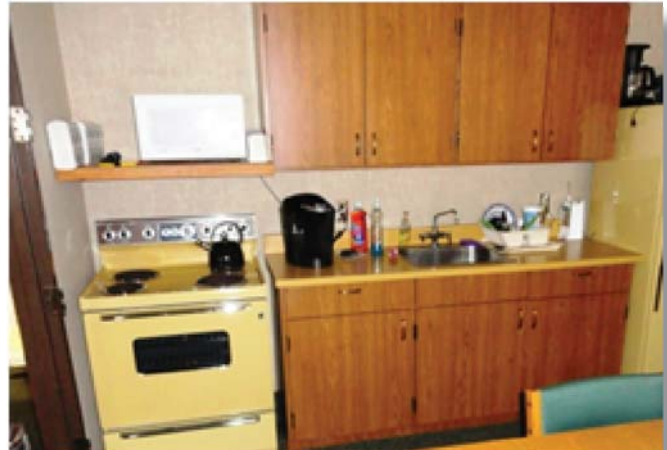
### **BREAKROOM**

Break room sink may need ADA updates.

- Modify break room cabinets for ADA compliance.
- Replace roofing and flashings. Consider adding tapered insulation to provide positive flow.
- Replace air handlers and condensing units at or near end of useful life. Replace original ductwork to improve air quality, occupant comfort and reduce energy costs. Install energy management system for optimal energy conservation with capability to monitor and control system off-site to reduce technician visits to building. Replace defective sewer and water piping along with valves.

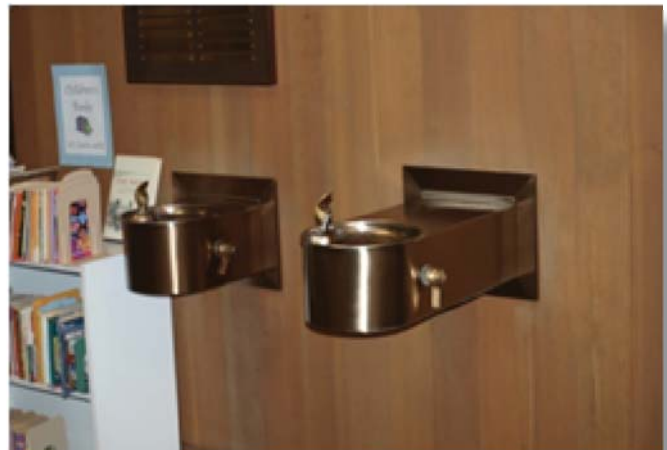
### **DRINKING FOUNTAIN**

Non ADA drinking fountain.

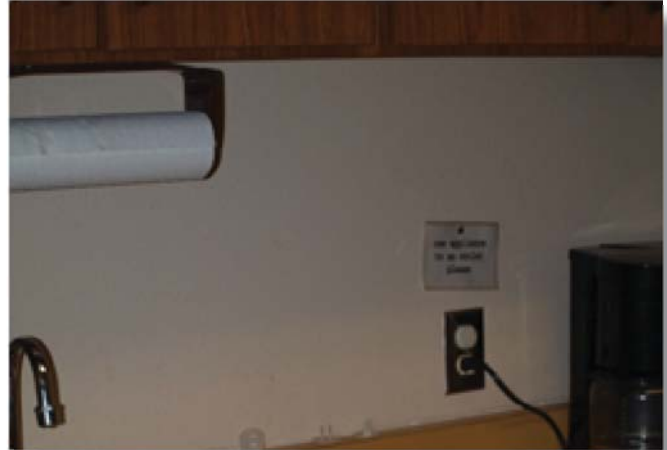
**GFI**

No GFI receptacle installed at sink.

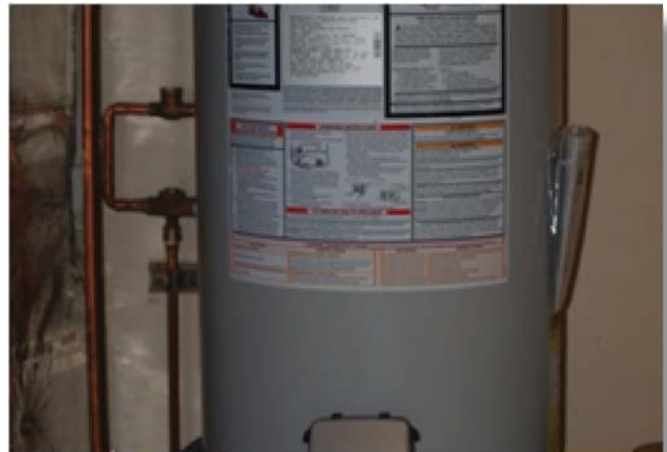
**HOT WATER**

Hot water heater does not have earthquake strap installed.

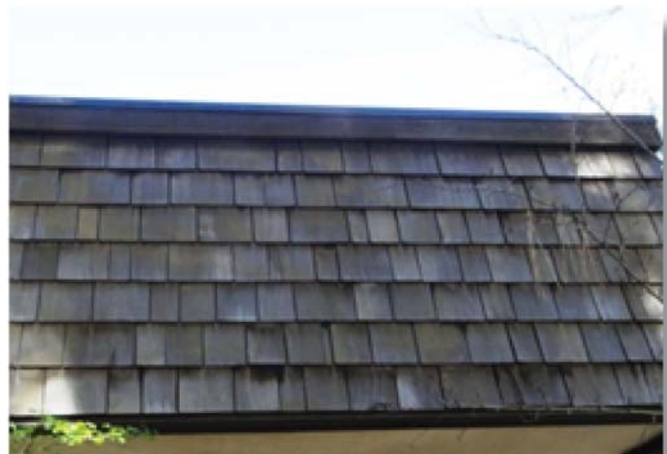
**MANSARD**

Wood shingles on mansard are brittle, cupped and have splits.

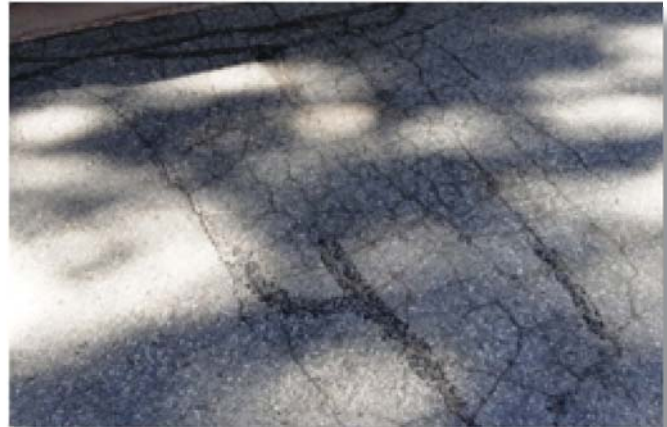
### **PAVEMENT**

Parking lot pavement deterioration.

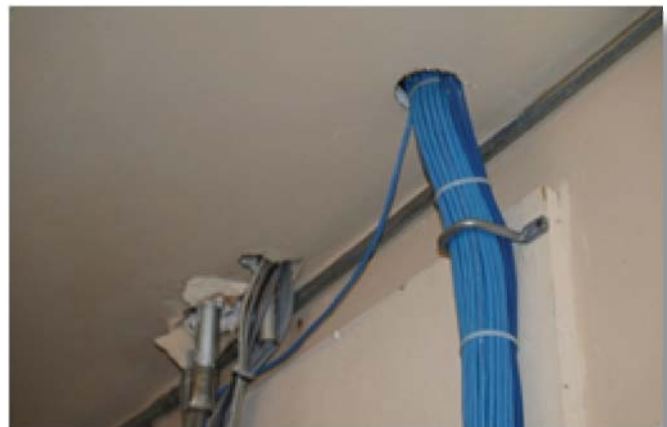
### **PENETRATIONS**

Penetrations for data cables and electrical conduits through the ceiling are not properly sealed.

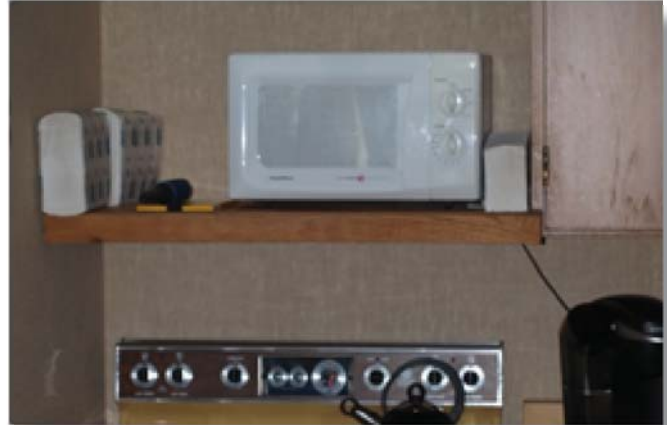
**STOVE**

The stove does not have a range hood.

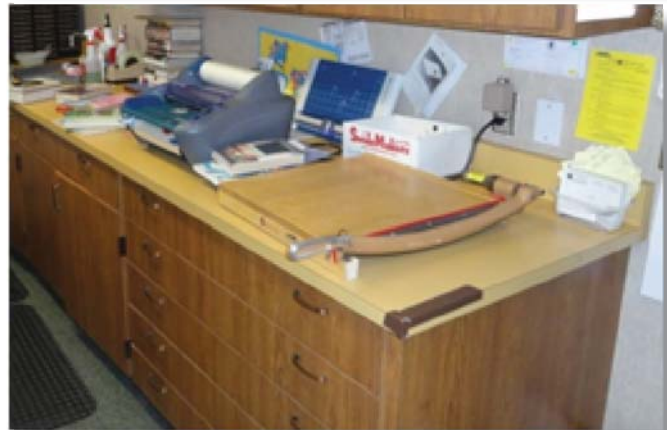
**WORKROOM COUNTER**

<b>Category</b>	<b>Deficiencies</b>	<b>Cost</b>
9	Miscellaneous	Plastic laminate counter in the workroom is chipped.	\$0

Laminate on counter top held in place with duct tape.
